Feasibility Investigation of Segmentally Precast Bridge Piers for Accelerated Construction

Final Report
March 2009

Sponsored by
the Iowa Department of Transportation (Project 06-257)
and
the Iowa Highway Research Board (Project TR-556)

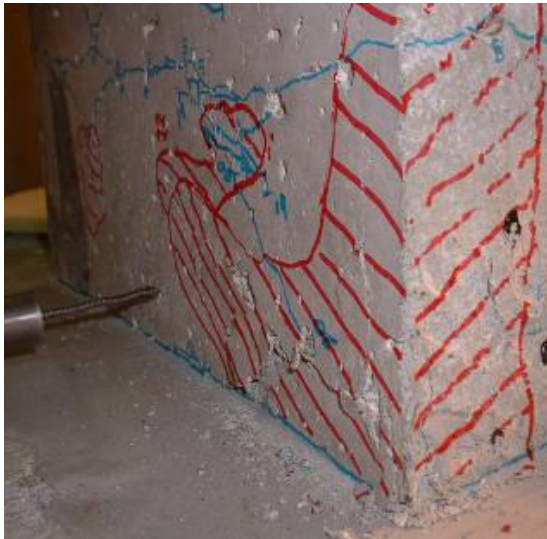
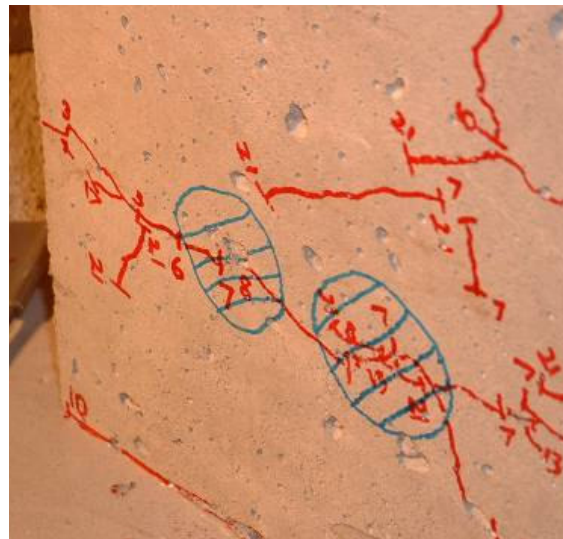
a.) Southwest corner compression damage

b.) East face initial compression damage

Figure 76. Photographs of Column 1 - Cycle 22.

Cracks continued to expand and develop further up the column as cycles continued and lateral loads increased (see Figures 73 and 74). From Cycles 20 to 22, several areas on the compression face of the column began to exhibit localized compression damage and are denoted by hatched areas drawn on the column faces (see Figures 75 and 76). Major compression damage that localized in the southwest corner of the column was observed on Cycle 20 (displacement = ± 5.0 in.) (see Figures 77a and 78). As the previously observed damage increased on subsequent cycles, the column began to tilt to the south, perpendicular to the axis of loading. On Cycle 21 (displacement = ± 5.0 in.), Column 1 attained its maximum lateral load of + 9.7 kips.

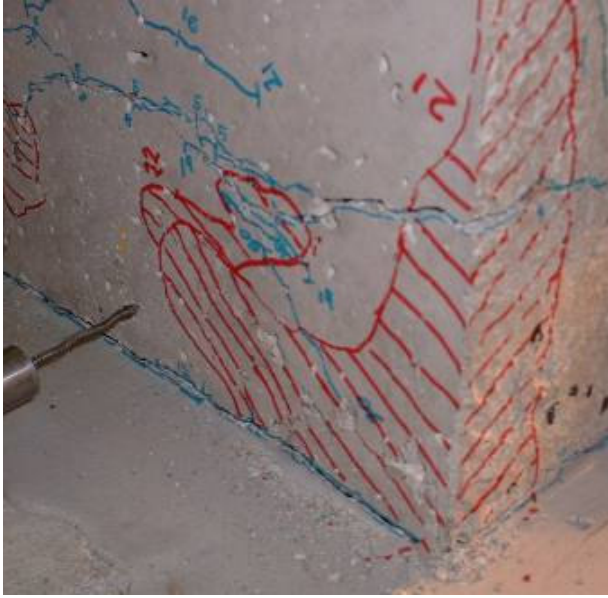
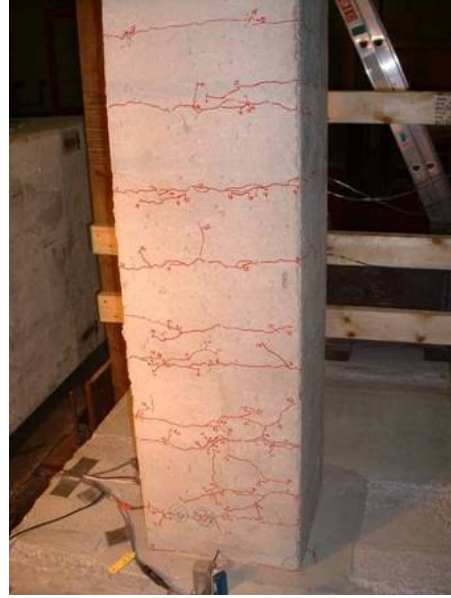
a.) Southwest corner compression damage

b.) East face crack progression

Figure 77. Photographs of Column 1 - Cycle 23.

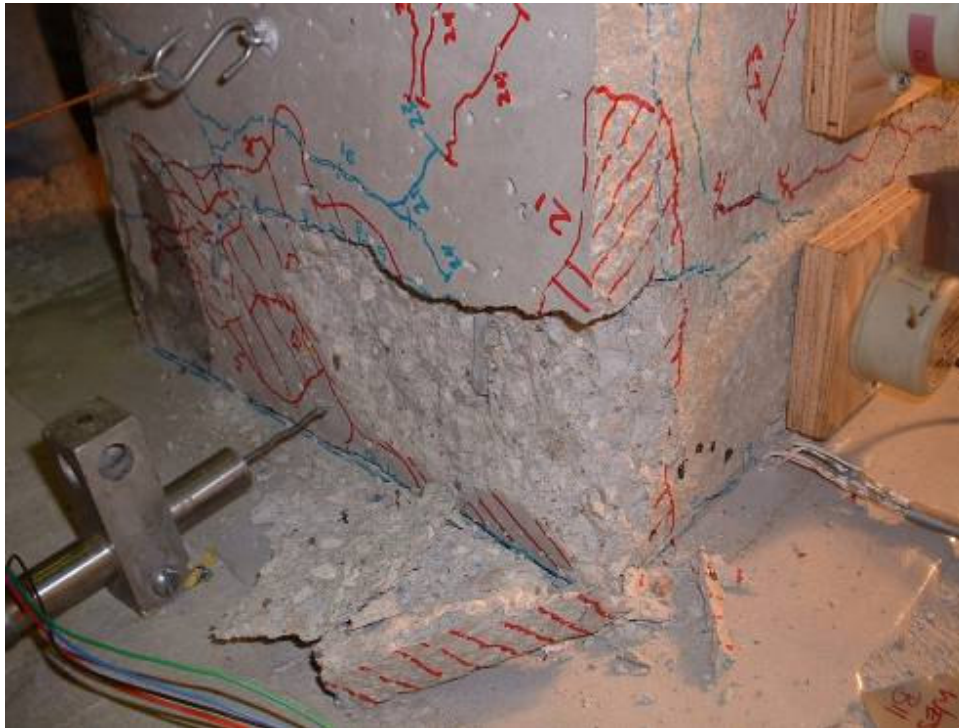
Figure 78. Photograph of Column 1 – Cycle 24 damage to southwest corner.

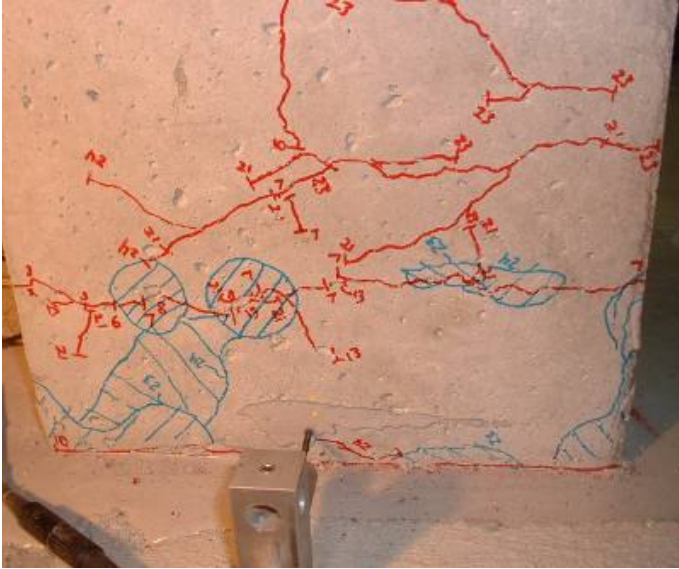
a.) East face damage

b.) North face crack progression

Figure 79. Photographs of Column 1 - Cycle 24.

Additional cycles produced more spalling of concrete, most notably on the southwest corner of the column near the base (see Figures 79-81), a reduction in lateral load, and further tilting of the column to the south (see Figure 82). It was observed during Cycle 25 that the load beam was in contact with the testing frame (see Figure 82a). On Cycle 27 (displacement = ± 9.0 in.), the damage was severe enough that the longitudinal reinforcement in the column was visible and exhibited clear signs of buckling (see Figures 82-84). Furthermore, the lateral load applied to the column had fallen off sharply, and the column was in danger of becoming unstable. Therefore, testing was stopped after Cycle 27. Quantitative lateral load versus displacement data are presented in Chapter 7.

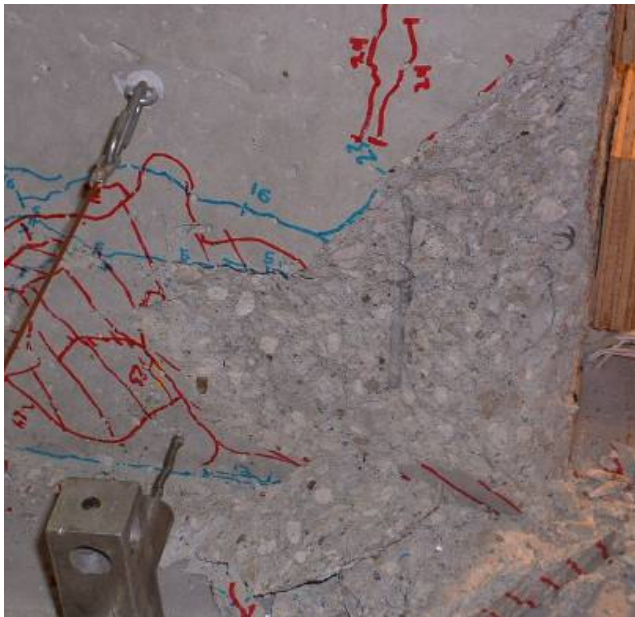
a.) Southwest corner damage

b.) East face damage

Figure 80. Photographs of Column 1 - Cycle 25.

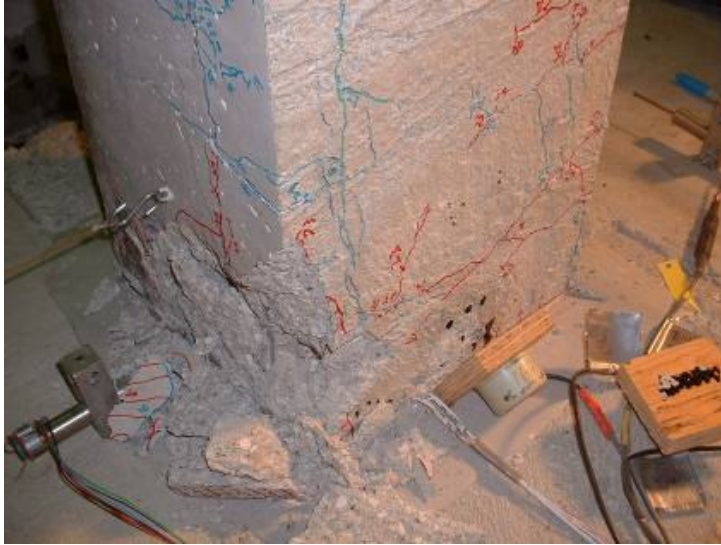
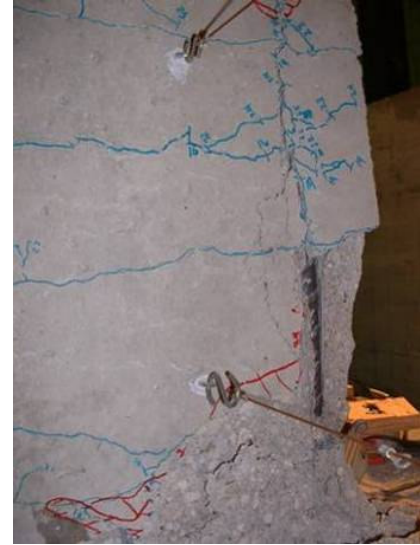
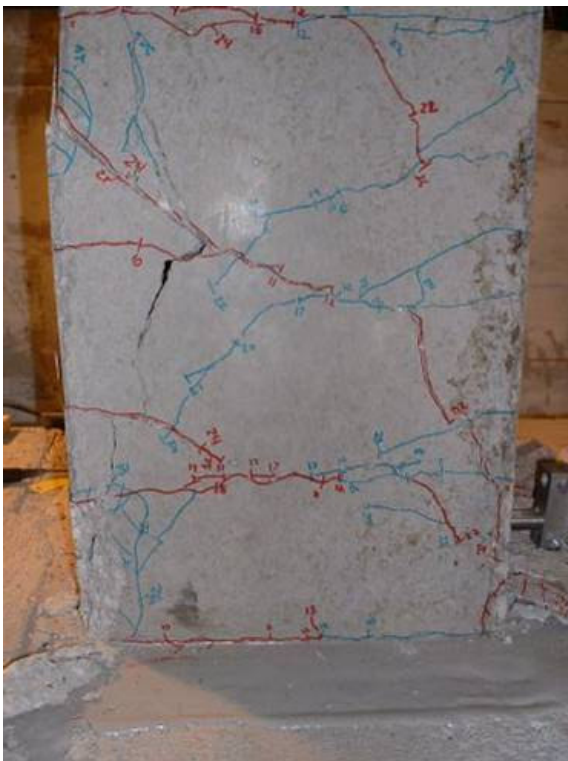
a.) Severe spalling of southwest corner

b.) Visible southwest corner reinforcement

c.) North face cracking/spalling

d.) East face bulging due to buckled reinforcement

Figure 81. Photographs of Column 1 - Cycle 26.

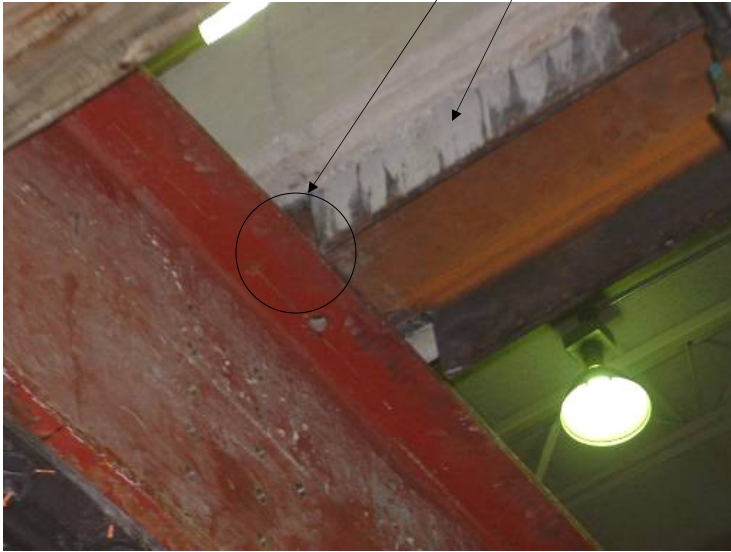
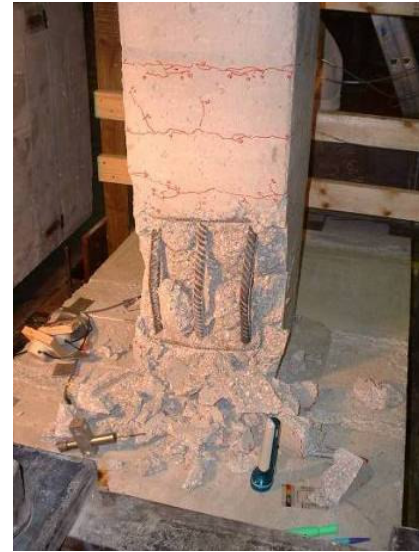
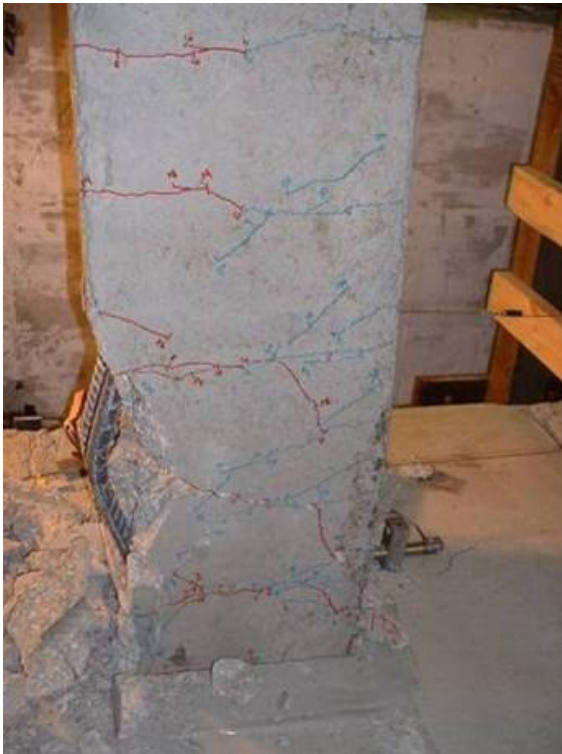
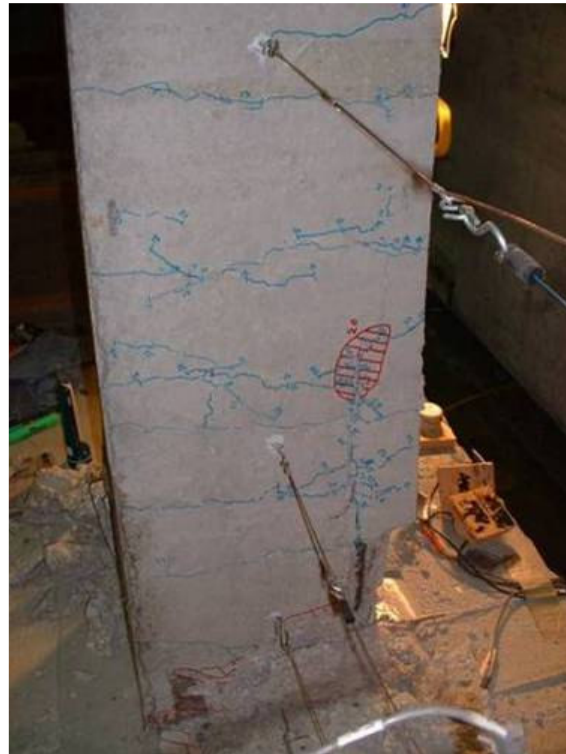
Contact between load frame and load beam Flange of load beam

a.) Frame impingement with underside of load beam

b.) East face reinforcement exposed

c.) North face cracking/bulging

d.) West face damage

Figure 82. Photographs of Column 1 - Cycle 27 damage/frame impingement.

During the last three positive (push) half-cycles of + 7.0 in., + 8.0 in., and + 9.0 in. displacements, the load beam impinged on the load frame when displacements exceeded + 7.0 in. This impingement and the associated tilting to the south occurred only on the positive portions of the loading cycles. This caused spuriously high lateral load readings on these half-cycles. Testing was continued beyond the + 7.0 in. displacement, because the problem did not occur on the negative (pull) half-cycles. Thus, testing was continued until failure occurred on the negative half of Cycle 27. Due to this occurrence, only the data collected for negative half-cycles for the three largest displacement cycles were considered reliable and indicative of typical column behavior.

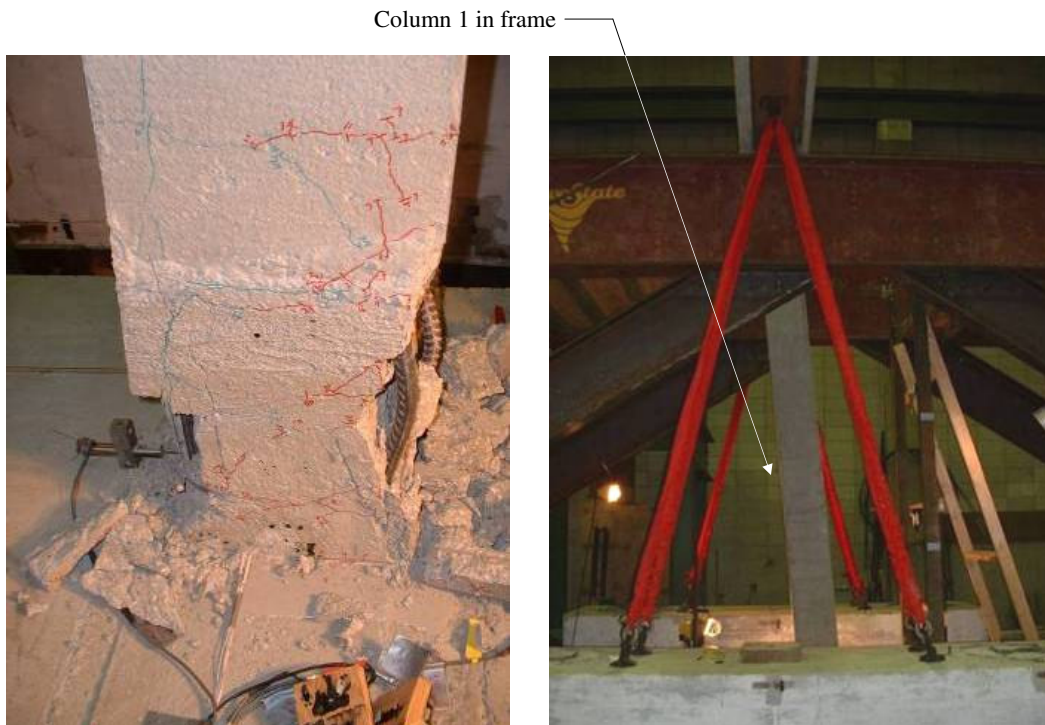
Figure 83. Photographs of Column 1 - Cycle 27 damage and deformation.

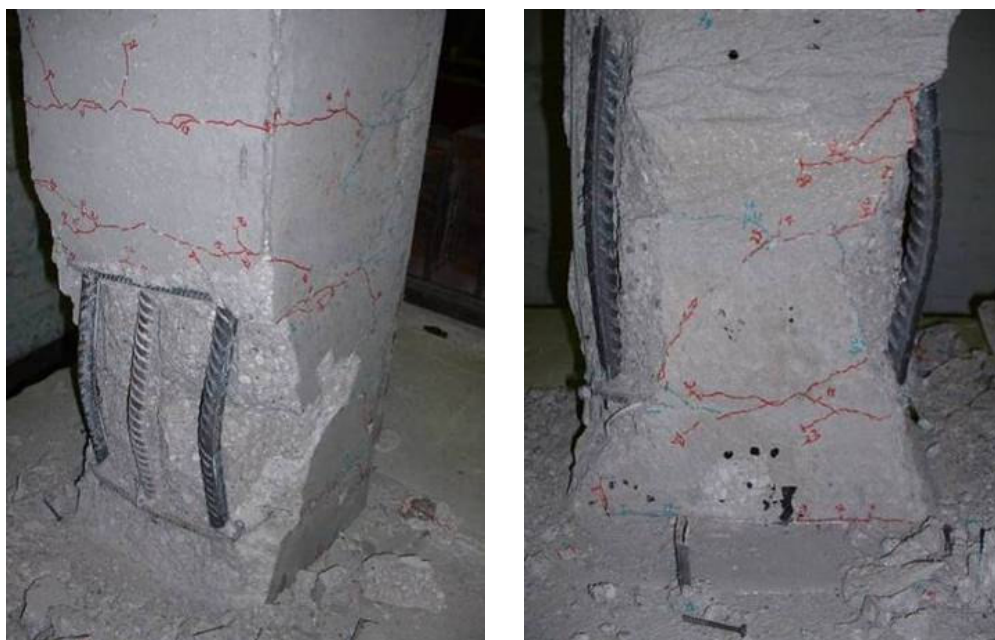
Figure 84. Photographs of Column 1 – After testing.

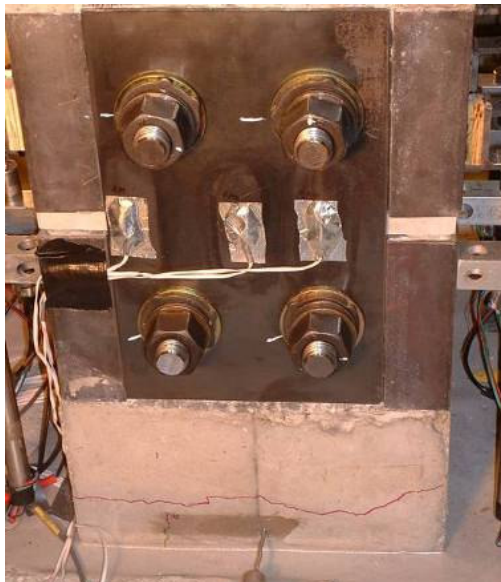
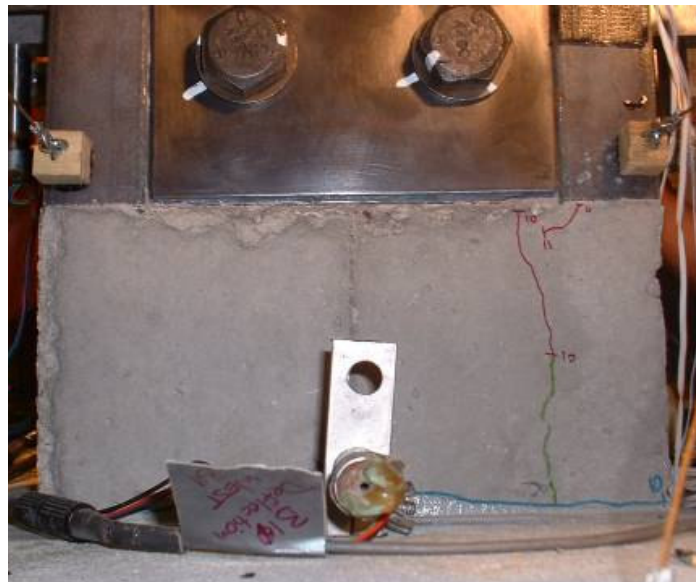
a.) East face

b.) West face

Figure 85. Photographs of Column 2 – Cycle 11a initial cracking.

Testing of Column 2 commenced and continued to a ± 6 in. displacement. The incremental damage accrued over the imposed displacement regimen is illustrated in Figures 85-92. Cracking across the entire column was first observed on Cycle 10a (displacement = ± 0.75 in.) (see Figure 85). On the positive (push) half-cycle, cracking occurred 2 in. above the base of the column on the east face; on the negative (pull) half-cycle, cracking occurred at the base of the west face of the column. Also during Cycle 10a, "pinging" in the fuse plate on the tension side of the column was heard, indicating slippage in the slip resistant connection between the fuse plate and the steel collar. "Pinging" was heard on each consecutive cycle in the tension fuse plates throughout the remainder of Test a. During Cycles 11a to 16a, small cracks formed every 8 in. to 12 in. across the column for several feet above the construction joint (see Figures 86 and 88). The fuse plate in compression began to buckle on Cycle 13a (displacement = ± 1.5 in.) and is shown buckling during Cycle 14a in Figure 87b. During Cycle 15a, the crack that formed between the upper column collar and the concrete grew noticeably (see Figure 88). Since Cycle 16a was the predetermined cycle to replace fuse plates, testing was stopped and new plates were mounted on the column. At this juncture, a peak load of + 6.39 kips had been applied to the column.

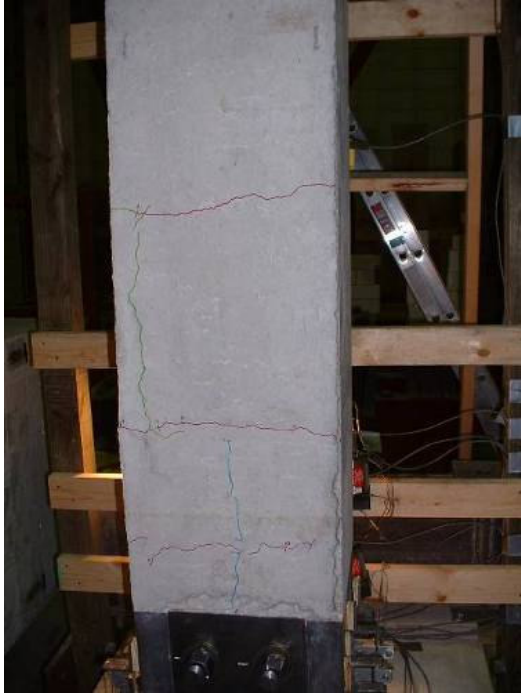
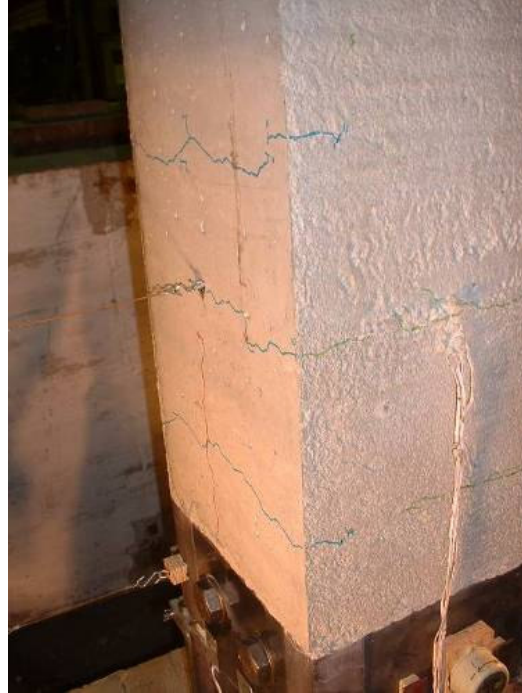
a.) East face crack progression

b.) Southwest corner crack progression

Figure 86. Photographs of Column 2 – Cycle 11a upper column crack progression.

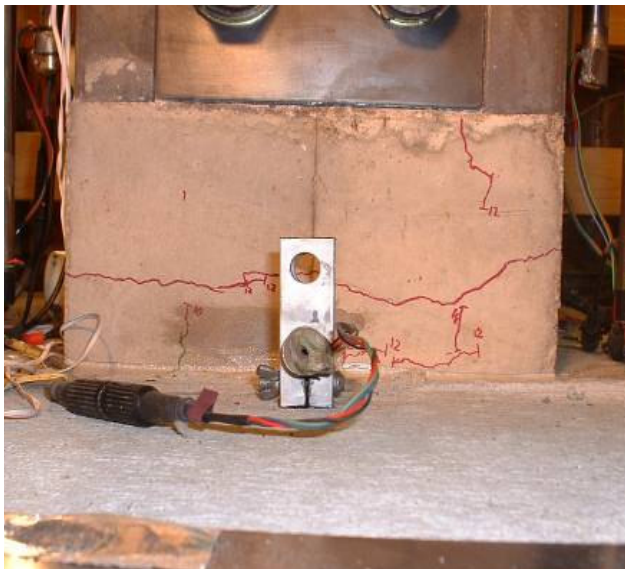
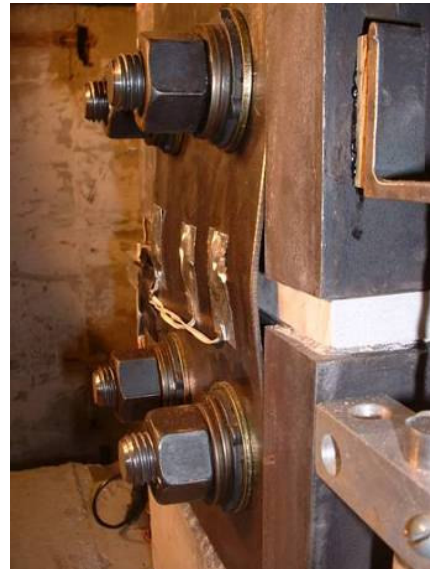
a.) East base cracking

b.) Initial buckling of east plate

Figure 87. Photographs of Column 2 – Cycle 14a.

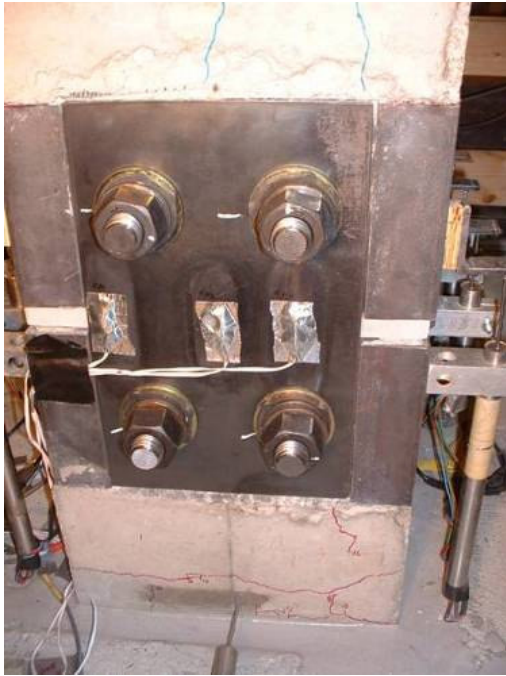
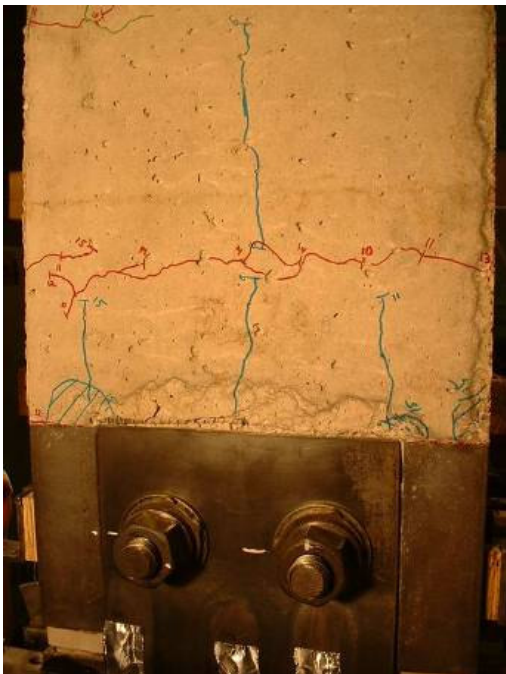
a.) East face

b.) East face crack progression

c.) East face cracking above top collar

d.) Southwest corner collar/column interface

Figure 88. Photographs of Column 2 – Cycle 15a.

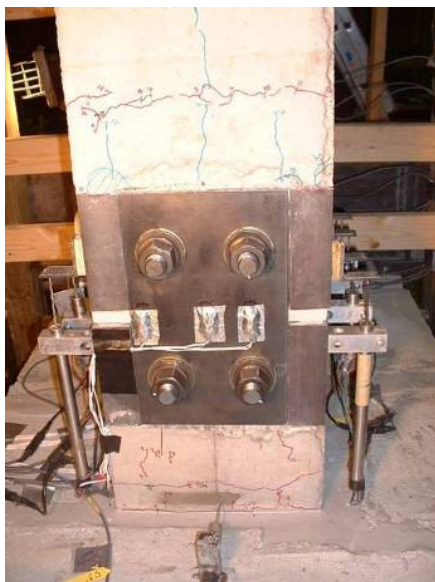
a.) East face

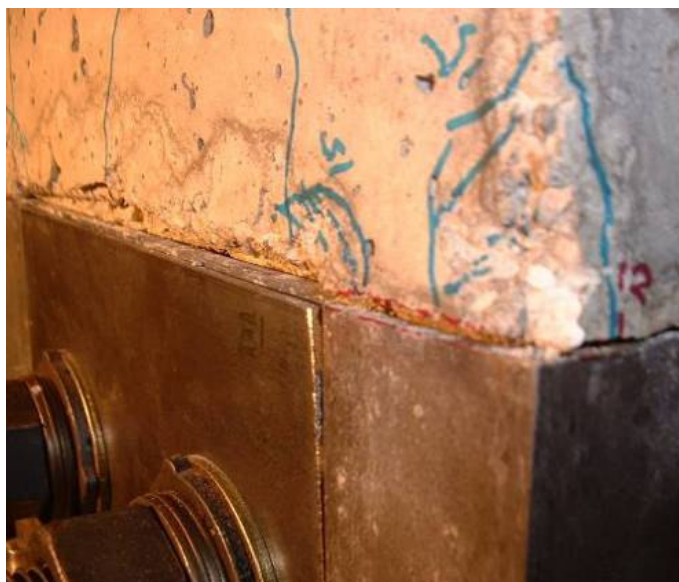
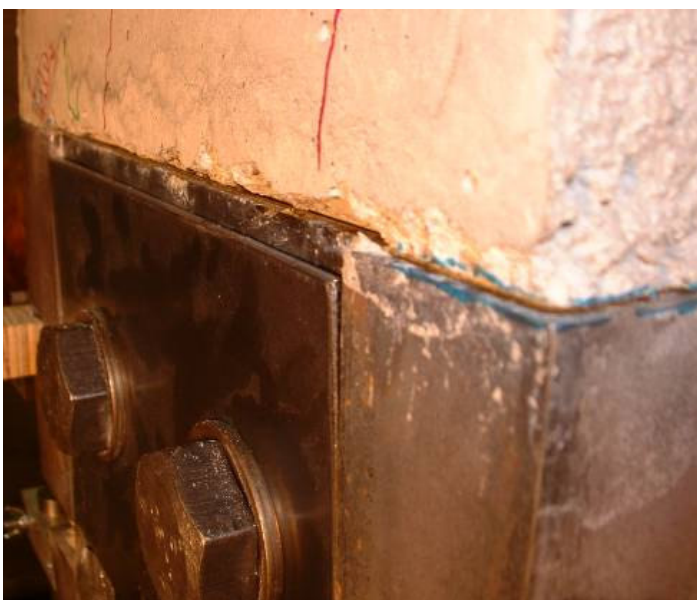
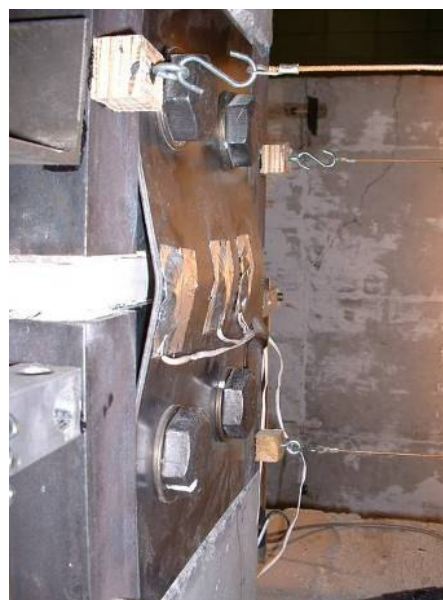
Figure 89. Photographs of Column 2 – Cycle 16b.

b.) Northeast corner collar/column interface

c.) West collar/column interface

d.) Buckling of replaced west plate

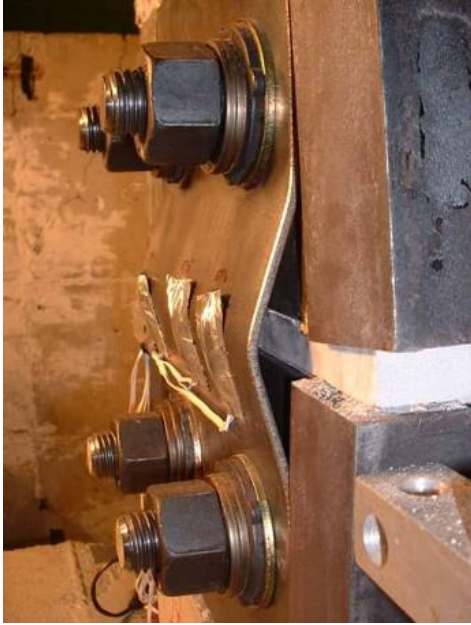
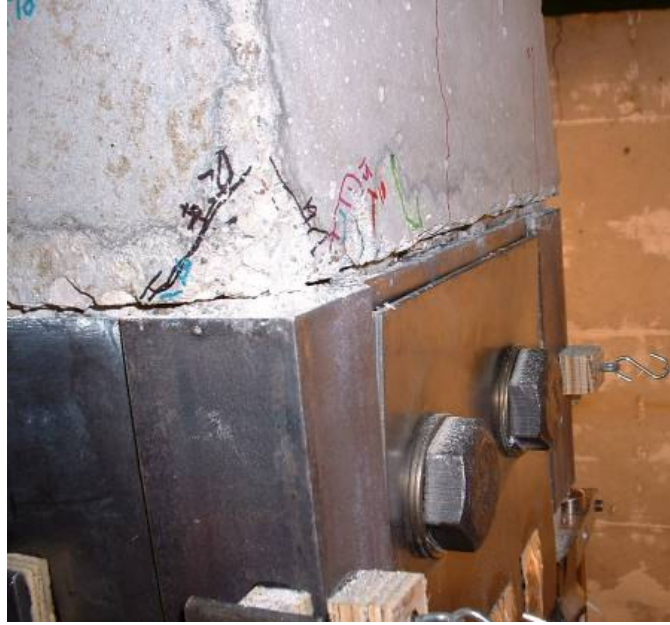
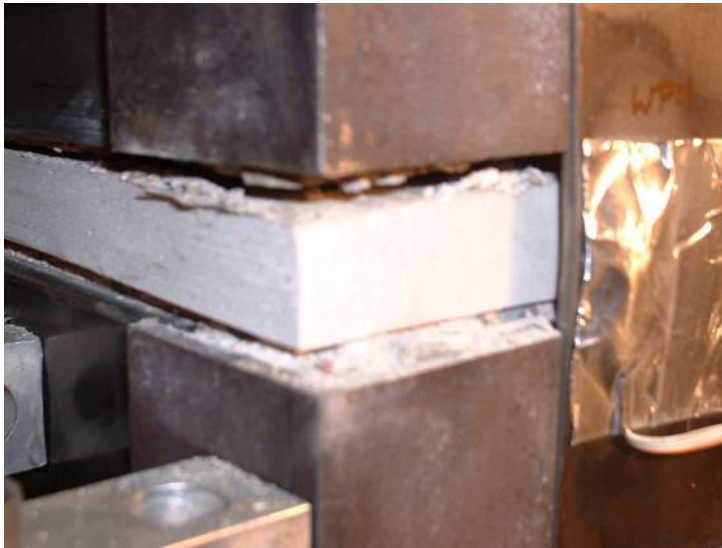
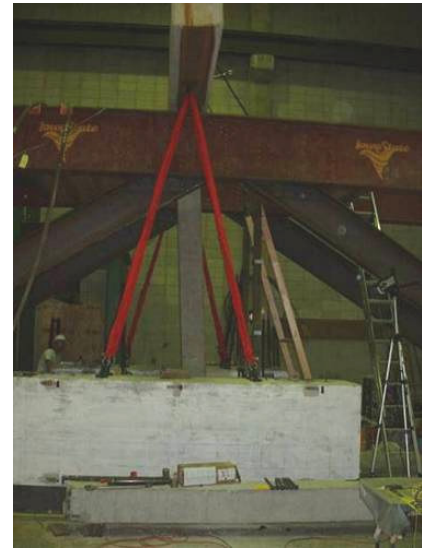
Figure 92. Photographs of Column 2 – Cycle 23b.

a.) East plate buckling during last cycle

b.) West collar/column interface final crack width

c.) Northwest corner of bearing plate

d.) Column tilt during negative half-cycle

to the segment. This phenomenon is shown during Cycle 23b in Figure 92b. Also during Cycle 22b, a crack was observed on the northwest corner of the bearing plate. The test was stopped after Cycle 23b due to the opening of the crack between the collar and column; it was evident that the decrease in load at each displacement was due to this phenomenon. A maximum load of + 6.64 kips was observed during Column 2's test on Cycle 14a (displacement = +/- 2.0 in.), while a maximum displacement of 6.0 in. was recorded for the test. At + 6.0 in., a load of + 4.48 kips was achieved, while a - 3.27 kip load was achieved at - 6.0 in. Quantitative lateral load versus displacement is shown in Chapter 7.

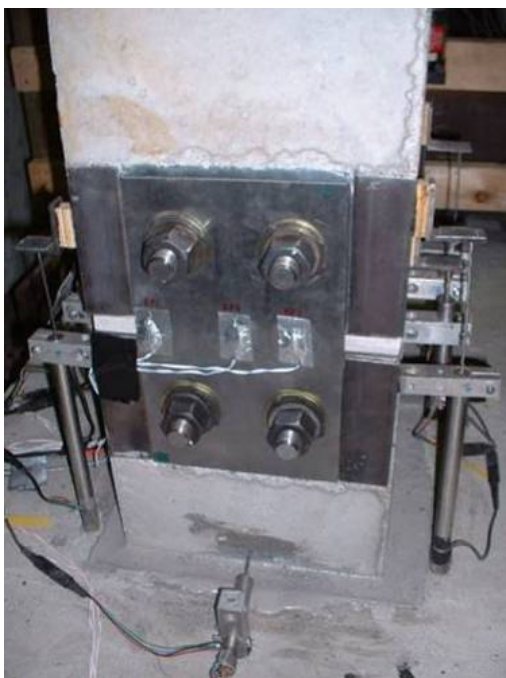
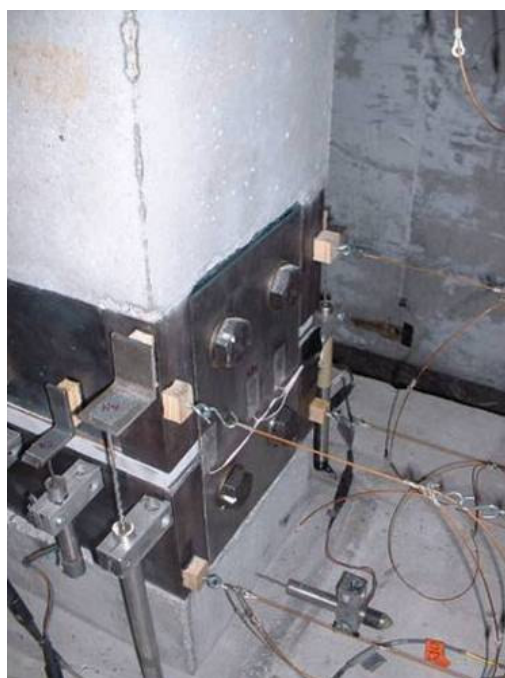
Figure 93. Photographs of Column 3 – Prior to testing.

a.) East face

b.) West face

Testing of Column 3 commenced and continued until ± 9.0 in. displacements were reached. The incremental damage accrued over the imposed displacement regimen is illustrated in Figures 93-105. Cracking across the entire column was observed on Cycle 10a (displacement = $\pm .75$ in.) (see Figures 94 and 95). On the positive (push) half-cycle, cracking occurred at the base of the column on the east face, as well as 1 ft. above the top collar; on the negative (pull) half-cycle, cracking occurred 1 in. above the base on the west face of the column. During the next several cycles, small cracks formed every 6 in. to 10 in. up the column face for several feet above the construction joint (see Figures 97a and 97b).

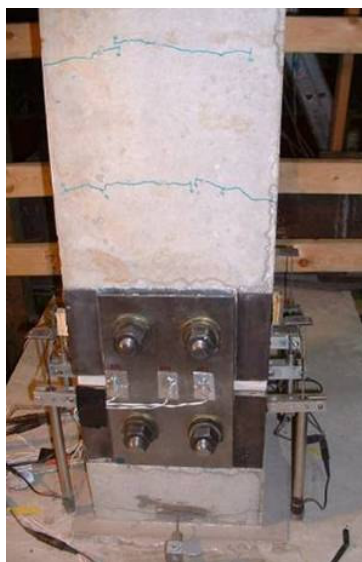
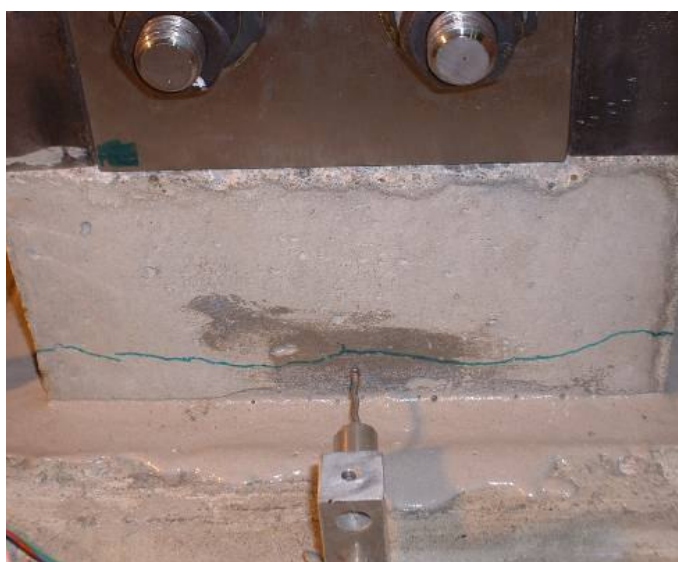
Figure 94. Photographs of Column 3 – Cycle 10a east face.

a.) East face crack progression

b.) East base initial cracking

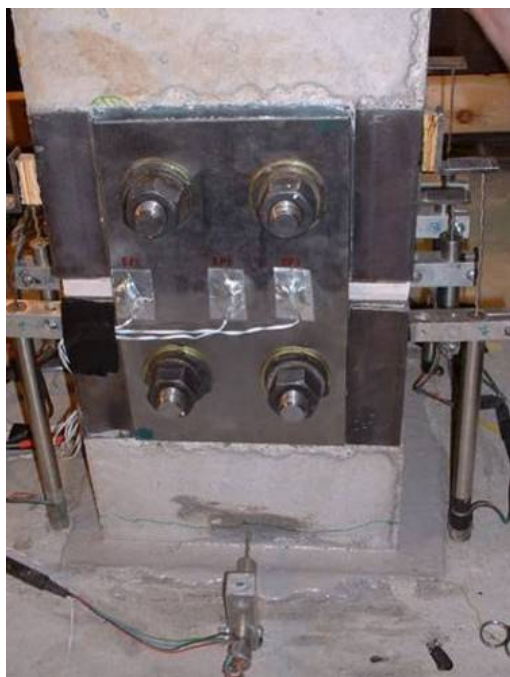
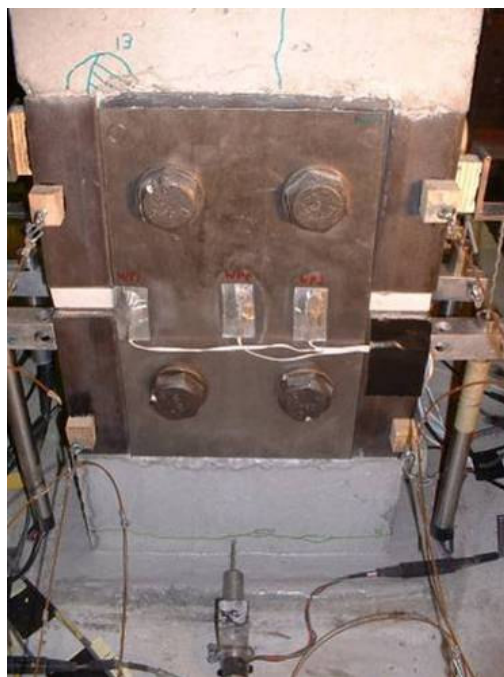
Figure 96. Photographs of Column 3 – Cycle 14a fuse plates.

a.) East plate and column face

b.) West plate and column face

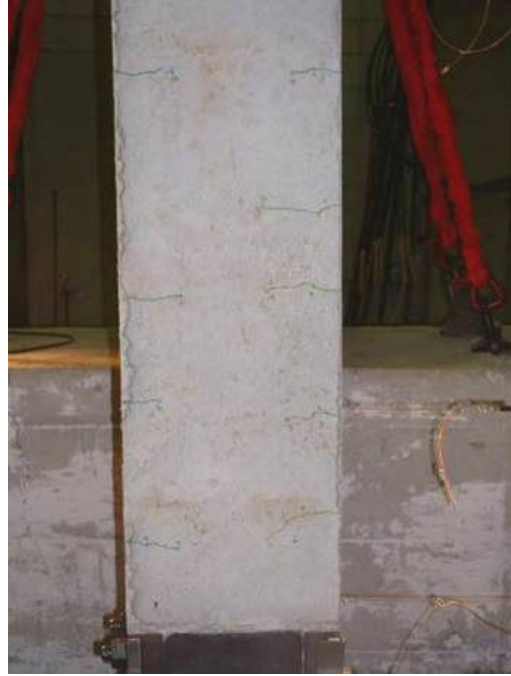
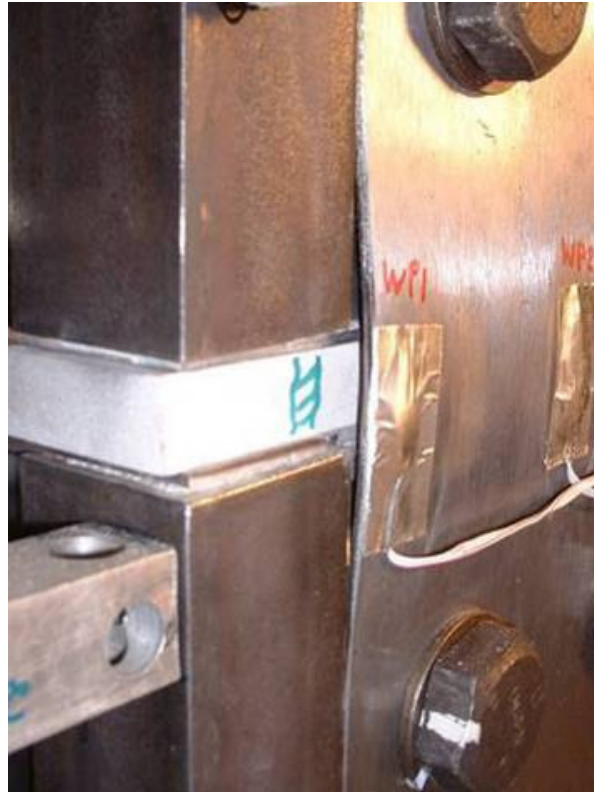
Figure 97. Photographs of Column 3 – Cycle 14a.

a.) West face cracking above collar

b.) North face crack progression

c.) Initial buckling of fuse plate and compression damage in bearing plate

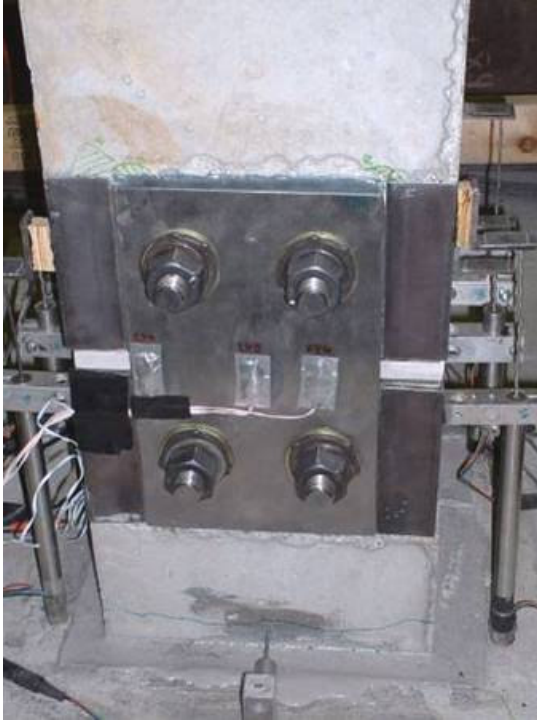
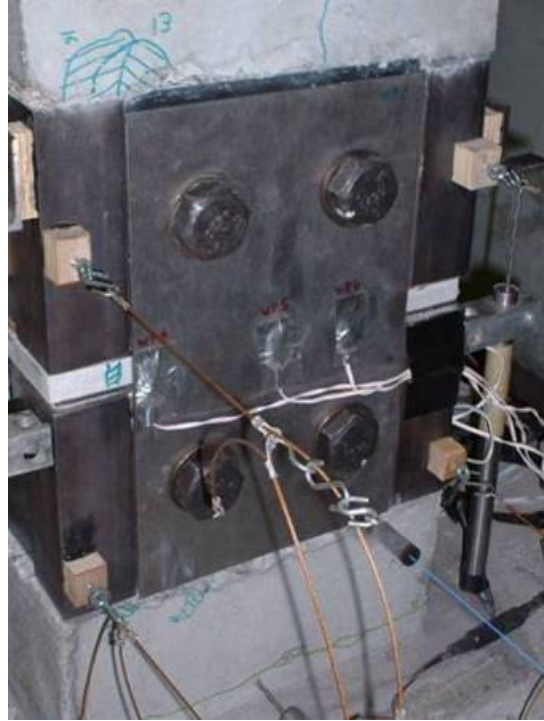
Figure 98. Photographs of Column 3 – Replacement fuse plates.

a.) East replacement fuse plate

b.) West replacement fuse plate

After replacing the fuse plates (see Figure 98), the displacement regimen was restarted. "Ticking" was heard in the east plate on Cycle 15b indicating slippage between the fuse plate and the collar. On Cycle 16b (displacement = ± 2.5 in.), the crack opening was noted between the top collar and the column segment (see Figure 99). Actuator problems occurred again on Cycle 17b (displacement = ± 3.0 in.) at $- 0.30$ in. At this point, the gain control was turned down in an attempt to regain control of the actuator.

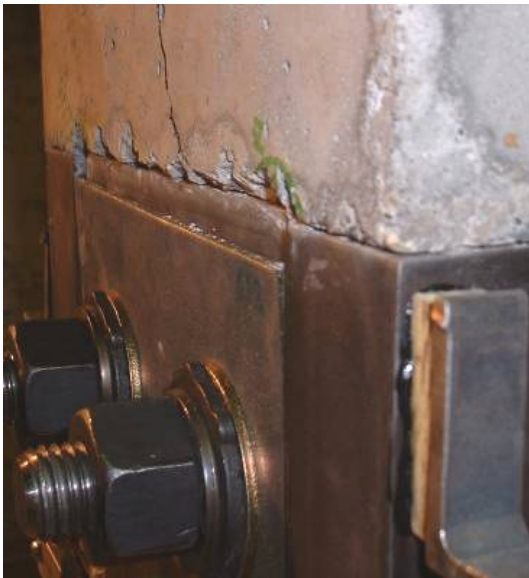
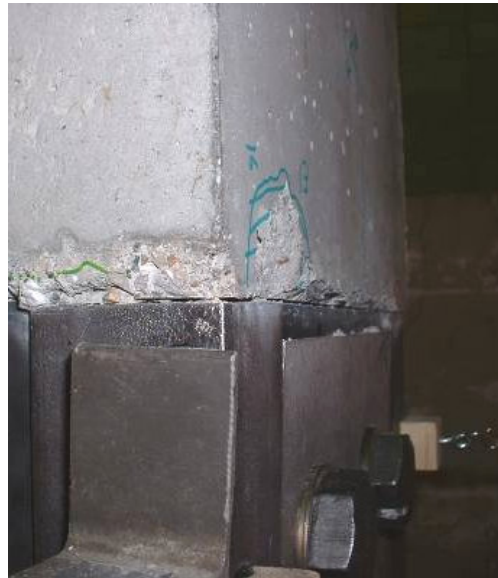
Figure 99. Photographs of Column 3 – Cycle 16b.

a.) Northeast corner interface opening

b.) Northwest corner interface opening

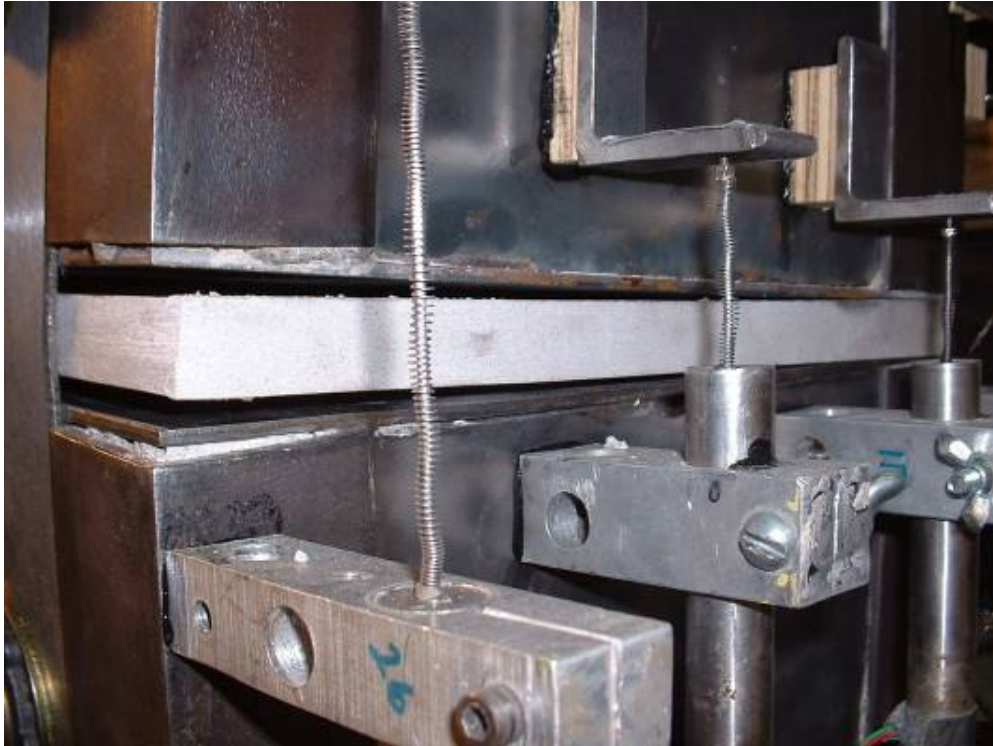
Figure 102. Photograph of Column 3 – Cycle 21b joint opening during push half-cycle.

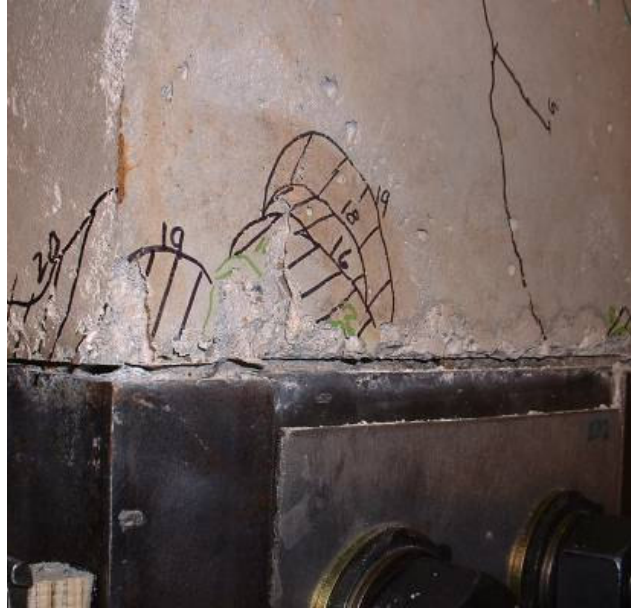
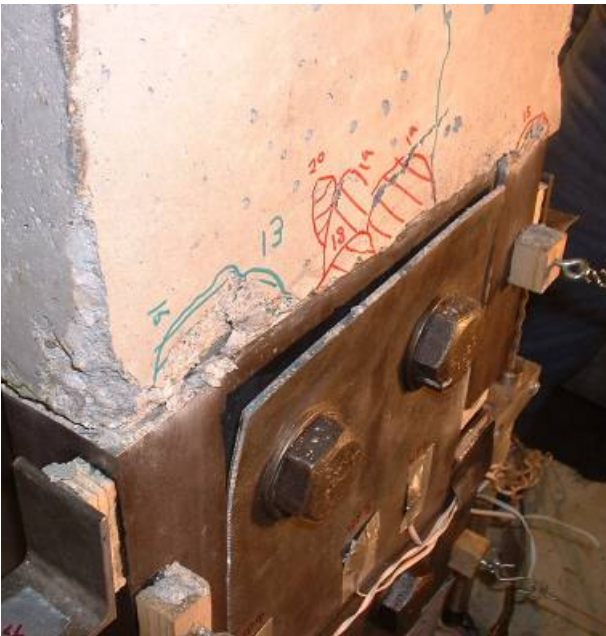
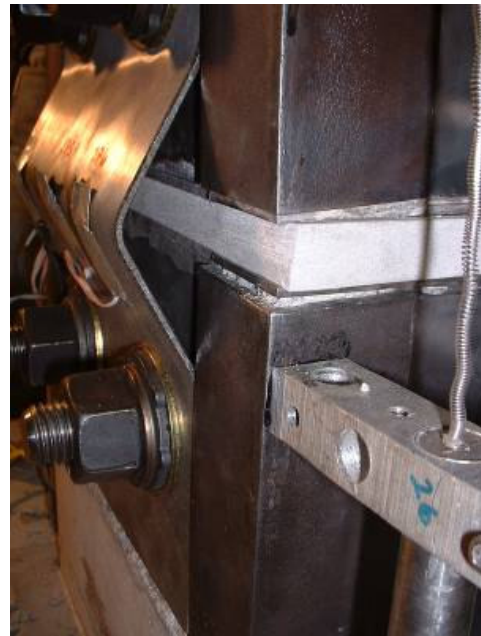
Figure 104. Photographs of Column 3 – Cycle 21b pull half-cycle.

a.) Southeast corner joint opening

b.) Southeast corner interface opening

c.) West bolt bearing causing plate curling

d.) East fuse plate buckling

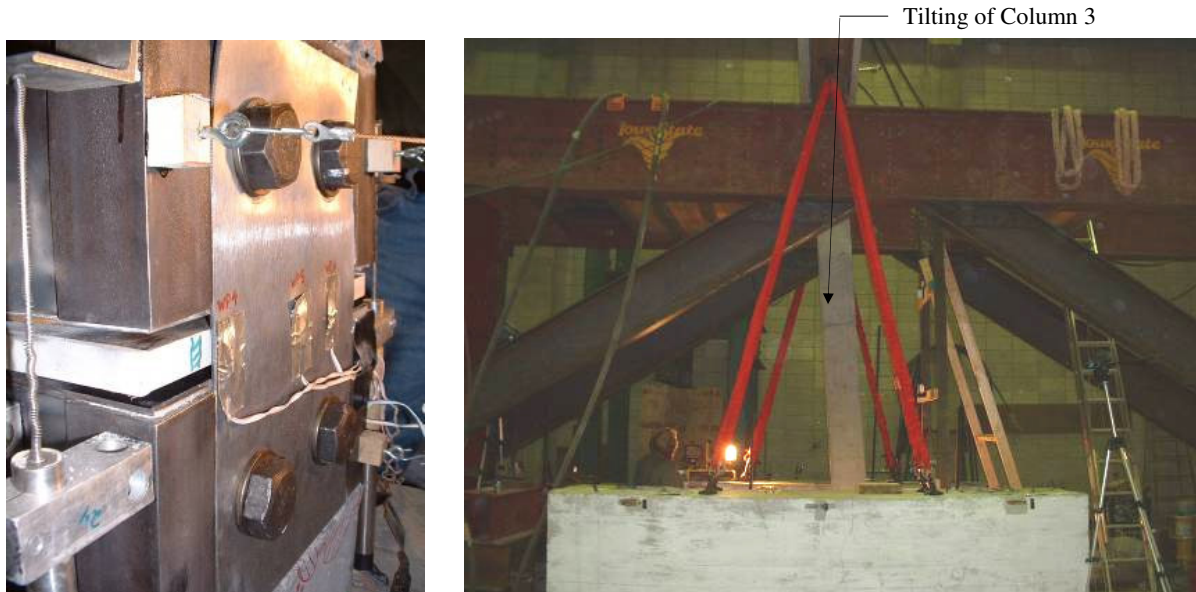
a.) Northeast corner joint opening

b.) Pull half-cycle column deformation

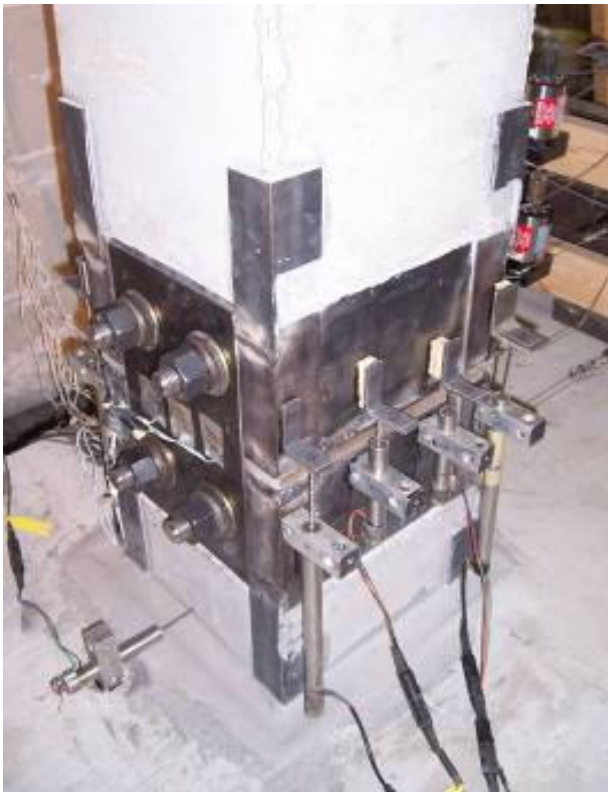
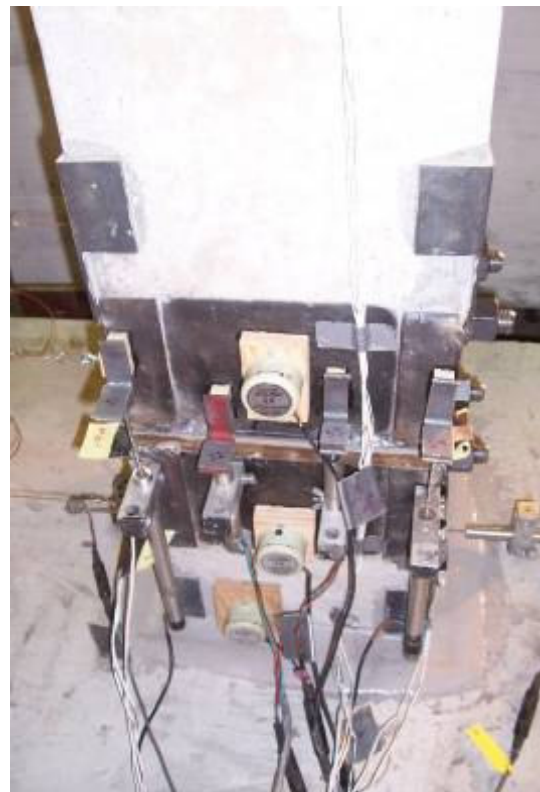
Figure 106. Photographs of Column 4 – Column prior to testing.

a.) Northwest corner of column

b.) South side of column prior to testing

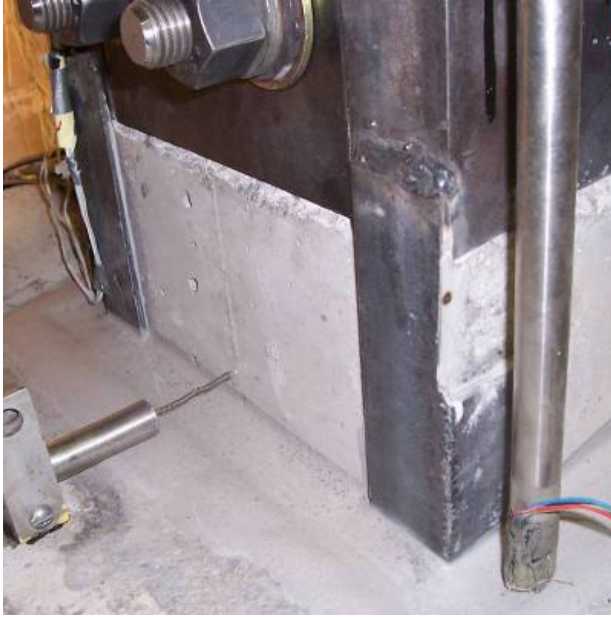
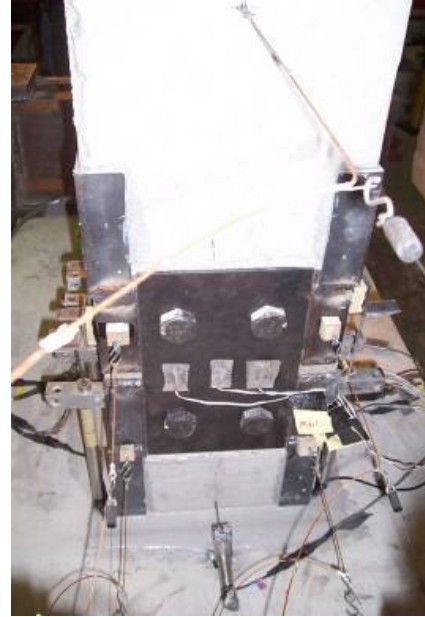
Figure 107. Photographs of Column 4 – Cycle 7a.

a.) Northwest retrofit angle on bottom column segment

b.) West face prior to testing
