Feasibility Investigation of Segmentally Precast Bridge Piers for Accelerated Construction

Final Report
March 2009

Sponsored by
the Iowa Department of Transportation (Project 06-257)
and
the Iowa Highway Research Board (Project TR-556)

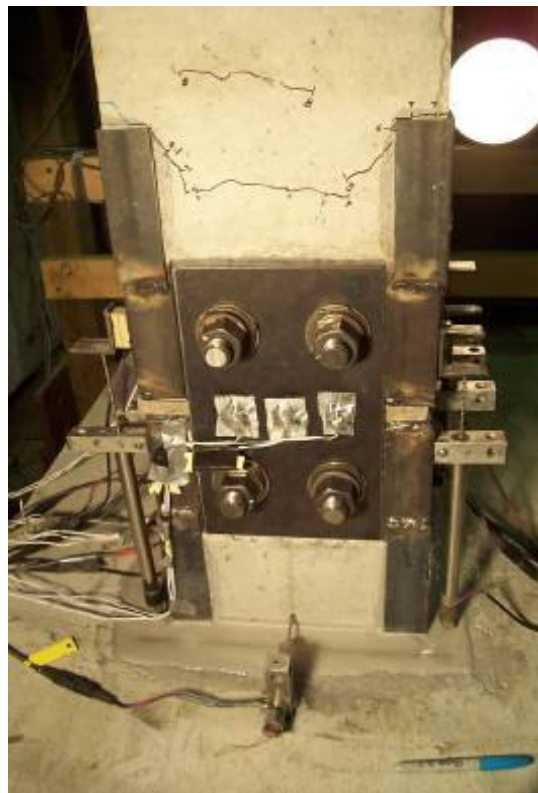
Figure 108. Photograph of Column 4 – Cycle 7a east face.

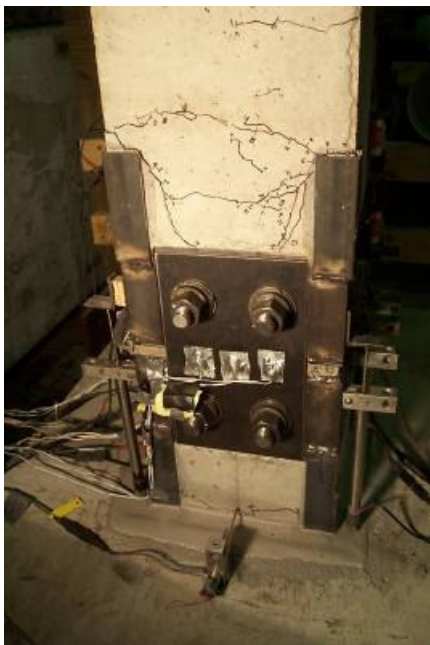
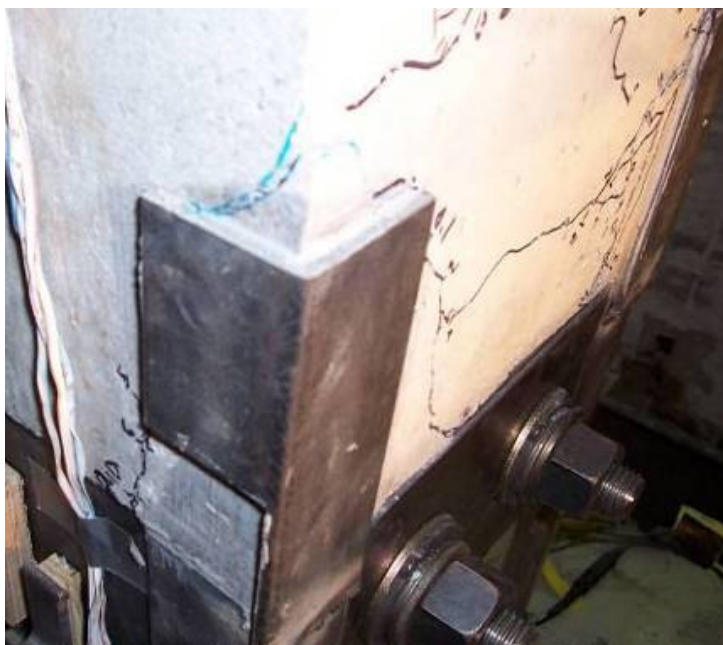
Figure 109. Photographs of Column 4 – Cycle 11a.

a.) East face crack progression

b.) Incipient cracking at southeast retrofit angle

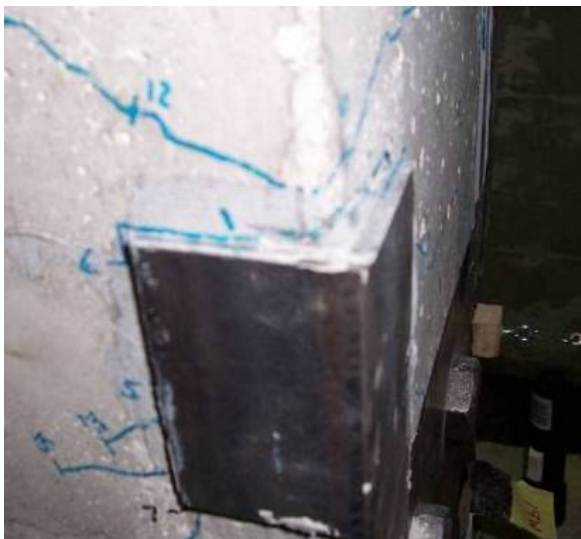
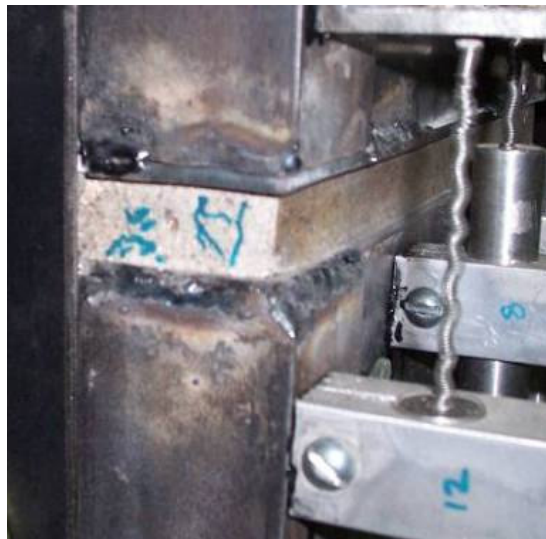
a.) Cracks forming around southeast retrofit angle

b.) Northeast corner bearing plate compression damage

Figure 110. Photographs of Column 4 – Cycle 15a.

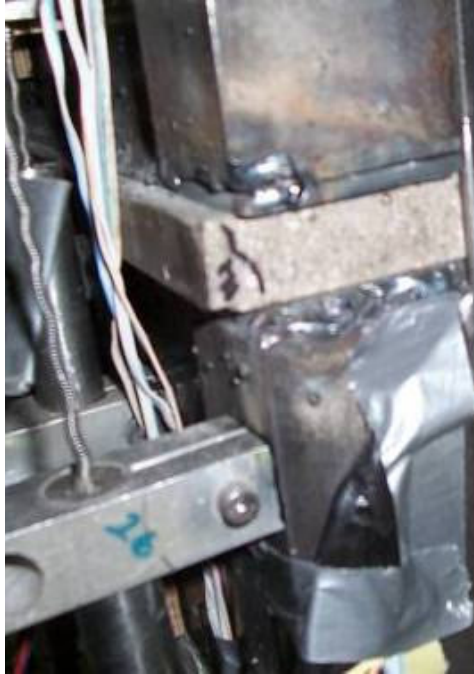
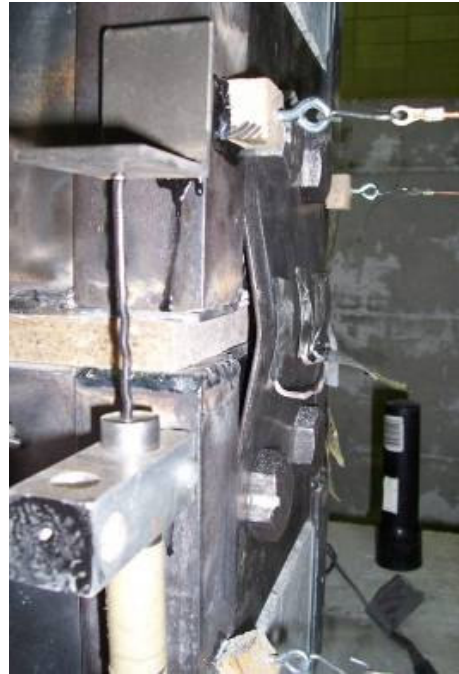
a.) Damage to bearing plate in southeast corner

b.) West fuse plate buckling

Figure 111. Photographs of Column 4 – Cycle 15a joint.

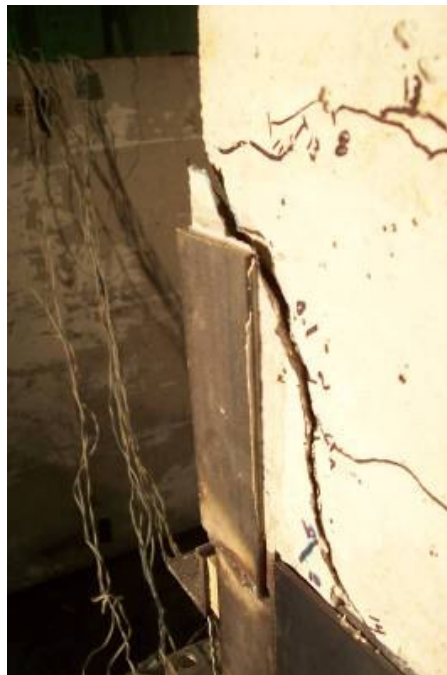
Figure 112. Photograph of Column 4 – Cycle 16a southeast retrofit angle damage.

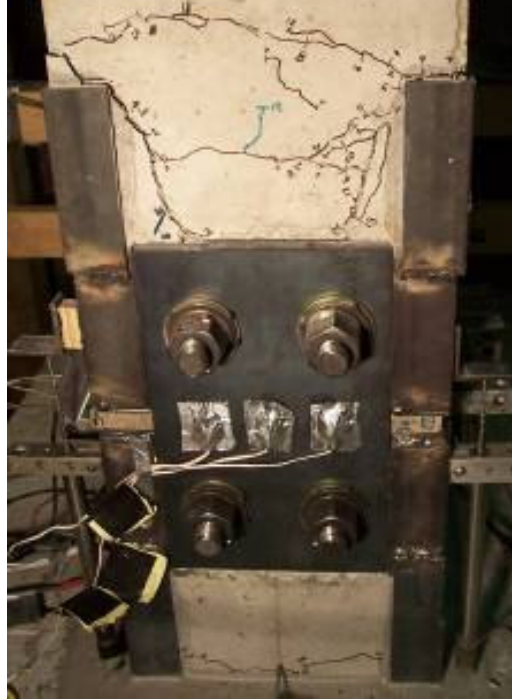
Figure 113. Photographs of Column 4 – Start of test 4b.

After replacing the fuse plates, the displacement regimen was restarted. The damage accrued in the column up to this point can be seen in Figure 113. Actuator control problems continued to increase in frequency and magnitude throughout the remainder of the Column 4 test. From Cycles 19b to 22b, damage to the upper column segment increased and the upper repair angles became detached from the column face (see Figures 114-117). By this point, rotation of the column concentrated almost exclusively at this location as the collar again pulled off the end of the segment. Testing of Column 4 was stopped after Cycle 23b, as it was again evident that the decrease in load at each displacement was due to this pull-off phenomenon. A maximum horizontal load of + 6.39 kips was observed on Cycle 19b (displacement = +/- 4.0 in.) and a maximum displacement of 6.0 in. was observed for the test. At + 6.0 in., a load of + 4.45 kips was achieved, while a - 5.16 kip load was achieved at - 6.0 in. Quantitative lateral load versus displacement data from the testing of Column 4 are presented in Chapter 7.

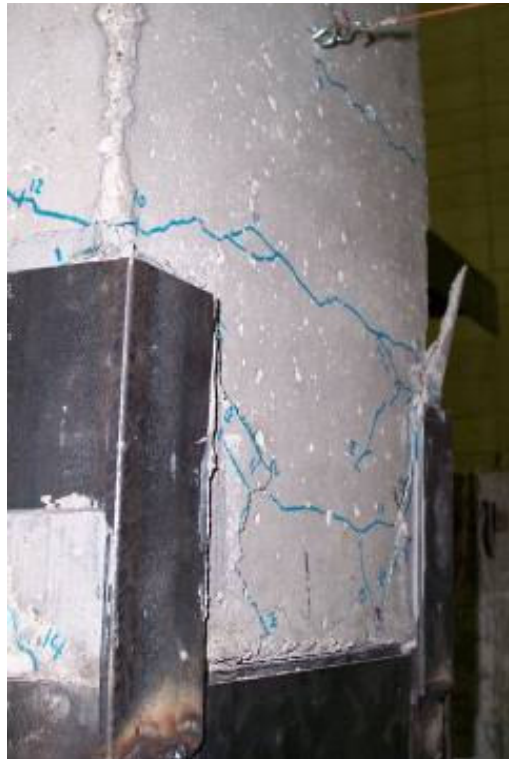
Figure 114. Photograph of Column 4 – Cycle 19b west face of upper column segment.

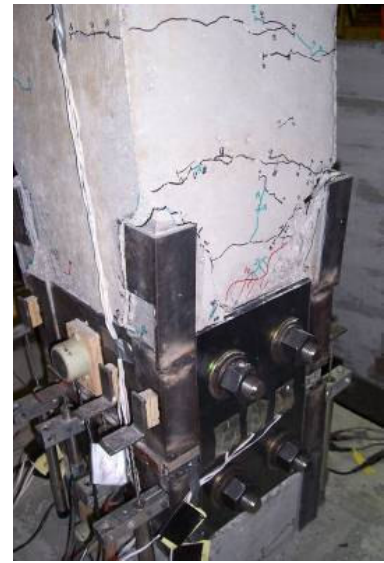
a.) North face joint opening during push half-cycle

b.) East face column damage

Figure 115. Photographs of Column 4 – Cycle 21b north and east faces.

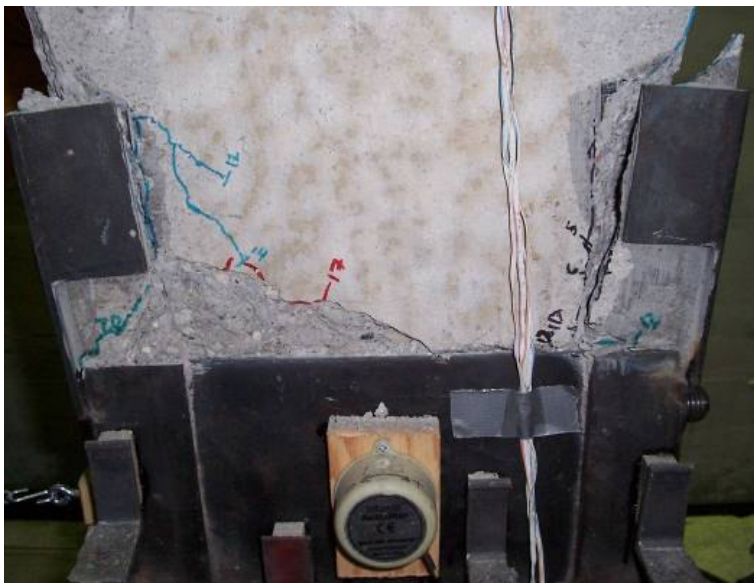
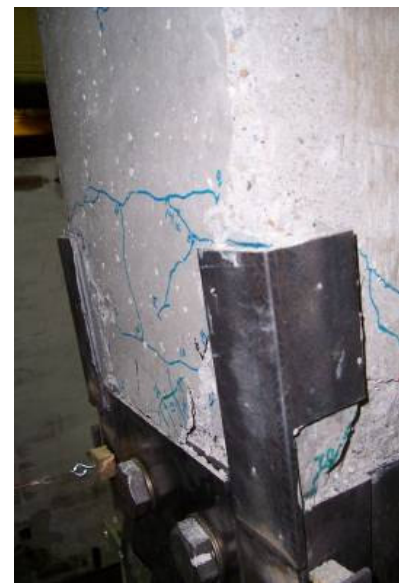
a.) South side view of retrofit angle failure

b.) Upper column segment damage

Figure 116. Photographs of Column 4 – Cycle 21b south and west faces.

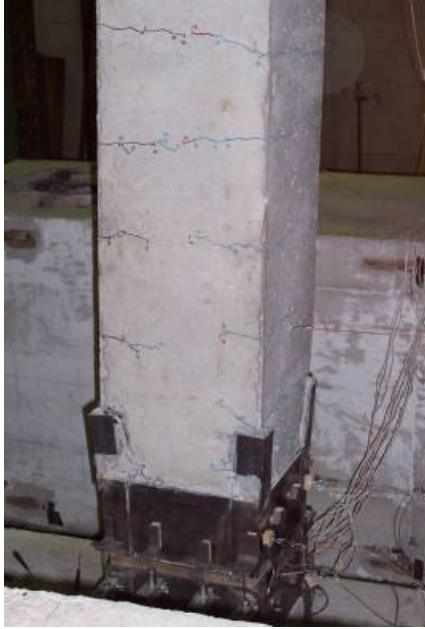
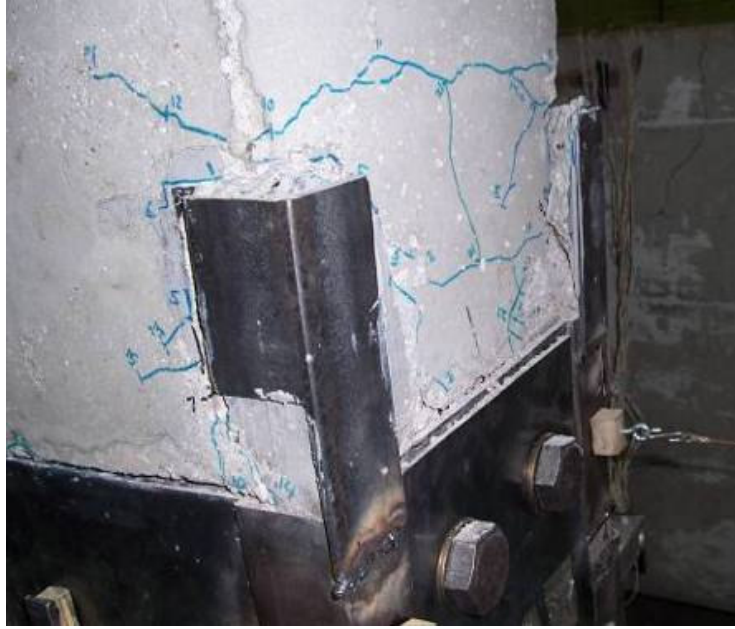
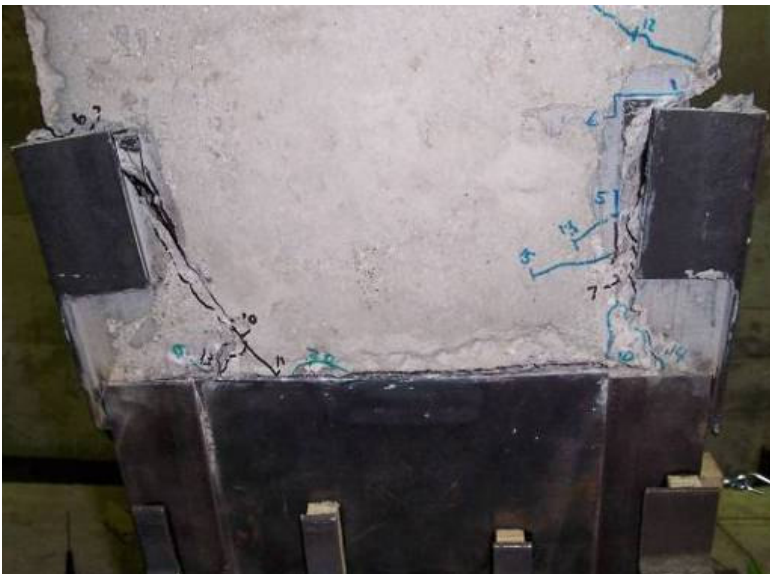
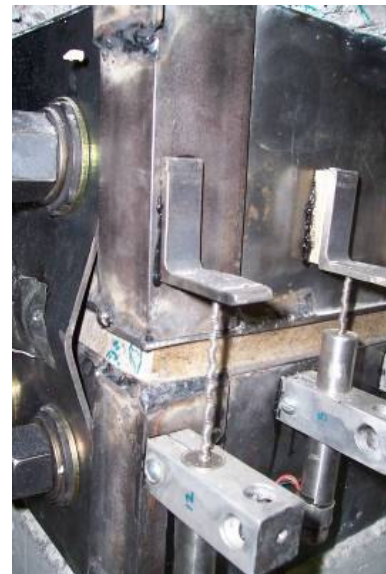
a.) Northwest corner damage

b.) Upper segment damage and retrofit failure

c.) North face damage and retrofit angle failure

d.) Northeast corner fuse plate buckling

Figure 117. Photographs of Column 4 – Cycle 22b.

The attempt to reinforce the collar (described in Section 4.2.3.1) against pull-off was unsuccessful as behavior of Column 4 was similar to that observed in Columns 2 and 3. Once again, little could be determined about the ability of the column to withstand its design load due to the premature failure mode. However, Tests 2, 3, and 4 allowed selection of the most effective fuse plate and bearing plate materials for subsequent tests of Columns 5 and 6, as well as identification of key detailing issues for the segmented columns.

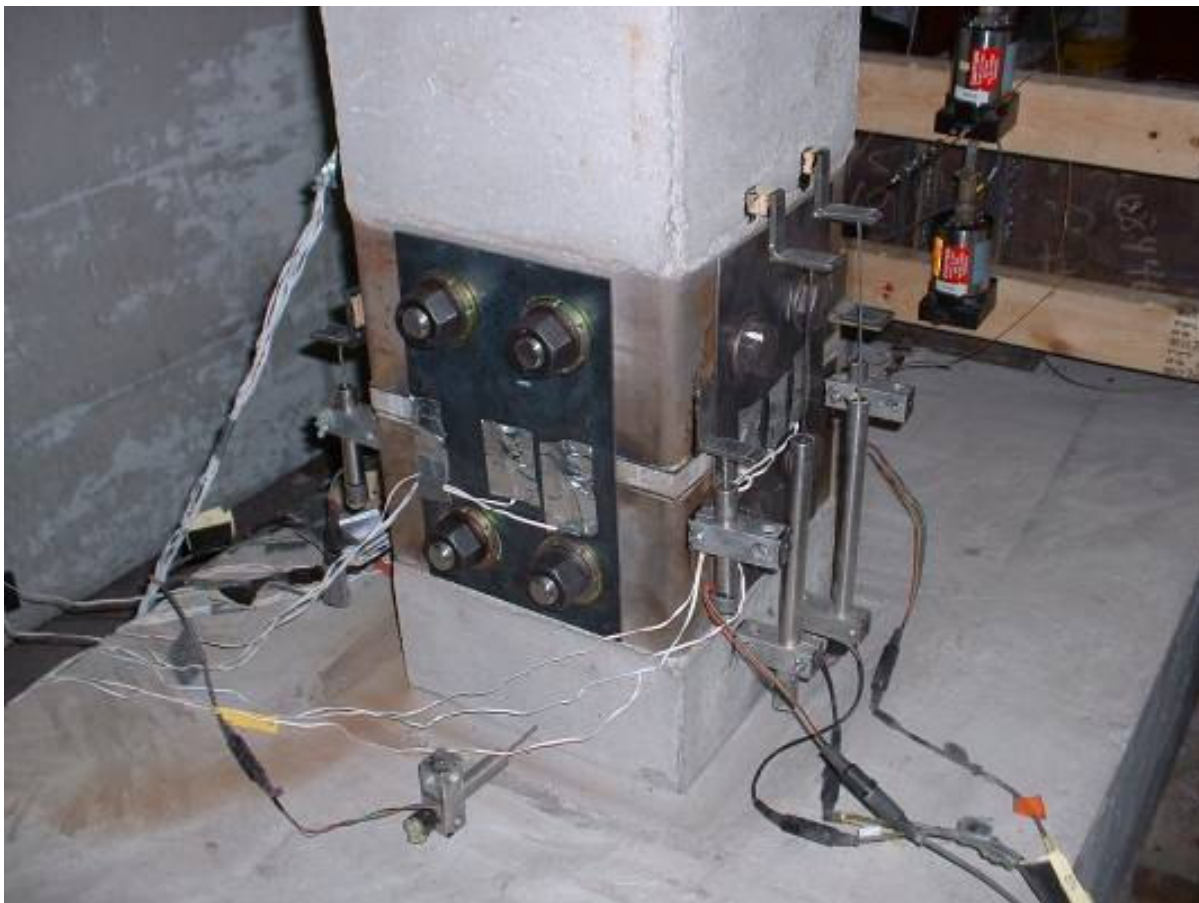
Figure 118. Photograph of Column 5 – Prior to testing.

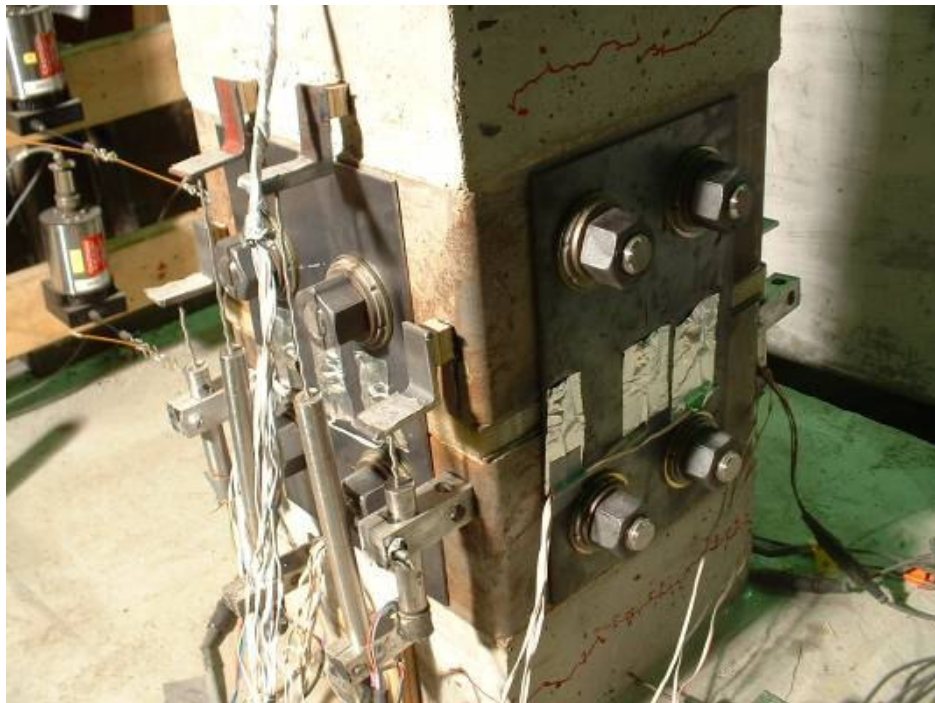
Figure 120. Photograph of Column 5 – Cycle 10a southeast corner view of cracking.

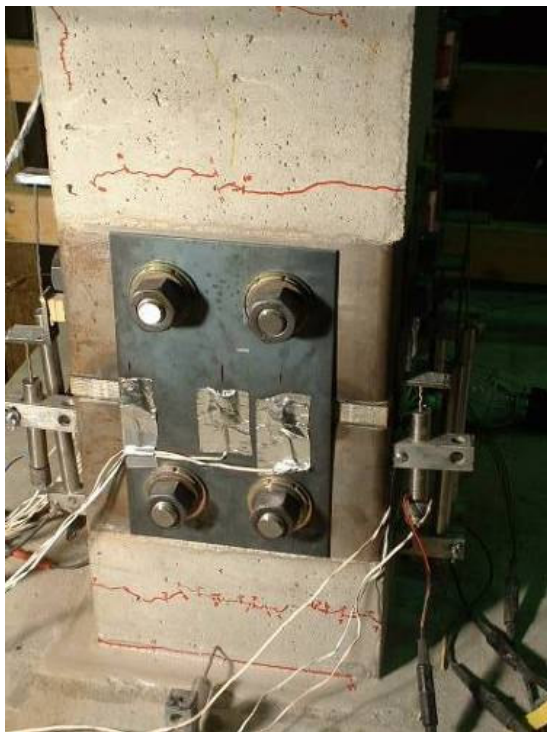
a.) Cracking around column joint

b.) Upper segment crack progression

Figure 121. Photographs of Column 5 – Cycle 13a east face.

After restarting the test, additional cracks formed across the column on Cycle 13a (displacement = +/- 1.5 in.) (see Figures 121 and 122). On Cycle 14a (displacement = +/- 2.0 in.), a small amount of compression damage was noted under the collar on the west face of the column (see Figure 123). This minute chipping was observed on previous specimens and was caused by the collar bearing on the surface of the concrete column. The depth of chipping was limited to the thickness of the collar and could be eliminated in the future by placing a small gap or indentation in the concrete at this location. Additional small regions of compression damage were marked on the positive (push) cycles of Cycles 15a and 16a (see Figure 125). By Cycle 16a, the fuse plates were visibly buckling. Since this was also the predetermined cycle to replace fuse plates, testing was stopped and new fuse plates were mounted on the column. At this time, a peak horizontal load of + 7.45 kips had been applied to the column during the positive (push) half-cycle, while a horizontal load of - 8.53 kips had been applied during the negative (pull) half-cycle.

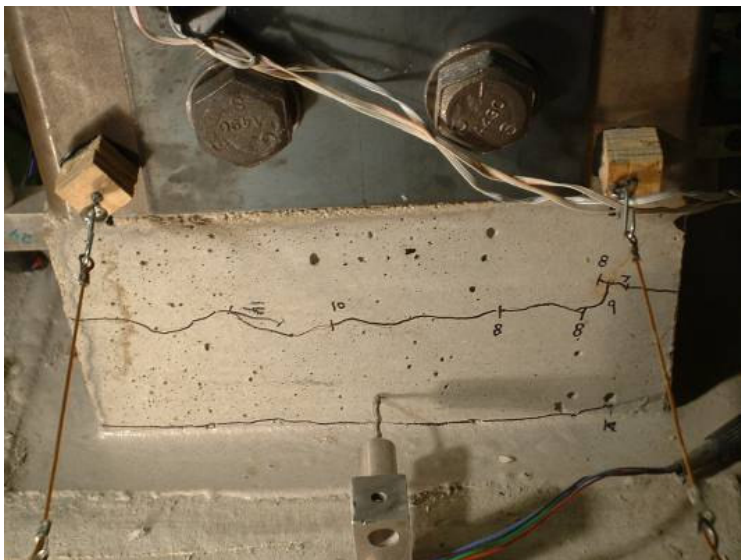
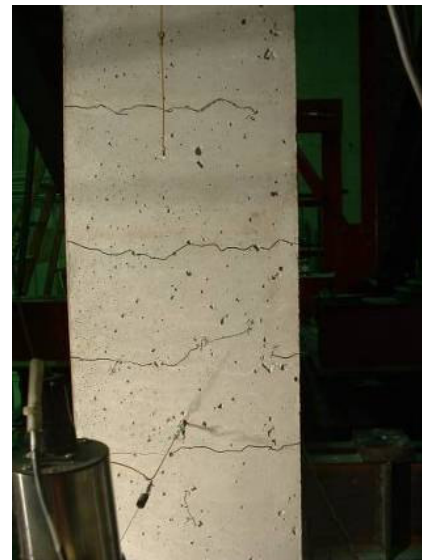
a.) Cracking at the base of the west face

b.) Upper segment crack progression

Figure 122. Photographs of Column 5 – Cycle 13a west face.

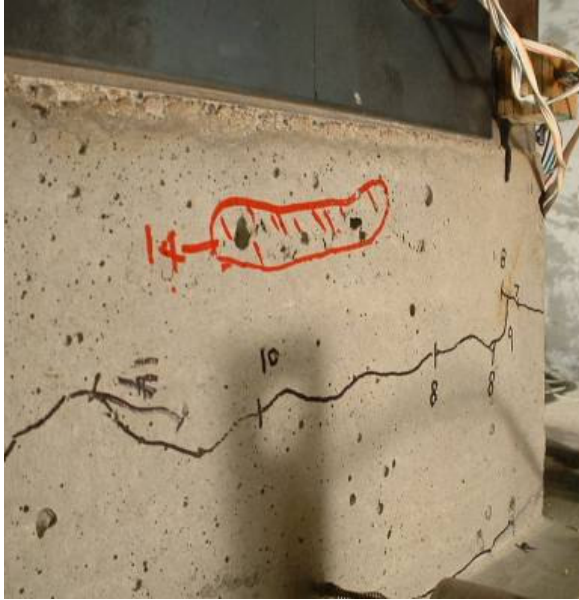
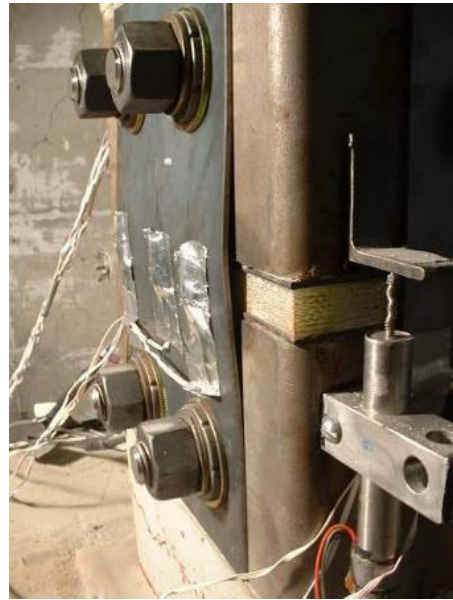
a.) West face at base

b.) East plate initial buckling

Figure 123. Photographs of Column 5 – Cycle 14a west face.

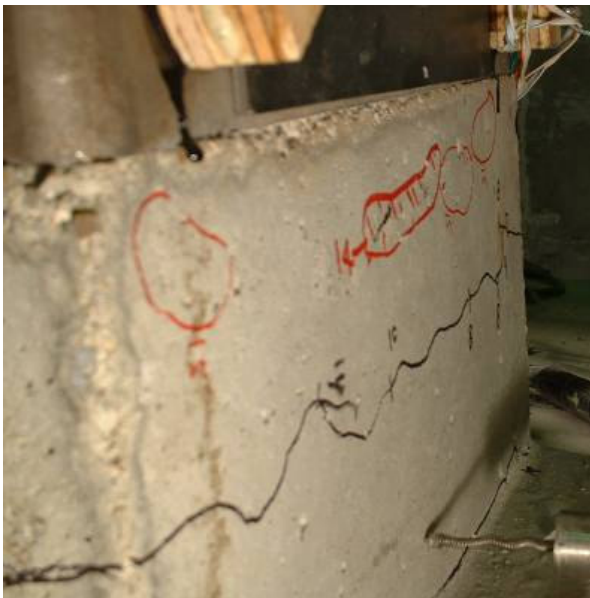
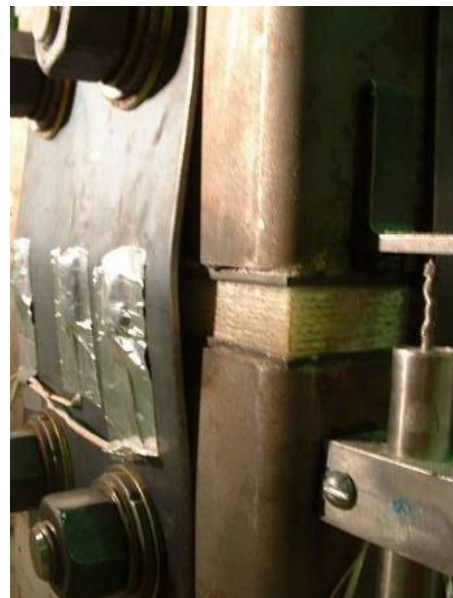
a.) West face compression damage and cracking at base

b.) East fuse plate buckling

Figure 124. Photographs of Column 5 – Cycle 15a.

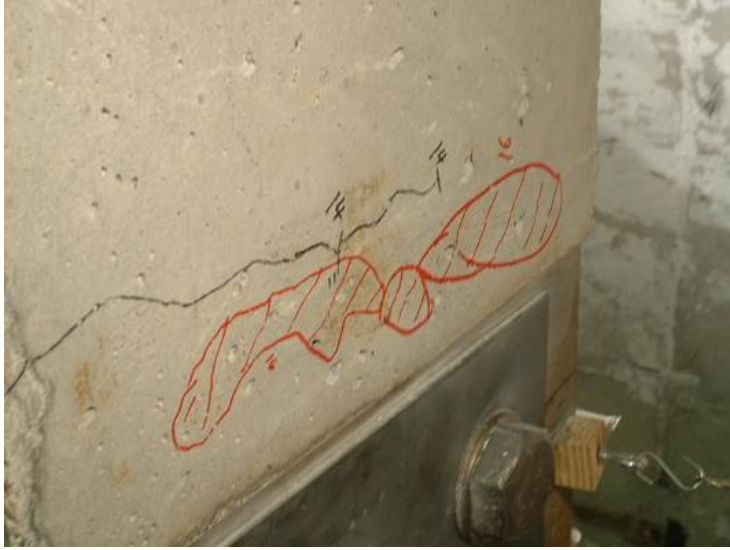
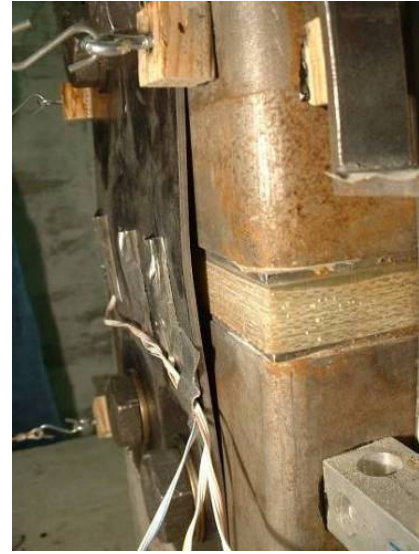
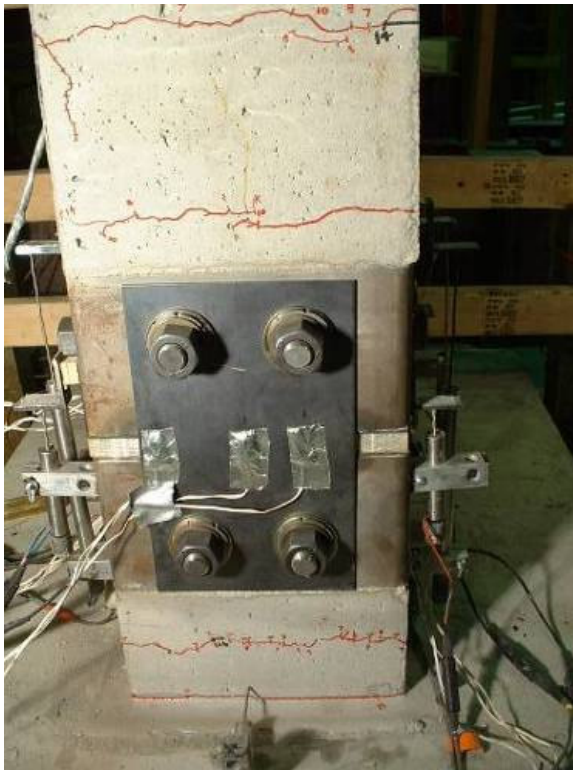
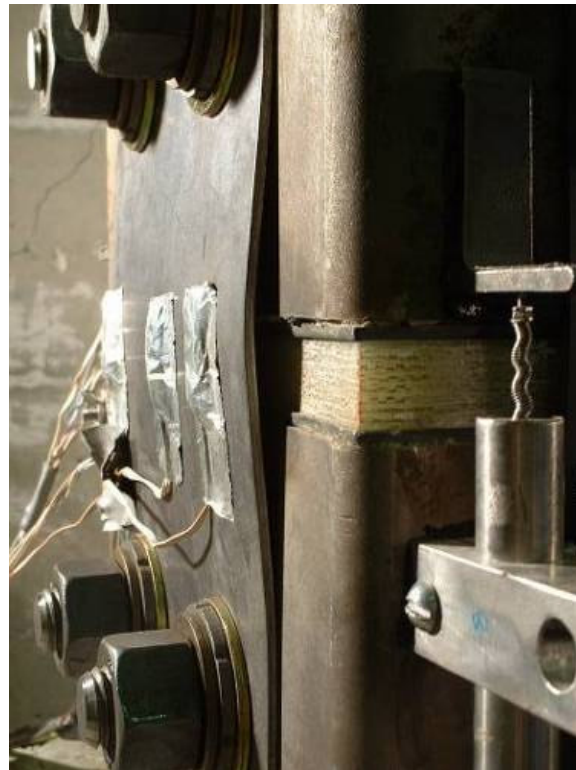
a.) Upper segment compression damage

b.) West fuse plate initial buckling

a.) West face cracking at the end of Test 5a

b.) East plate buckling in compression

Figure 125. Photographs of Column 5 – Cycle 16a.

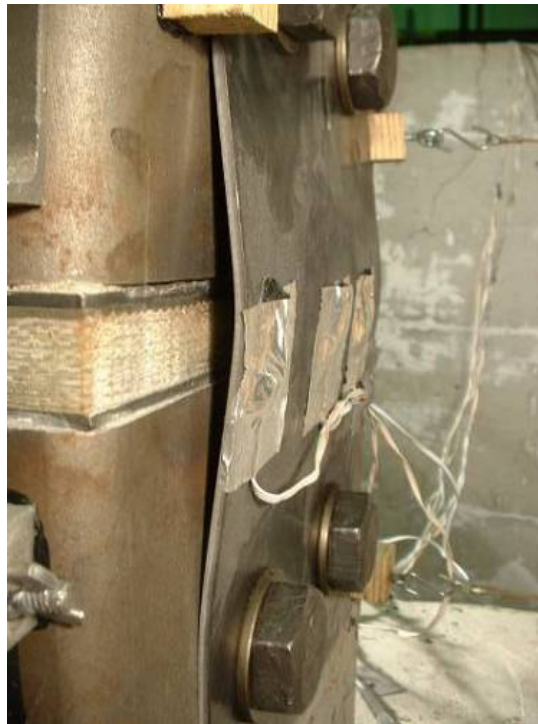
Figure 126. Photographs of Column 5 – Cycle 18b west fuse plate buckling.

The displacement regimen was then restarted with the second set of fuse plates. Testing continued without incident or additional cracking until Cycle 17b (displacement = +/- 3.0 in.) when the actuator control was lost briefly. Fuse plate buckling that occurred during Cycle 18b can be seen in Figure 126. Testing was stopped again after Cycle 18b due to several large actuator incidents and was resumed the following day after several adjustments were made to the control system. Cycles 19b and 20b (displacements = +/- 3.5 in. and 4.0 in.) were completed before another actuator incident halted testing again. A lateral load during this incident was recorded at 15 kips, possibly causing internal damage to Column 5 and initiation of slip in the fuse plate connections.

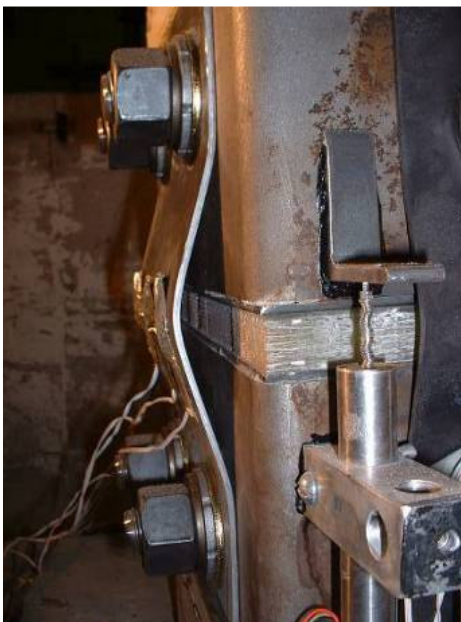
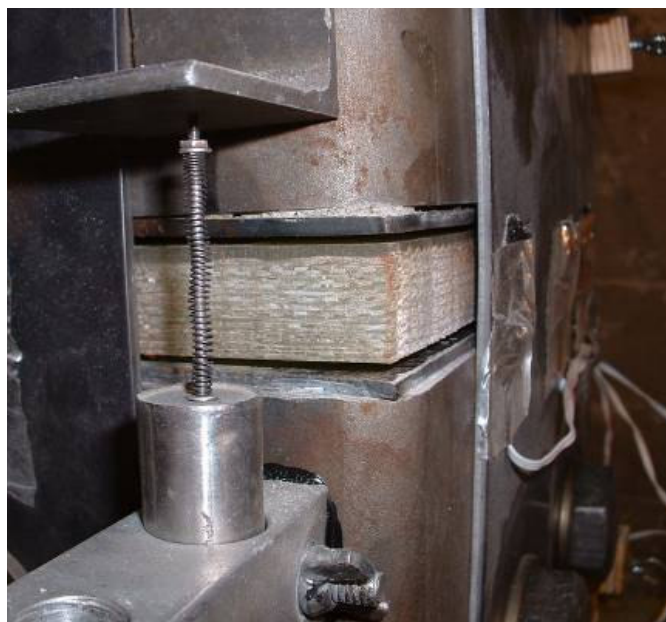
a.) East fuse plate buckling

b.) West joint opening during pull half-cycle

Figure 127. Photographs of Column 5 – Cycle 21b.

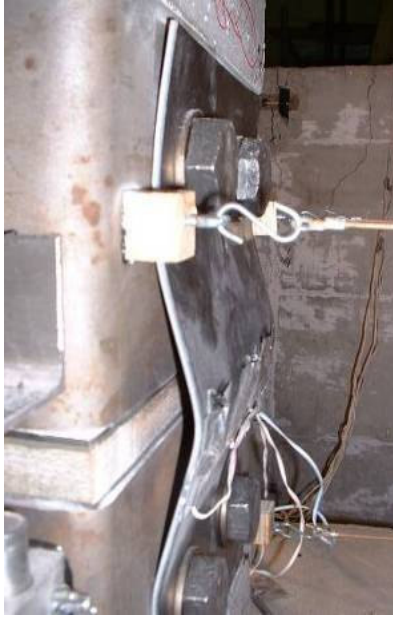
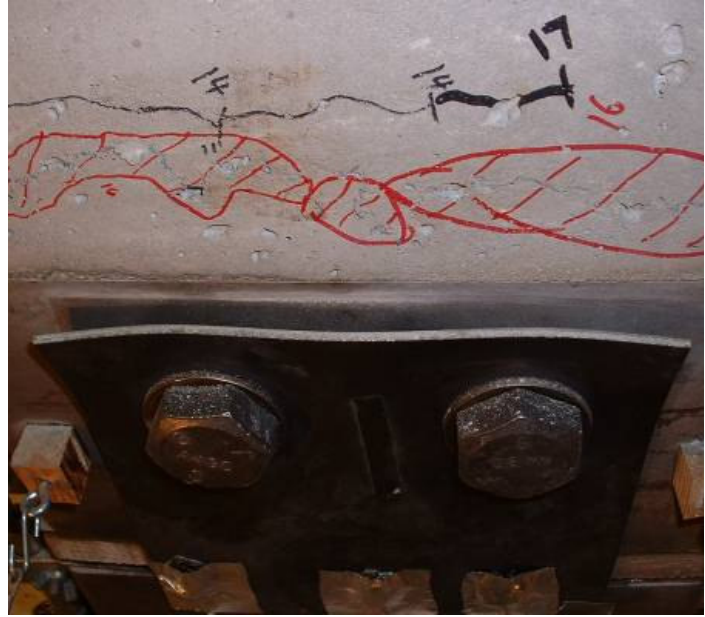
a.) West fuse plate buckling

b.) Bolt bearing on west fuse plate causing plate curling

Figure 128. Photographs of Column 5 – Cycle 23b.

After setting interlocks and increasing the dither in the control system in an attempt to improve actuator control, testing was resumed. On Cycle 21b, several "pings" were heard in the plates, indicating slipping between the plates and the steel collars. Prior to the previous actuator incidents, no evidence of slippage had been noted. On the negative (pull) half-cycle of Cycle 21b, the top of the west plate began to curl due to this slippage and subsequently began bearing

on the through-bolts. This condition continued on each cycle and can be seen during Cycle 23b in Figure 128b. With each significant "pinging" noise, a loss of load was also observed while displacement of the column continued. Slippage and the resulting bearing condition continued during each cycle until the full stroke of the actuator was reached (see Figures 128b, 130a, 130b, 133, 134c). Despite this slippage, the gap opening at the column segment continued to widen throughout the remainder of the test (see Figures 127b, 131a, 132c, 135a, 136c, 137b) and the crack width at the interface between the upper column segment and collar remained small. The final condition of the west fuse plate and the condition of Column 5 are shown after Cycle 30 in Figure 138. Post-test damage for all sides of Column 5 can be seen in Figure 139.

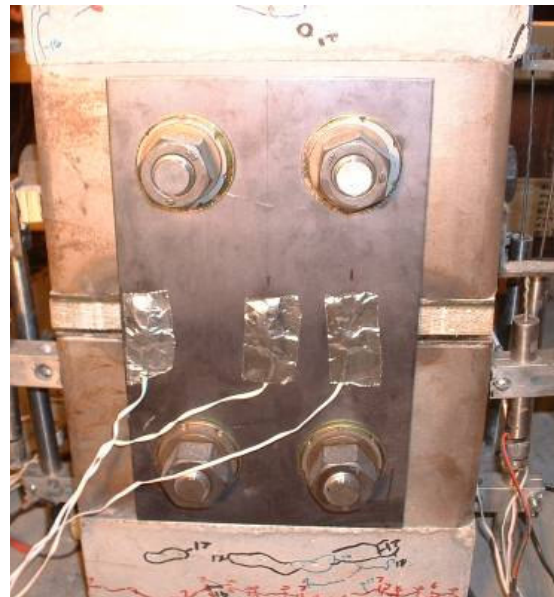
a.) Southeast corner joint opening

b.) East joint opening during push half-cycle

Figure 129. Photographs of Column 5 – Cycle 24b joint opening.

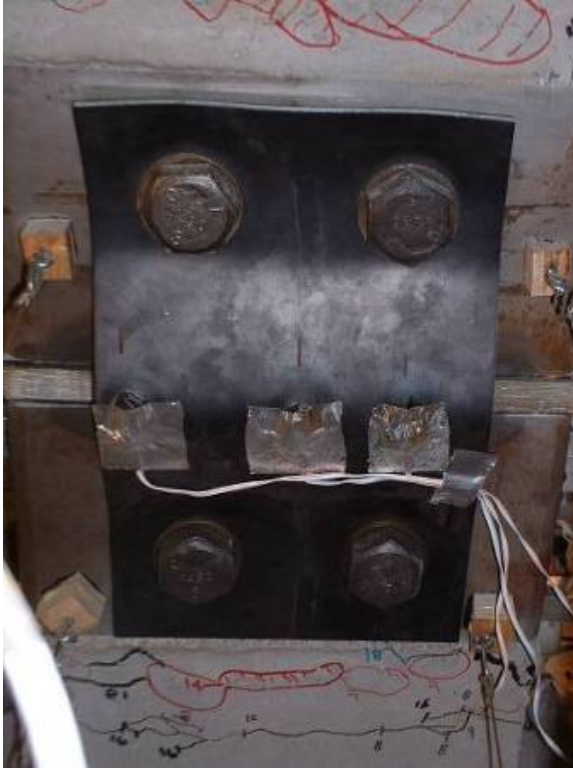
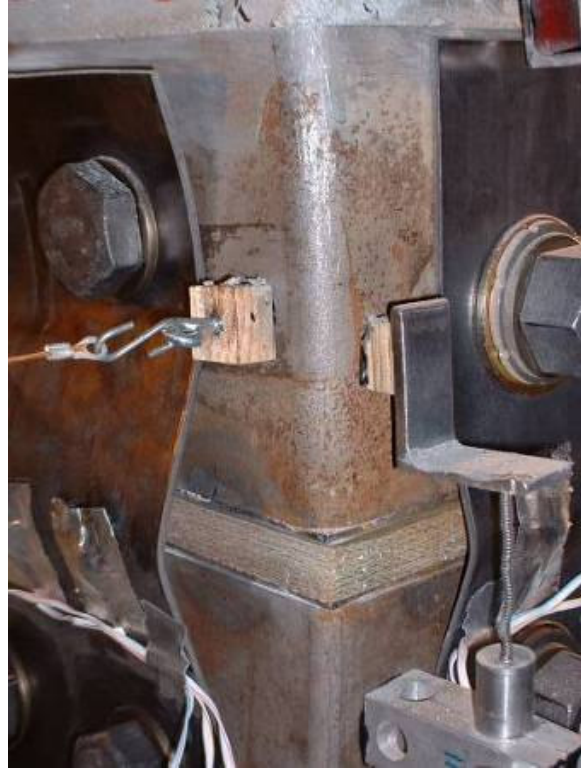
a.) West face damage and fuse plate buckling

b.) Southwest corner fuse plate buckling

c.) East fuse plate buckling

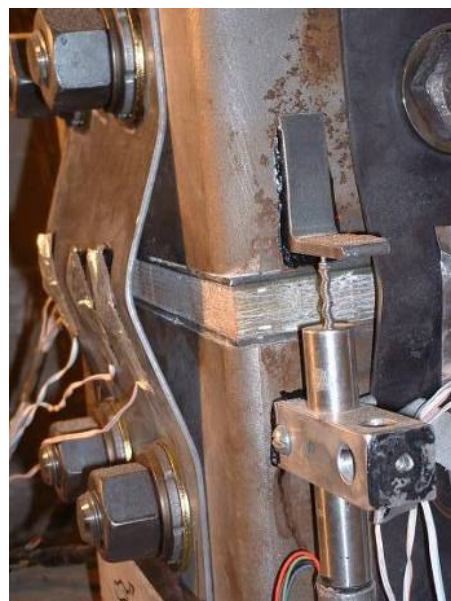
d.) Northeast corner fuse plate buckling

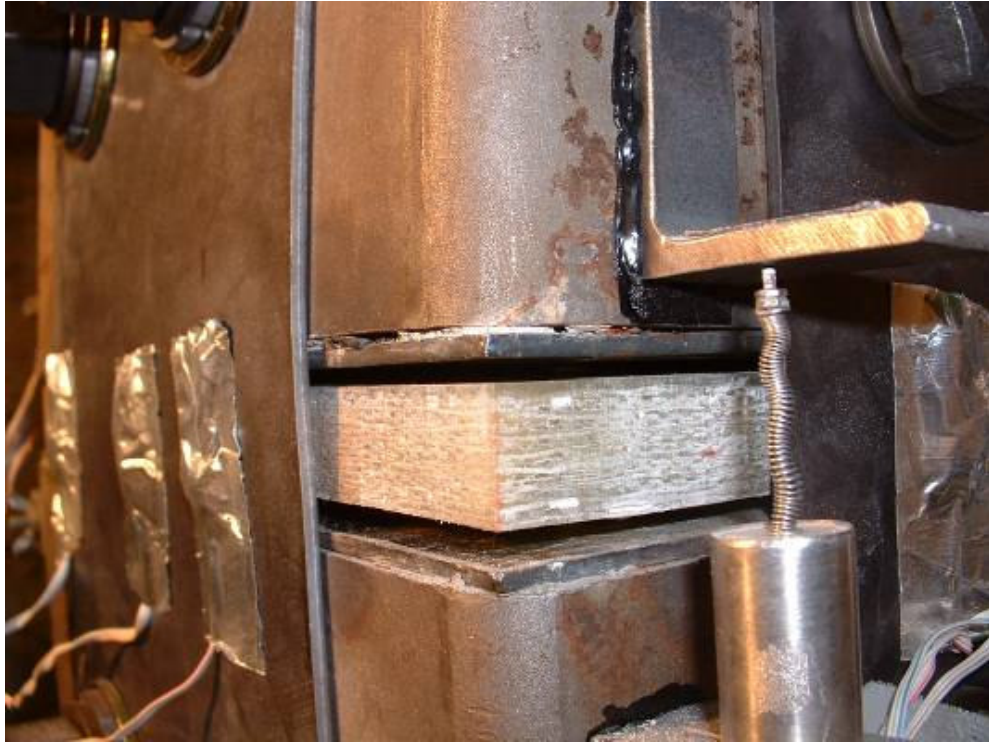
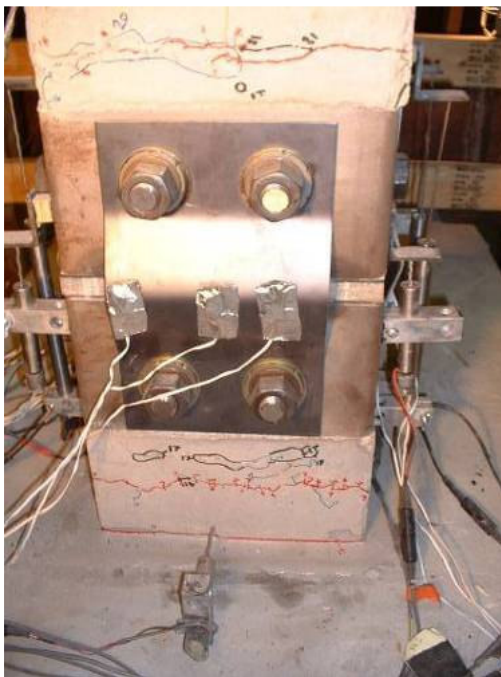
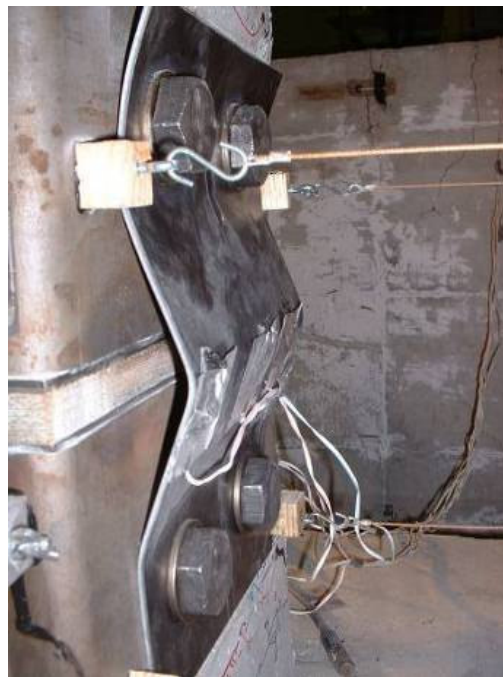
Figure 131. Photographs of Column 5 – Cycle 26b.

a.) Northeast corner joint opening

b.) East fuse plate buckling and segment damage

c.) West fuse plate buckling

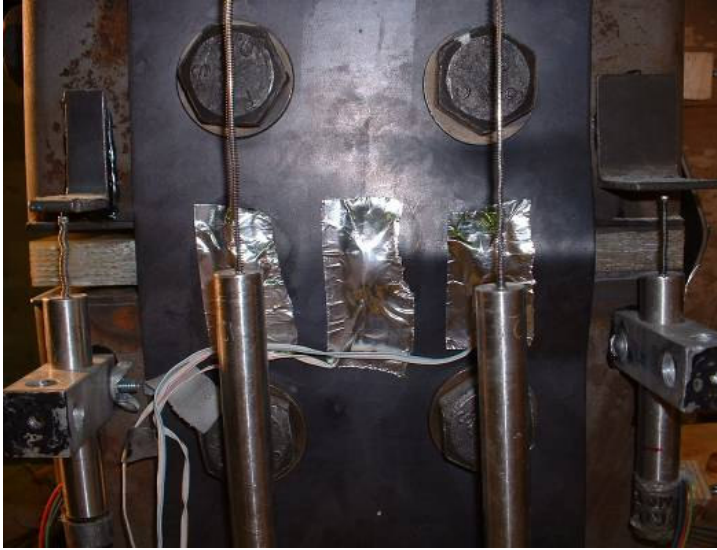
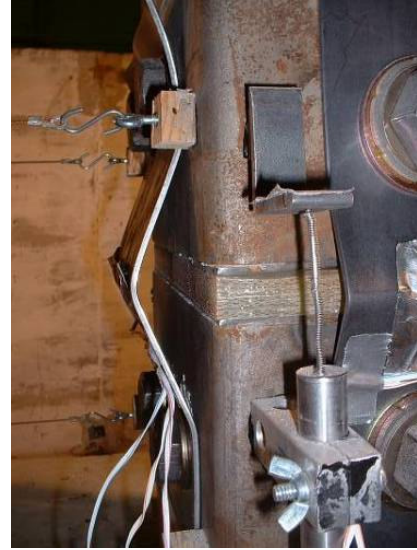
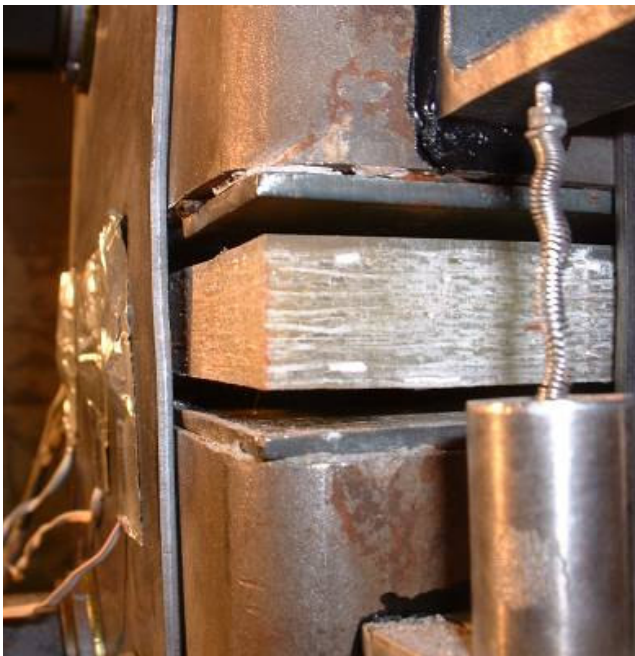
Figure 132. Photographs of Column 5 – Cycle 27b push half-cycle.

a.) Differential buckling in north fuse plate buckling

b.) West fuse plate buckling

c.) East joint opening

d.) East joint opening and segment damage

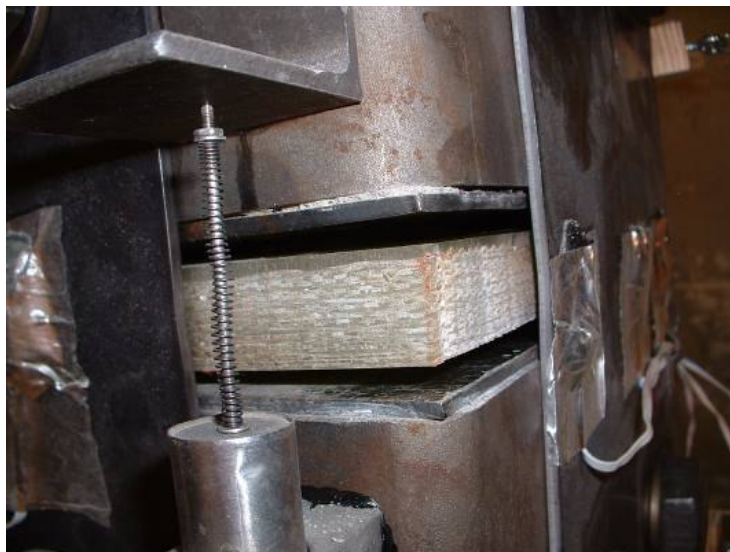
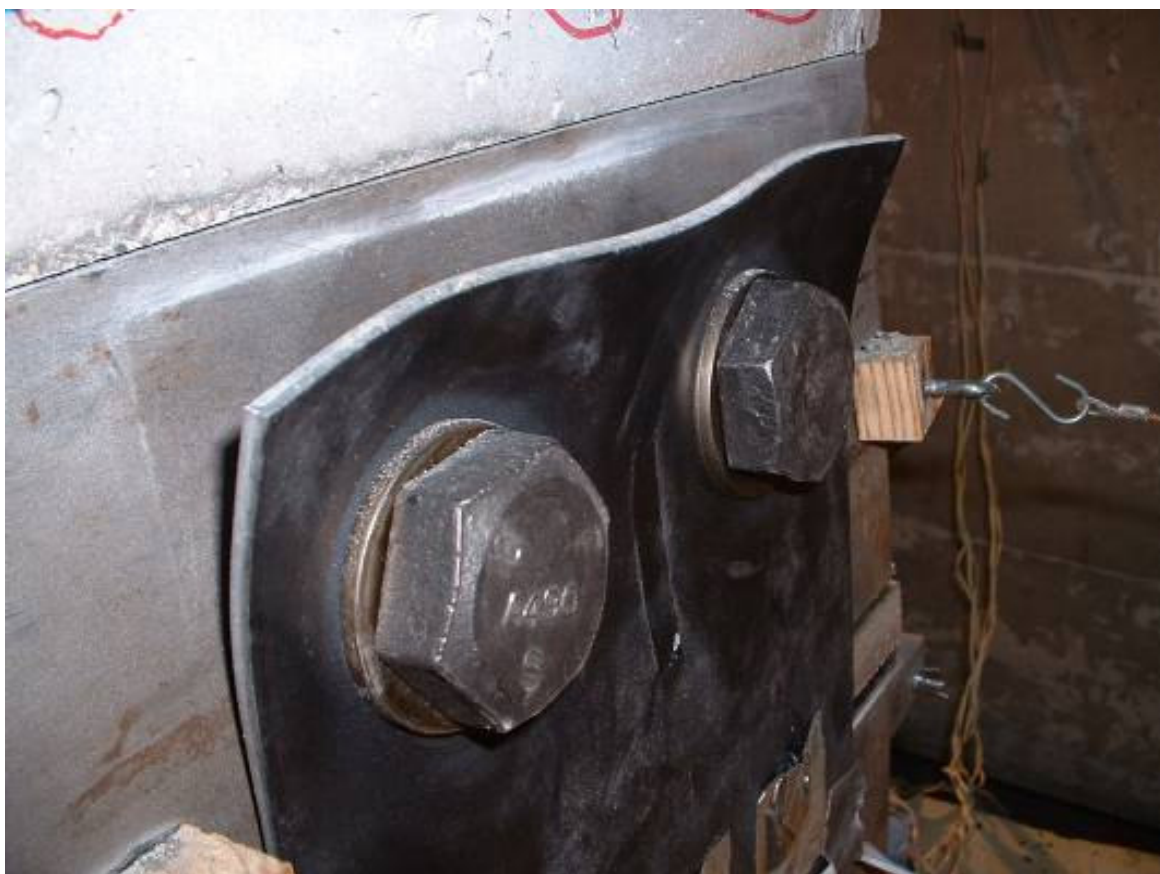
Figure 133. Photographs of Column 5 – Cycle 27b pull half-cycle.

a.) East face under compression

b.) West joint opening

c.) Curling of west plate

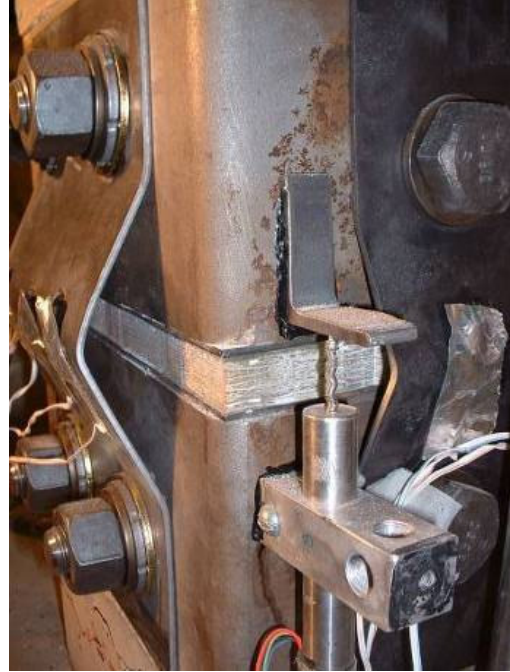
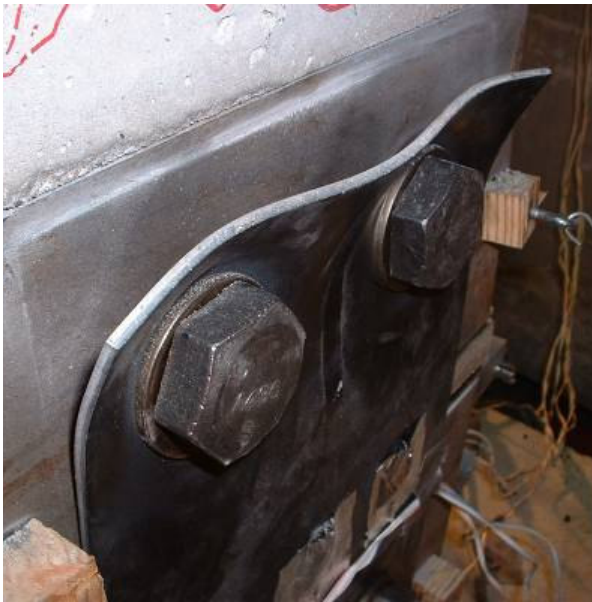
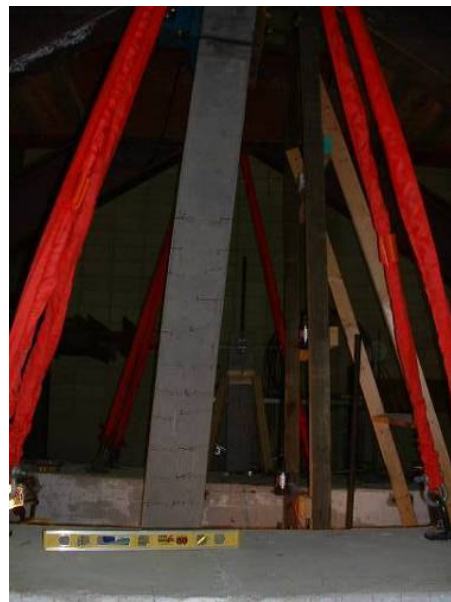
Figure 134. Photographs of Column 5 – Cycle 28b.

a.) East fuse plate buckling and column damage

b.) East fuse plate buckling

c.) Curling on top of the west plate

d.) Column deformation during push half-cycle
