Feasibility Investigation of Segmentally Precast Bridge Piers for Accelerated Construction

Final Report
March 2009

Sponsored by
the Iowa Department of Transportation (Project 06-257)
and
the Iowa Highway Research Board (Project TR-556)

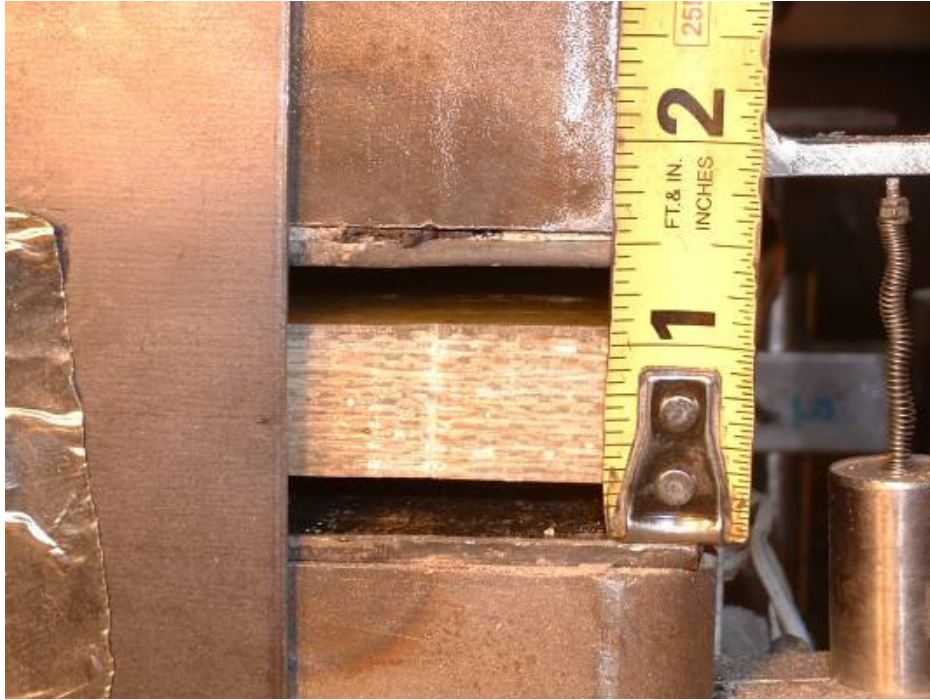
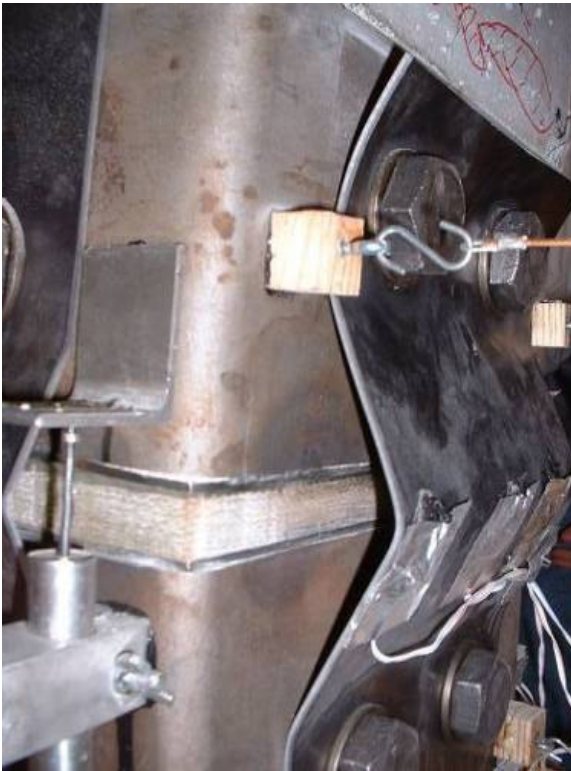
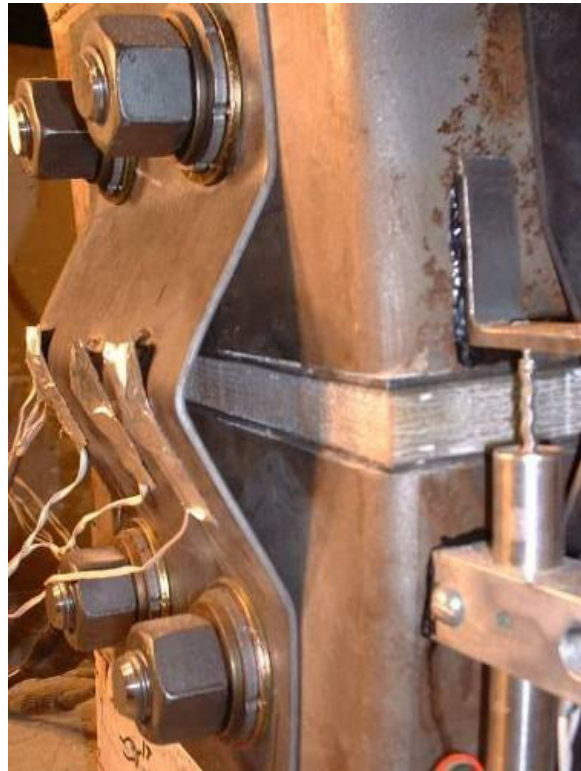
Figure 135. Photographs of Column 5 – Cycle 29b.

a.) East joint opening during push half-cycle

b.) West fuse plate buckling during push half-cycle

c.) East fuse plate buckling during pull half-cycle

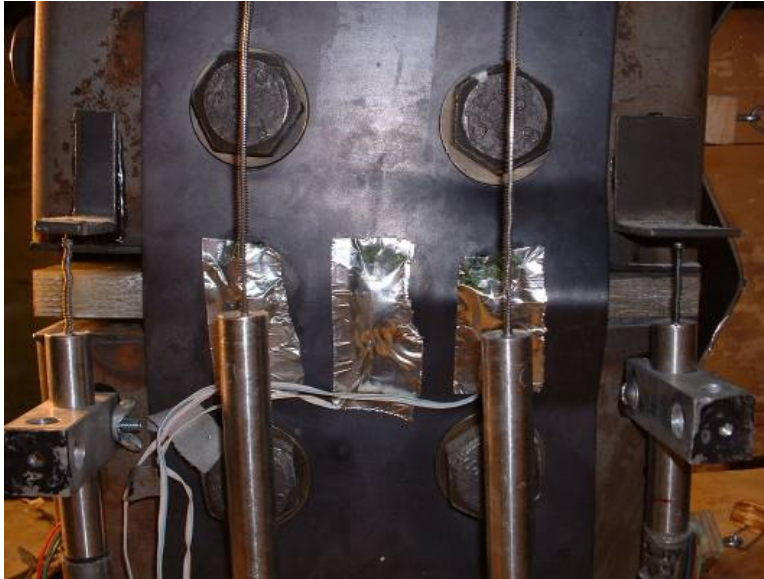
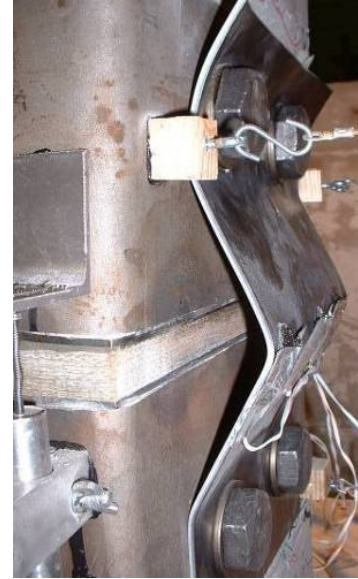
Figure 136. Photographs of Column 5 – Cycle 30b push half-cycle.

a.) North fuse plate differential buckling

b.) West fuse plate buckling

c.) East face damage and joint opening

d.) East joint opening

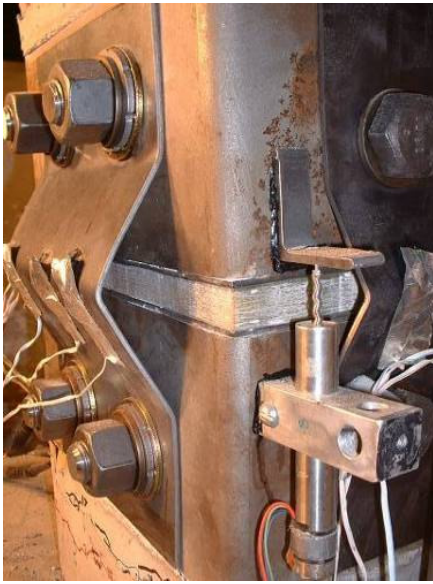
Figure 137. Photographs of Column 5 – Cycle 30b pull half-cycle.

a.) East fuse plate buckling

b.) West joint opening and bearing of west fuse plate on bolts

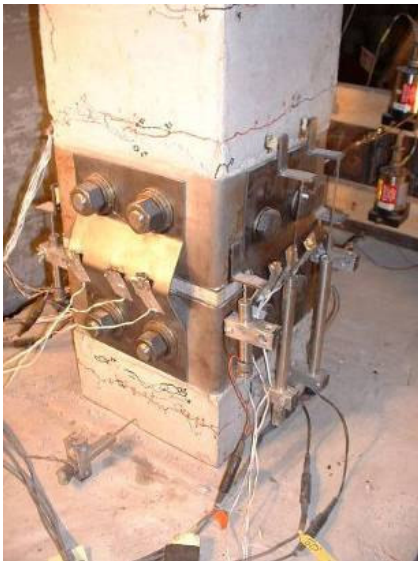
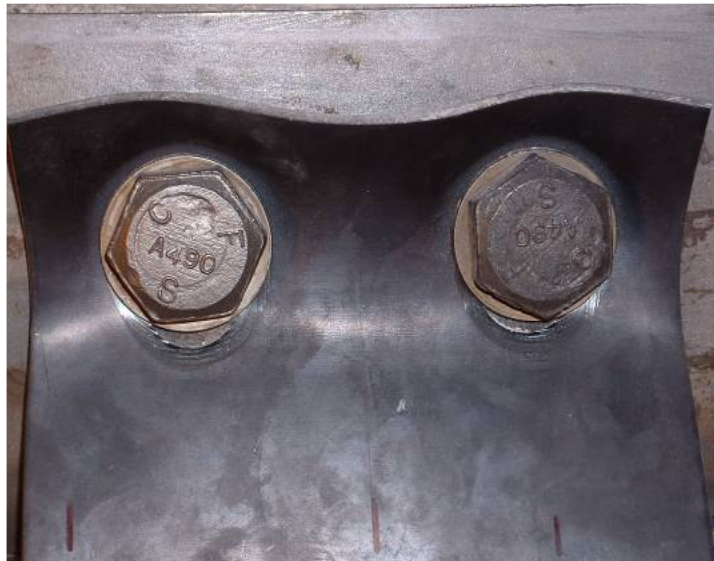
Figure 138. Photographs of Column 5 – After test.

a.) Residual fuse plate buckling

b.) Residual curling on top of west plate

on the through-bolts. This condition continued on each cycle and can be seen during Cycle 23b in Figure 128b. With each significant "pinging" noise, a loss of load was also observed while displacement of the column continued. Slippage and the resulting bearing condition continued during each cycle until the full stroke of the actuator was reached (see Figures 128b, 130a, 130b, 133, 134c). Despite this slippage, the gap opening at the column segment continued to widen throughout the remainder of the test (see Figures 127b, 131a, 132c, 135a, 136c, 137b) and the crack width at the interface between the upper column segment and collar remained small. The final condition of the west fuse plate and the condition of Column 5 are shown after Cycle 30 in Figure 138. Post-test damage for all sides of Column 5 can be seen in Figure 139.

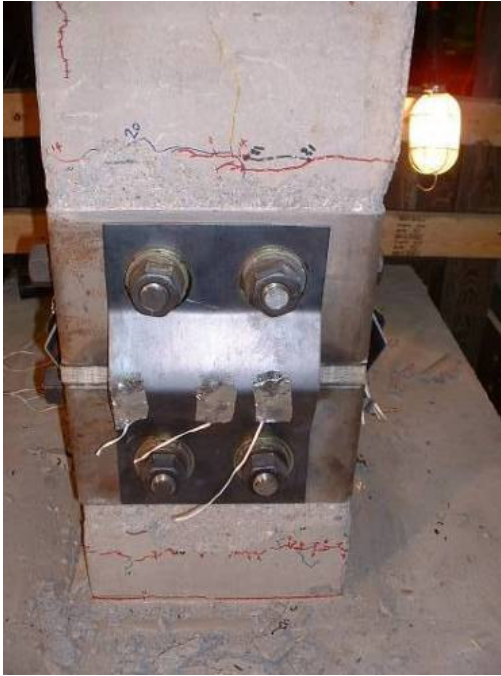
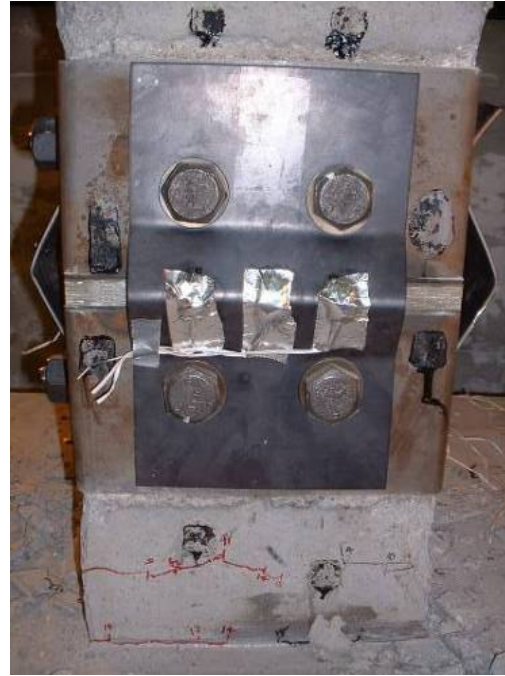
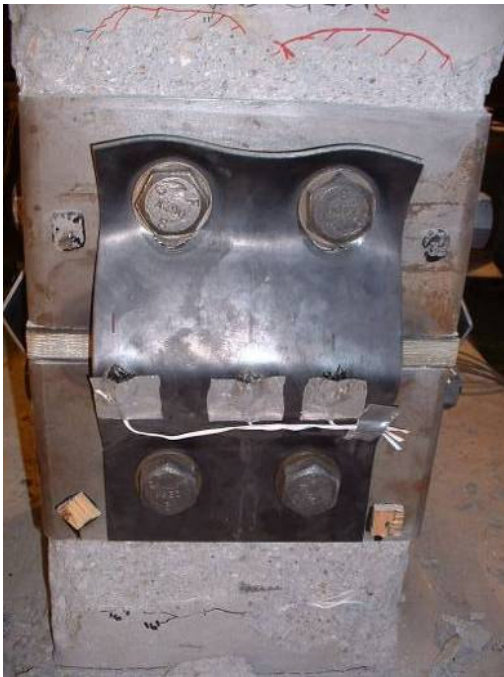
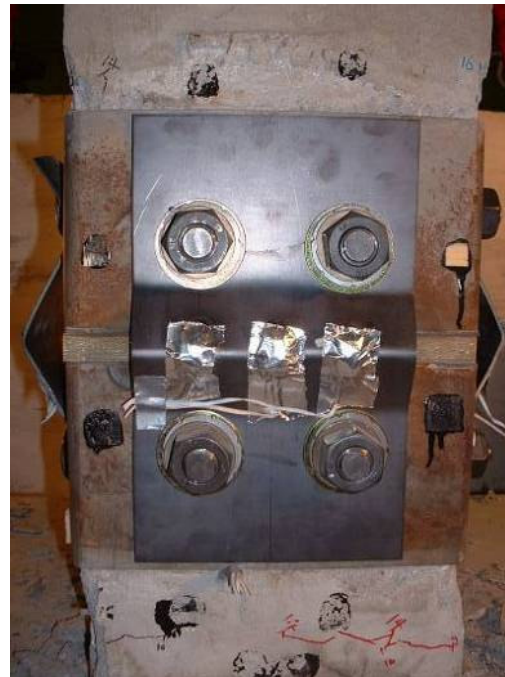
Figure 139. Photographs of Column 5 – Final damage after test.

a.) East face after test

b.) North face after test

c.) West face after test

d.) South face after test

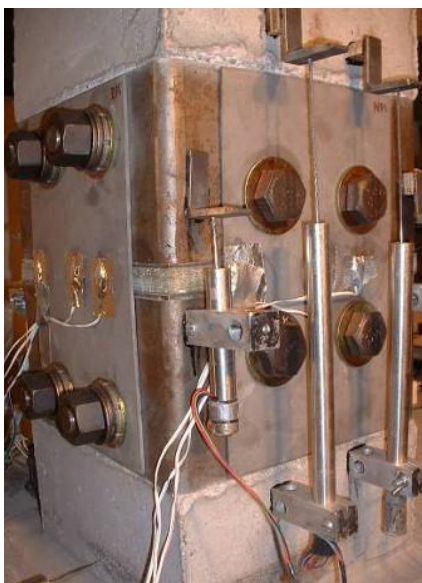
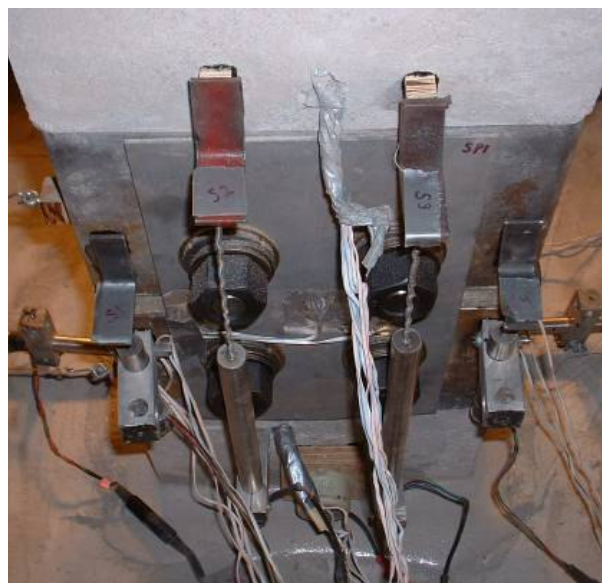
Figure 140. Photographs of Column 6 – Segment joint prior to testing.

c.) Northeast corner

d.) South face

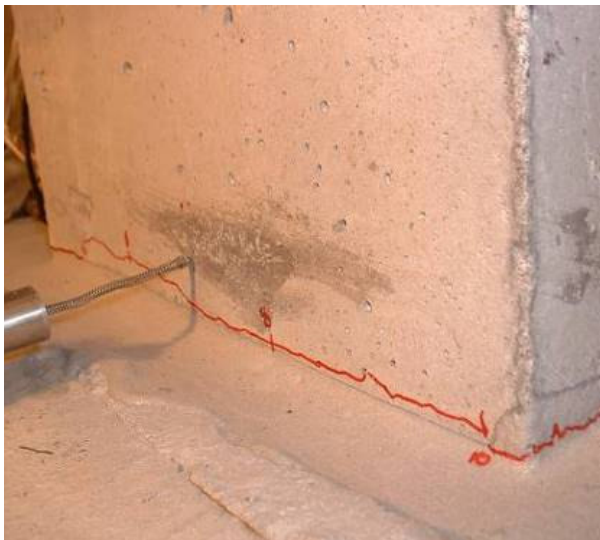
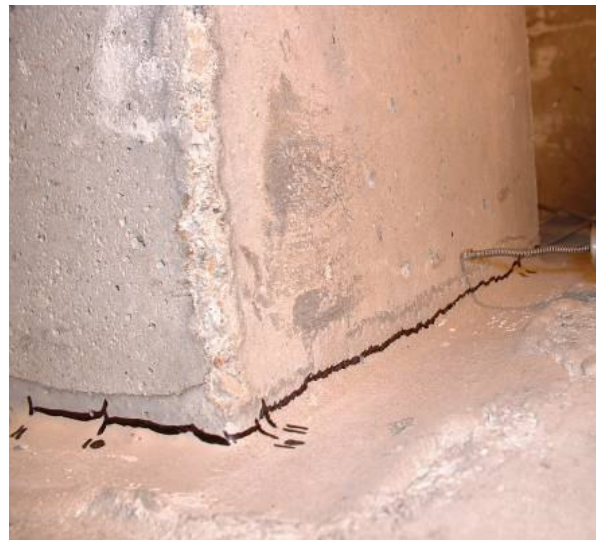
Figure 142. Photographs of Column 6 – Cycle 11a.

a.) East face initial cracking

b.) West face initial cracking

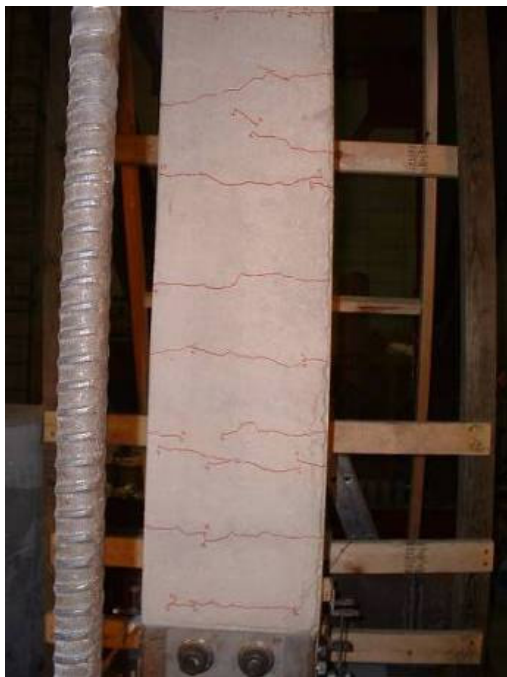
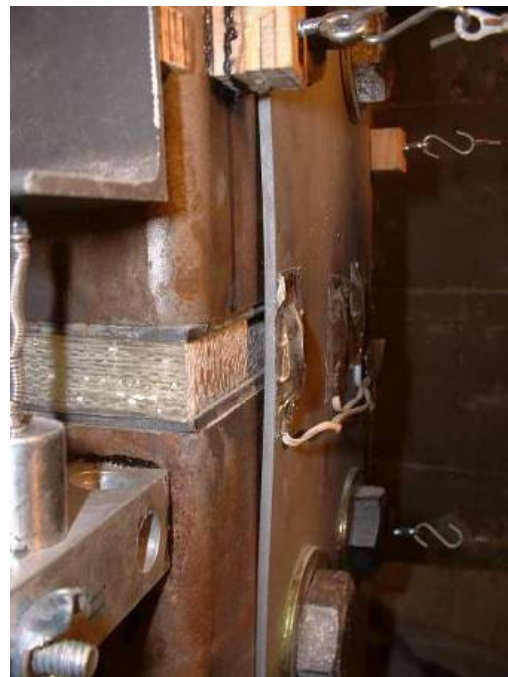
Figure 144. Column 6 – Cycle 16a.

a.) East face of upper segment crack distribution b.) West fuse plate initial buckling

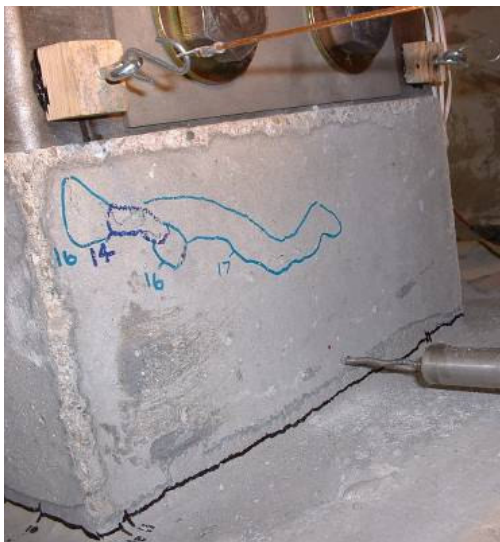
a.) West face initial compression damage

b.) East face initial compression damage

Figure 146. Photographs of Column 6 – Cycle 17b.

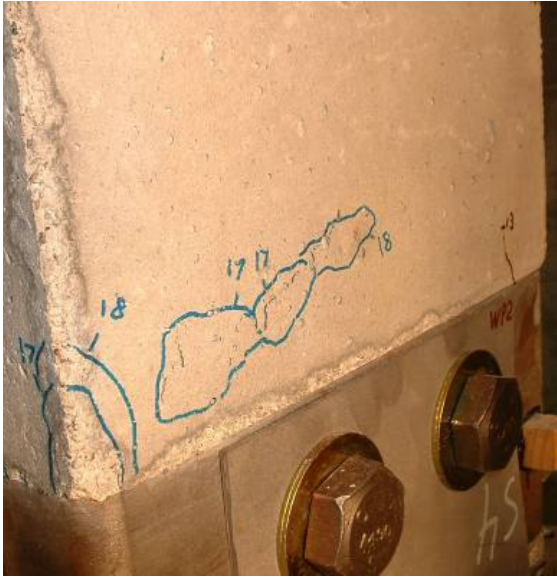
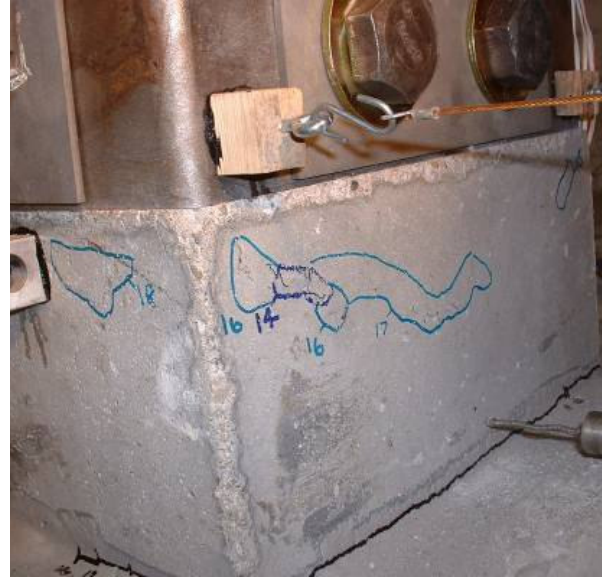
a.) Upper west column segment compression damage

b.) Northwest corner compression damage

Figure 147. Photographs of Column 6 – Cycle 18b.

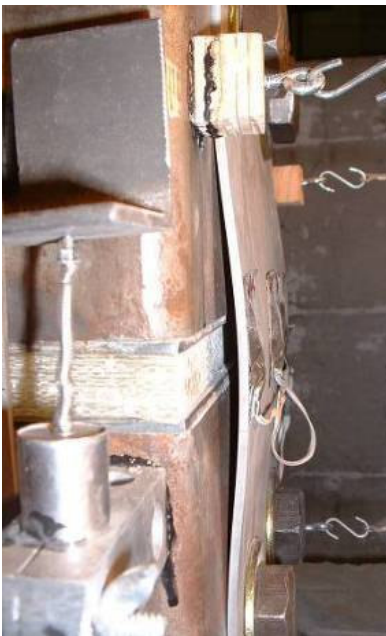
a.) West fuse plate buckling

b.) East face compression damage

Figure 148. Photographs of Column 6 – Cycle 19b.

"Pinging" in the fuse plates was noted during Cycle 19b (displacement = ± 3.5 in.), again indicating slippage between the fuse plates and through-bolts. Also during this cycle, the construction joint gap between column segments began to widen significantly. More "pinging" was heard from the fuse plates during Cycle 21b (displacement = ± 5.0 in.), Cycle 22b (displacement = ± 5.0 in.), and Cycle 23b (displacement = ± 6.0 in.). After Cycle 23b, continuous "pinging" was heard in the fuse plates during the remaining cycles of the test. Compression damage continued to increase over the next few cycles, along with superficial, shallow (< 0.25 in. deep) spalling of the concrete around the collars (see Figures 151a, 151b, and 153). A decrease in lateral load was noted as the slippage in the fuse plates continued, as with previous tests.

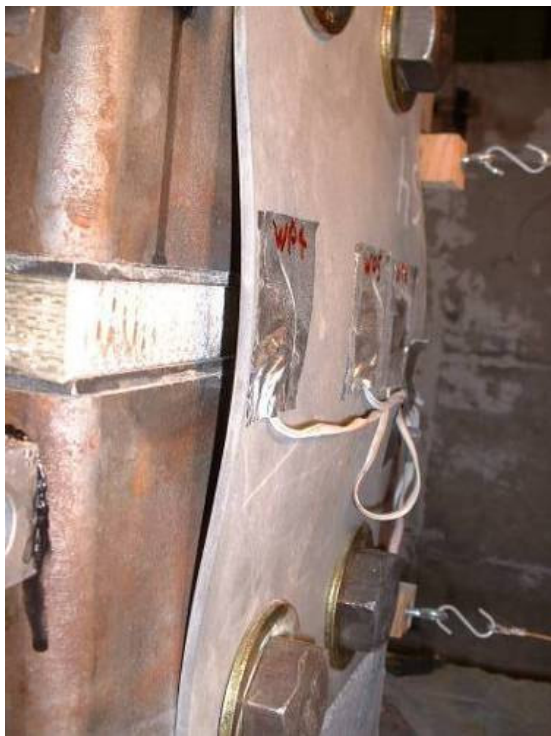
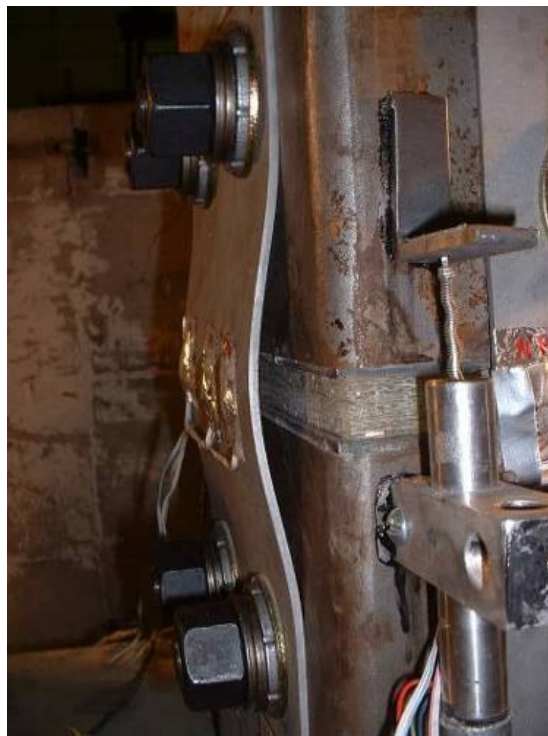
a.) West fuse plate buckling

b.) East fuse plate buckling

Figure 149. Photographs of Column 6 – Cycle 20b.

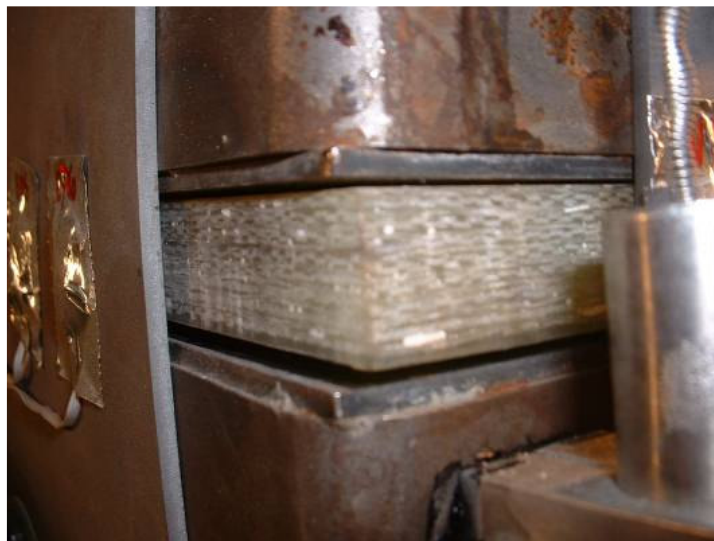
Figure 150. Photographs of Column 6 – Cycle 21b, joint opening.

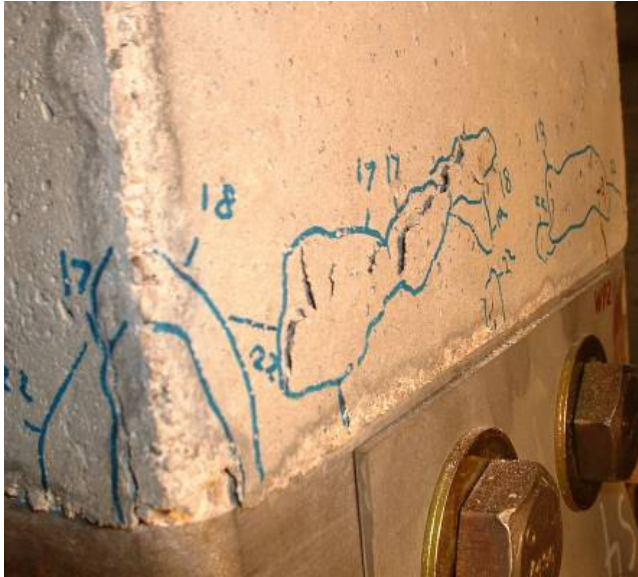
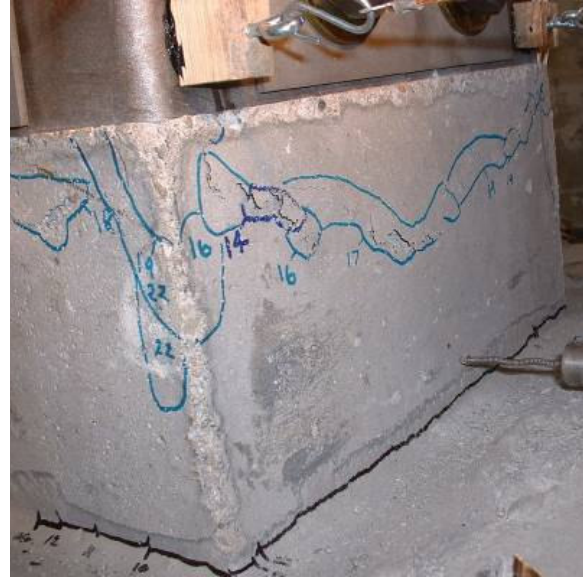
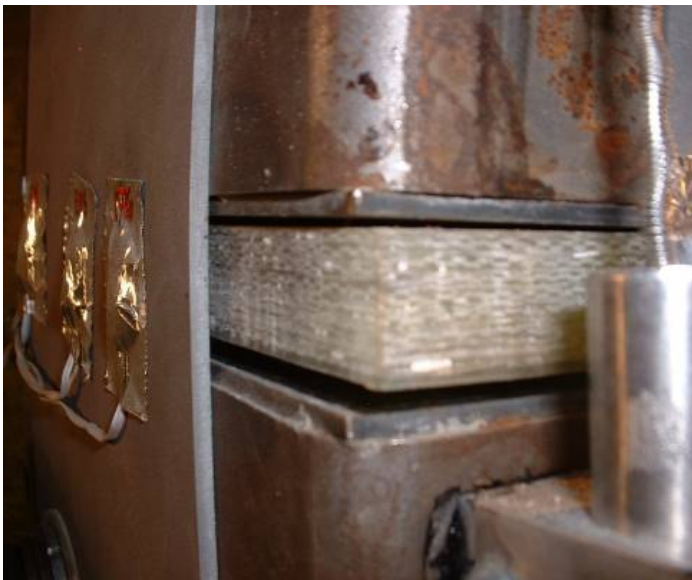
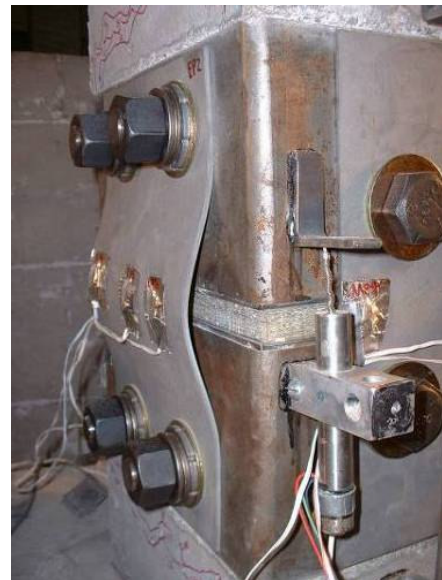
a.) Upper segment west face compression damage

b.) Lower segment west face compression damage

c.) Northwest corner joint opening

d.) West fuse plate buckling

Figure 151. Photographs of Column 6 – Cycle 23b, push half-cycle.

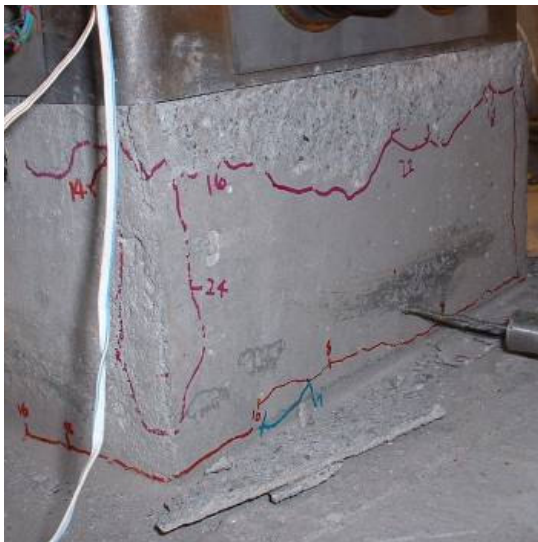
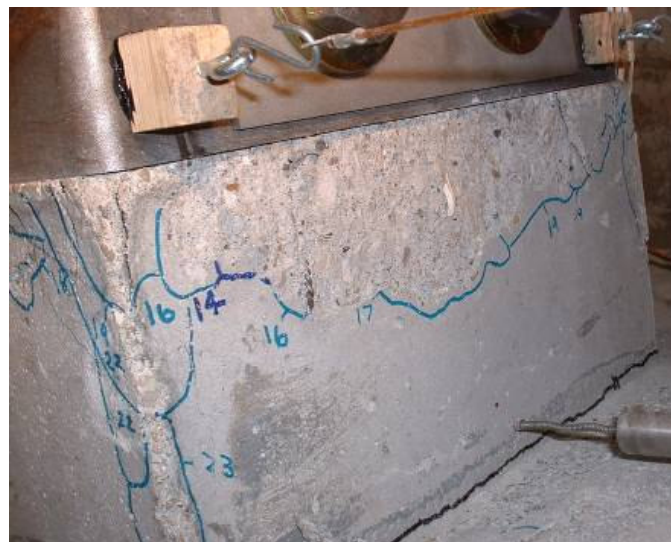
a.) Lower segment east face spalling

b.) Lower segment west face spalling

Figure 153. Photographs of Column 6 – Cycle 26b.

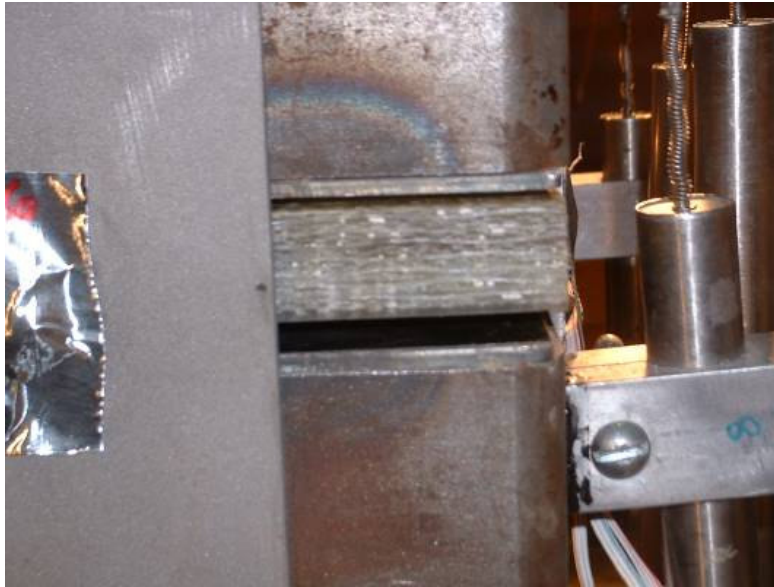
Figure 154. Photograph of Column 6 – Cycle 26b, east joint opening.

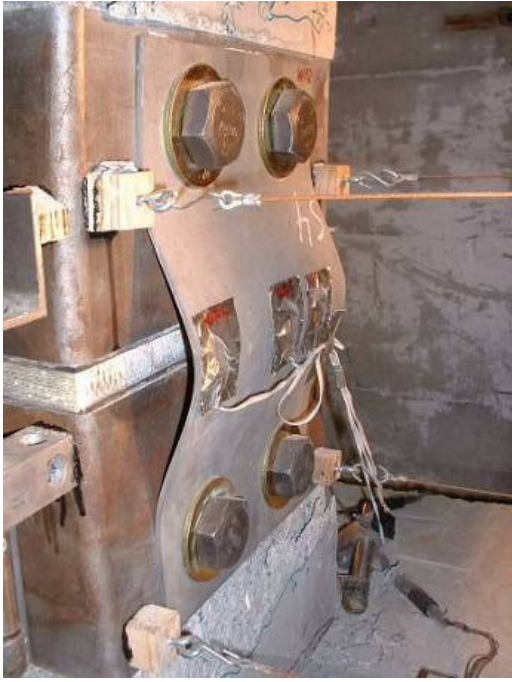
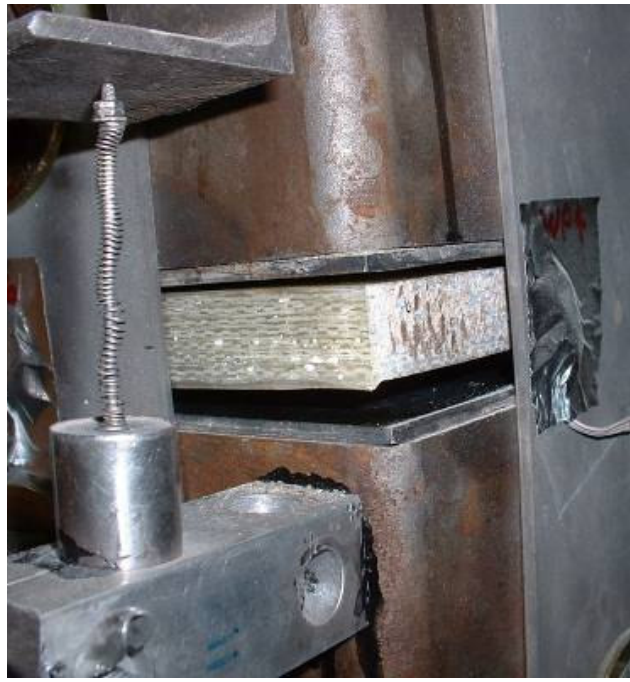
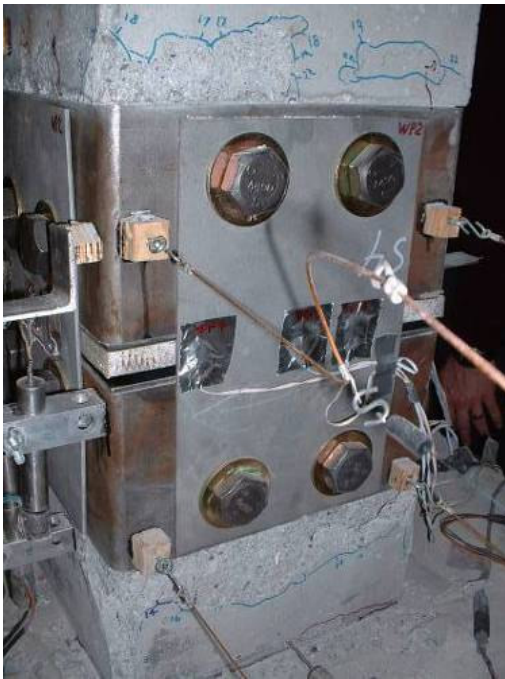
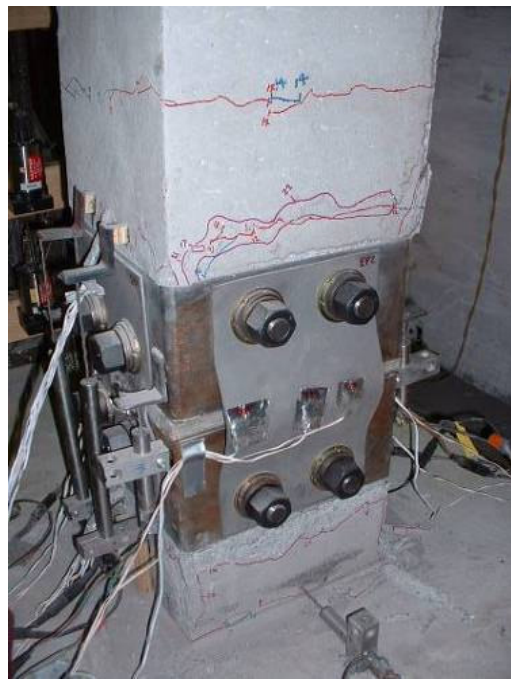
a.) West fuse plate buckling

b.) Northwest corner joint opening

c.) West face under tension

b.) East face under compression

Figure 156. Photographs of Column 6 – Cycle 28b.

The damage to Column 6 up to Cycle 26b can be seen in Figure 155. Fuse plate buckling and joint opening that took place during Cycle 28b is illustrated in Figure 156. On Cycle 29b, the south fuse plate fractured below the top left bolt and washer at a displacement of -5.22 in. (see Figure 157a). This fracture was likely caused by the small-radius bending of the lateral plates due to buckling on previous cycles. Testing was continued until the -9.0 in. displacement on Cycle 29b (see Figure 157b), when testing was terminated; the column began to tilt perpendicular to the axis of loading due to the fractured fuse plate, and it caused the load beam to impinge on the load frame (see Figure 158).

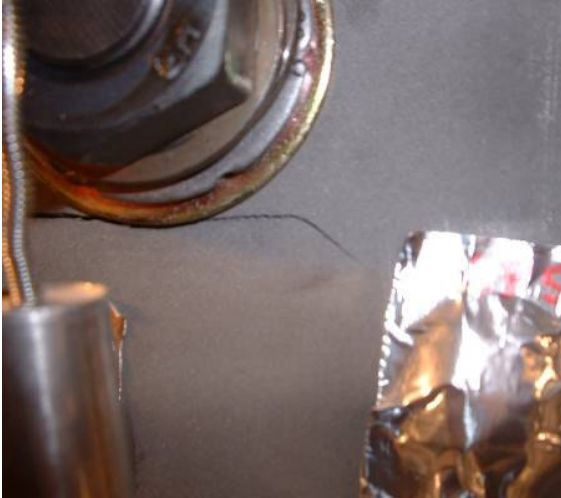
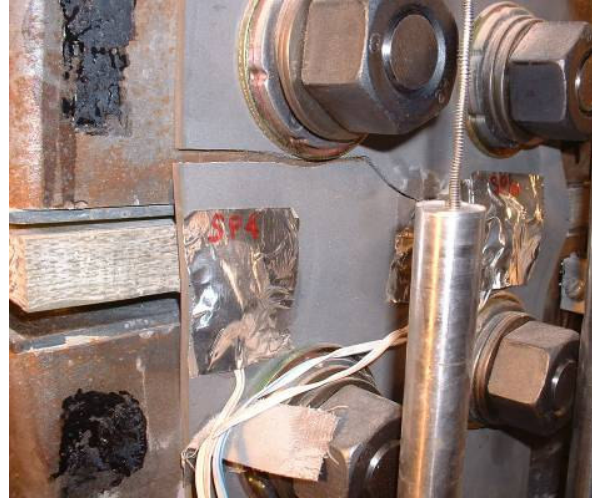
a.) Initial fracture of south fuse plate at -5.22 in. displacement

b.) Fuse plate crack at -9.0 in. displacement

Figure 157. Photographs of Column 6 – Cycle 29b fuse plate crack.

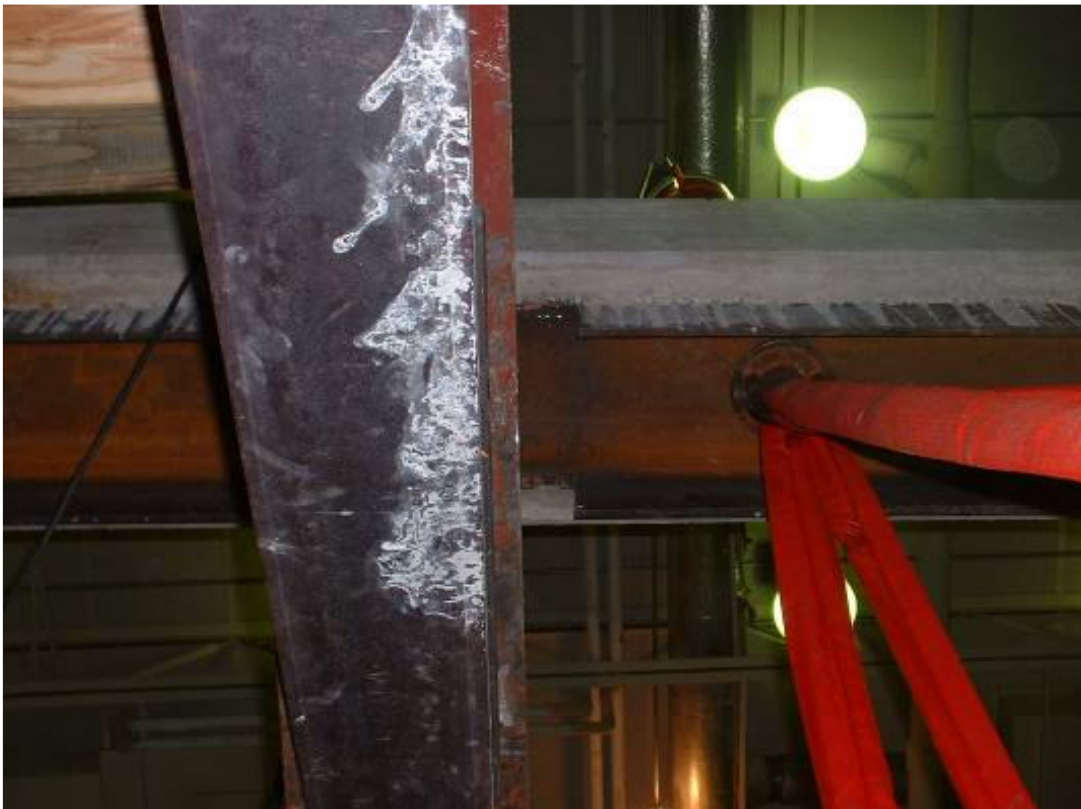
c.) Load beam impinging on load frame

Figure 158. Photographs of Column 6 – Cycle 29b.
