# MASH 2016 Evaluation of a Non-Proprietary Type III Barricade

**Final Report – Revision-1  
September 2018**

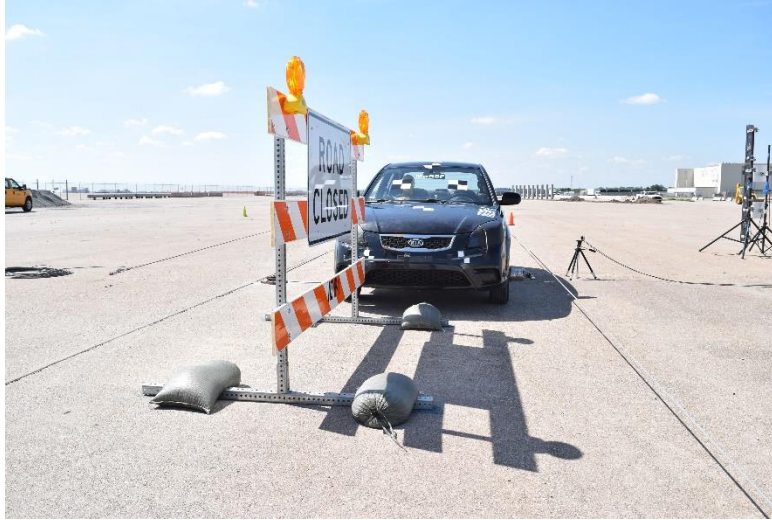
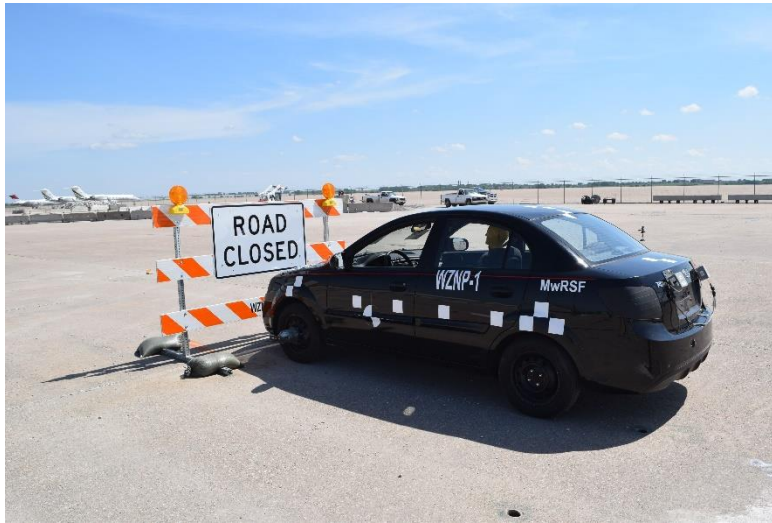
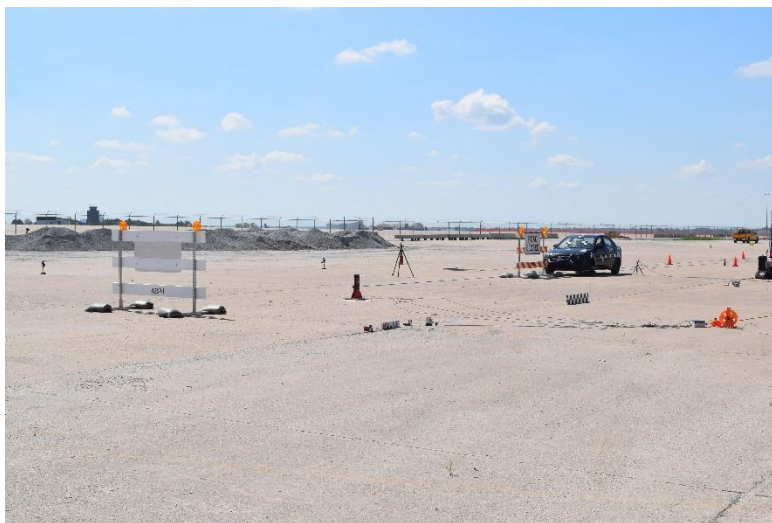
**Figure 61. Impact Location, Test No. WZNP-1**

Initial vehicle impact with System A was to occur with a right quarter-point offset from the centerline of the car and initial vehicle impact with System B was to occur with a left quarter-point offset from the centerline of the car, as shown in Figure 61. Although MASH 2016 does not provide specific guidance about how to align the test vehicle and test article, a centerline impact seemed reasonable. However, in order to have two devices impacted in one test run using the previously established method, the systems were aligned with the quarter points of the vehicle to distinguish damage between the two systems. A sequential description of the impact events is contained in Table 7 for System A and Table 8 for System B. The vehicle came to rest 310 ft (94.5 m) downstream and 5 ft – 1 in. (1.5 m) laterally to the left after brakes were applied. The vehicle trajectory and final position are shown in Figures 58, 59, and 62.

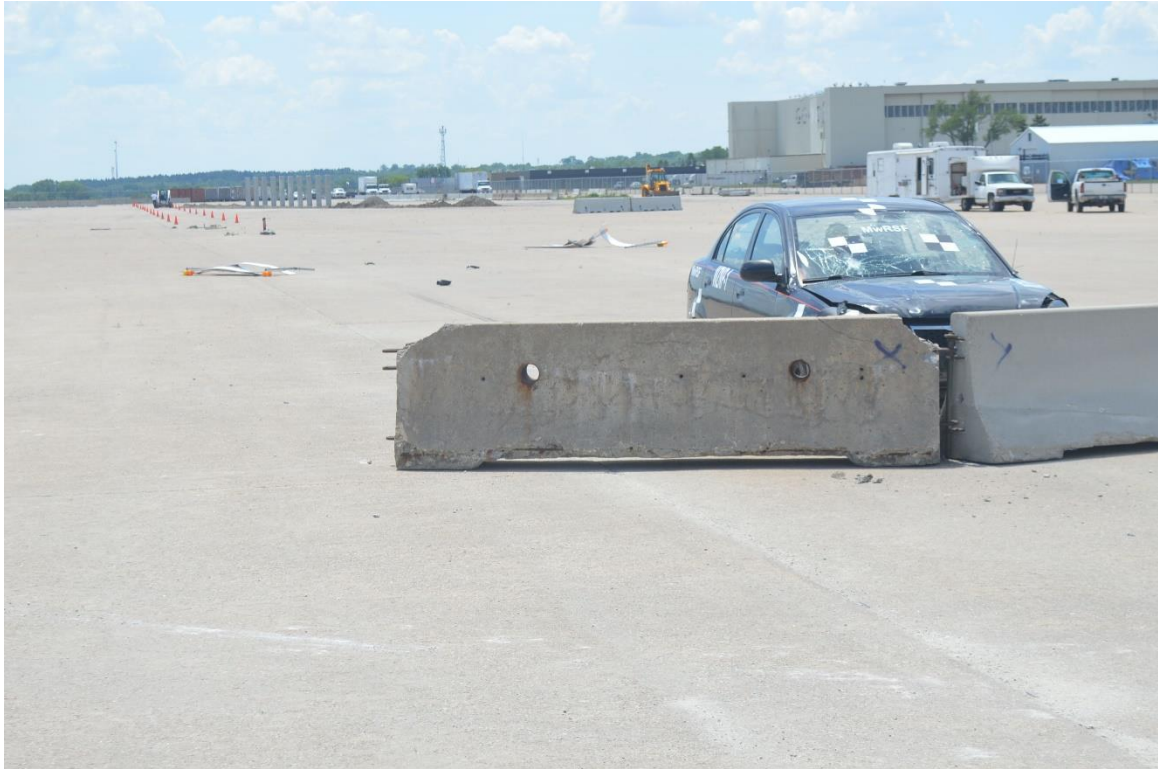
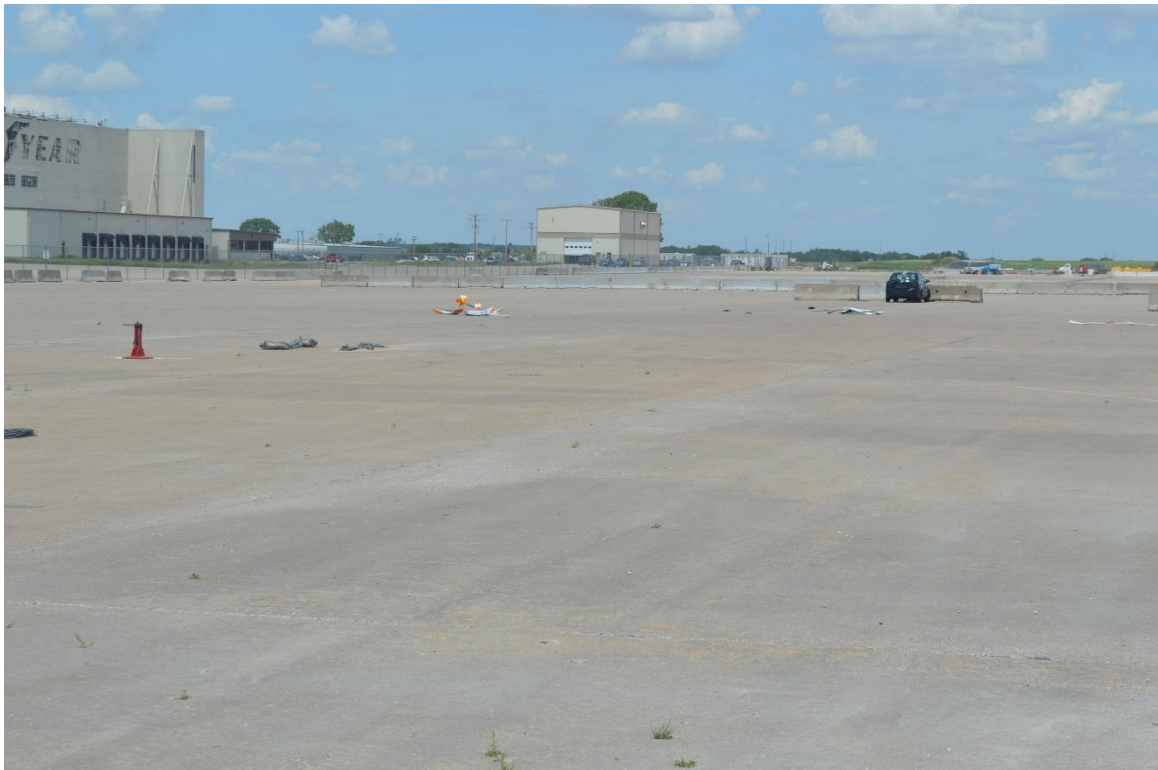
**Figure 62. Vehicle Final Position and Trajectory Marks, Test No. WZNP-1**

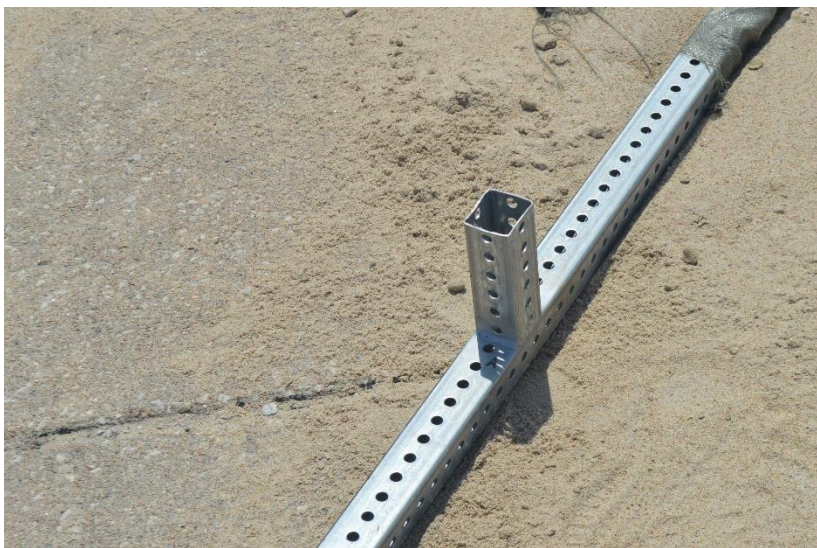
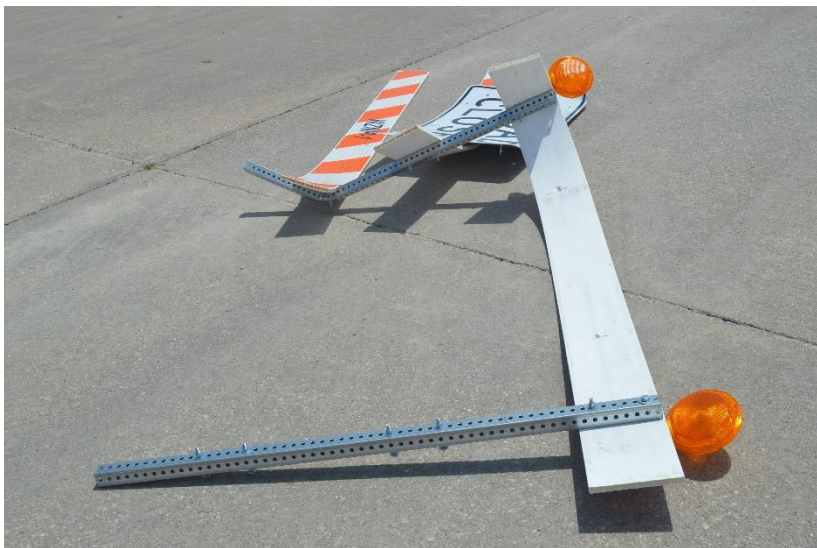
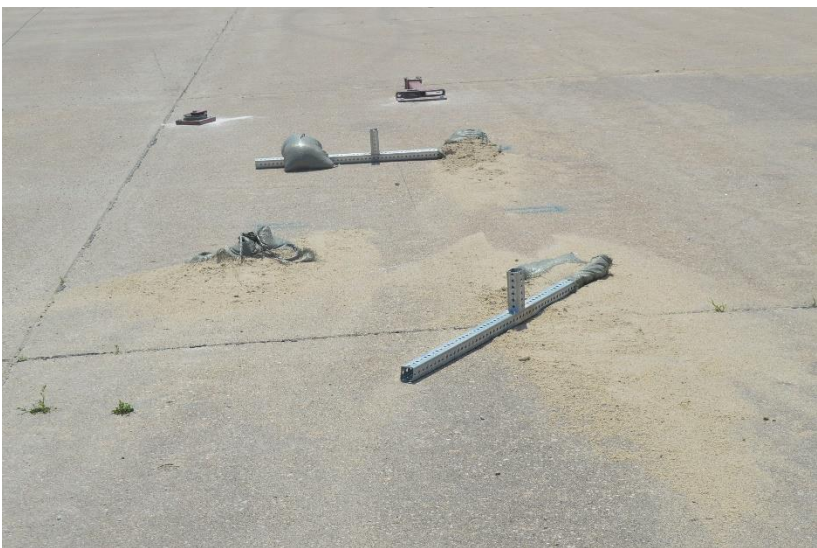
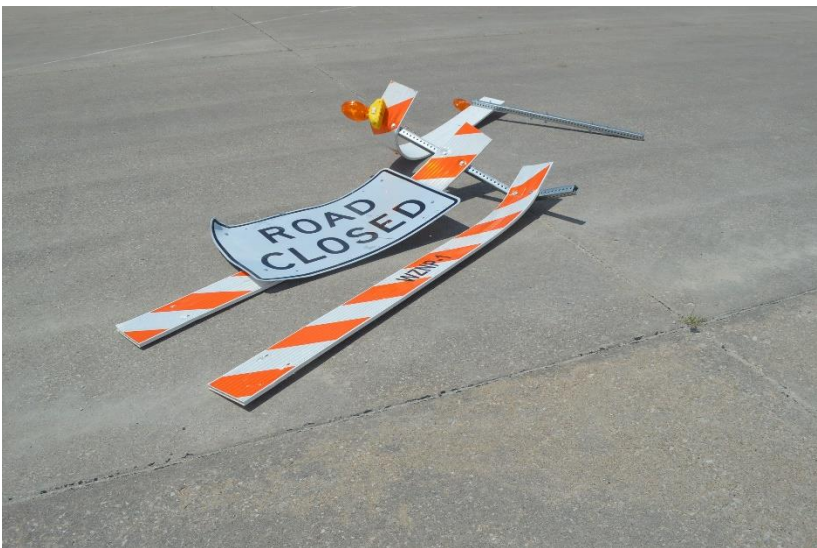
**Figure 63. System Damage –Test No. WZNP-1, System A**

Damage to the barricades was moderate, as shown in Figures 63 and 64. System damage consisted of bends and buckles in the uprights and panels, tears in the weighed sandbags, and bolt pullouts.

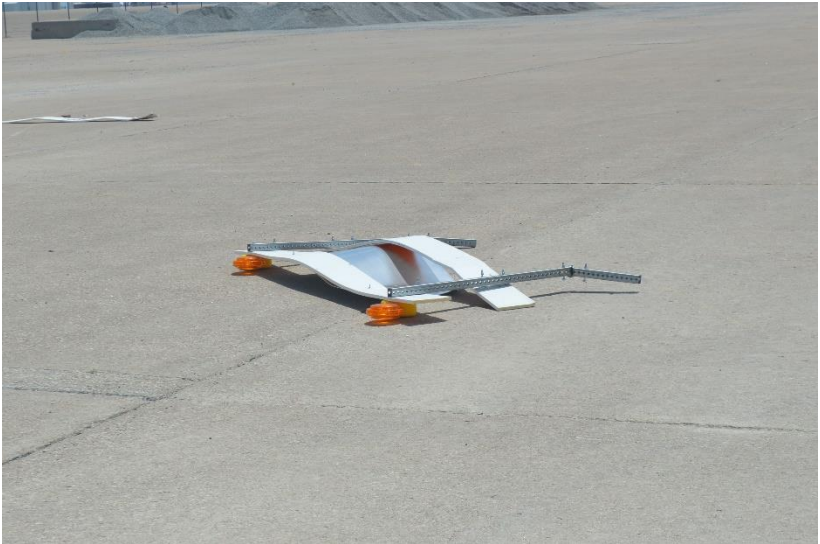
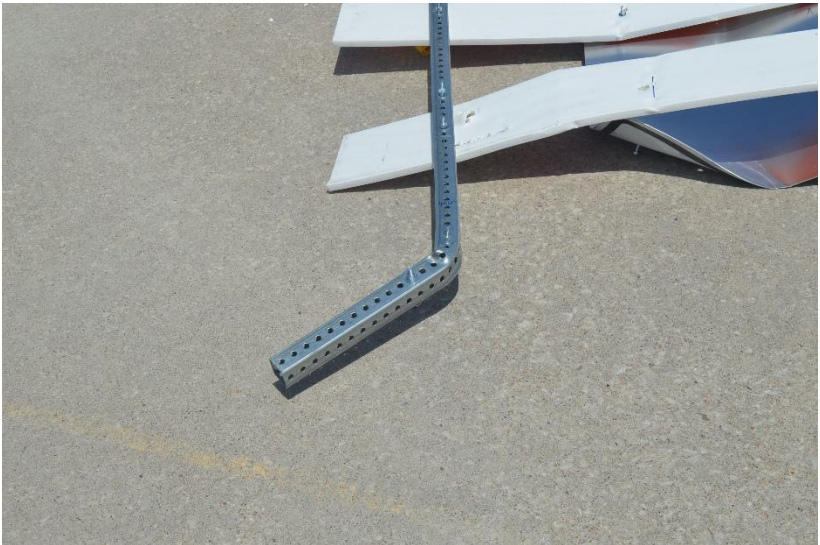
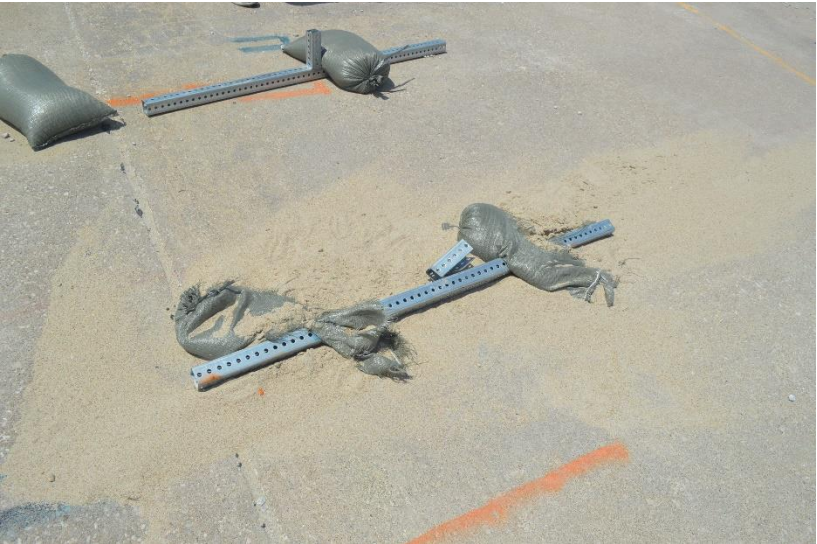
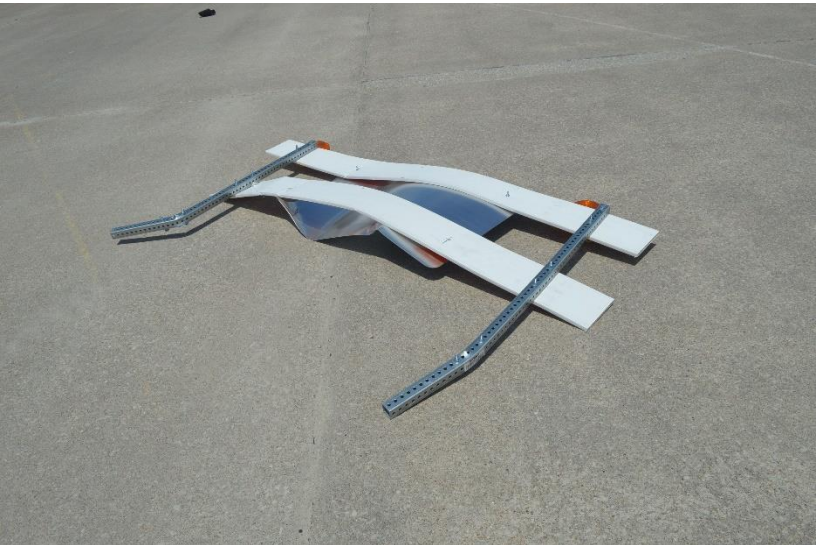
**Figure 64. System Damage –Test No. WZNP-1, System B**

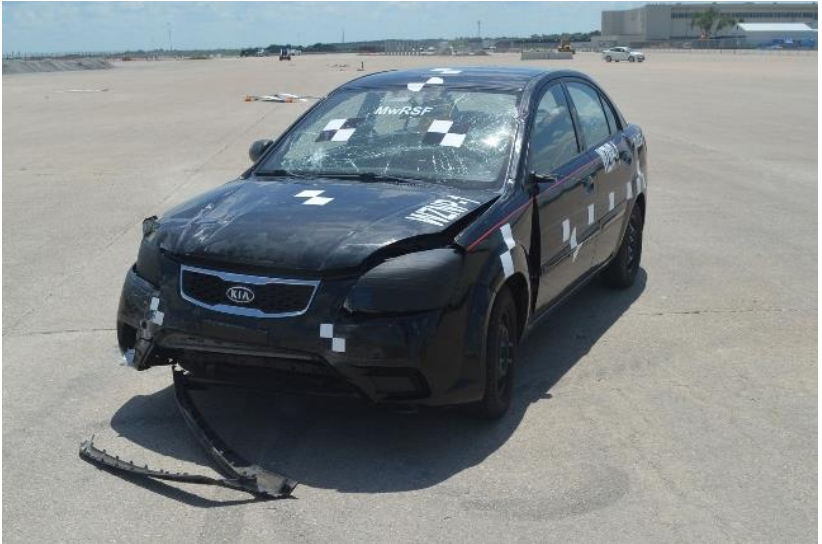
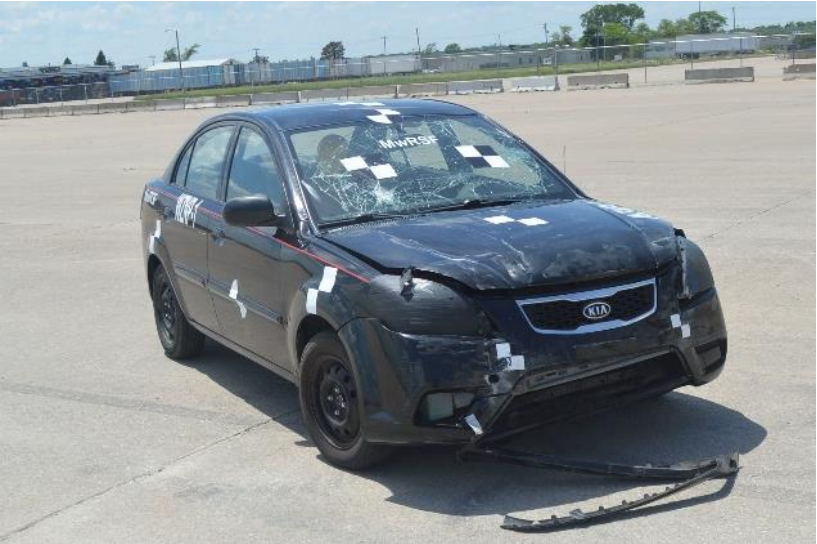
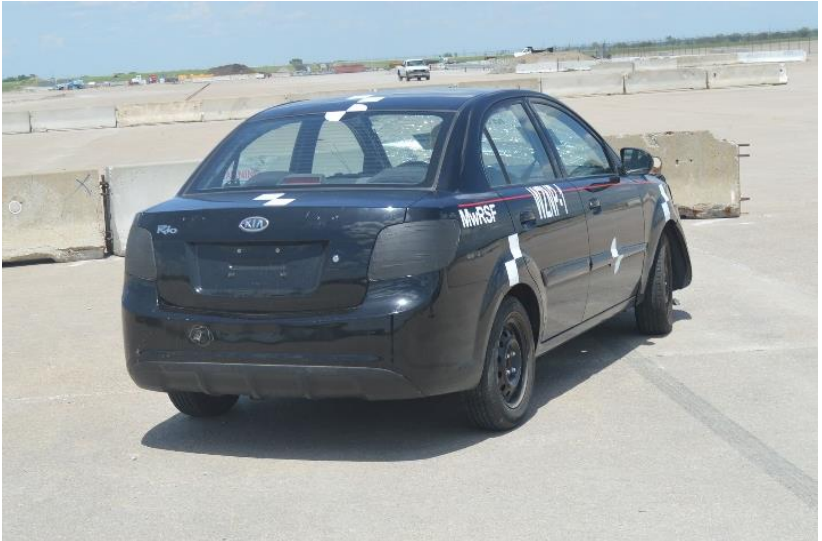
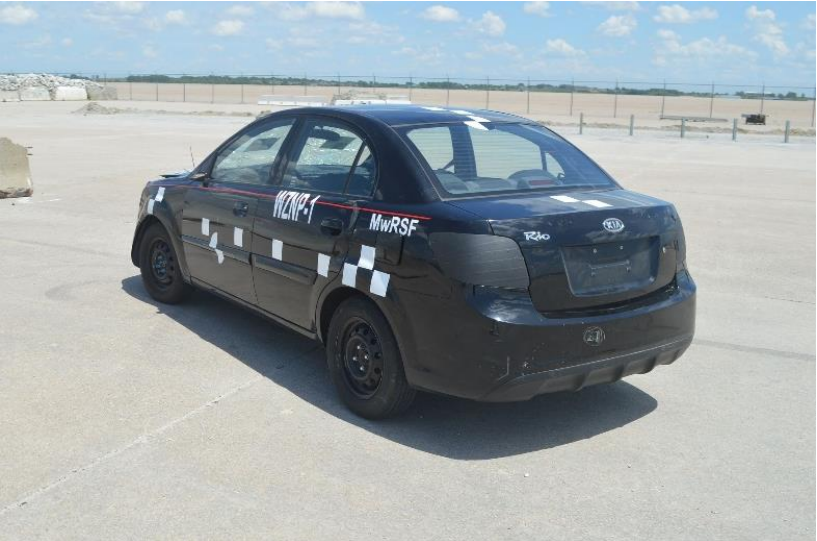
Figure 65. Vehicle Damage, Test No. WZNP-1

The damage to the vehicle was minimal, as shown in Figures 65 through Figure 67. After impacting both barricade systems, the car impacted a concrete barrier that was placed downstream from the test, which caused most of the vehicle damage. The maximum occupant compartment deformations are listed in Table 9 along with the deformation limits established in MASH 2016 for various areas of the occupant compartment. A negative value indicates that deformation was outward and not toward the occupant. Note that none of the established MASH 2016 deformation limits were violated. The maximum windshield crush of 0.8 in. (20 mm) was caused by the 0-degree barricade impact (System B) and was located near the left-side A-pillar. Complete occupant compartment and vehicle deformations and the corresponding locations are provided in Appendix C.

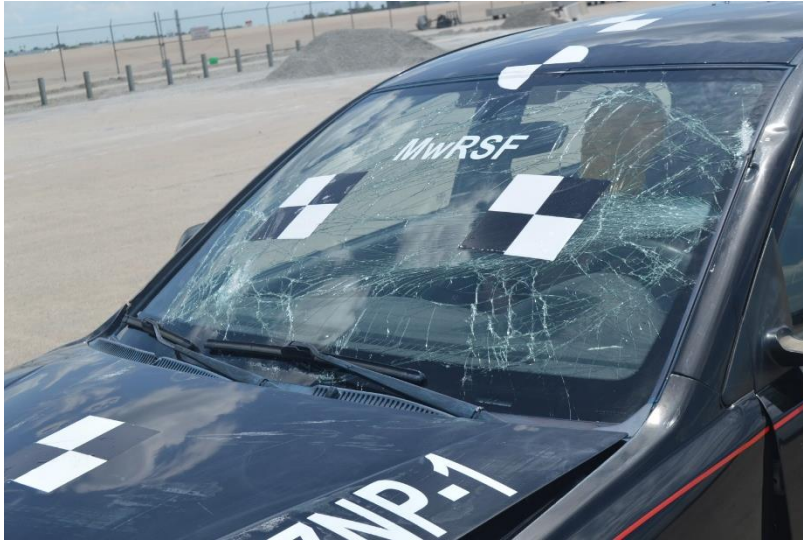
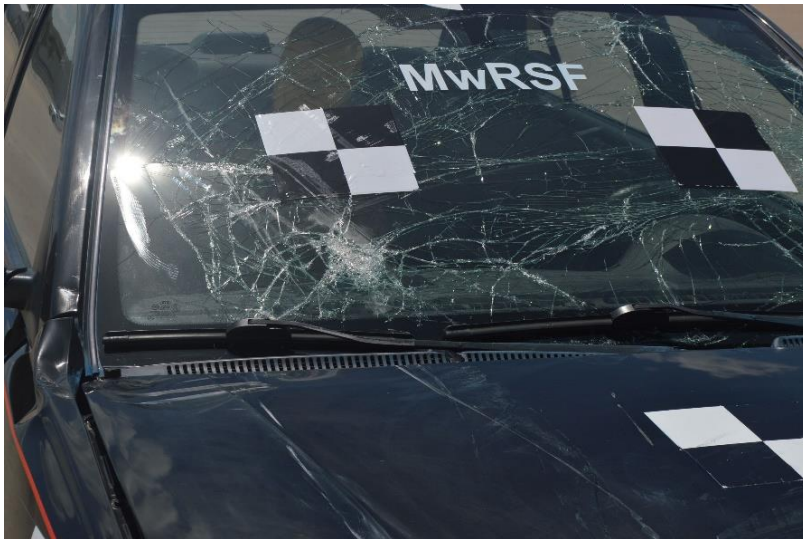
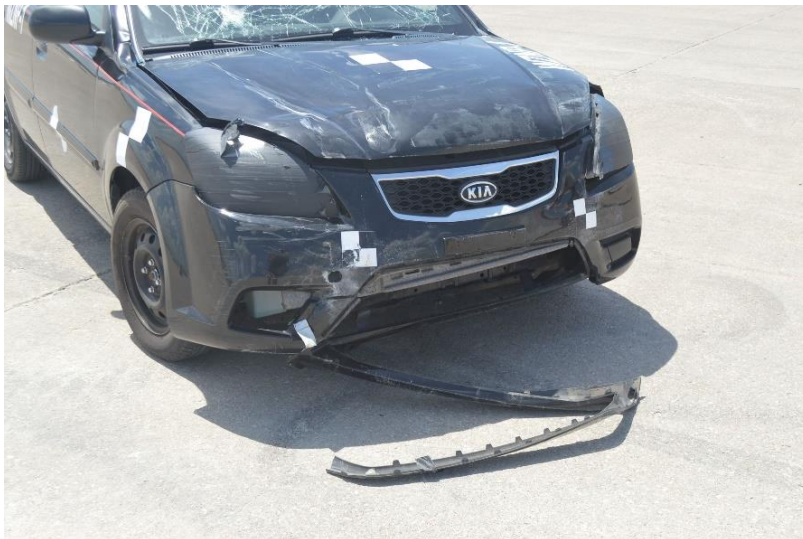
**Figure 66. Vehicle Damage, Test No. WZNP-1**

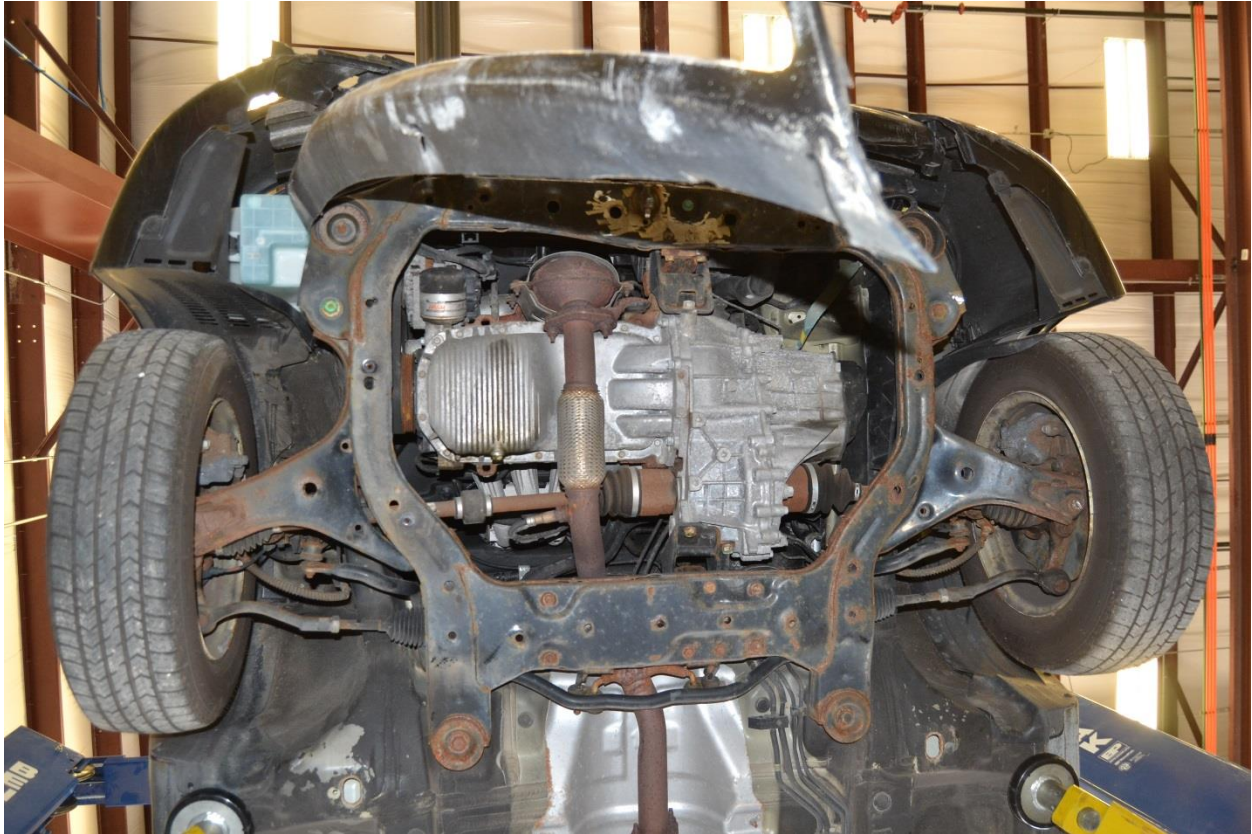
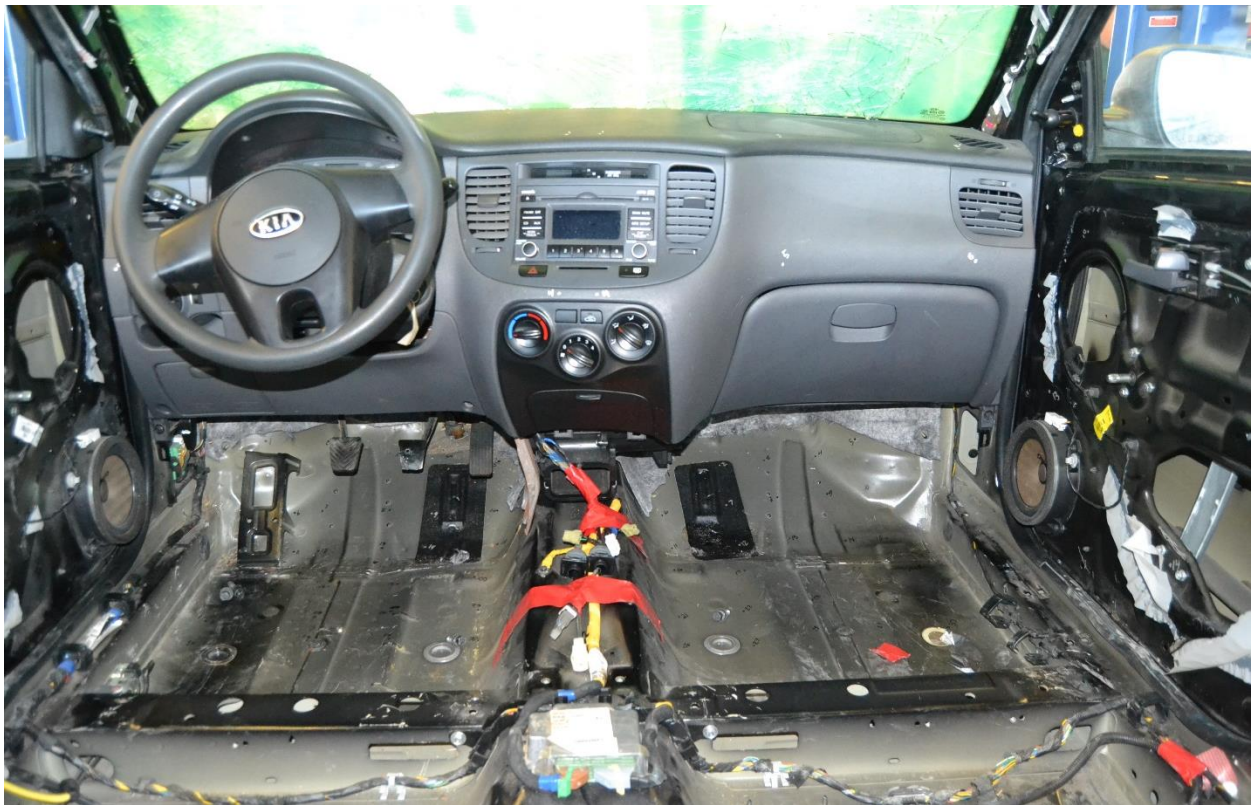
**Figure 67. Vehicle Damage, Test No. WZNP-1**

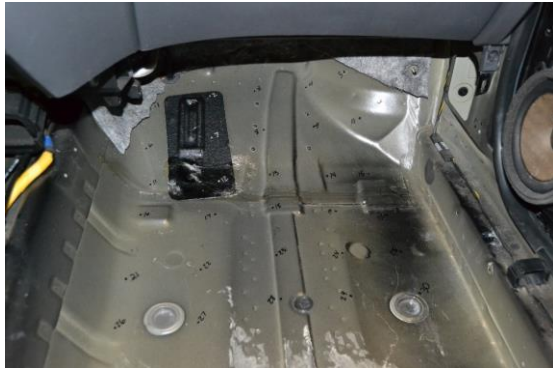
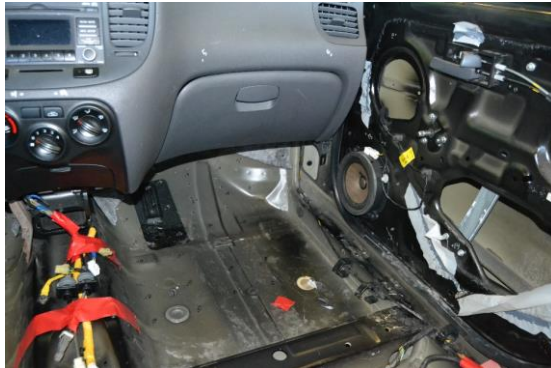
Pretest Floor Pan	Posttest Floor Pan

Figure C-1. Floor Pan Deformation Data – Set 1 (Right), Test No. WZNP-1

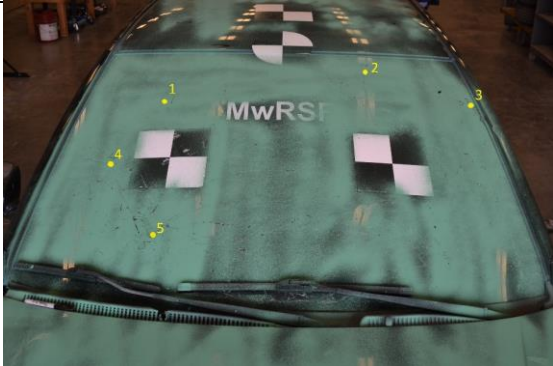
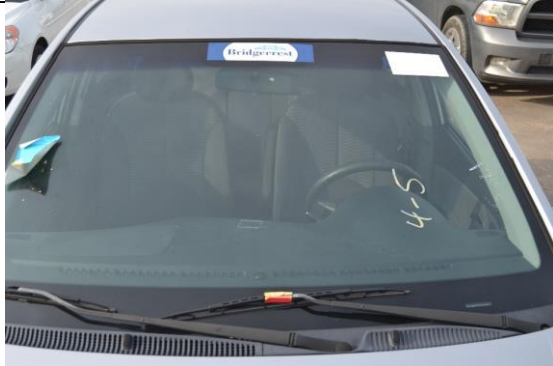
The windshield was 3D scanned with the FARO hand held scanner both pre and post test.

<p><b>Test Vehicle Damaged Windshield</b></p>

<p><b>Exemplar Vehicle Windshield</b></p>

Figure C-10. Windshield Damage, Test No. WZNP-1
