SIGNAL SYSTEM STUDY for the CENTRAL BUSINESS DISTRICT

Burlington, Iowa

George L. Crawford and Associates, Inc.
St. Louis, Missouri

February 20, 1976

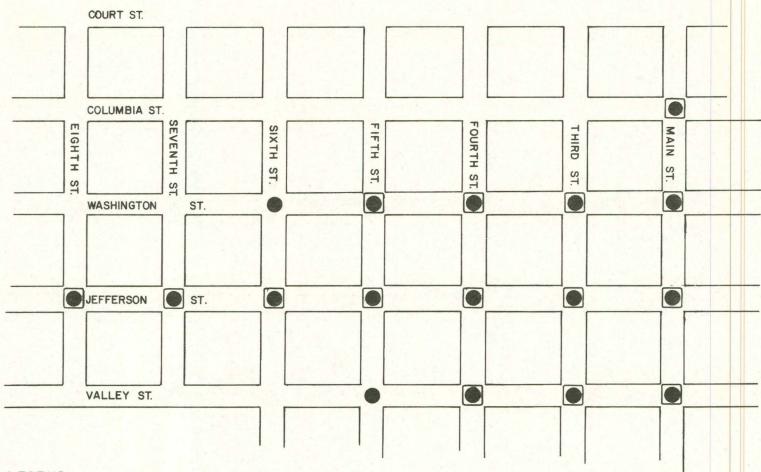
A considerable amount of data was collected in this project. Manual traffic counts were made at all major intersections. Existing traffic signals were inventoried to determine the condition of their equipment as well as their present operation. Physical characteristics of the streets, such as width, number of lanes, etc., were also measured. Exhibit 1, page 2, illustrates the locations studied.

STUDY INTERSECTIONS

STUDY AREA BURLINGTON, IOWA The following sections of the report discuss this study in detail. An estimate of the cost for implementing the recommended improvements has also been prepared and is presented at the conclusion of this report.

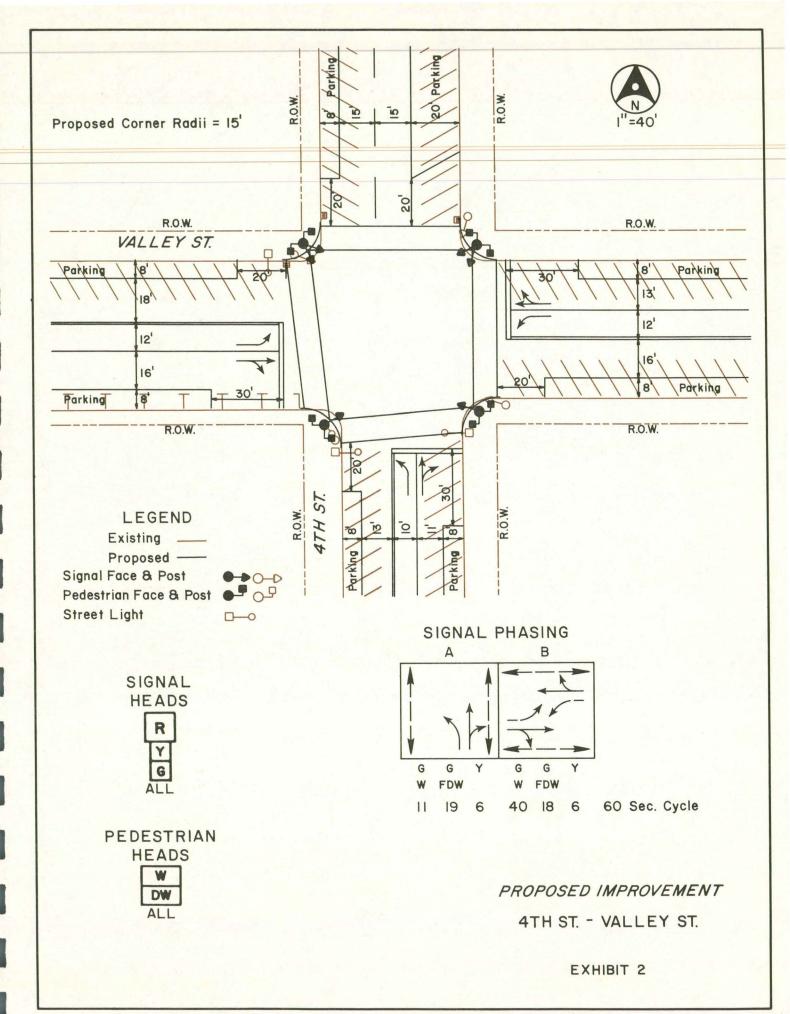
To correct the above mentioned problems, the following improvements are recommended.

- The diagonal parking should be replaced by parallel parking on east, west, and south legs of the intersection. A portion of the diagonal parking should also be eliminated on the north approach to the intersection.

- 2. The pavement should be restriped to provide left turn lanes on the east, west, and south approaches.
- 3. Many of the existing signal heads should be relocated and additional heads installed to provide far left and far right signal indications within the 20 degree cone of visibility recommended by national standards.

These recommendations are shown in detail in Exhibit 2, page 16. Additional information concerning traffic volumes, accident patterns, and capacity studies are included in the Data Appendix.

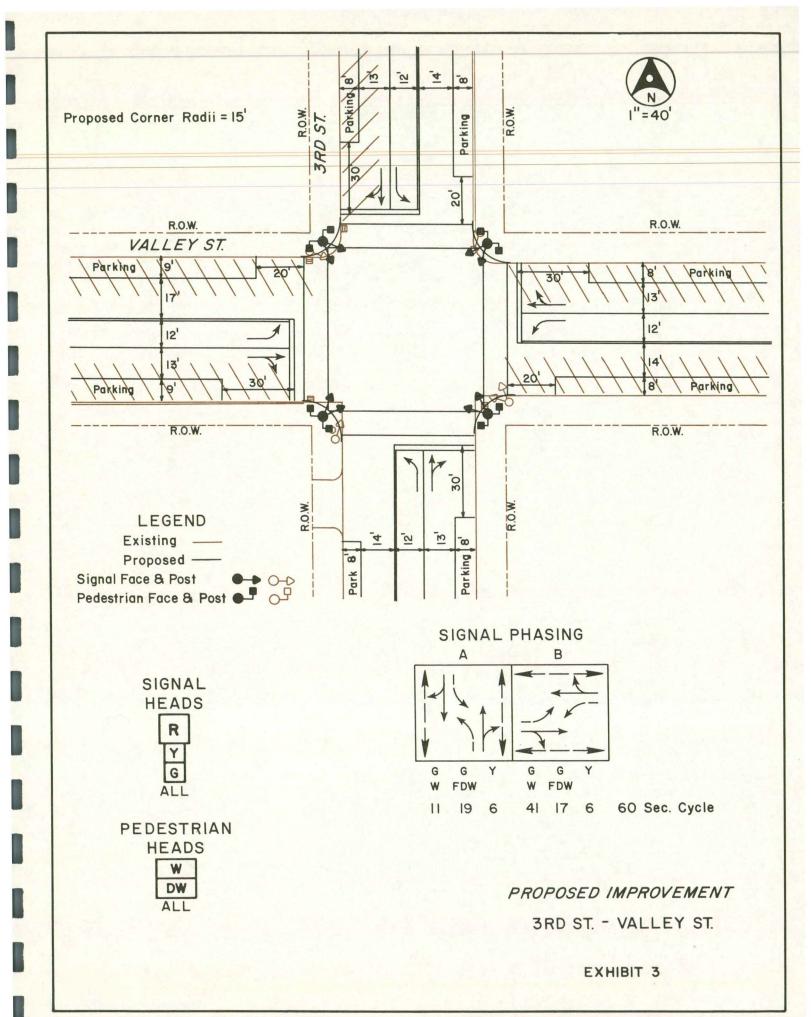
A number of improvements are recommended to accommodate traffic flows. These recommendations, illustrated in Exhibit 3, page 18, are listed below.

- 1. Replace the diagonal parking on both streets with parallel parking.
- 2. Restripe the pavement on all approaches to allow a left turn and through traffic lane on each approach to the intersection.
- 3. Add 12 inch red signal indications on all approaches.
- 4. Install rectangular walk and don't walk pedestrian signals.
- 5. Relocate the existing signal heads and install additional far left signal indications so that motorists will have adequate far right and far left indications.
- Retime the traffic signal to give a greater percentage of the green time to Valley Street, the more heavily used of the two streets.
- 7. Reconstruct the curb corners so as to increase the corner radii to a minimum of 15 feet.

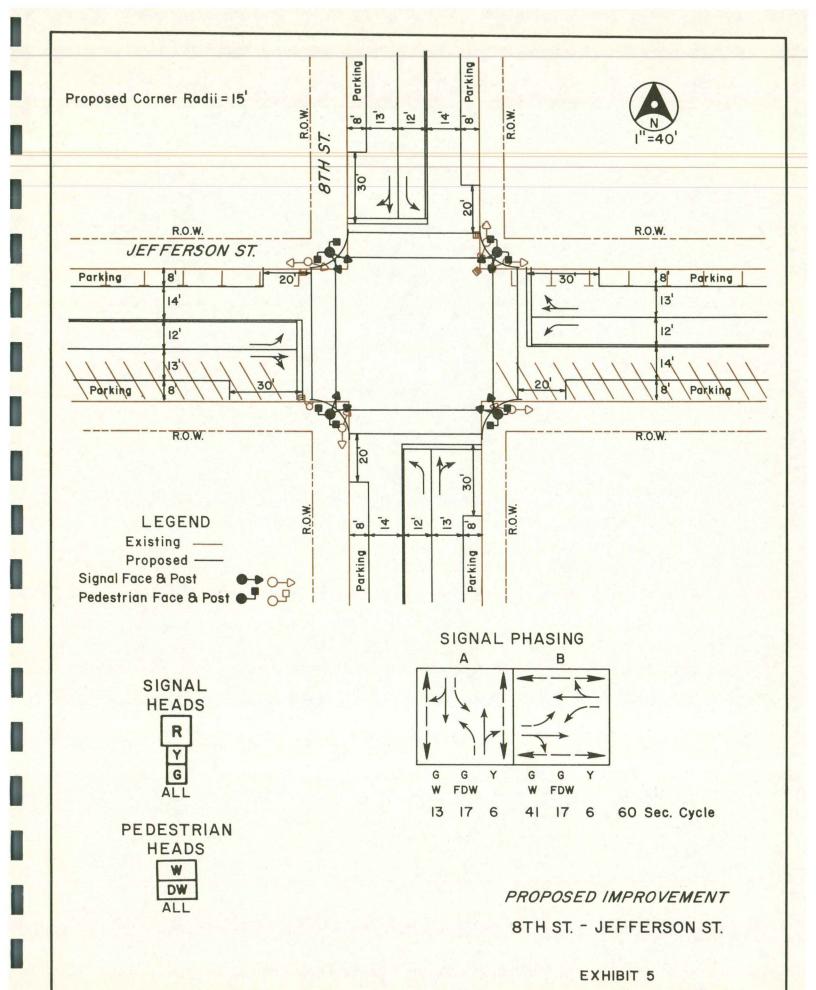
A number of improvements are recommended to facilitate traffic flows at this location. These include:

- 1. Eliminate the existing diagonal parking along the south side of Jefferson Street and replace it with parallel parking.
- 2. Restripe the approaches to this intersection to allow a through and left turn lane on each approach.
- 3. Provide 12 inch red signal indications on all approaches.
- 4. Provide rectangular walk don't walk pedestrian signal indications on all approaches.
- 5. Relocate the existing signal heads and additional heads to give adequate far right and far left signal indications on all approaches.
- 6. Cut back the corners so as to provide a 15 foot turning radius on each corner.
- Retime the signals to give more green time for Jefferson Street.

The above recommendations are illustrated in Exhibit 5, page 23. Additional data concerning the traffic characteristics of this intersection can be found in the Data Appendix.

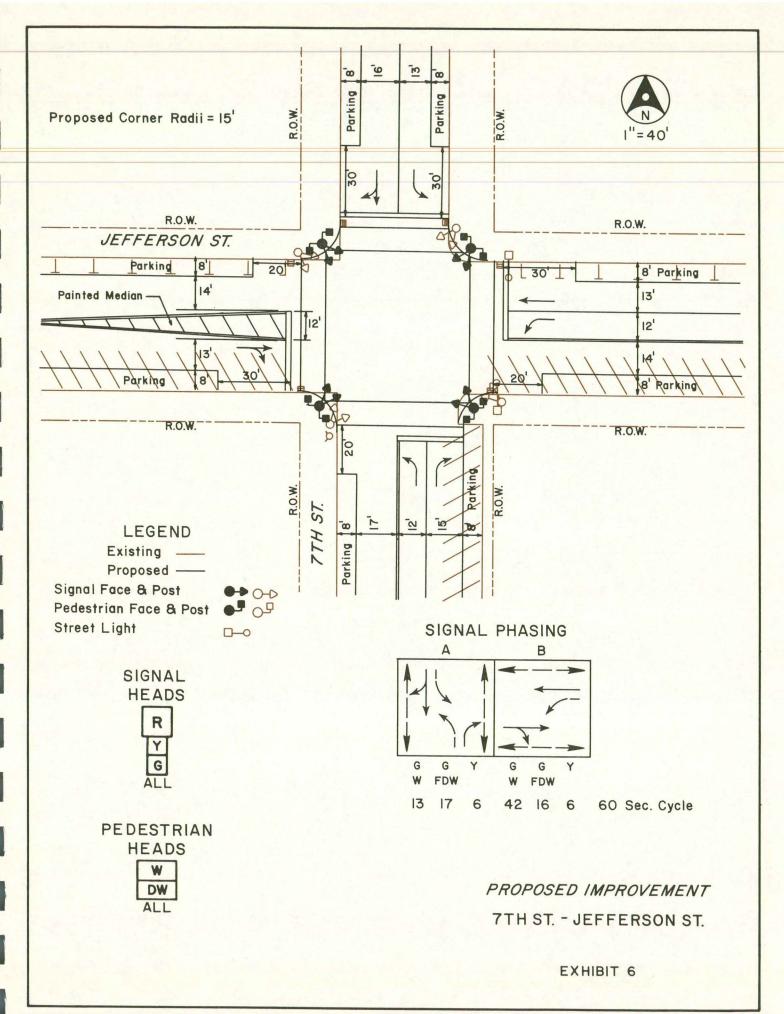
A number of improvements are recommended to reduce the heavy incidence of accidents. These recommendations are illustrated in Exhibit 6, page 25, and are also listed below.

- 1. Eliminate the diagonal parking on both streets and replace it with parallel parking as shown in Exhibit 6.
- 2. Restripe the approaches to the intersection so that separate left turn lanes are provided on the east and south approaches. An island should be painted on the west leg of the intersection opposite the left turn lane thereby forcing motorists using this lane to turn south into 7th Street.
- 3. The signal heads should be repositioned at the intersection to improve signal visibility.
- 4. Twelve inch red signal indications should be used on all approaches.
- 5. Rectangular walk don't walk pedestrian heads should be used on all approaches.
- 6. The curb corners should be cut back so as to provide 15 foot corner radii.
- 7. The signal phasing should be revised to provide 30 percent green time in the north-south direction and 58 percent green time on the east-west approaches.

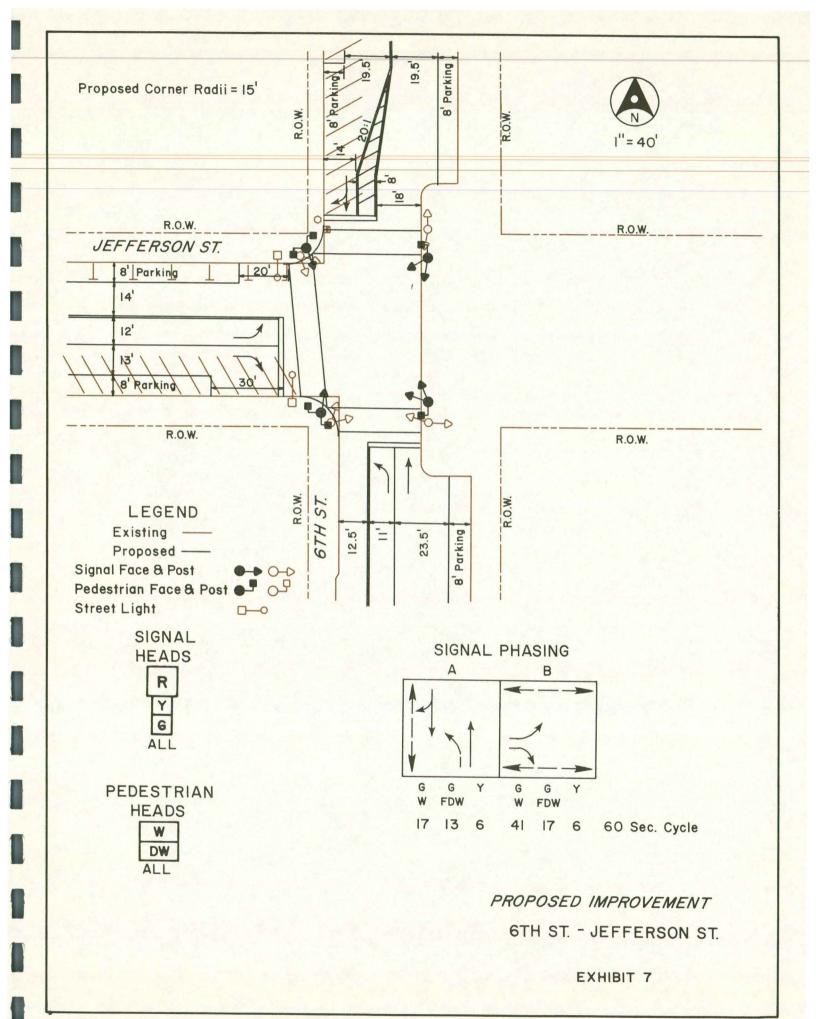
1. Remove diagonal parking along the north and west legs of this intersection, replacing it with parallel curb parking as shown in Exhibit 7, page 27.

- 2. Restripe the intersection to provide two approach lanes on the west leg, a left turn and a right turn lane. Sixth Street should also be restriped to provide a left turn lane for northbound traffic and to channelize southbound traffic.
- 3. As noted above, signal visibility should be improved by repositioning the signals to give the motorists better visibility, particularly of the far left indications.
- 4. Twelve inch red indications should be used on all signal heads.
- 5. Rectangular walk don't walk pedestrian indications should be installed.
- 6. The northwest and southwest corners of the intersection should be cut back to provide 15 foot turning radii.
- 7. Signal timing should be adjusted to provide 30 and 58 percent green time for the north-south and west-bount traffic movements respectively.

Exhibit 7, page 27, illustrates the above recommendations.

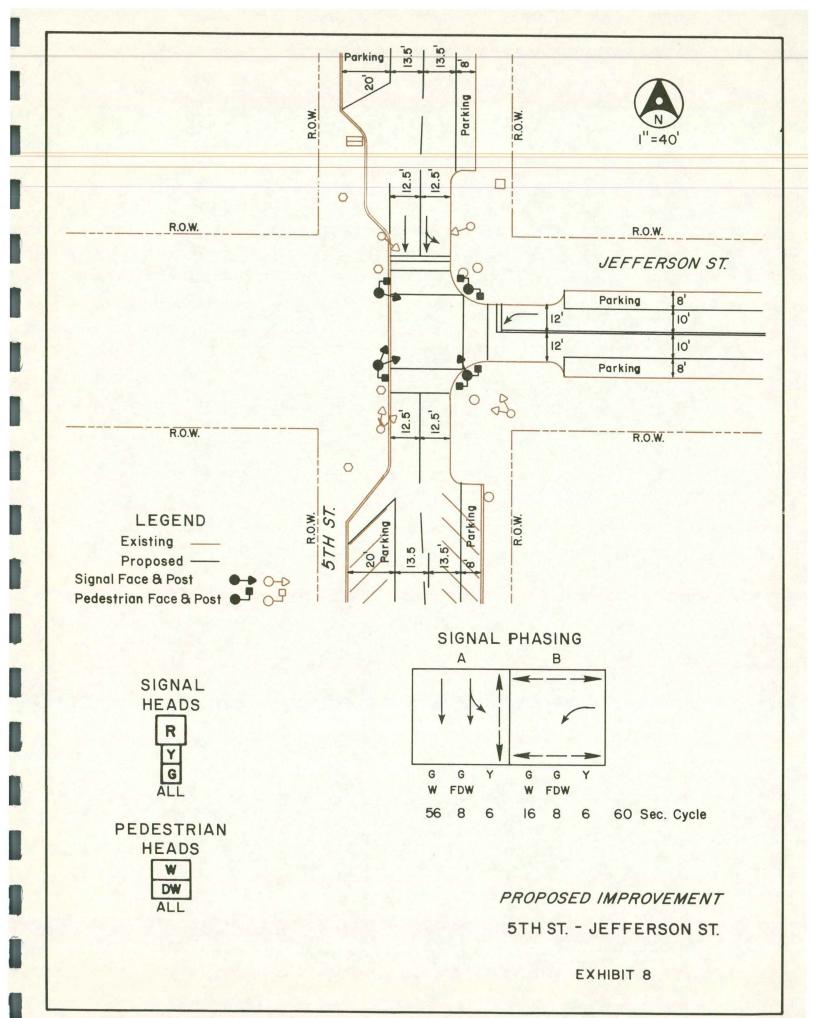
There are a number of additional improvements which should be implemented. These are enumerated below and shown in more detail in Exhibit 8, page 30.

- 1. Eliminate the angle parking along the east side of 5th Street south of the intersection and replace with parallel parking.
- Reposition the signal heads so their visibility to motorists will be improved. This repositioning is particularly desirable in light of the fact that Jefferson Street will be narrowed east of the intersection.
- 3. Install 12 inch red signal indications on all approaches.
- 4. Utilize rectangular pedestrian walk don't walk signal indications at all crosswalks.

5. Revise the signal timing so as to allow the majority of the green time (64 percent) for north-south traffic.

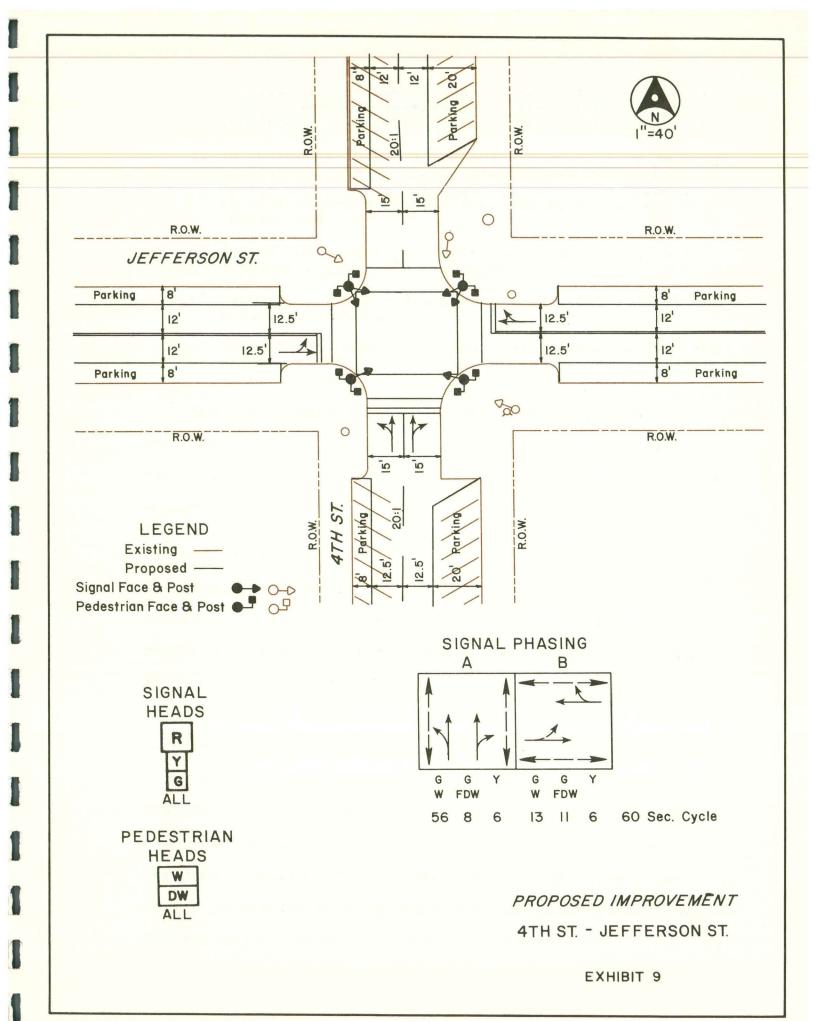
Most of these accidents involved motorists traveling along Jefferson Street. The de-emphasis of vehicular flows along this street plus a repositioning of the traffic signals to give better visibility should help alleviate the problem. A number of other traffic improvements are also recommended. These are listed below and shown in detail in Exhibit 9, page 32.

1. Diagonal parking is presently allowed along both sides of 4th Street. Parallel parking should be

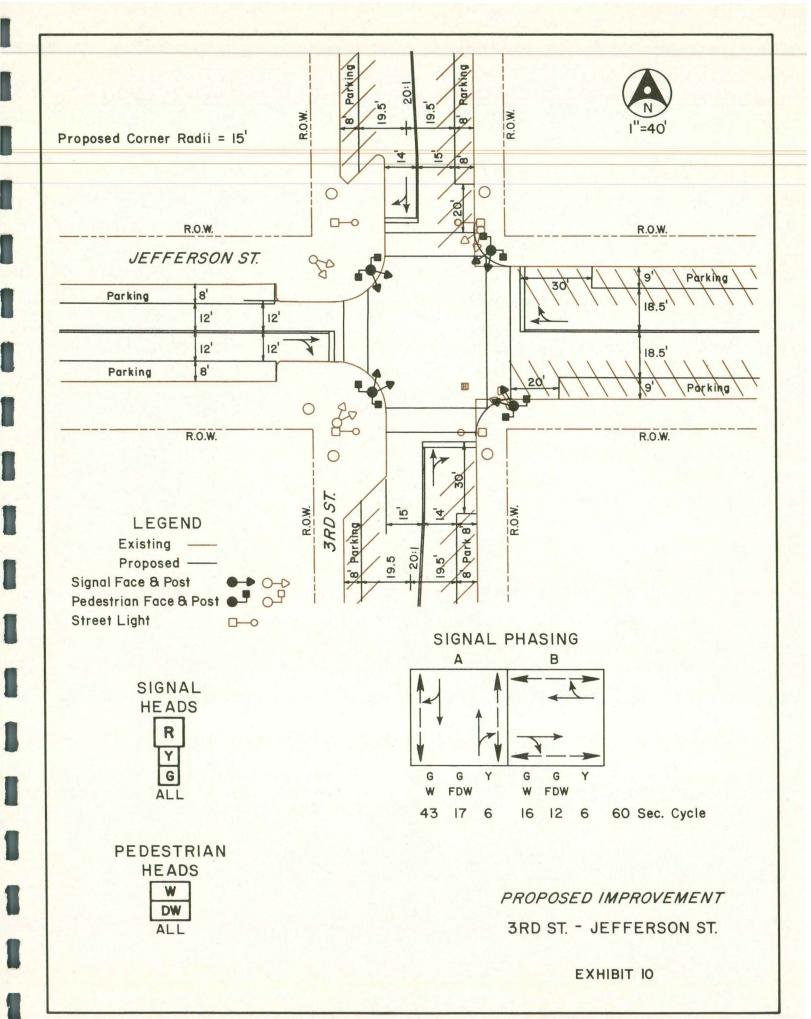
It appears that the use of diagonal parking contributes greatly to the accident problem at this location. The City's plan to narrow Jefferson Street west of 3rd Street and replace the diagonal parking along Jefferson Street with parallel parking should improve this situation. A number of other improvements should also be implemented to reduce traffic hazards. These are enumerated below and shown in detail in Exhibit 10, page 35.

- 1. Parallel parking should be substituted for the diagonal parking along Jefferson Street on both sides of the intersection. In addition, diagonal parking along the east side of 3rd Street should be eliminated and the pavement restriped to provide wider moving traffic lanes.
- Reconstruction of Jefferson Street west of this intersection will necessitate repositioning of the traffic signals so that they will be more visible to motorists along Jefferson Street.
- 3. Twelve inch red signal indications should be used on all approaches.
- 4. Rectangular pedestrian heads should be used on all crosswalks.
- 5. With a de-emphasis of vehicular flows along Jefferson Street, the signals should be retimed to give additional green time to 3rd Street. This timing and phasing is shown in Exhibit 10.
- 6. The northeast and southeast curb corners should be rebuilt to give wider turning radii.

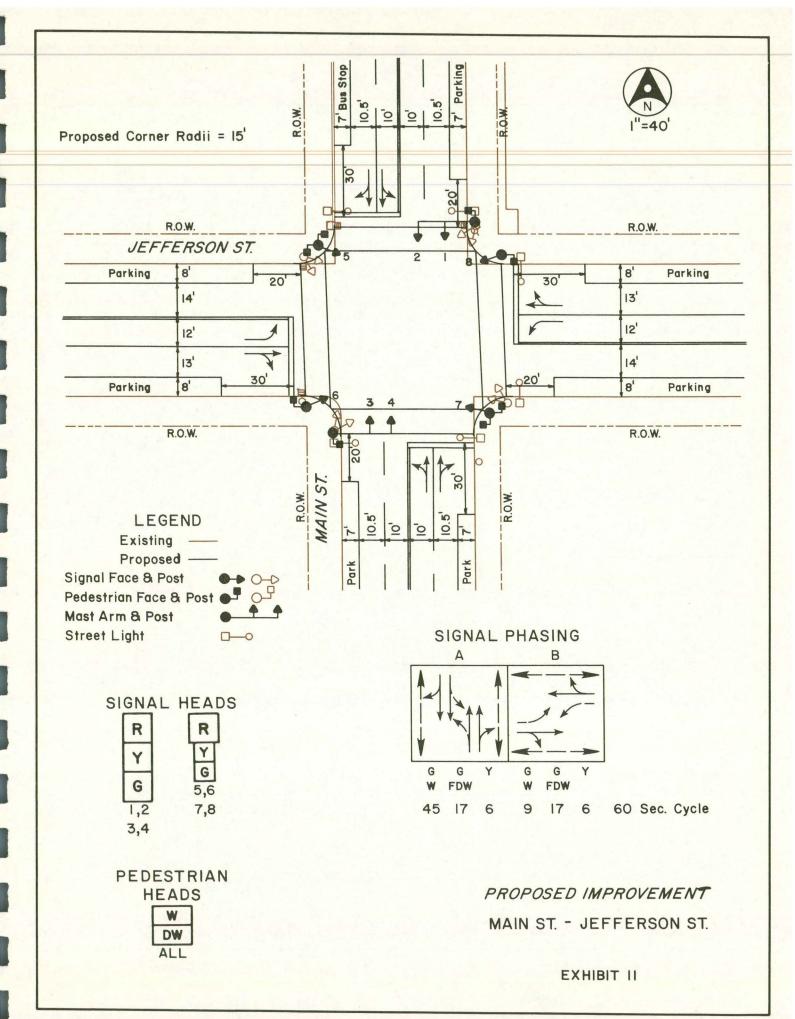
1. As shown in Exhibit 11, page 37, parking should be eliminated along the curb for a minimum of 30 feet back on the approach lanes to the intersection. A 20 foot parking restriction should also be imposed along the curb opposite these approach lanes. These restrictions will provide better visibility for motorists as they enter the intersection and eliminate many of the vehicle conflicts discussed previously.

- 2. Mast arm signal indications should be installed along Main Street to improve signal visibility and 12 inch signal indications used on these mast arms.
- 3. Twelve inch red signal indications should be used on all post mounted traffic signals.
- 4. Rectangular pedestrian walk and don't walk signal heads should be installed to control pedestrians at the crosswalks.
- 5. The curb corners should be cut back to provide a minimum 15 foot radius on each corner.
- 6. The signal timing should be modified to give greater green time to Main Street traffic.

These recommendations are illustrated in detail in Exhibit 11, page 37, of this report. Collision diagrams and other specific traffic data relating to this intersection are included in the Data Appendix.

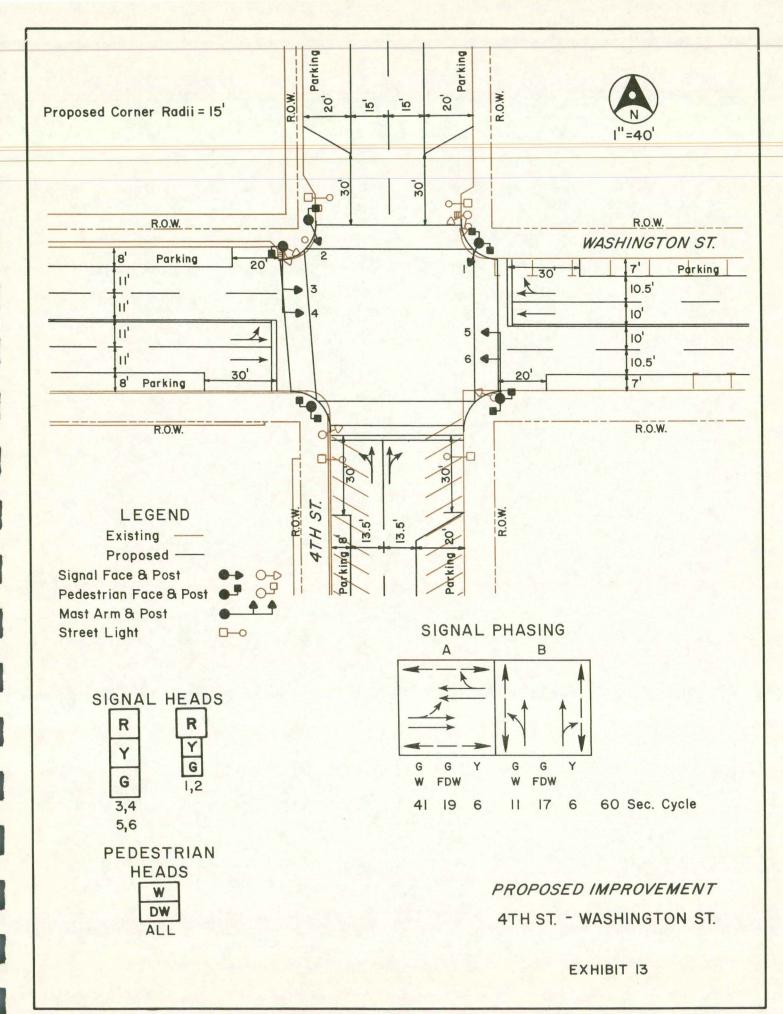
To improve traffic flows, it is recommended the City implement the following traffic engineering improvements. These recommendations are also illustrated in Exhibit 13, page 42, of this report.

- 1. Diagonal parking should be eliminated along the east curb line of 4th Street south of this intersection. Use of parallel parking along this side of the street will enable the City to stripe two approach lanes thereby reducing traffic conflicts. To further reduce interference between moving and parked vehicles, it is recommended that parking be prohibited for a minimum of 30 feet in advance of the intersection on all approaches.

- 2. Washington Street is the heavier carrier of traffic. To give motorists along this street better signal visibility, it is recommended that mast arms be installed for both the eastbound and westbound flows.

- 4. Rectangular walk and don't walk pedestrian indications should be installed for all crosswalks.
- 5. Curb corners should be cut back to give a minimum of 15 foot radii on all corners.

- 6. Washington Street carries two-thirds of the vehicles entering this intersection. However, the signal timing gives an equal amount of green time to motorists on both streets. This timing should be revised to give approximately two-thirds of the green time to Washington Street traffic.

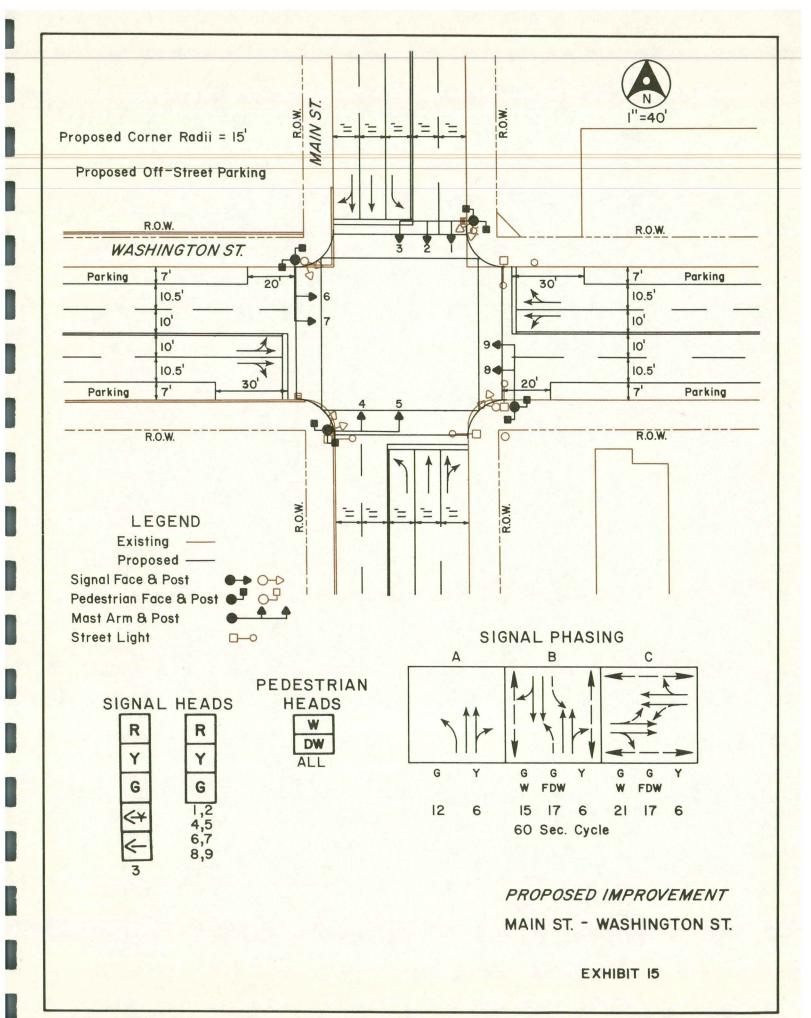
Several right angle collisions also occurred as north-bound motorists attempted to turn left onto Washington Street. This left turn movement exceeds 100 vehicles during the PM peak hour period. As shown in Exhibit 15, page 47, a number of traffic signal improvements are recommended to reduce the accident problem. These recommendations include the following.

- 1. Mast arm signal indications should be installed controlling traffic on all approaches. Twelve inch signal indications should be used on all signal heads to improve their visibility.
- 2. Rectangular walk and don't walk pedestrian heads should be installed at all crosswalks.
- 3. The signal phasing should be revised to provide a leading left turn phase for northbound left turning motorists. This phase will give left turning traffic an opportunity to clear the intersection prior to the movement of southbound motorists. Exhibit 15 shows the recommended timing for the new signal phasing.

4. The corner curb should be cut back to provide minimum radii of 15 feet for turning vehicles.
