Evaluation of Rock Check Dam Performance using Large-Scale Testing Techniques

Final Report
May 2025

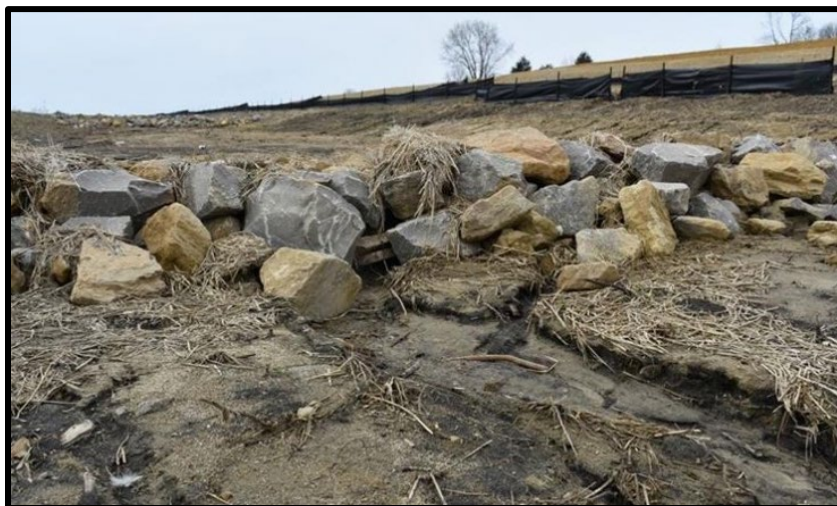
Figure 2.1: Iowa DOT Rock Check Dam Undermining

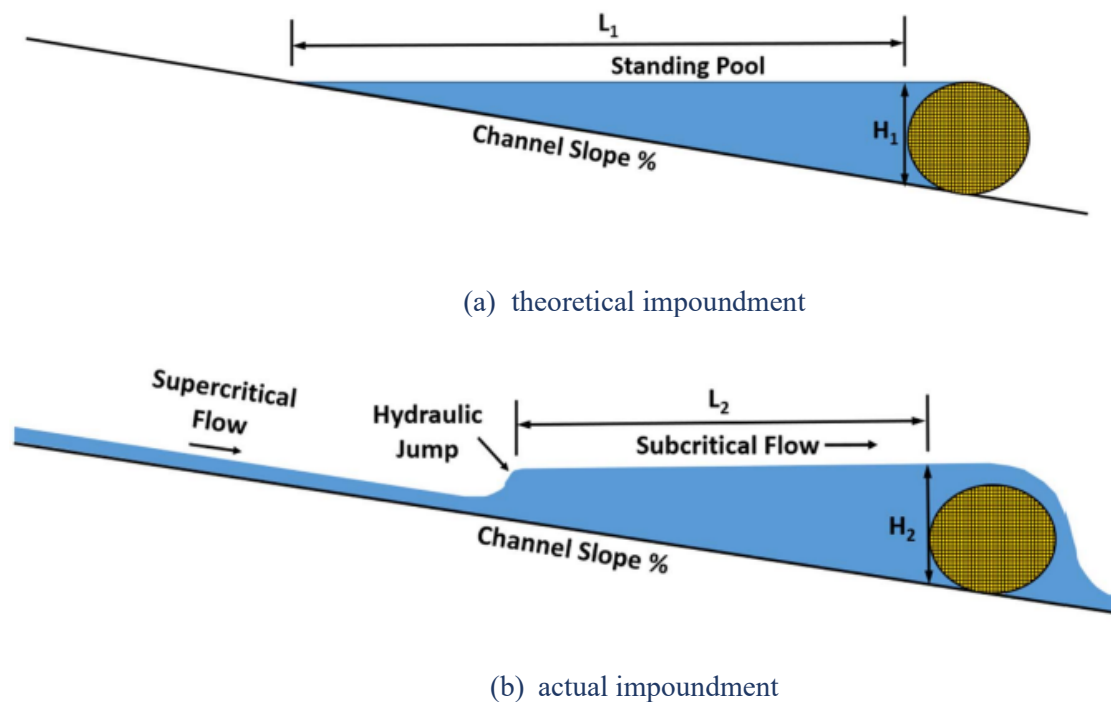
Figure 2.2: Theoretical and Actual Impoundment Formed by Ditch Checks (*Whitman et al. 2021*)

Small-scale laboratory testing of ditch check practices has typically been conducted on wattles, including fill material and encasement; however, the results and conclusions from these testing efforts can be applied to rock check dam installations. Multiple flume studies have compared the theoretical impoundment, a level pool with a height of the ditch check that most spacing guidance is based on, to the actual impoundment facilitated; Figure 2.2 shows a diagram of the theoretical and actual impoundment. Whitman et al. calculated depth and length ratios comparing the actual impoundment to the theoretical impoundment as a performance indicator for wattle ditch checks; testing found that all but one wattle tested, an excelsior fiber fill, had depth ratios exceeding 100%, which represents the experimental impoundment depth being greater than the theoretical impoundment depth. Length ratios ranged from 61% to 96%, showing that for every wattle tested, there would be an area of supercritical flow in the channel that can lead to channel erosion, as spacing guidance is based on the theoretical impoundment length (*Whitman et al. 2021*).

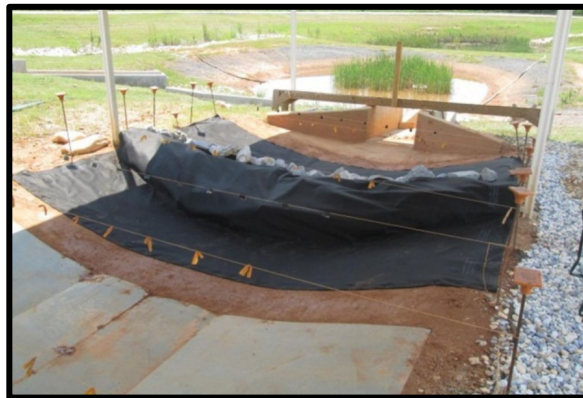
(a) Alabama DOT standard rock check dam

(b) rock check dam with aggregate choker

(c) rock check dam with geotextile overlay

Figure 2.3: Rock Check Dams Evaluated by Zech et al. (2014)

The standard Alabama DOT rock check dam installation, 18 in. (45.7 cm) high over a geotextile underlay, was ineffective at forming impoundment due to high flow-through rates during testing. The standard rock check dam installation facilitated a maximum impoundment length of only 14.5 ft (4.42 m); this resulted in an efficiency of only 48.3%, indicating that more than half of the channel was unprotected from erosion due to highly erosive supercritical flows. Two alternative installations were tested to increase impoundment potential: a choker consisting of No. 4 coarse aggregate on the upstream face of the dam and a geotextile wrapped around the front face of the check dam. Figure 2.3 shows the standard and modified rock check dam tested at the AU-SRF. Both modifications increased impoundment, with the choker stone increasing impoundment to 20.5 ft and increasing efficiency to 68% and the geotextile choker doubling impoundment to 29.1 ft (8.9 m) and increasing efficiency to 97.0% (*Zech et al. 2014*).

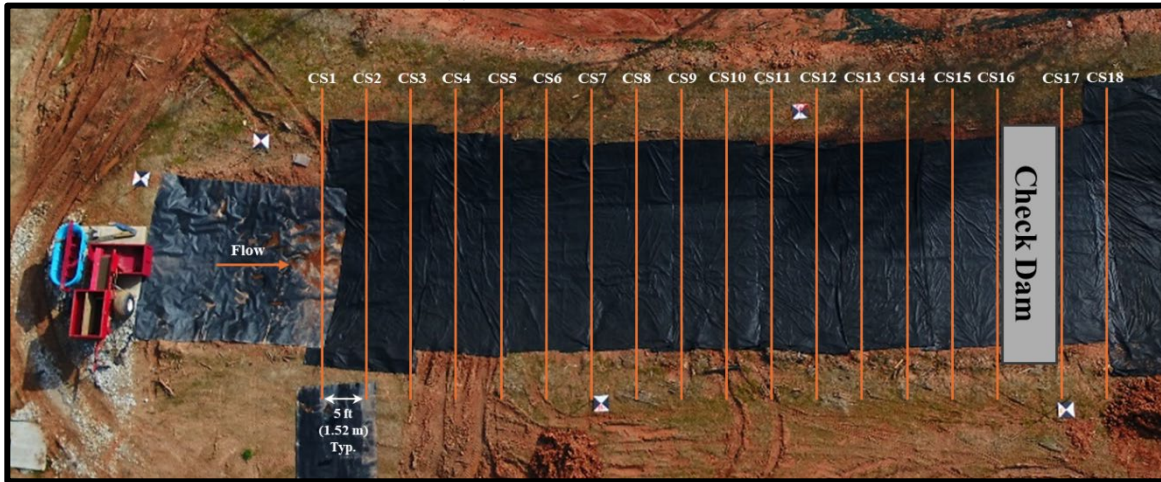
(a) channel cross-section

(b) channel layout

Figure 3.1: AU-SRF Iowa DOT Test Channel

An existing channel at the AU-SRF that was previously used for the evaluation of in-channel sediment basins for the Iowa DOT was used for all rock check dam testing efforts and is representative of an Iowa DOT roadside channel with a sediment basin at the downstream end. The test channel has an approximate slope of 3%, side slopes of 3H:1V and 3.5H:1V, a bottom width of 10 ft (3.0 m), and a depth of 5 ft (1.5 m). To allow for consistency and repeated testing, the entire channel was lined with geotextile to prevent erosion from occurring, which would result in increased maintenance between tests and inconsistent flow depths. Figure 3.1a shows a cross-section of the test channel. Along the channel, 18 string lines, spaced 5 ft (1.5 m) apart, were installed across the channel to provide reference points for data collection during testing. Sixteen string lines were installed upstream of the check dam, stretching past the theoretical maximum impoundment length of 63 ft (19.2 m) to ensure a complete flow profile could be created for each installation; two string lines were downstream of the rock check dam installation to evaluate downstream flow conditions. The theoretical maximum impoundment length was determined through a survey of the channel and was the point at which the bottom elevation of the channel was the same as the lowest point of the rock check dam installation. Figure 3.1b shows a layout of the data collection cross-sections.

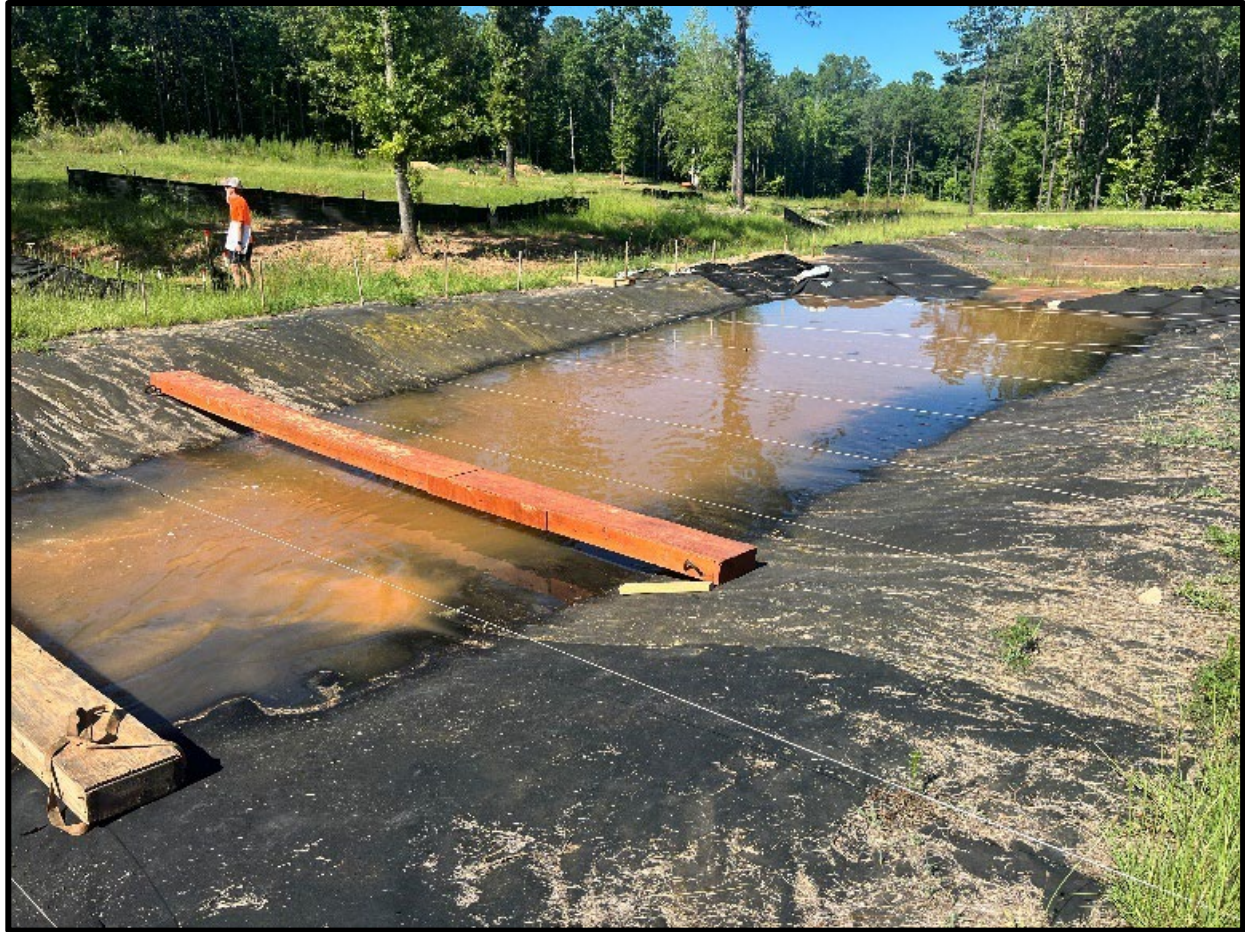
Figure 4.4: Upstream Impoundment of M3

The smaller rock gradation and decreased pore size improved performance compared to the standard installation with the larger rock gradation; however, highly erosive flow velocities were still present for more than half of the channel indicating that additional performance improvements needed to be made to fully protect channels from erosion. Past performance evaluations of rock check dams have shown that adding a geotextile overlay improves performance through the formation of additional impoundment. M3 was developed using the Iowa DOT standard rock gradation with a non-woven geotextile secured with 6 in. (15.2 cm) sod staples 2 ft (0.6 m) upstream of the dam, draped over the front face of the installed and secured on the back side of the installation with loose rock. M3, due to the addition of the geotextile, increased impoundment length to 49.3 ft (15 m) and 48.4 ft (14.8 m) on average for the low and high flow rates, respectively. For the low flow testing, impoundment length increased during each subsequent test as the geotextile became clogged with the low amounts of sediment from the supply pond; the third simulated storm event had an impoundment length of 62.5 ft (19.1 m). A similar pattern was shown for impoundment depth, with the first simulated storm event having the lowest depth and increasing for each subsequent test for the low flow rate. Additionally, for all but the first simulated storm event, the higher testing flow rate had a lower impoundment length than the low flow rates, with all tests having between 47.5 and 49.1 ft (14.5 and 15 m). The improved performance of M3 is shown in Figure 4.4.

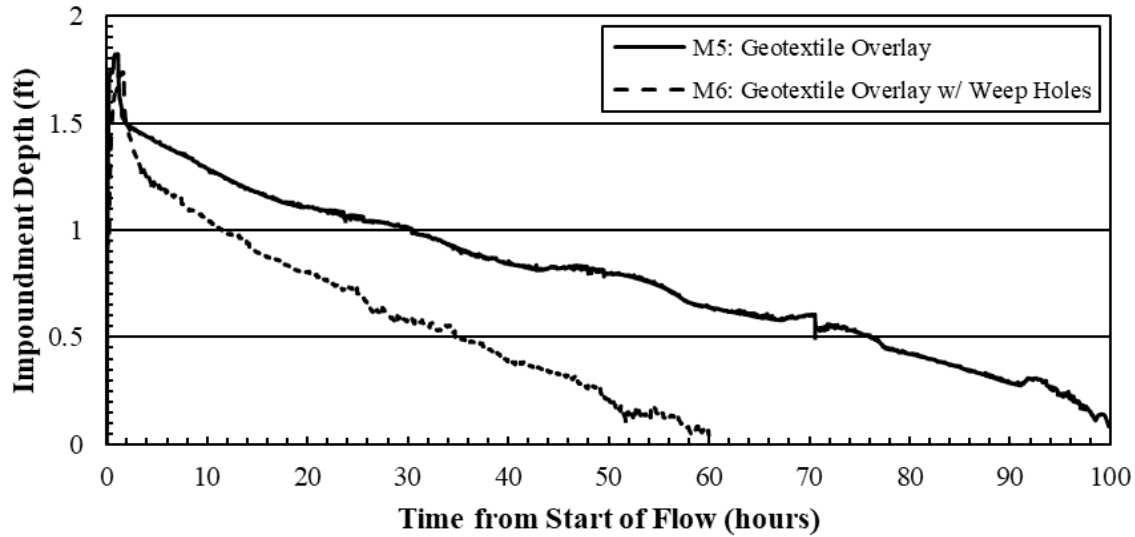
Figure 4.8: Dewatering times of M5 and M6

M5, due to the geotextile overlay clogging with sediment, experienced long dewatering times, with an average of 60 hours to fully drain between tests. Dewatering time increased during each subsequent simulated stormwater runoff event, reaching a maximum of over 100 hours for the third and final test period. Adding the dewatering holes to M6 reduced dewatering time on average to 26 hours, with a maximum of 60 hours for the final test periods; the first and second tests had dewatering times of 5 and 12 hours, respectively. The increase in dewatering times with the dewatering holes indicates a potential need for maintenance of dewatering holes to ensure steady dewatering. A comparison of the maximum dewatering times experienced by two installations in the final test periods is shown in Figure 4.8. Both installations had a steady dewatering, with the weep holes leading to a considerably faster dewatering period.

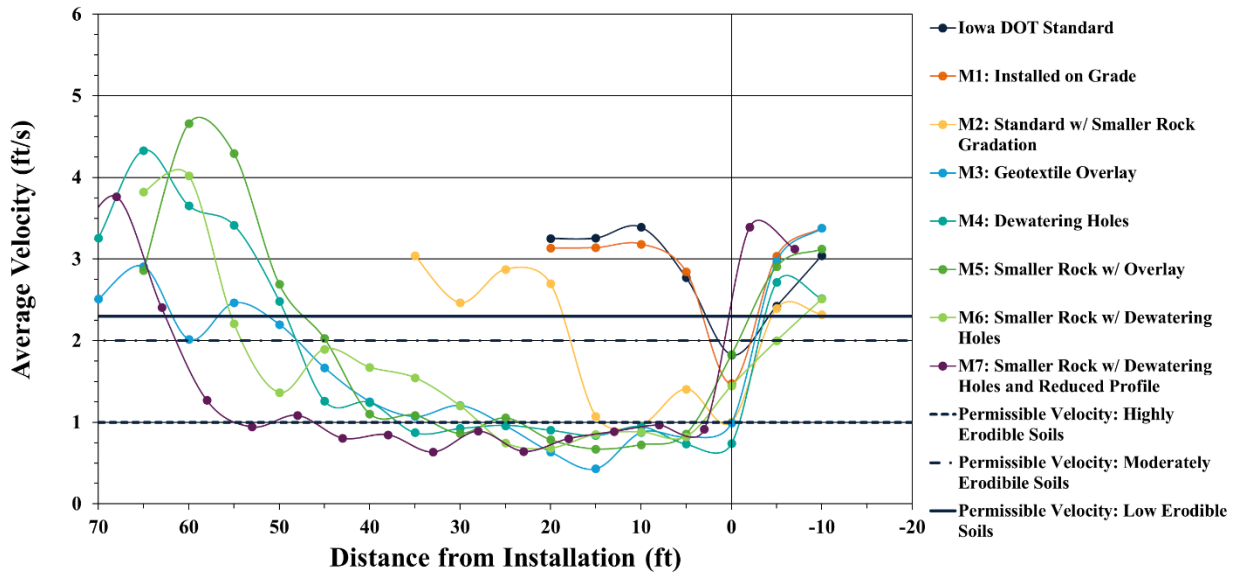
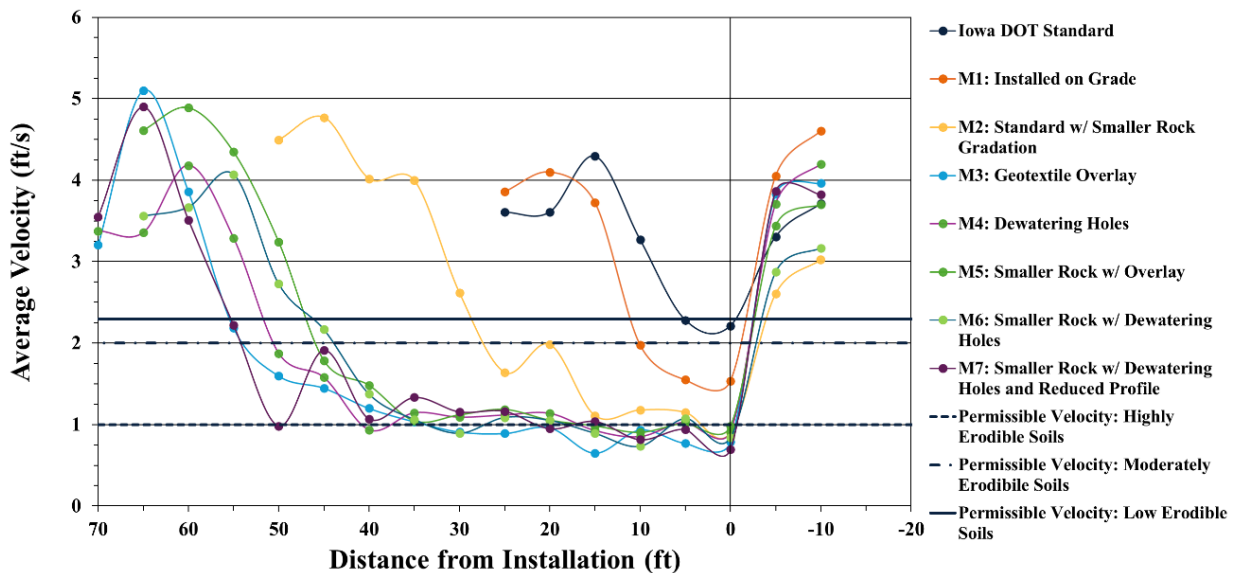
Figure 4.11: Average Flow Velocity for Rock Check Dam Installations

(a) low flow testing

(b) high flow testing

The formation of impoundment by rock check dams results in reduced flow velocity, protecting channels from erosion; areas where the flow velocity is below permissible values are protected from erosion. Figure 4.9 shows the average velocity for both the low and high flow rates. Practices that performed similarly in impoundment formation also had similar flow velocity patterns. The two installations, the Iowa DOT standard and M1 without the excavation that used the standard rock gradation without the addition of a geotextile overlay only slowed flow velocities to non-erosive levels immediately upstream of the rock check dam installation, indicating that much of the channel was not protected from erosion. M2, using the same configuration of the standard installation with a smaller rock gradation, had a distance upstream of approximately 25 ft (7.6 m) with non-erosive flows for most soil types; however, this still resulted in erosive flows for much of the channel. The five installations with geotextile overlays showed similar results in flow velocity, with larger portions of the channel having flow velocities that would lead to non-erosive conditions.

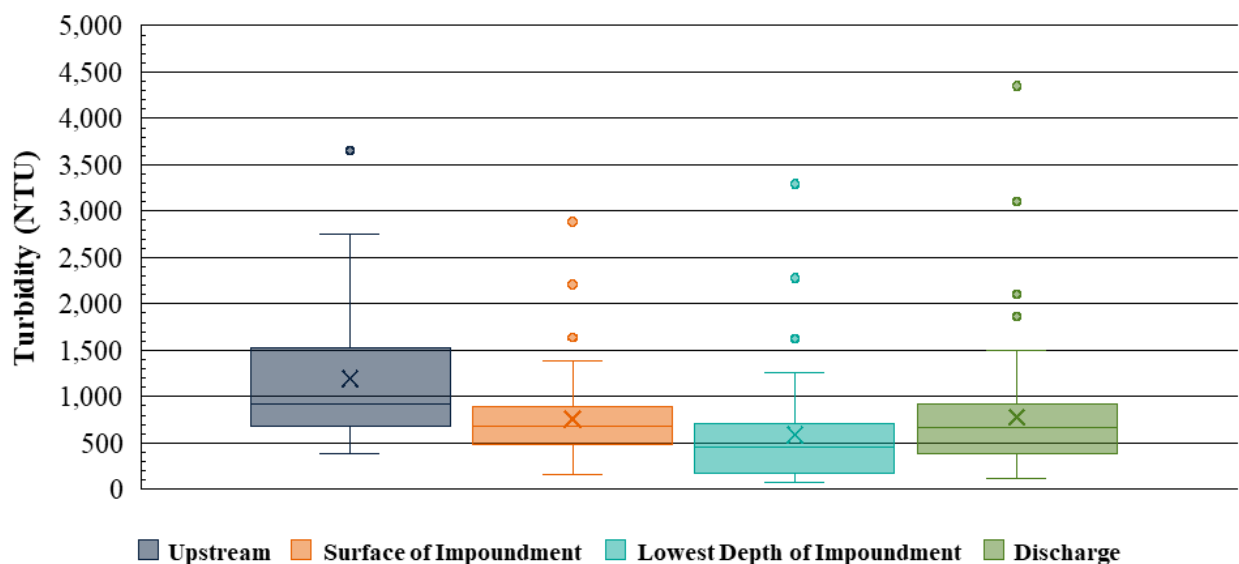
Figure 4.15: MFE-I Turbidity

(a) turbidity distribution

(b) turbidity over time

Due to the increased impoundment depth facilitated by the MFE-I rock check dam installation, water quality grab samples could be taken at both the surface and the lowest depth of the impoundment upstream of the installation. The average turbidity at the surface of the impoundment was 756 NTU; the lowest depth of the impoundment averaged 641 NTU. The discharge immediately downstream of the installation averaged 777 NTU. Figure 4.14a shows a distribution of the turbidity of water grab samples at the water's surface of the impoundment, the lowest depth of the impoundment, and discharge; the surface of impoundment and discharge had similar ranges and averages due to the installation overtopping. Figure 4.14b, showing average turbidity over time, indicates a “first-flush” effect occurred as the first runoff resuspended deposited sediment and increased turbidity immediately at the beginning of each test period, with turbidity then stabilizing to approximately 650 NTU for the water's surface of the impoundment and discharge.
