Impact of Curling and Warping on Concrete Pavement

Iowa Highway Research Board (IHRB Project TR-668) Iowa Department of Transportation (InTrans Project 13-486) Federal Highway Administration

tech transfer summary

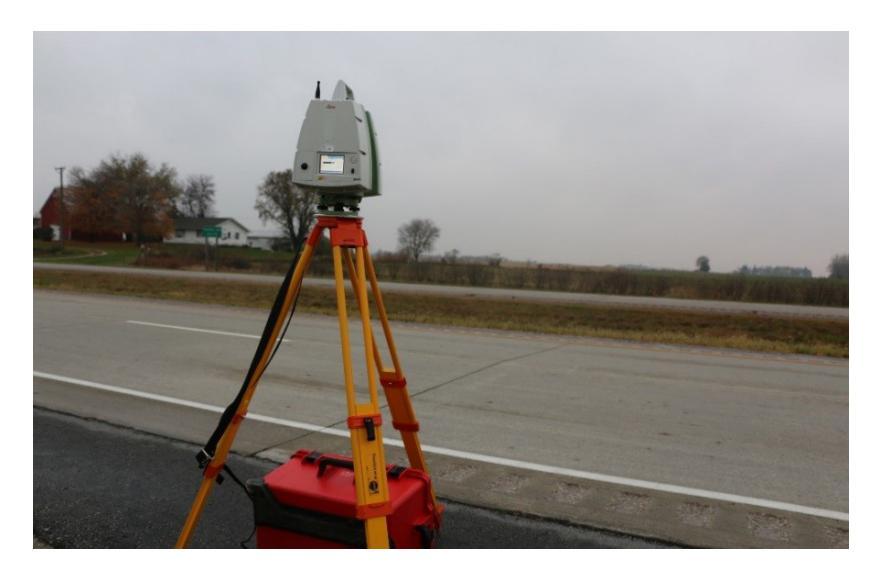
LiDAR device utilized in this study

These sites had PCC pavements with various ages, slab shapes, mix design aspects, and environmental conditions during construction. By using the Leica ScanStation C10 LiDAR device, the researchers obtained point clouds for these sites during field investigations.

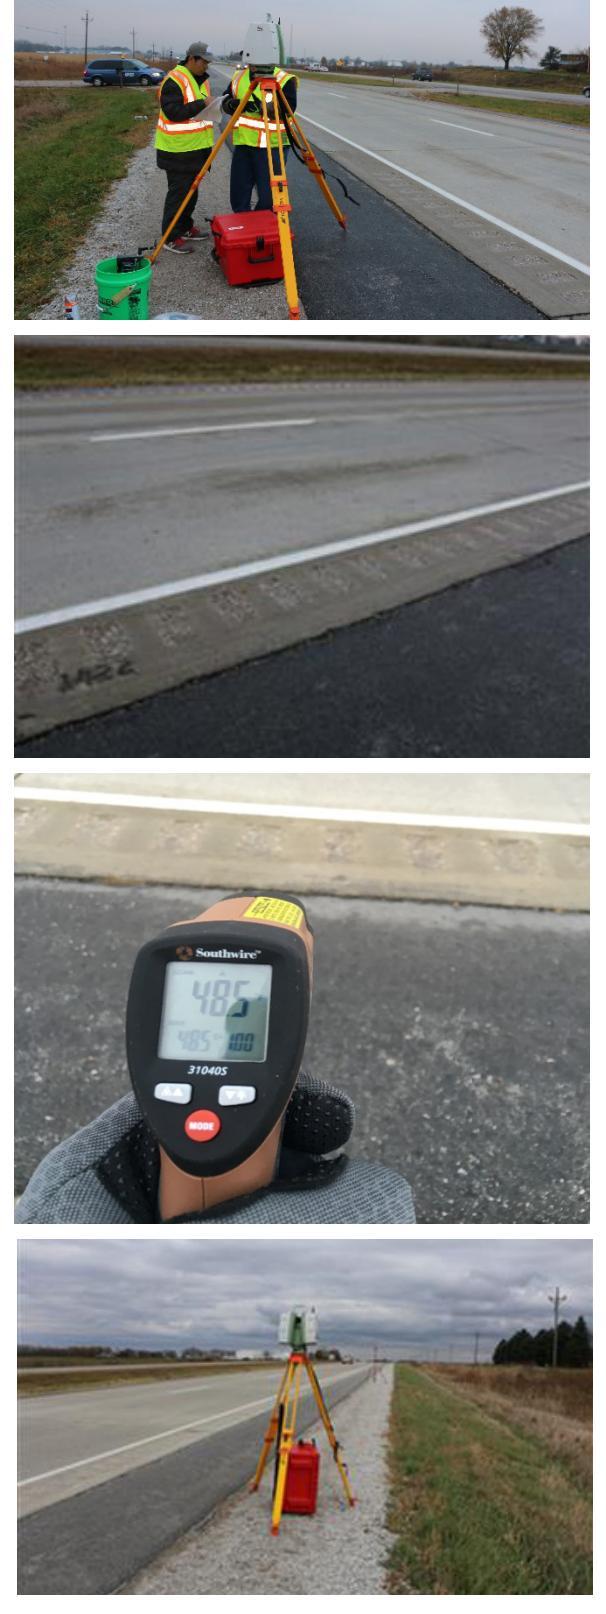
Field investigation of concrete pavement systems on US 30 near Ames in Story County, Iowa

This research was directed toward documenting PCC pavement surface profiles by utilizing the light detection and ranging (LiDAR) system and comparing the degree of curling and warping between the concrete pavement systems used on those pavements. Field investigations were performed at six concrete pavement sites in Iowa at different times of the day during the late fall of 2015.

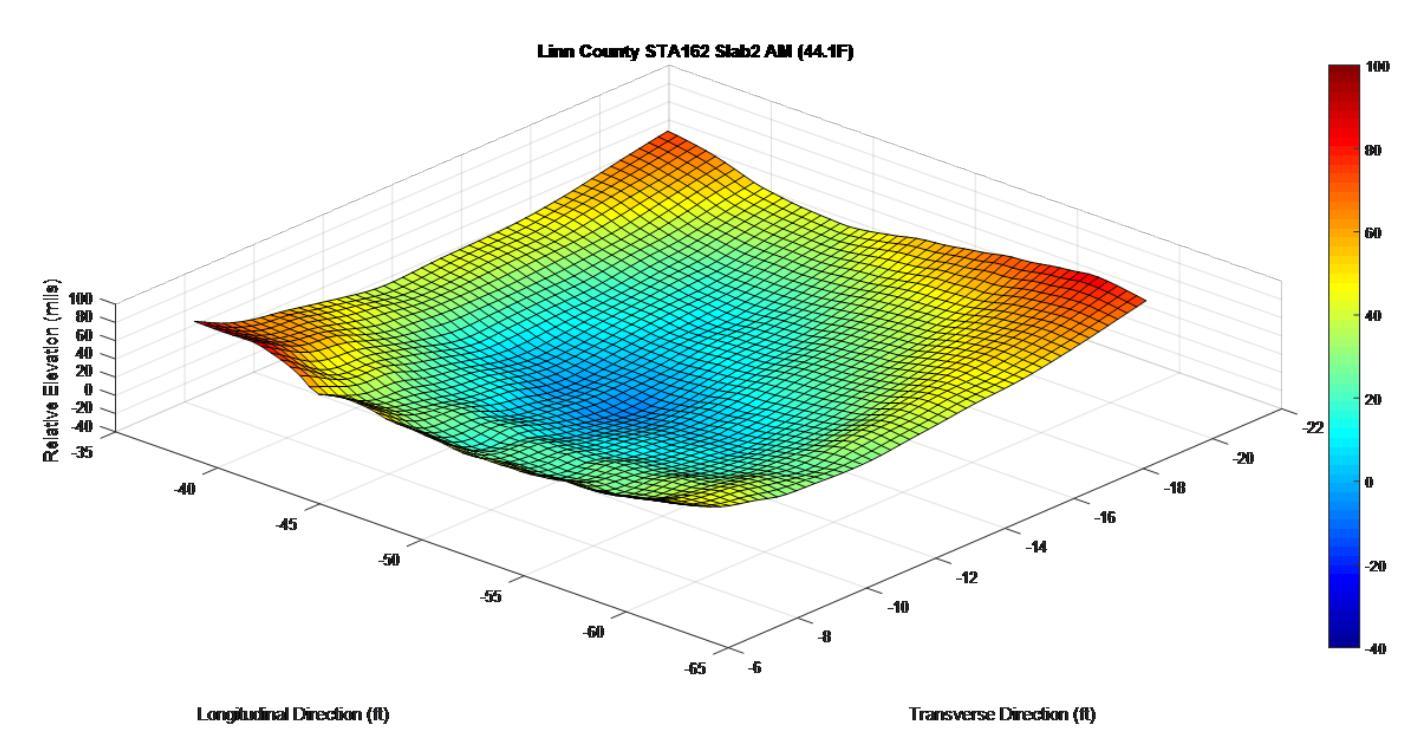
Computer-generated three-dimensional (3D) shape of an upwardly curled and warped PCC slab in the field under temperature and moisture gradients produced from processing LiDAR point cloud data

The researchers developed recommendations on how to minimize curling and warping based on literature review findings and field investigations. They also developed some examples of how to use LiDAR point cloud data to build three-dimensional (3D) models for the overall curvature of the slab shape to show the feasibility of using this 3D analysis method for studying the curling and warping behavior of concrete pavements.
