**Final report
IHRB Project TR-610**

**ON-THE-SPOT DAMAGE DETECTION METHODOLOGY FOR HIGHWAY
BRIDGES**

July, 2010

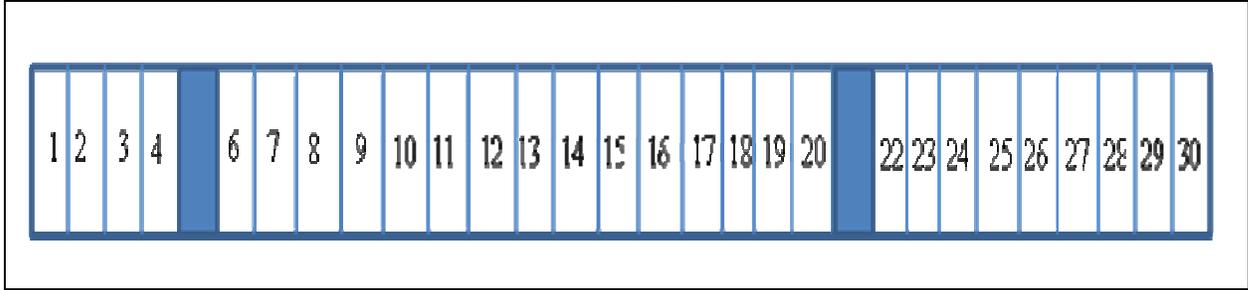
Figure 2.1 Schematic of the plate used in numerical simulation

To show the FRF curvature method's ability to detect damage, a numerical simulation was completed with a 30 element long plate. The plate was assumed to have free-free boundary conditions at its ends. Two damage locations were simulated at elements 5 and 21 by decreasing the plate's thickness by 60% and 5%, respectively. Figure 2.1 shows a schematic of the plate.

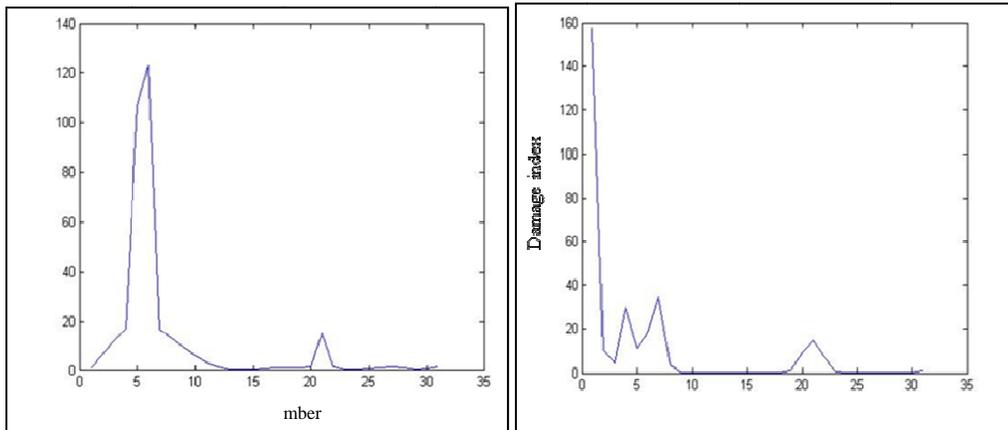
Figure 2.2 Summed Damage Index for plate using local curve fitting and Figure 2.3 Summed Damage Index for plate using global curve fitting

Figures 2.2 and 2.3 show the summed damage indices for the plate using local and global curve fitting, respectively. Local curve fitting accurately locates the damage and seems to quantify the magnitudes of the damage as well. Global curve fitting also locates the damage, but fails to show a significant difference in the thickness between elements 5 and 21.

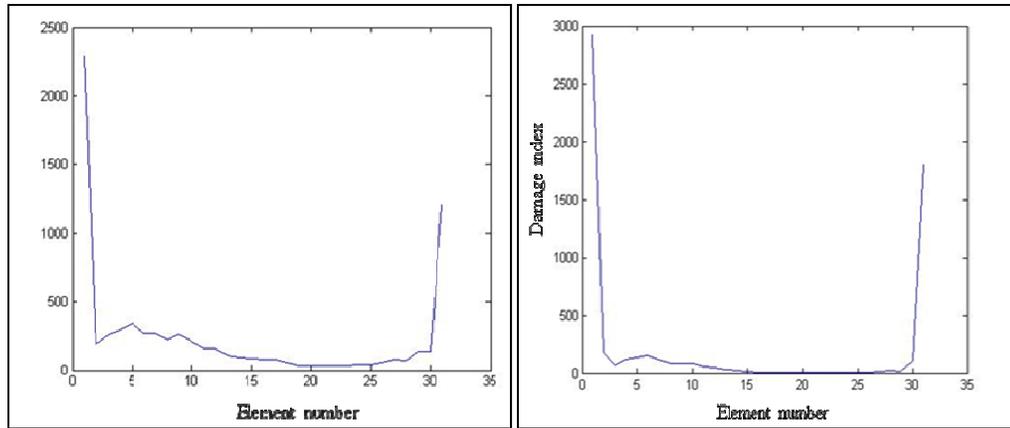
Figure 2.4 Summed Damage Index for plate with 1% noise using local curve fitting and Figure 2.5 Summed Damage Index for plate with 1% noise using global curve fitting

Because there is significant and inevitable noise in experimental measurements, the same numerical simulation was run with the addition of 1% random noise. Figures 2.4 and 2.5 show the summed damage indices for the plate with 1% noise using local and global curve fitting, respectively. Both fitting methods identify a broad damage location between elements 3 and 15 and are unable to identify any curvature change around element 21. Therefore, the addition of noise has significantly impacted the quality of the damage detection results.

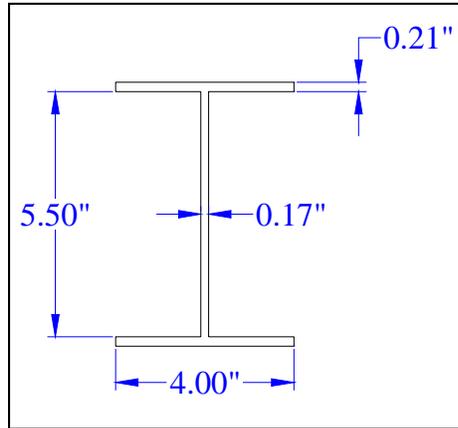
Figure 3.2 Cross section of 81" long laboratory I-beam

on the I-beam. Damage was simulated by fixing masses of different sizes to the centerline of the top flange of the beam, thereby creating a local change in mass and stiffness in the region surrounding each mass. Figure 3.2 shows a cross section of the I-beam. Two different methods were used to determine the dynamic response of the I-beam due to forced excitation: roving response and roving excitation. For both methods, frequencies from 0-10000 Hz were analyzed with a spectral density of 1 line/6.25 Hz.

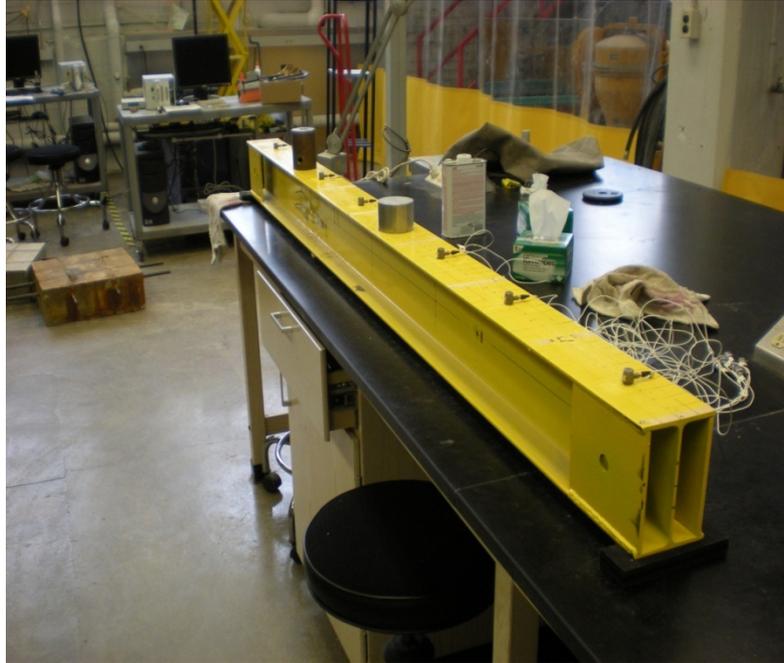
Figure 3.3 Typical laboratory I-beam setup with six fixed accelerometers and two damage zones

During a roving excitation test, the I-beam was impacted at each node and six accelerometers were fixed to various nodes on the structure. Figure 3.3 shows a picture of a typical roving excitation setup. As shown in Figure 3.4, accelerometers were fixed on nodes 4, 16, 26, 43, 55, and 74. Similarly to the roving response test setup, for damaged beam tests, a mass of 1.7 kg was fixed to the top flange between nodes 60 and 62, and a mass of 0.5 kg was fixed to the top flange between nodes 33 and 36.

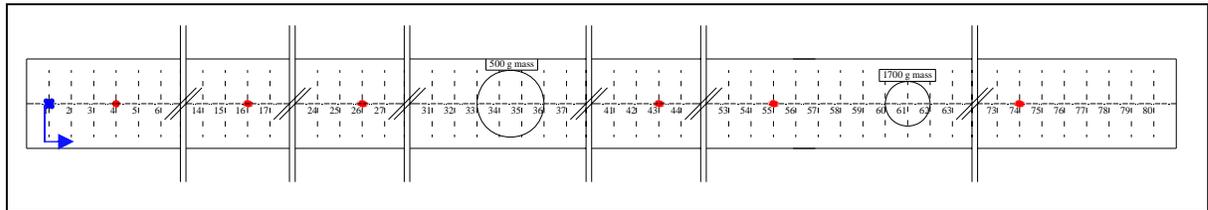
Figure 3.4 Roving excitation test setup with two damage zones

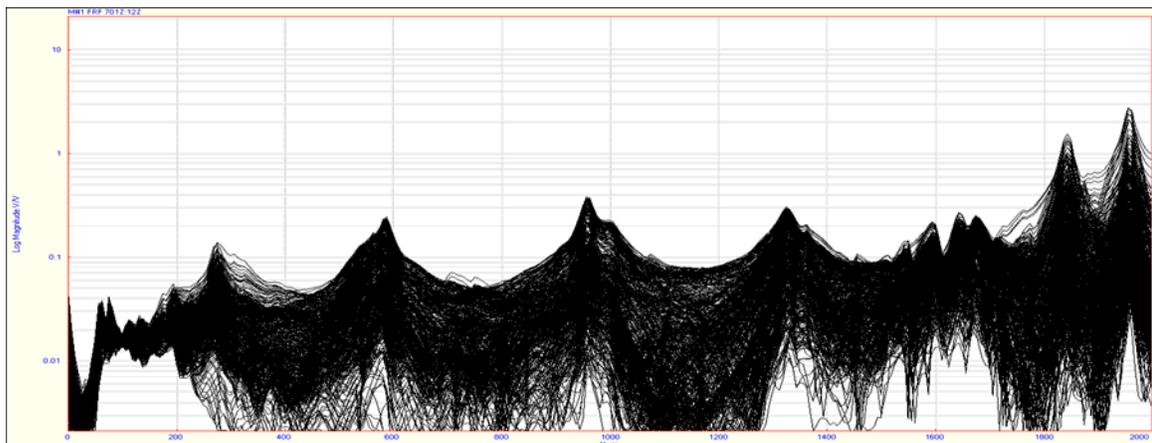
Figure 3.5 Overlaid FRFs from a roving excitation test on the undamaged I-beam

Figure 3.5 shows all 480 overlaid FRFs from 0-2000 Hz collected from a roving excitation test (see Section 3.2.2) on the undamaged I-beam. Although these FRFs are not needed in the damage detection algorithms, they can be compared to the FRFs from the same structure with added damage. Figure 3.6 shows the overlaid FRFs from 0-2000 Hz collected from a roving excitation test on the I-beam with two masses fixed to the top flange. The small mass between nodes 33 and 36 and the large mass between nodes 60 and 62 represent 1.8% and 6% of the beam's total mass, respectively. In comparing Figures 3.5 and 3.6, one can notice both a change in shape of the FRFs and a shift in natural frequencies. Although observation of a shift in natural frequencies identifies the presence of damage, other methods must be used to locate and quantify the damage (i.e., VBDI algorithms).

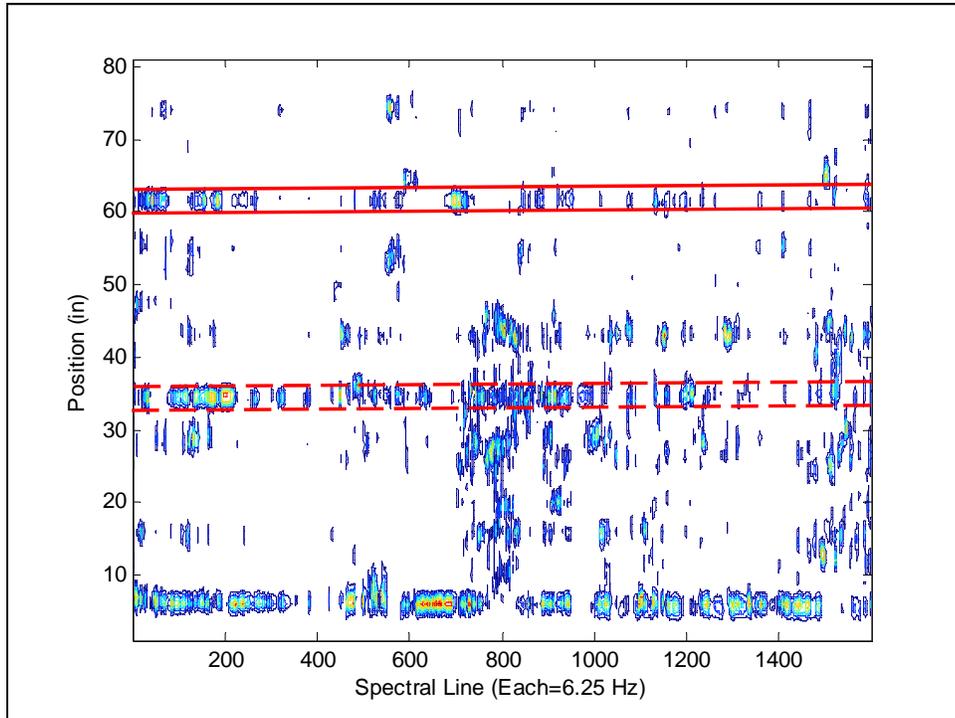
Figure 3.7 Damage index using difference between FRFs and GSM-fit FRFs

As stated in Chapter 2, damage can be simulated by the addition of mass to a structure because mass is a dynamic property. Figure 3.7 shows the damage index (calculated using Eq 2.18) from a roving excitation test. The y-axis is position along the beam from 0 to 81 inches, and the x-axis is frequency shown in spectral lines. Warm colors represent the largest change in curvature between actual FRF test results and the curve fit FRF test results (using GSM), and white indicates virtually no change. The frequency range for this particular test was 10000 Hz at 1 line/6.25 Hz. The solid red lines indicate the boundaries of the large mass. Likewise, the dashed red lines indicate the boundaries of the small mass.

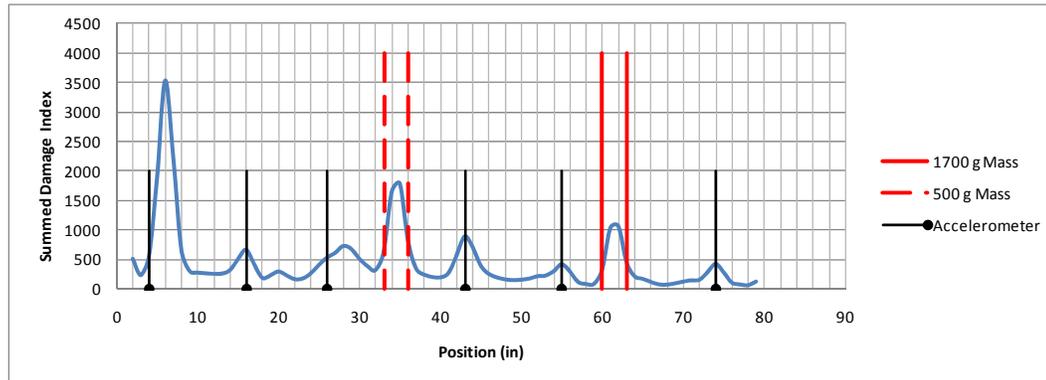
Figure 3.8 Summed damage index using difference between FRFs and GSM fit FRFs for all frequencies

black lines were added to show the location of each accelerometer. Figure 3.8 not only locates the damage properly, but also shows a relationship between small intermediate peaks in summed damage index and accelerometer location: accelerometers at nodes 16, 43, 55, and 74 were located perfectly.

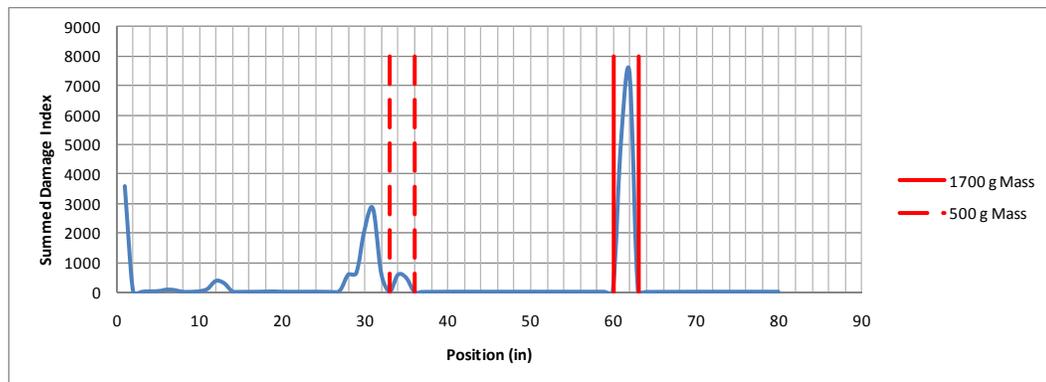
Figure 3.9 Summed damage index using difference between SMN-FRF and SMN-MEscape-fit FRFs for frequencies from 875-925 Hz

As stated in Chapter 2, GSM is a local curve fitting method, whereas MEscape software is capable of globally smoothing FRF test results. The results presented in this section represent a novel approach to smoothing data in damage detection. First the FRF data is globally smoothed in MEscape only within a region where a mode is well-defined (because global smoothing of the entire frequency spectrum fails to accurately curve fit the data). For this test, the third mode from 875-925 Hz was chosen (see Figure 3.6). Next, the curve fit data and actual data within this 50 Hz region are exported from MEscape and run through the normal FRF Curvature with GSM damage detection algorithm independently of each other. The squared difference of the summed damage index from the curve fit data and actual data is then calculated, as shown in Figure 3.9.

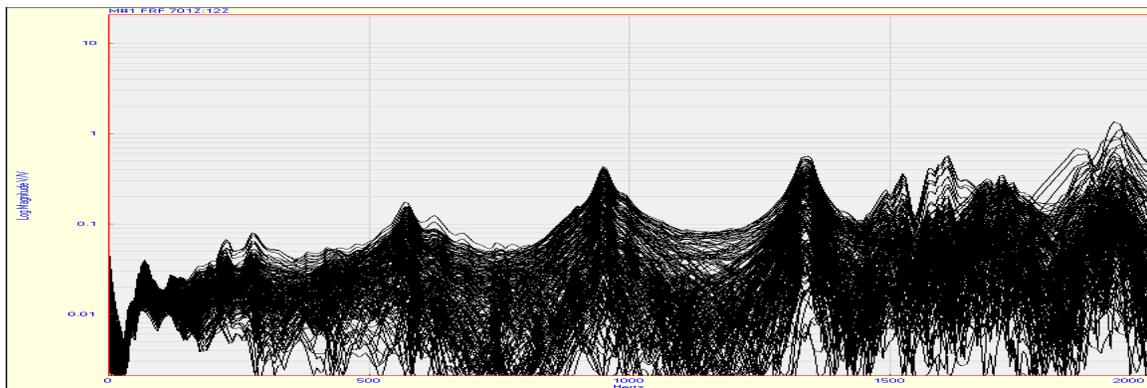
Figure 3.10 Overlaid FRFs from roving excitation test with two masses and 2 inch elements

Three roving excitation tests with varying nodal meshes were completed on the I-beam with the same damage configuration as described in the previous two sections. Figures 3.10-3.12 show the 240, 120, and 84 overlaid FRFs from tests with 2 inch, 4 inch and 6 inch roving excitation point measurements. All three figures have approximately the same shape and natural frequencies, which is to be expected.

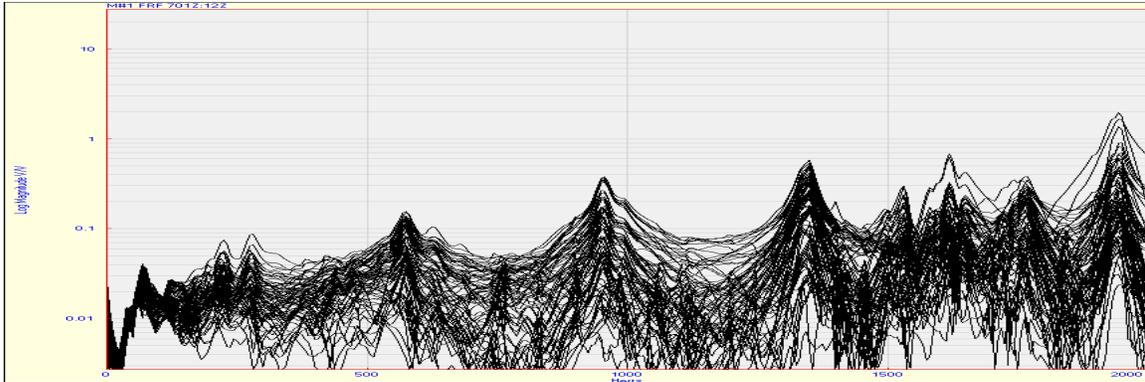
Figure 3.12 Overlaid FRFs from roving excitation test with two masses and 6 inch elements

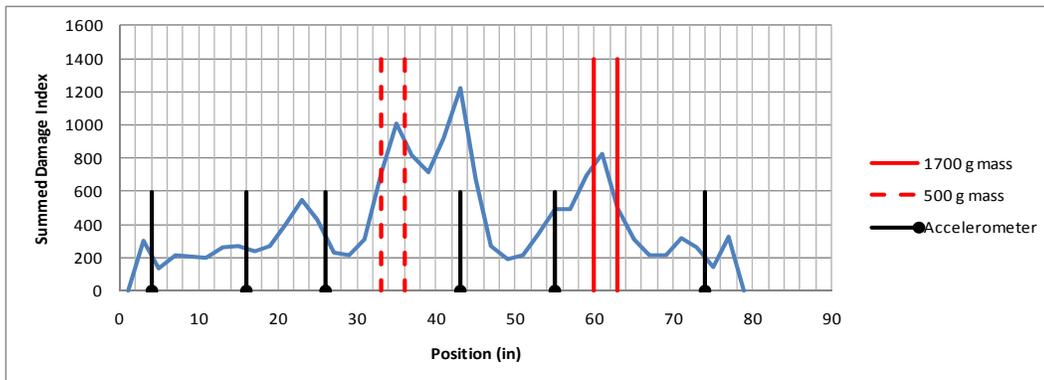
Figure 3.13 Summed damage index for roving excitation test using 2 inch elements

Figures 3.13-3.15 show the summed damage indices for roving excitation tests with 2 inch, 4 inch, and 6 inch nodal meshes, respectively. Although not as smooth as the summed damage index from a nodal mesh of 1 inch, Figure 3.14 shows that the damage is still noticeable when exciting the beam every 2 inches. However, with this setup, the accelerometer locations are not identified as clearly as the fine mesh, which means it will be harder to account for their presence with numerical techniques. Also, the magnitude of the fourth accelerometer peak is actually greater than both damage locations. Both Figures 3.14 and 3.15 show that nodal meshes of one excitation point per 4 inches and 6 inches is not adequate to detect damage.

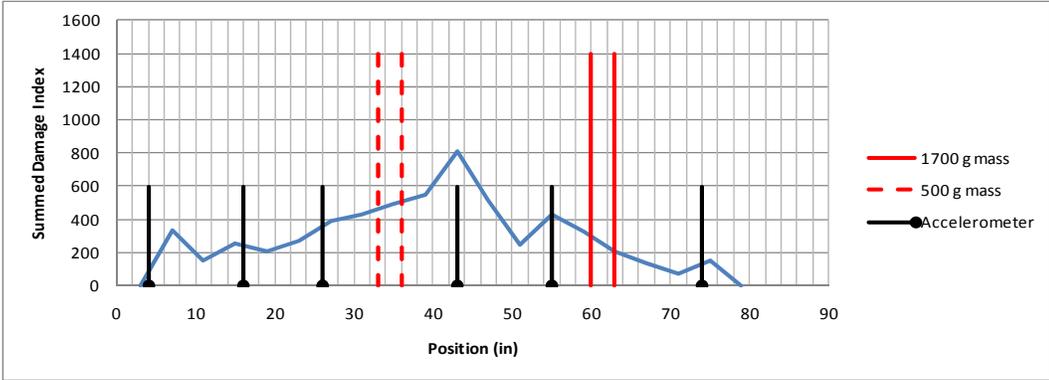
Figure 3.14 Summed damage index for roving excitation test using 4 inch elements

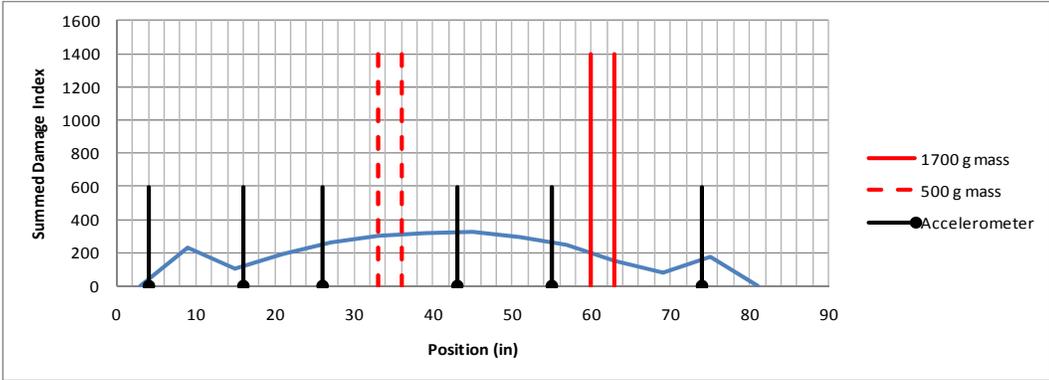
Figure 3.15 Summed damage index for roving excitation test using 6 inch elements

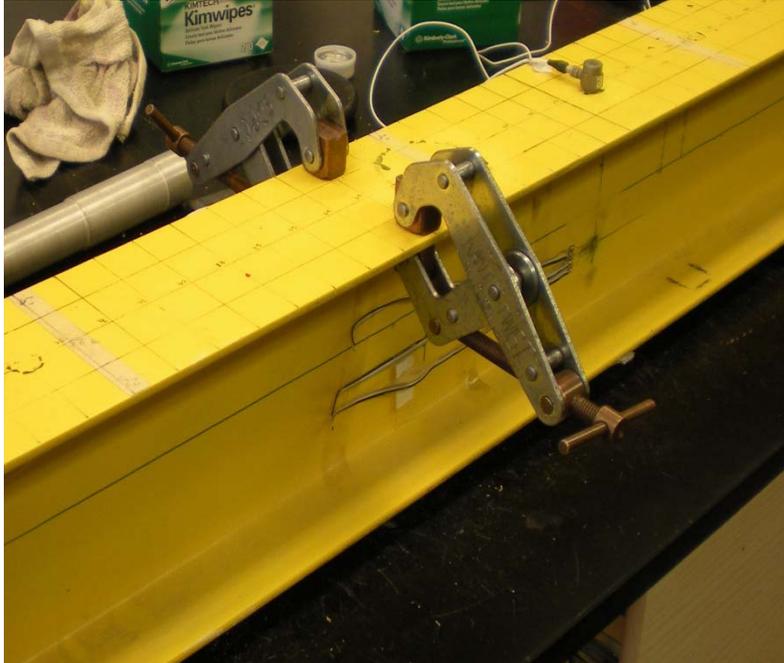
Figure 3.16 Clamps (510 g each) fixed to outer edge of top flange of beam at node 61

Other damage locations and types were considered while testing the I-beam. In order to test the ability of the method to detect damage away from the centerline, 510 g clamps were fixed to the outer edge of the top flange at node 61 as shown in Figure 3.16. A roving excitation test similar to that shown in Figure 3.6 was run with this setup.

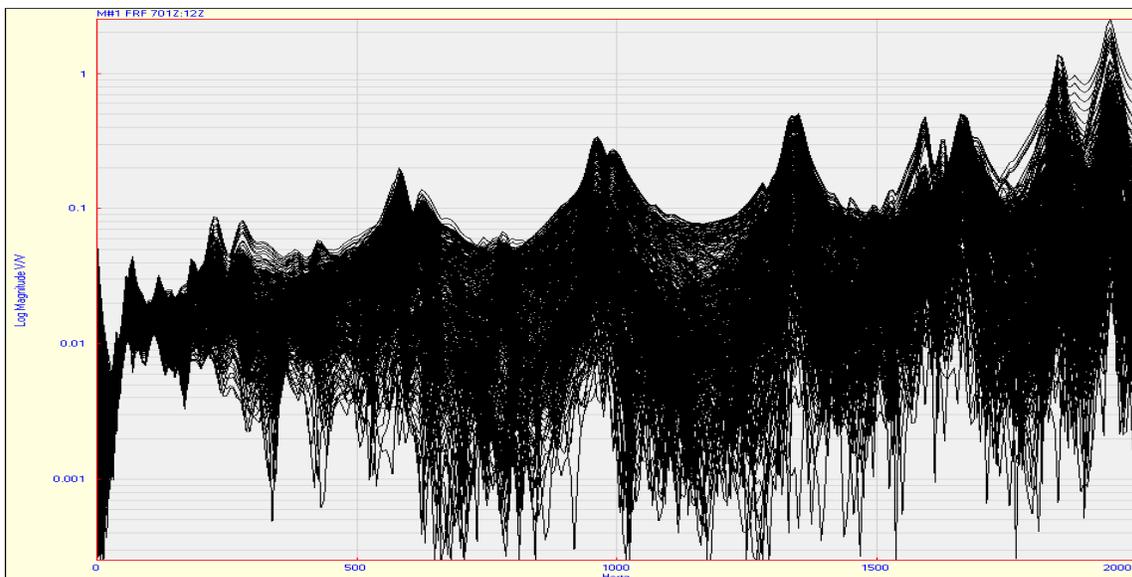
Figure 3.17 Overlaid FRFs from roving excitation test on I-beam with two clamps

Figure 3.17 shows the overlaid FRFs from 0-2000 Hz collected from a roving excitation test on the I-beam with clamps fixed to the top flange at node 61. Together, the 510 g clamps represent 3.7% of the beam's total mass.

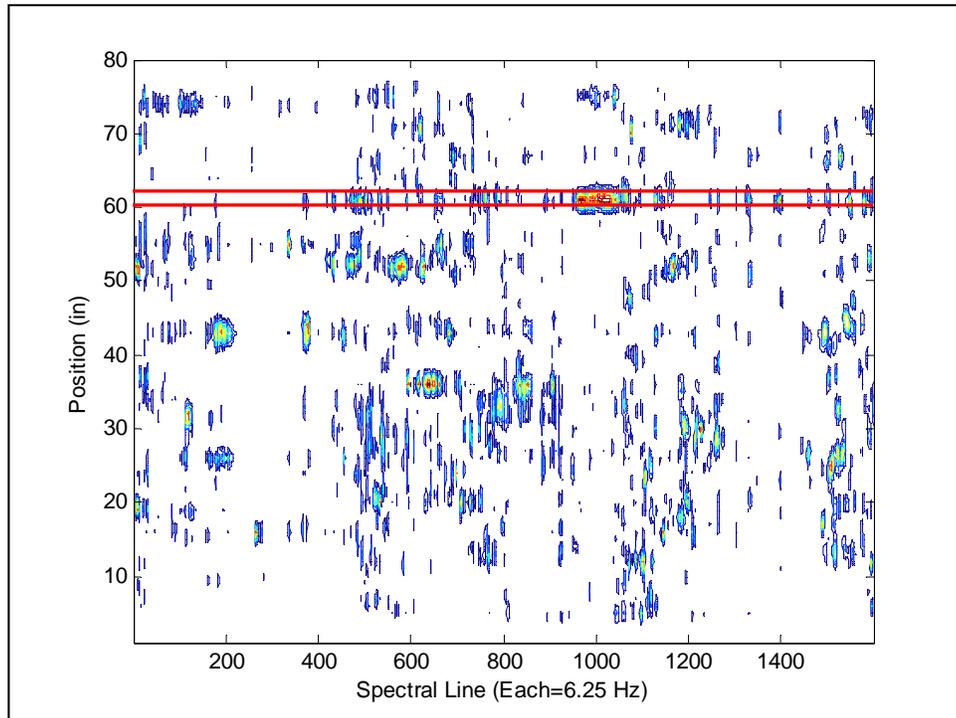
Figure 3.18 Damage index from roving excitation test on I-beam with two clamps at node 61

Figure 3.18 shows the damage index of a roving excitation test on the I-beam with two 510 g clamps fixed to the edges of the top flange at node 61. As shown, a thick band of color exists between nodes 60 and 62, indicating large changes in curvature between the experimental FRF and the smoothed FRF. Figure 3.19 shows the summed damage index with red lines for the region where the clamps were fixed and black lines indicating the locations of accelerometers. Once again, the accelerometer locations are clearly located with the roving excitation test method; however, the damage magnitude is 50% greater than the largest accelerometer peak.

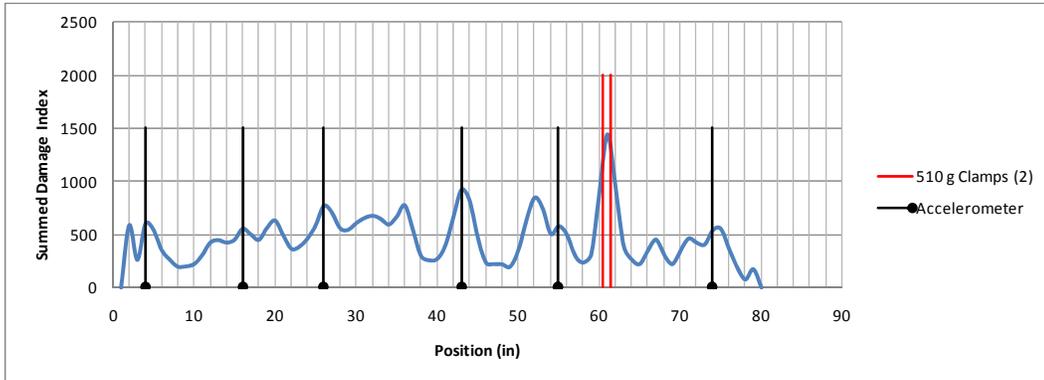
Figure 3.19 Summed damage index from roving excitation test on I-beam with two clamps at node 61

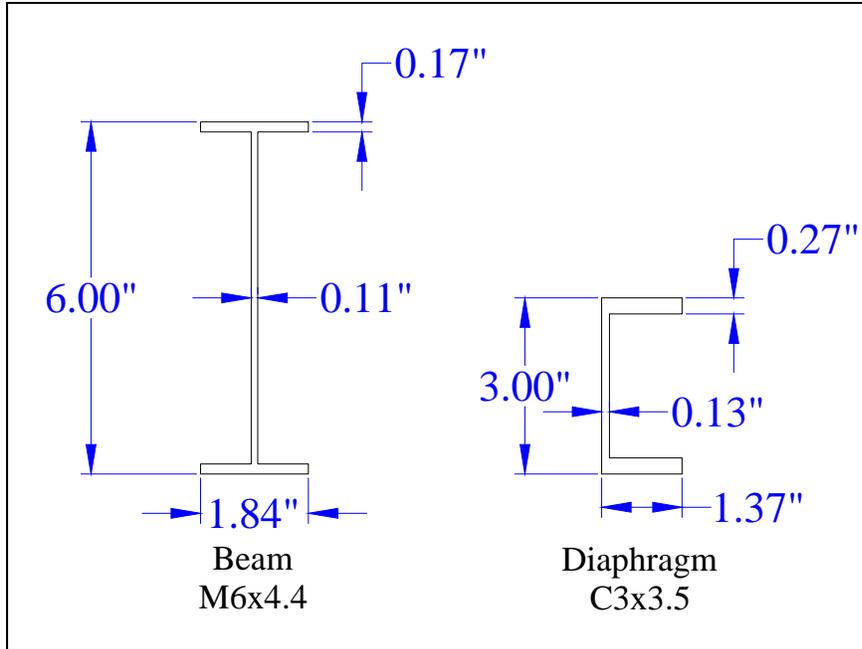
Figure 3.20 Scale bridge member cross sections

Laboratory testing was completed on a scale model of half of the FHWA # 31690 bridge. The model was constructed at approximately 1/6 scale and was made with two 10 foot long M6x4.4 junior I-beams and four 2 foot 6 inch long C3x3.5 channel sections, as shown in Figure 3.20. The channel sections were fixed to the I-beams with small angles and 1/4 inch bolts. Each bearing pad is made of two steel plates (3/4 inch and 1/2 inch thickness). One side of the model bridge utilizes a pintle in the top bearing plates, as does the actual bridge, to create a simply supported structure. Figure 3.21 shows the scale bridge in the laboratory.

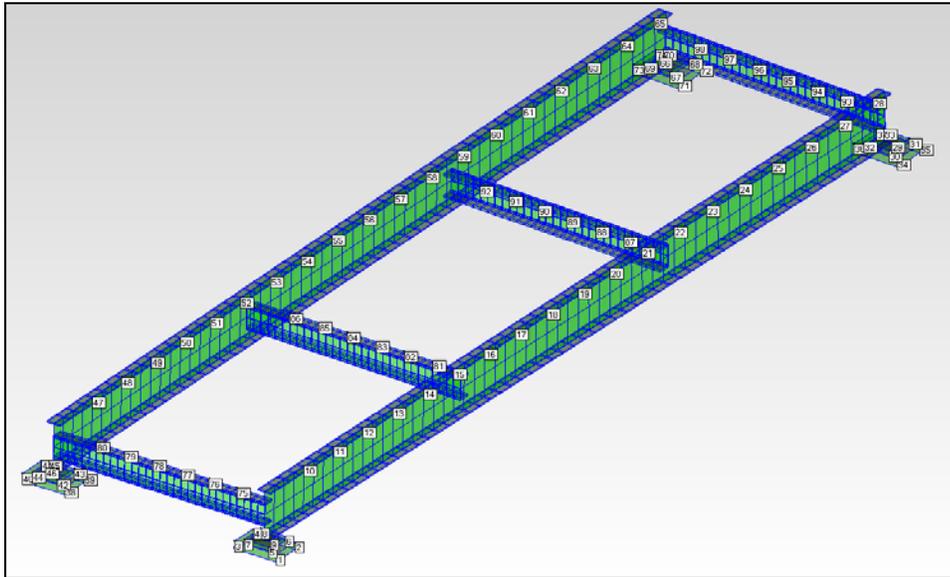
Figure 3.22 Rendering of scale bridge with 98 labeled response points

Six uniaxial accelerometers were roved on the top flanges and bearing plates of each beam. A nodal mesh of one response point per six inches was used on the top flanges of the beams, and each corner of both end plates was measured for all four boundary conditions. The right beam was impacted in the downward vertical direction 20 inches from the end of the beam (node 12). Figure 3.22 shows a 3-D rendering of the structure with 98 labeled points (9 per boundary condition, 19 per beam, and 6 per diaphragm member), and Figure 3.23 shows a close-up of the right beam's first boundary condition with accelerometers on the first six response points. Frequencies from 0-10000 Hz were analyzed with a spectral density of 1 line/6.25 Hz.

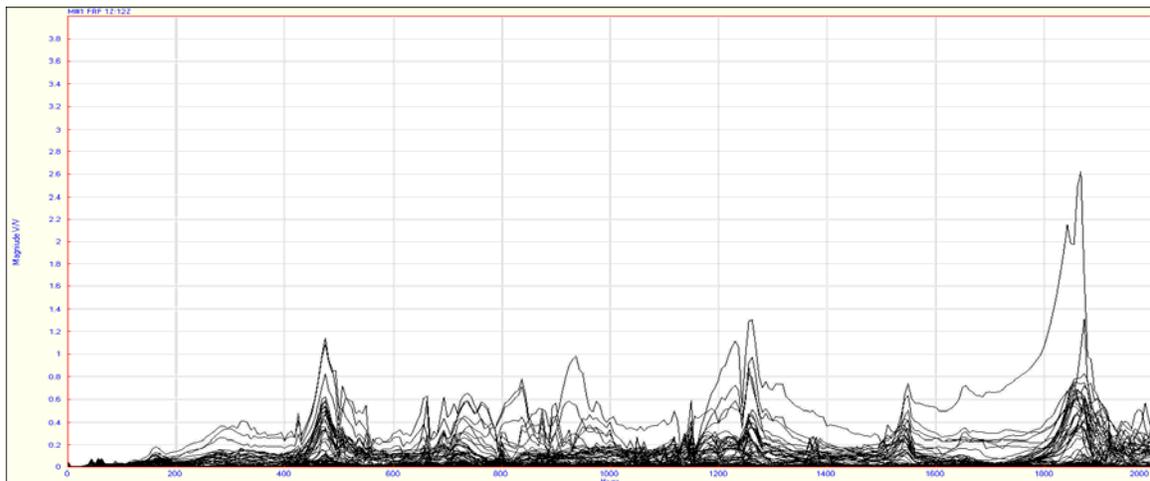
Figure 3.24 Overlaid FRFs from forced excitation, roving response test on baseline scale bridge

Figure 3.24 shows the overlaid FRFs from 0-2000 Hz collected from a roving response test on the scale bridge with no added damage. Some of the FRFs appear to have little agreement with the others because there were response points on various substructures such as end plates and diaphragm members.

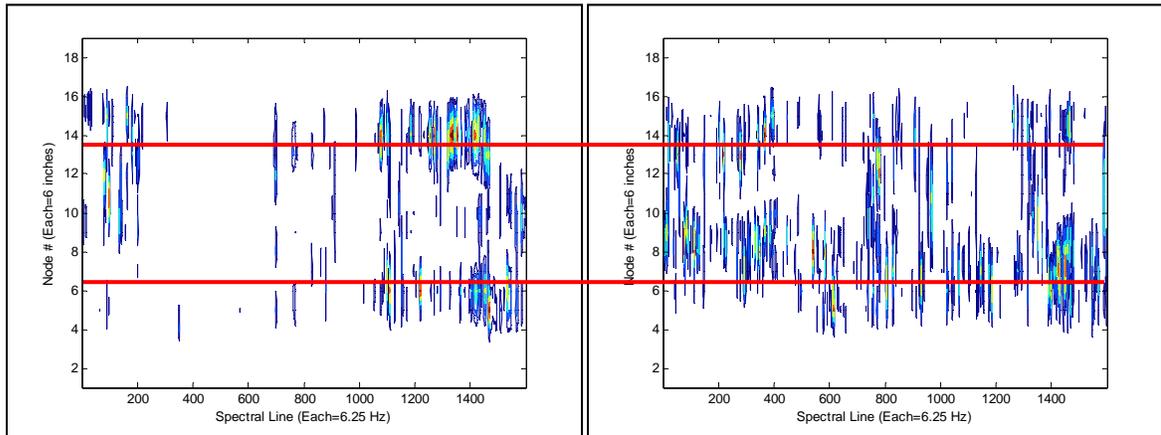
Figure 3.25 Damage index for right beam of baseline scale bridge and Figure 3.26 Damage index for left beam of baseline scale bridge

Figures 3.25 and 3.26 show the damage indices for response points on the right and left beams, respectively. The solid red lines indicate the location of the intermediate diaphragm members at the third points of the 10 foot long beams. With no damage added to the structure, the use of a local curve fitting method should only show areas of the beam that are highly stiffened. The regions of color in Figures 3.25 and 3.26 are mostly within the intermediate diaphragm members, but also extend out past the channel sections for approximately 1 foot on each side. Therefore, for this structure with intermediate diaphragm members at third points, the stiffened region due to those members covers approximately the middle two-thirds of the structure.

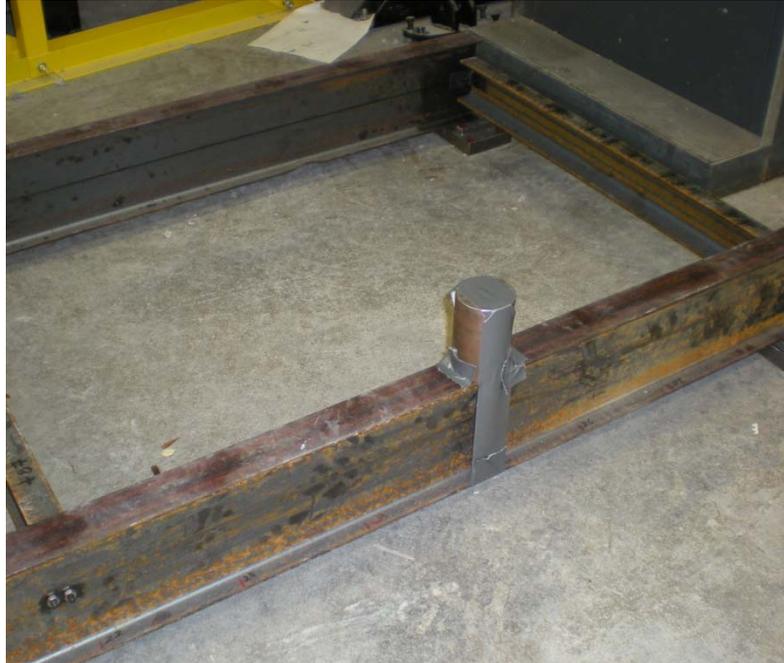
Figure 3.27 Mass (1500 g) added to top flange of beam 1, 20 inches from the far end

Damage was added to one of the beams of the scale bridge to determine if the highly stiffened region in the middle of the structure has an effect on damage detection using the FRF curvature method. For this experiment, a 1500 g mass was fixed to the top flange of the right beam 20 inches from the far end (on node 16), as shown in Figure 3.27. This mass represents 3.2% of the total structure's mass (excluding the bearing plates) and 7.5% of the right beam only. Response points for this test were the same 98 points shown in Figure 3.22.

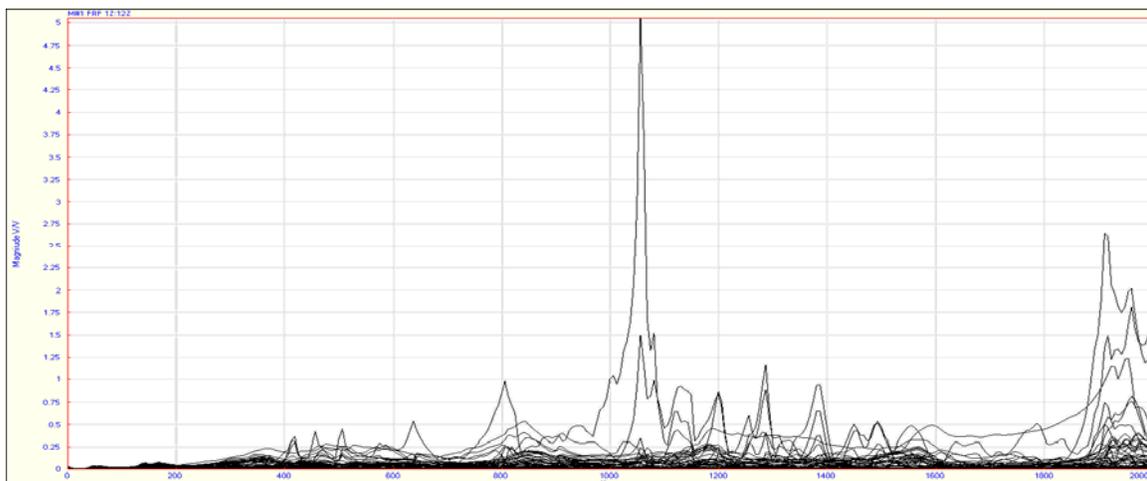
Figure 3.28 Overlaid FRFs from forced excitation, roving response test on damaged scale bridge

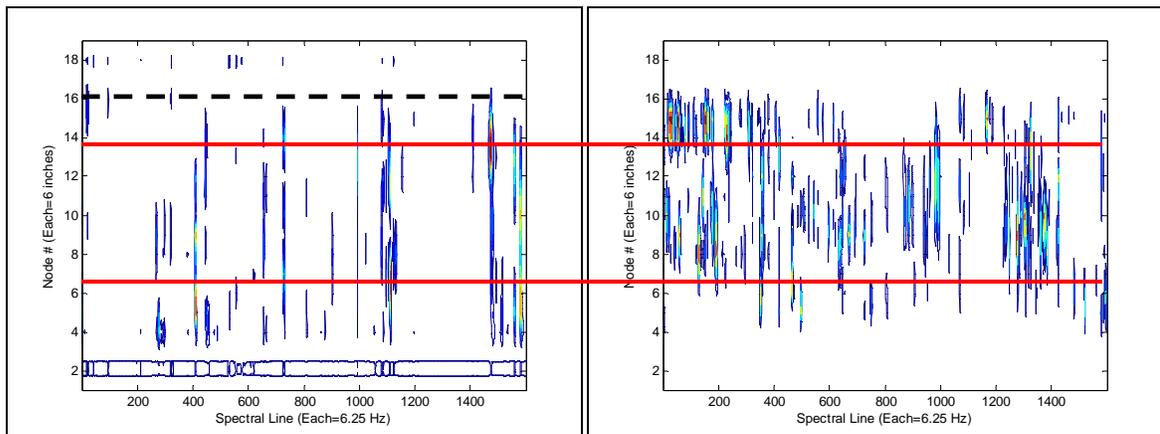
Figure 3.29 Damage index for damaged right beam of scale bridge and Figure 3.30 Damage index for undamaged left beam of baseline scale bridge

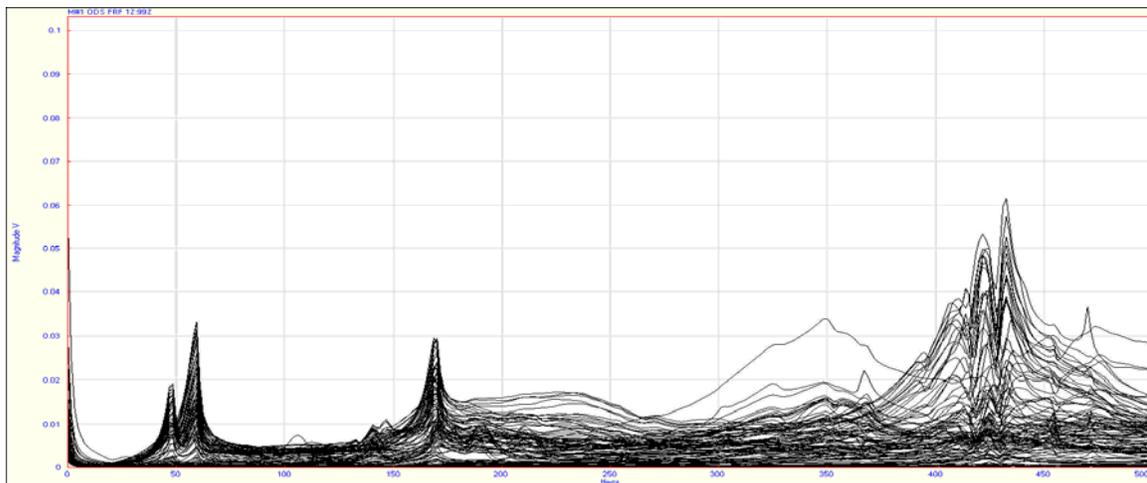
Figure 3.31 Overlaid FRFs from operational vibration, roving response test on damaged scale bridge

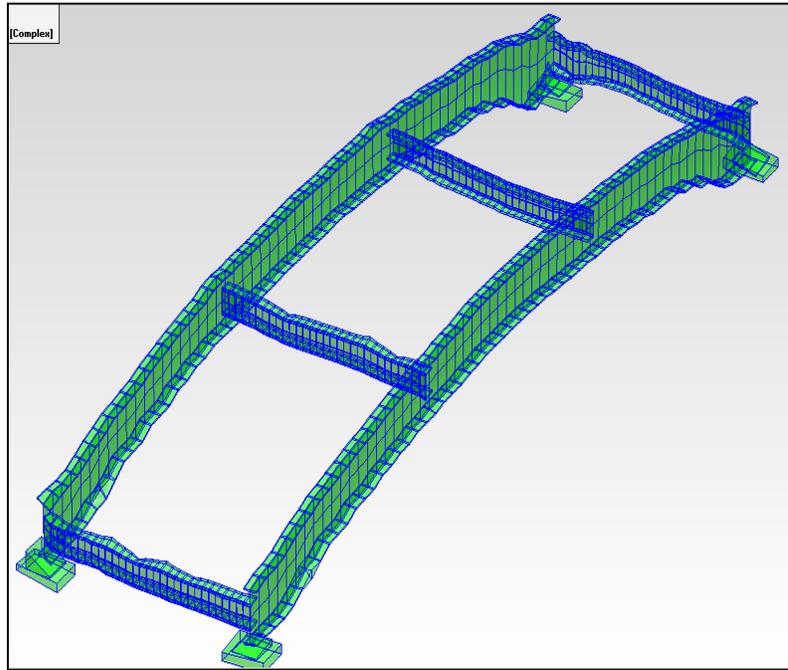
Figure 3.32 Screenshot of MEscope animation of scale bridge ODSFRFs at 46.9 Hz

present on top of the beams, it can be inferred that if the structure was often excited at this frequency, it would cause significant lateral cracking in the deck.

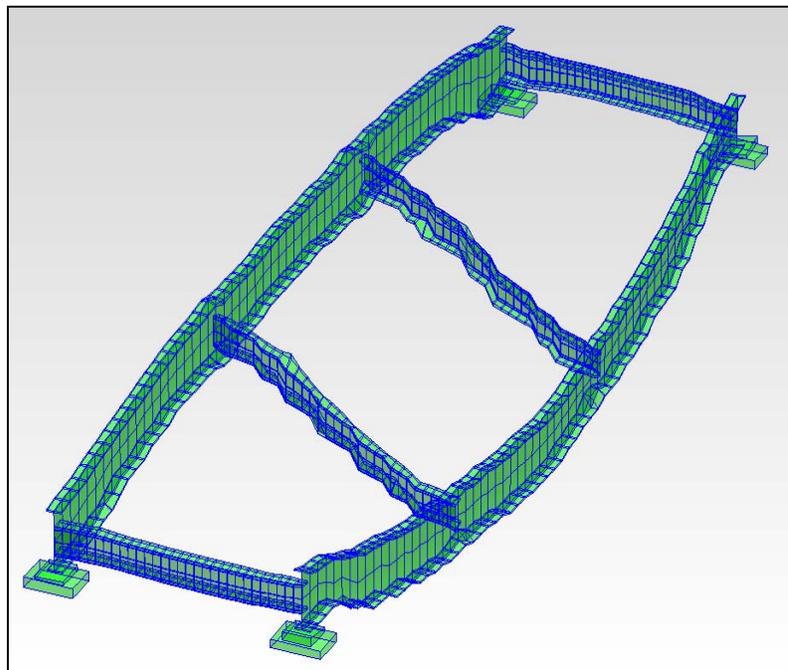
Figure 3.33 Screenshot of MEscope animation of scale bridge ODSFRFs at 59.4 Hz

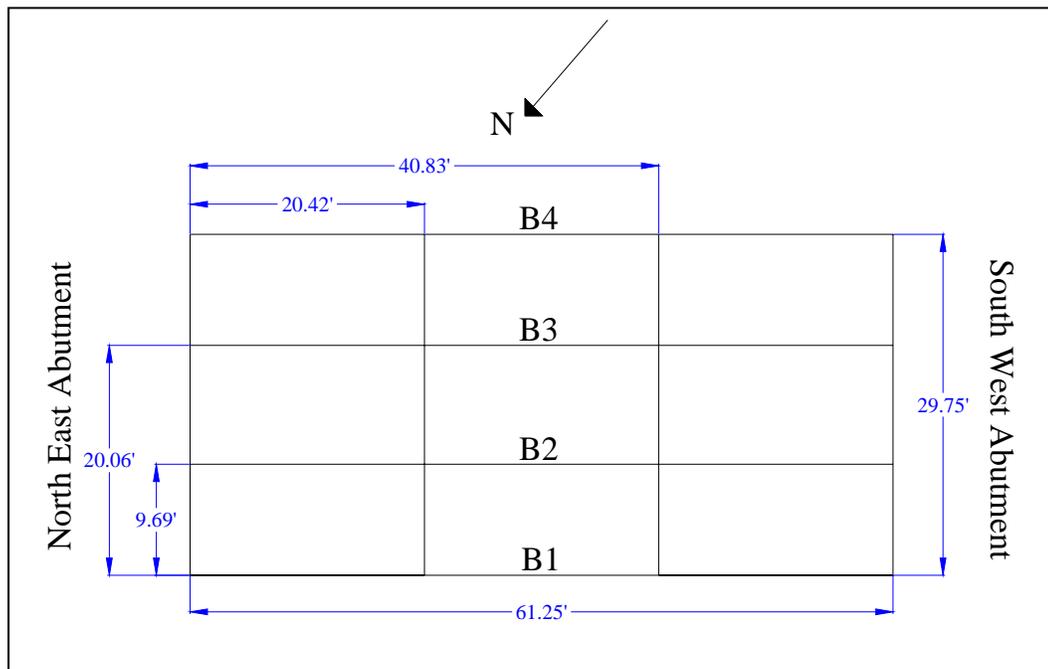
Figure 4.1 Plan view of FHWA # 31690

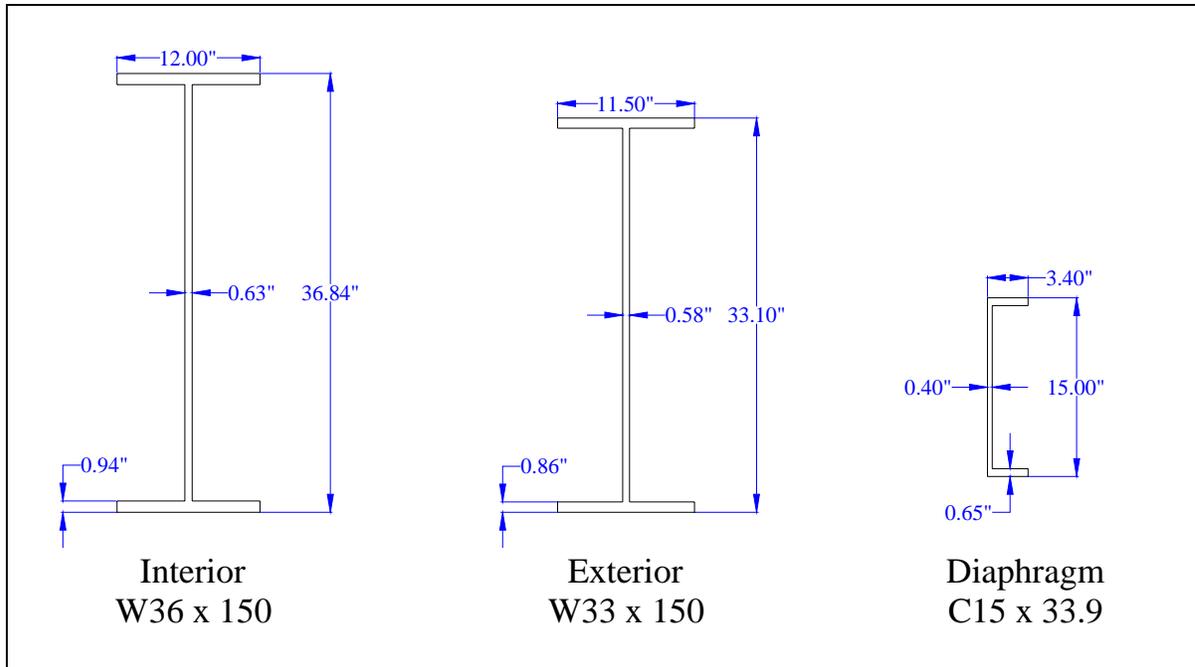
Figure 4.2 Schematic of member cross sections

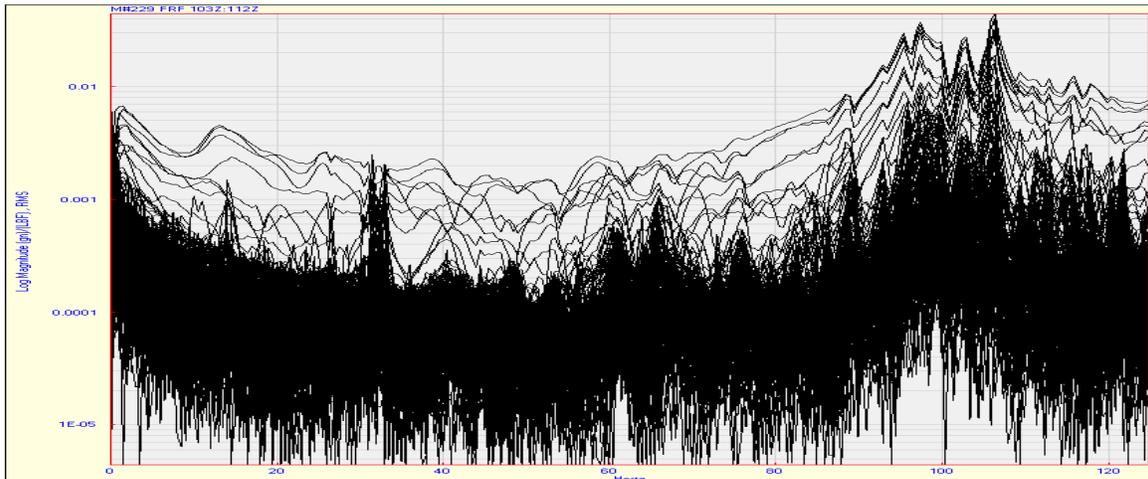
Figure 4.8 Overlaid FRFs from roving response test on all four beams of field bridge

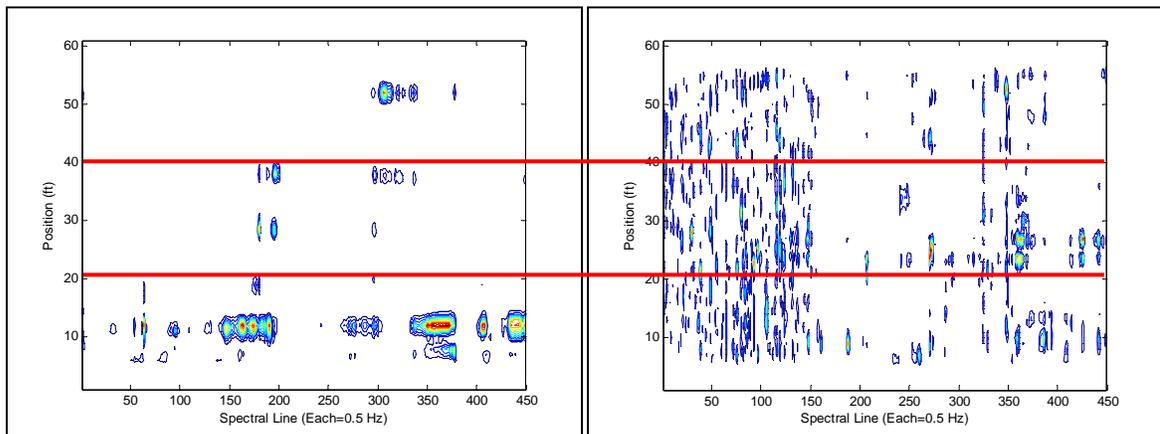
Figure 4.9 Damage Index for beam 1 and Figure 4.10 Damage Index for beam 2

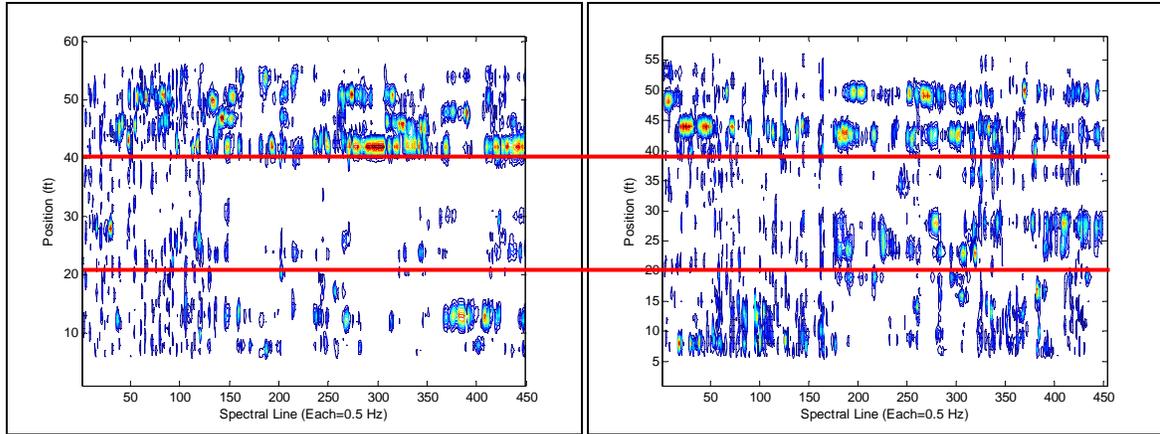
Figure 4.11 Damage index for beam 3 and Figure 4.12 Damage Index for beam 4

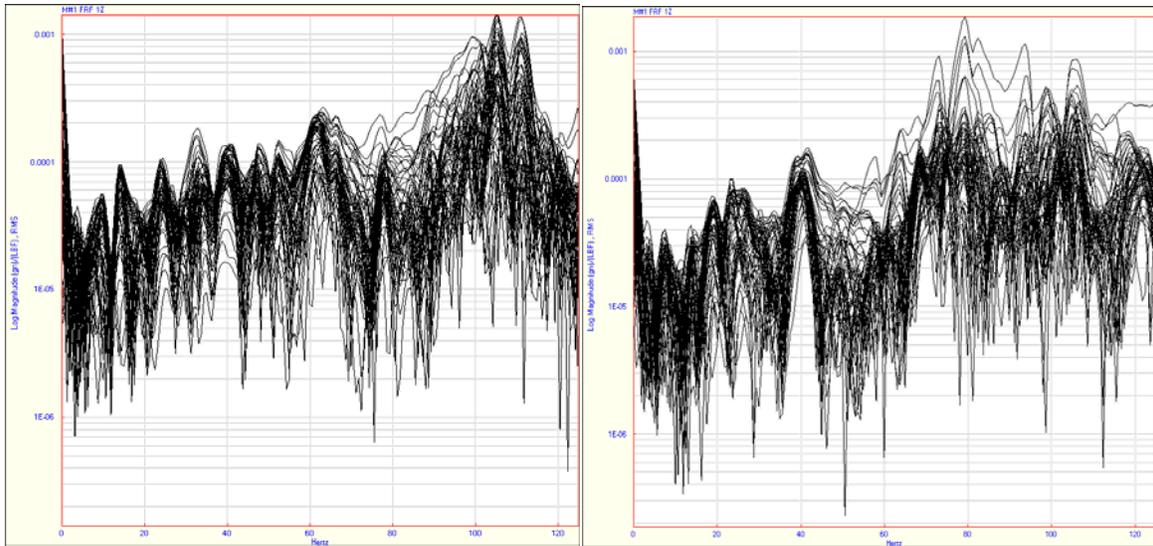
Figure 4.16 Overlaid FRFs for roving response test on beam 1 and Figure 4.17 Overlaid FRFs for roving response test on beam 2

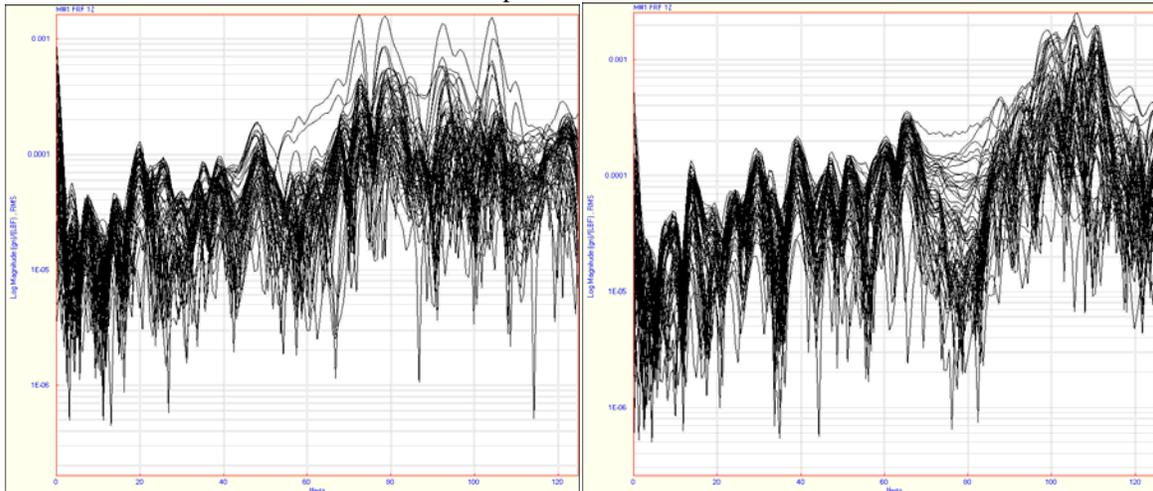
Figure 4.18 Overlaid FRFs for roving response test on beam 3 and Figure 4.19 Overlaid FRFs for roving response test on beam 4

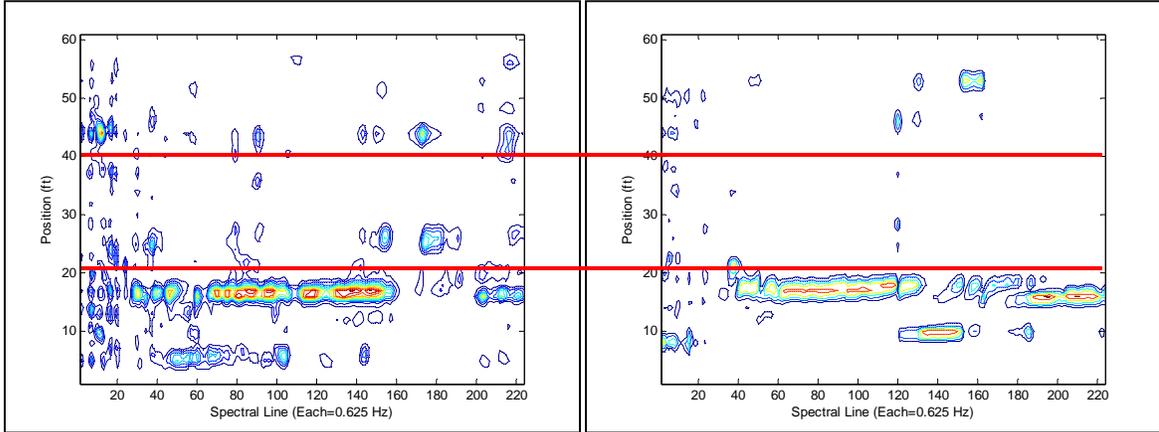
Figure 4.20 Damage index for beam 1 and Figure 4.21 Damage index for beam 2
