**Final report
IHRB Project TR-610**

**ON-THE-SPOT DAMAGE DETECTION METHODOLOGY FOR HIGHWAY
BRIDGES**

July, 2010

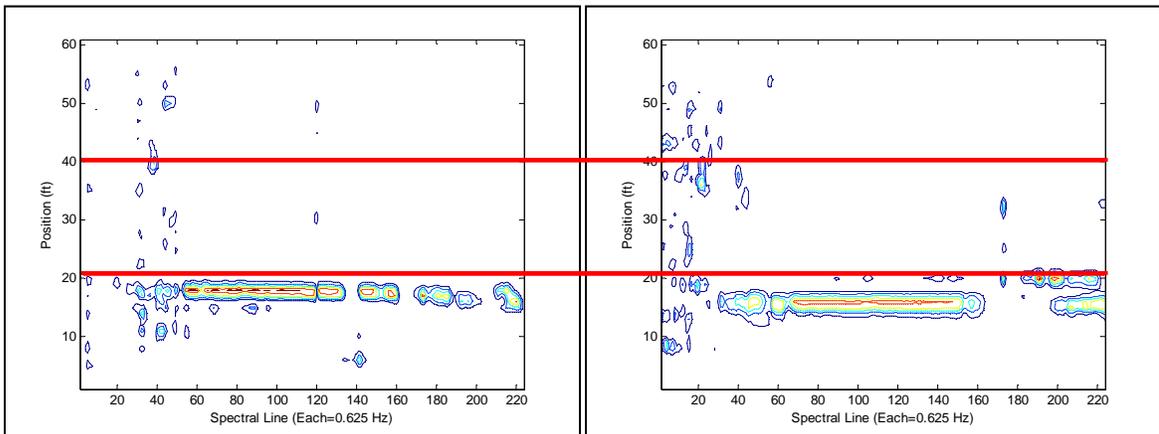
Figure 4.22 Damage Index for beam 3 and Figure 4.23 Damage Index for beam 4

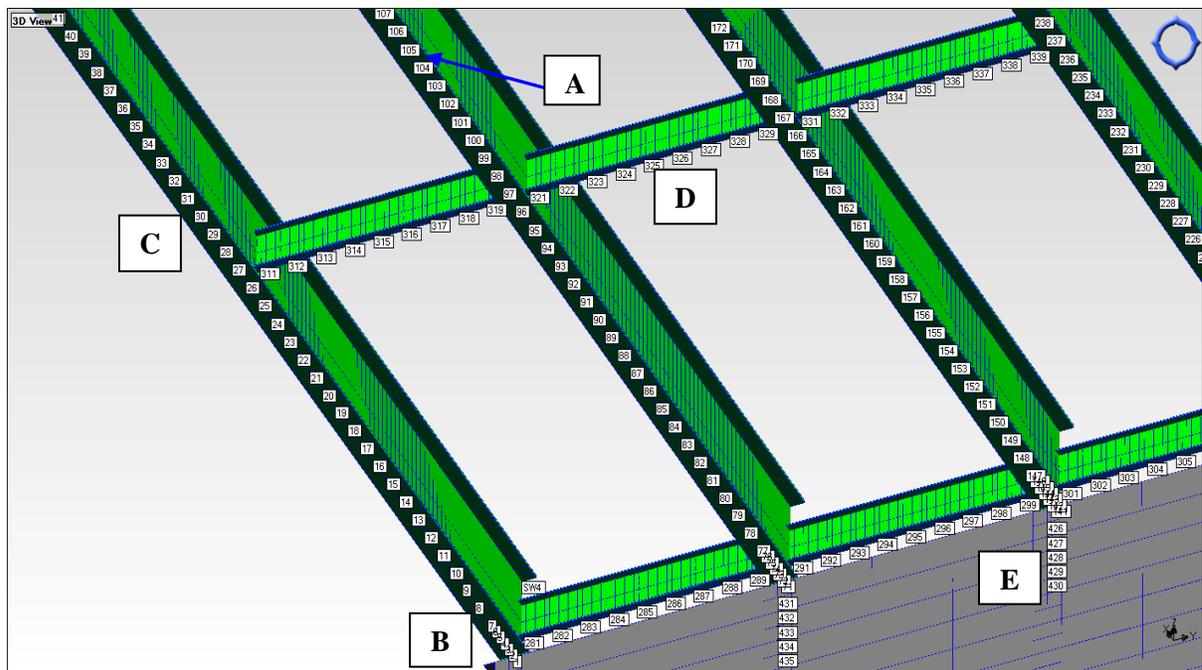
Figure 4.24 Rendering of the bridge with the reference response location (A), concentrated beam mesh near boundary conditions (B), normal beam mesh (C), diaphragm member mesh (D), and abutment mesh (E)

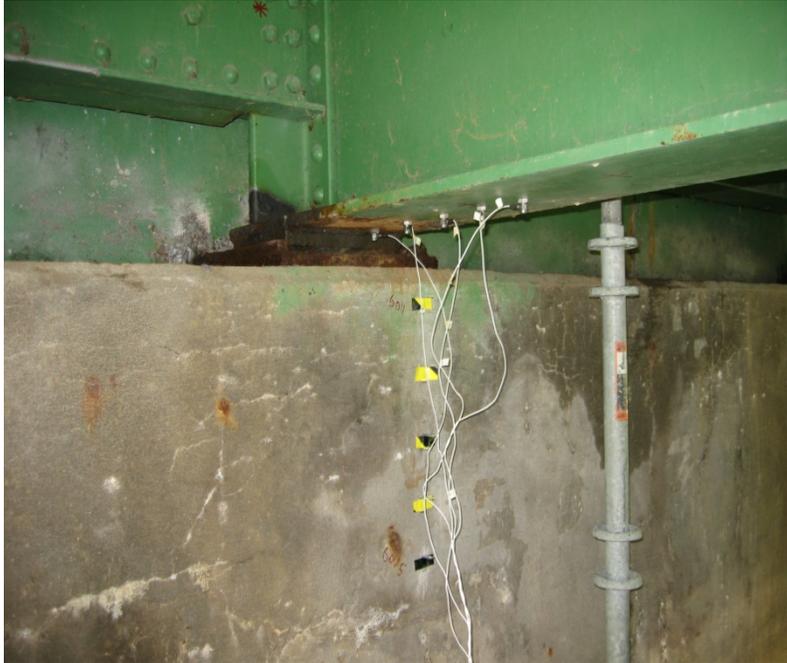
Figure 4.25 Operational vibration response measurement of a beam near the boundary condition

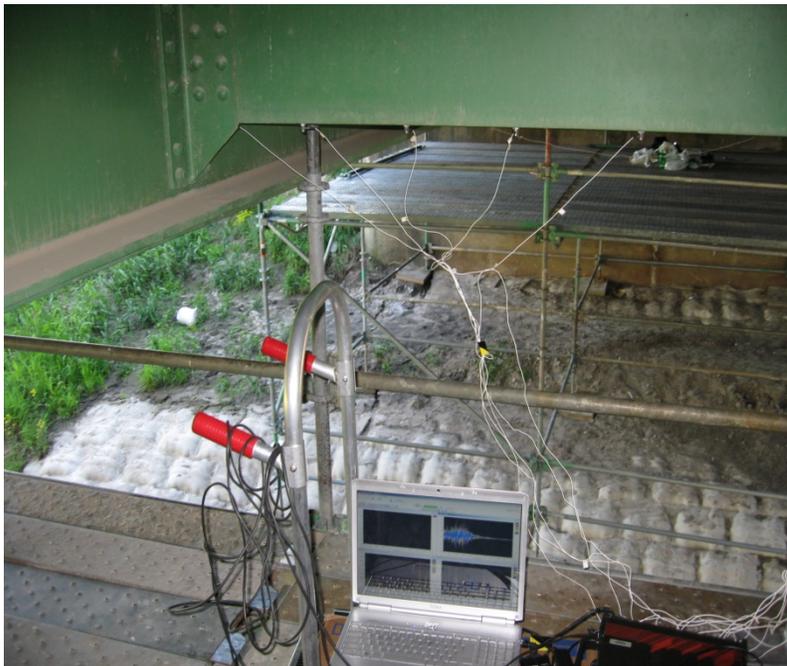
Figure 4.26 Operational vibration response measurement of a diaphragm member

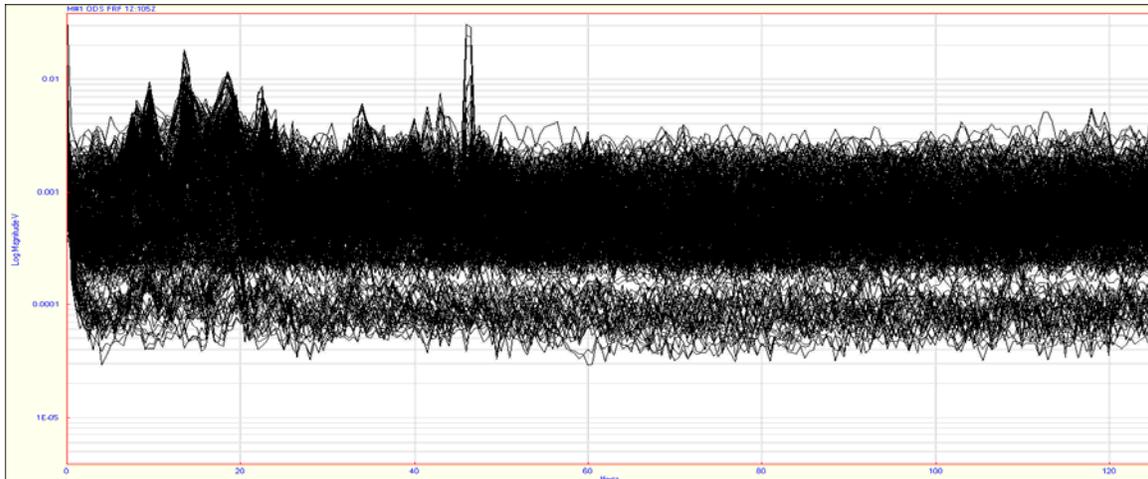
Figure 4.28 Overlaid ODSFRFs from global operational vibration test

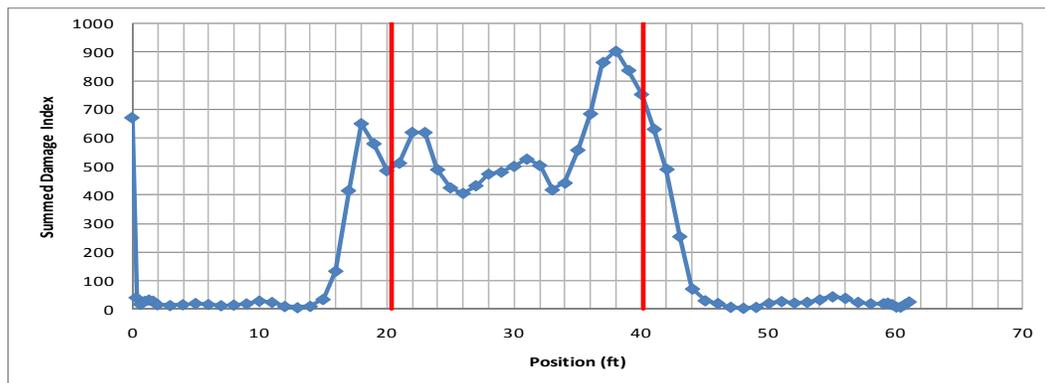
Figure 4.29 Summed damage index for beam 1

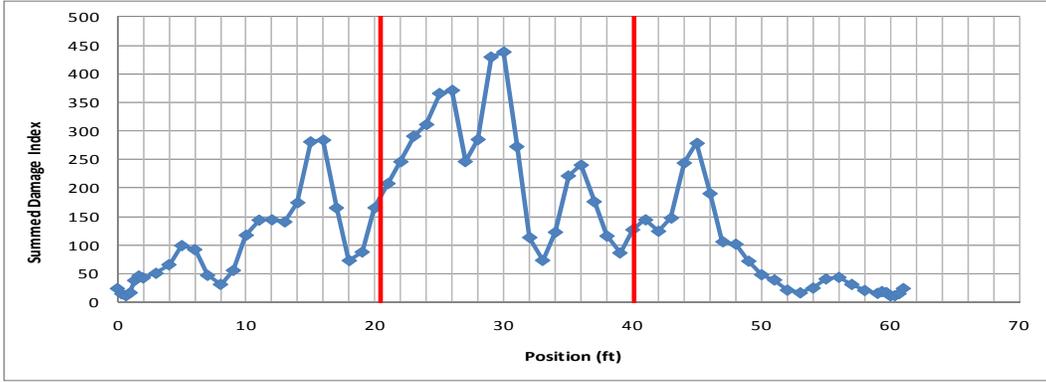
Figure 4.30 Summed damage index for beam 2

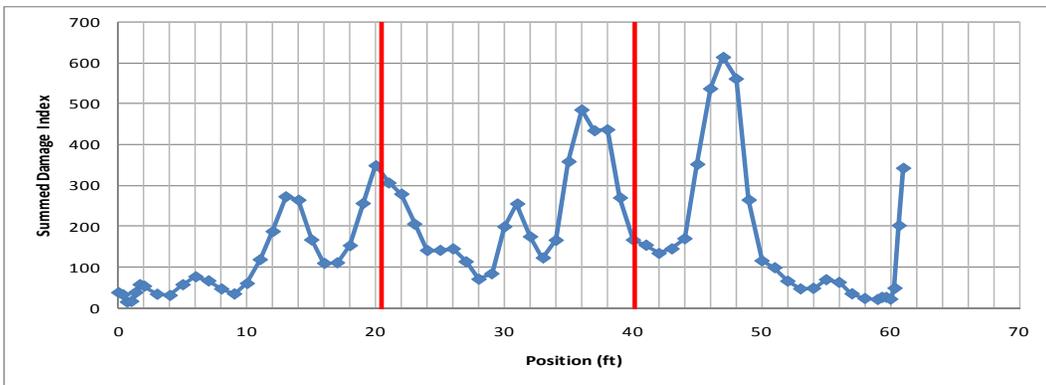
Figure 4.31 Summed Damage index for beam 3

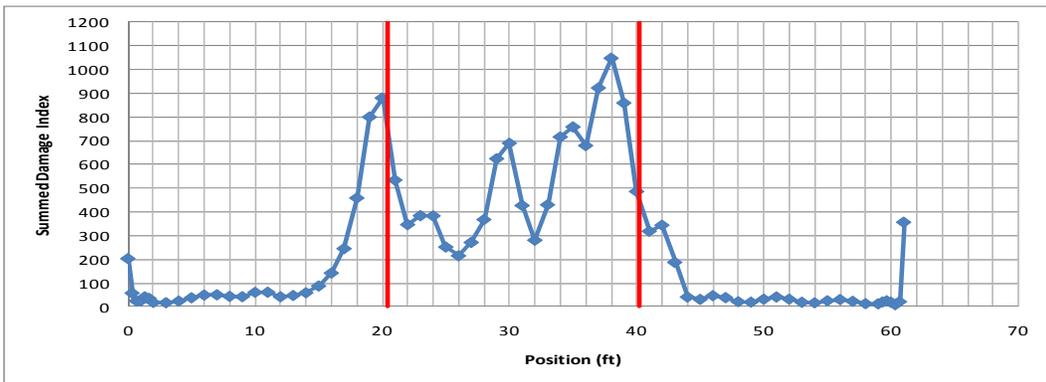
Figure 4.32 Summed damage index for beam 4

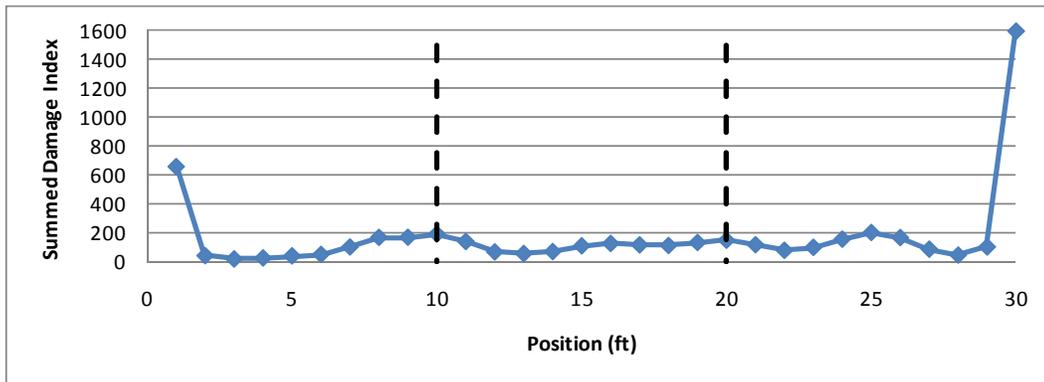
Figure 4.33 Summed Damage index for diaphragm row 1

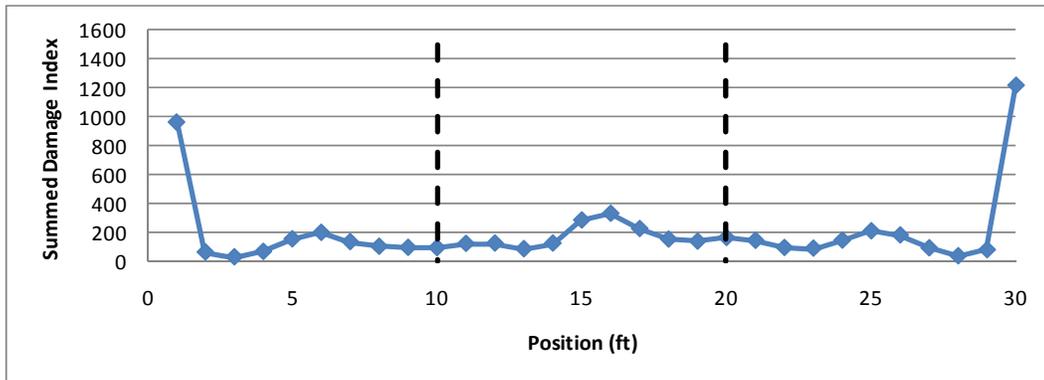
Figure 4.34 Summed damage index for diaphragm row 2

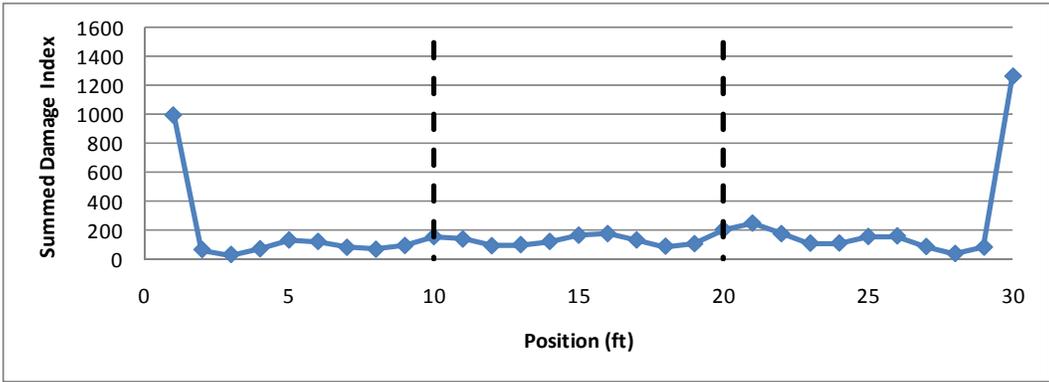
Figure 4.35 Summed damage index for diaphragm row 3

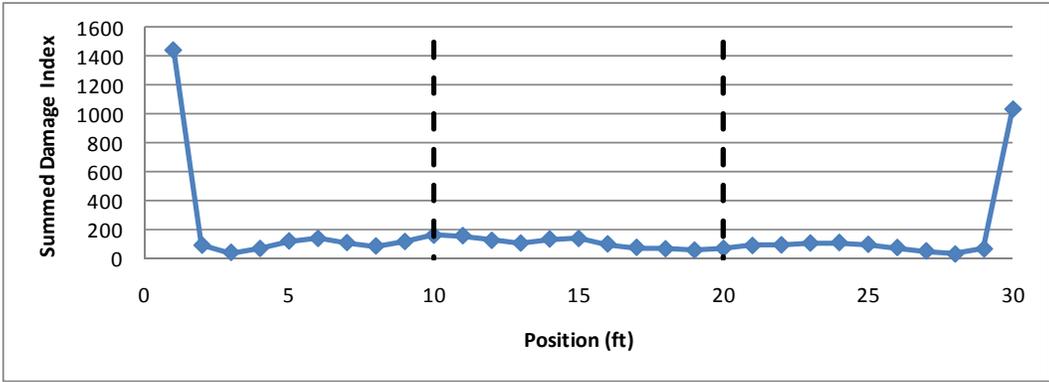
Figure 4.36 Summed damage index for diaphragm row 4

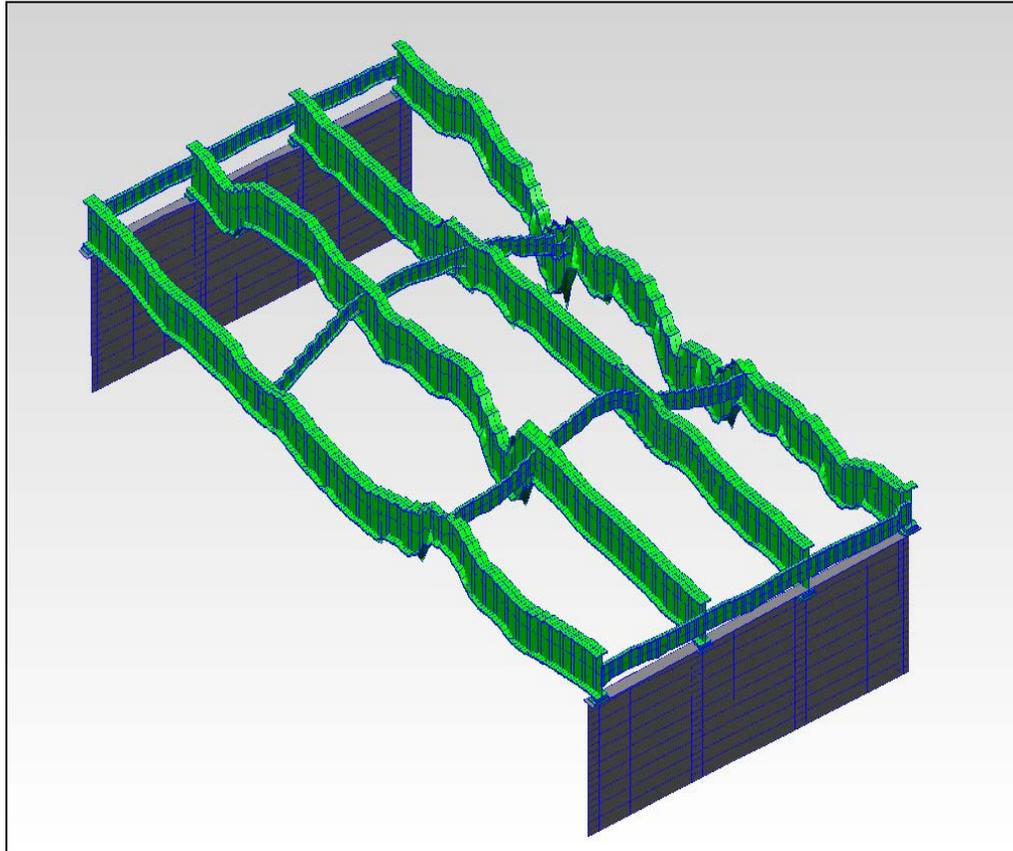
Figure 4.37 Screenshot of MEscape animation of entire bridge ODSFRFs at 13.5 Hz

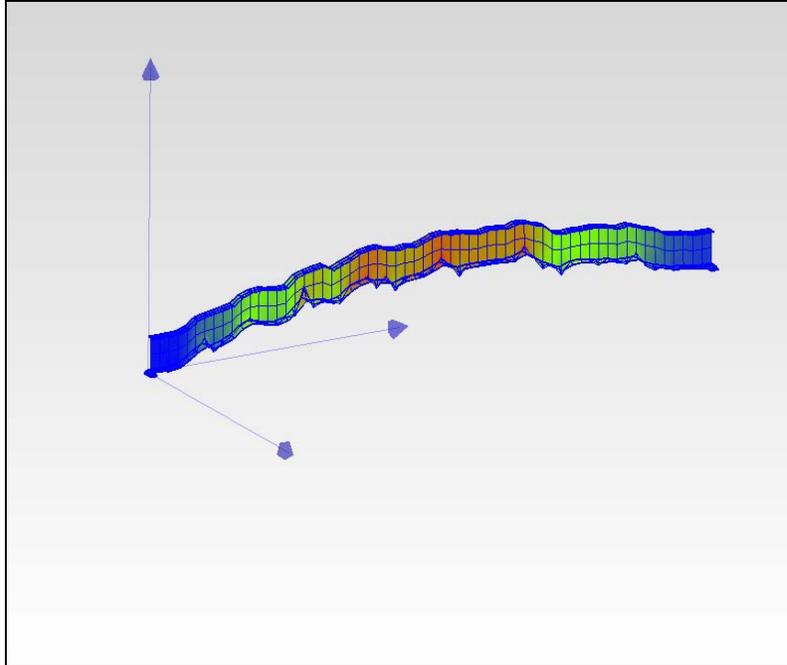
Figure 4.38 Screenshot of MEscape animation of independent beam FRFs at 13.5 Hz

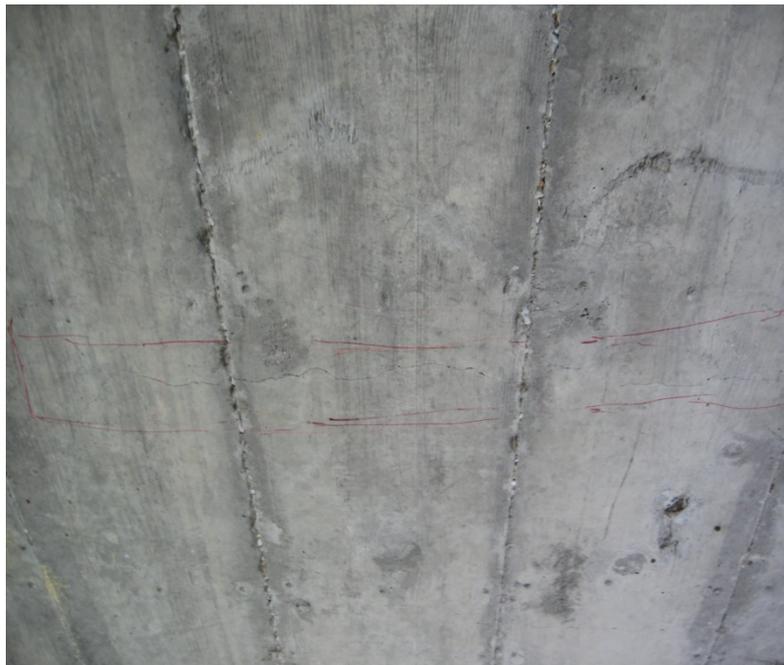
Figure 4.39 Lateral surface crack in concrete deck near midspan of bridge

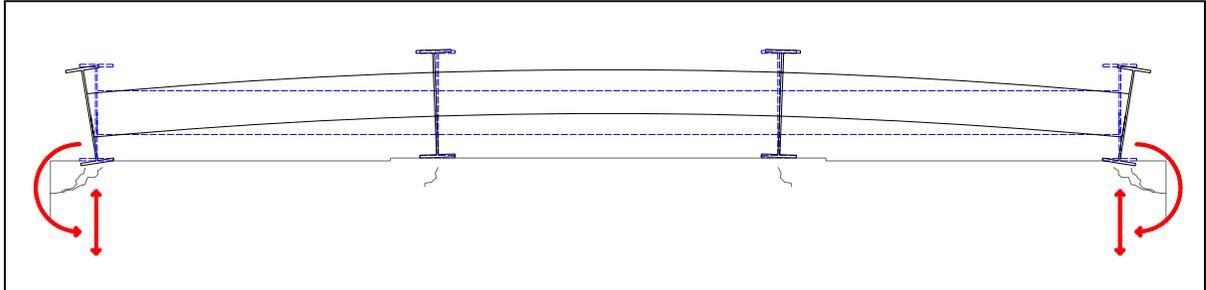
Figure 4.40 Schematic of torsional and compression-tension action caused by first bending mode of diaphragm members

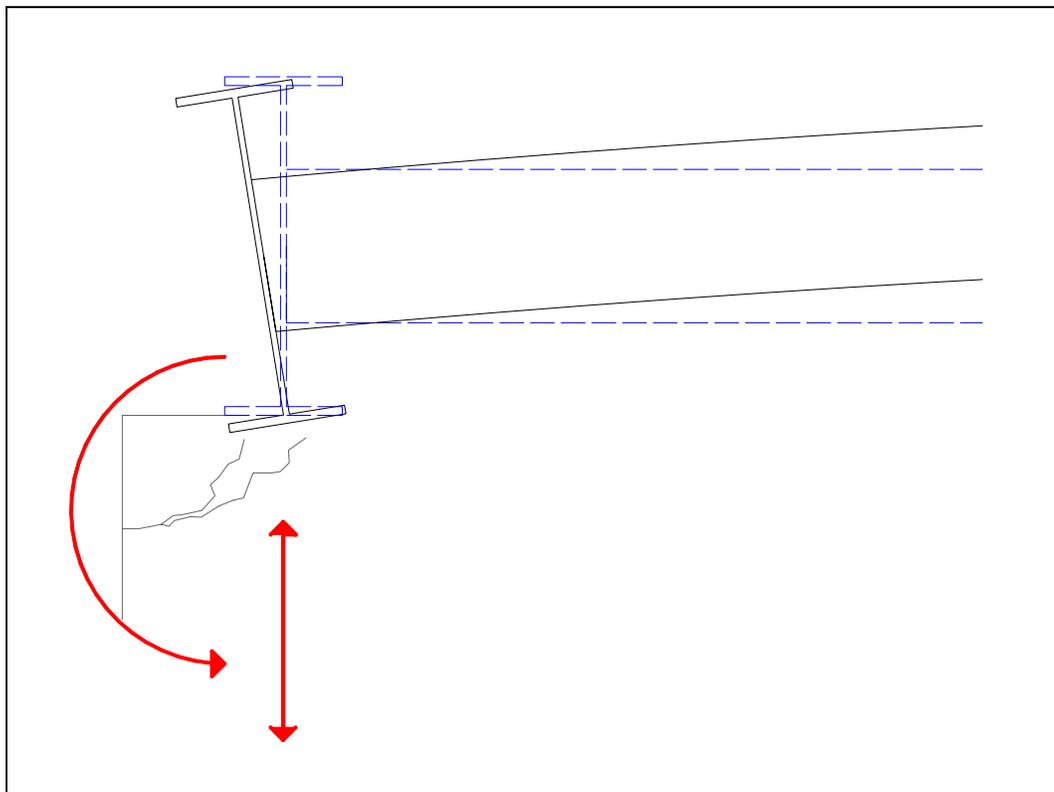
Figure 4.41 Zoomed-in schematic of torsional and compression-tension action caused by first bending mode of diaphragm members

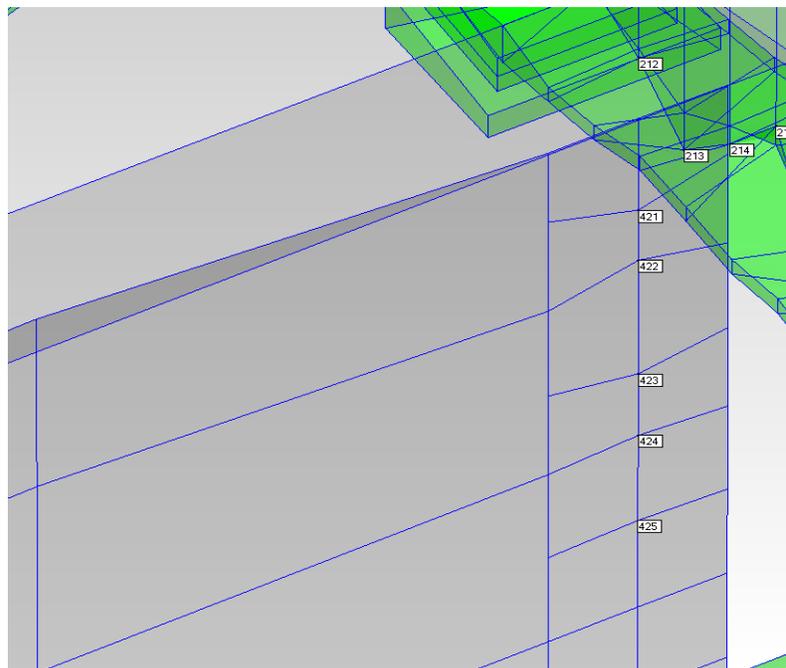
Figure 4.42 Screenshot of MEscape NE4 boundary condition animation of ODSFRFs at 15 Hz

- Video 3: MEscape North east beam 4 (NE4) boundary condition animation of ODSFRFs at 15 Hz (screenshot: Figure 4.42)
- Video 4: MEscape North east beam 3 (NE3) boundary condition animation of FRFs at 151 Hz (screenshot: Figure 4.49)

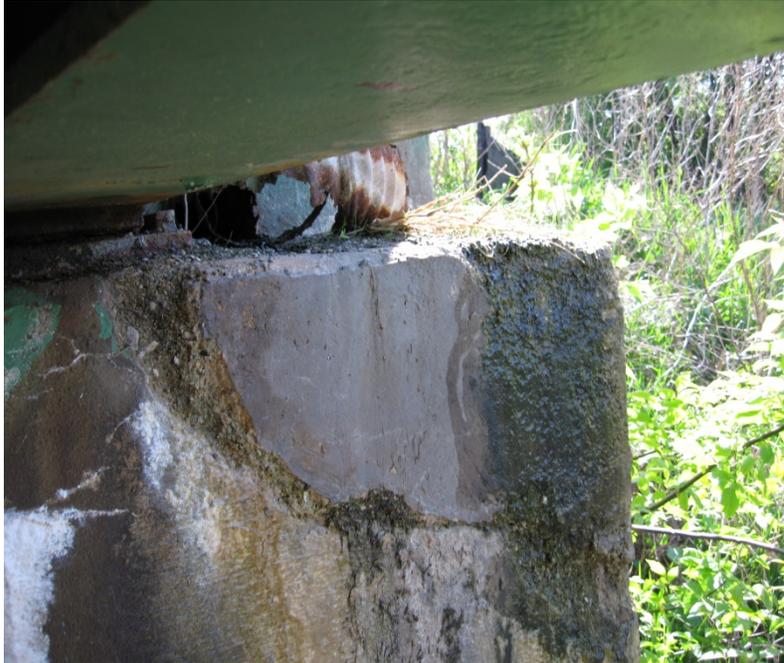
Figure 4.43 Large crack in the northeast abutment wall beneath beam 4

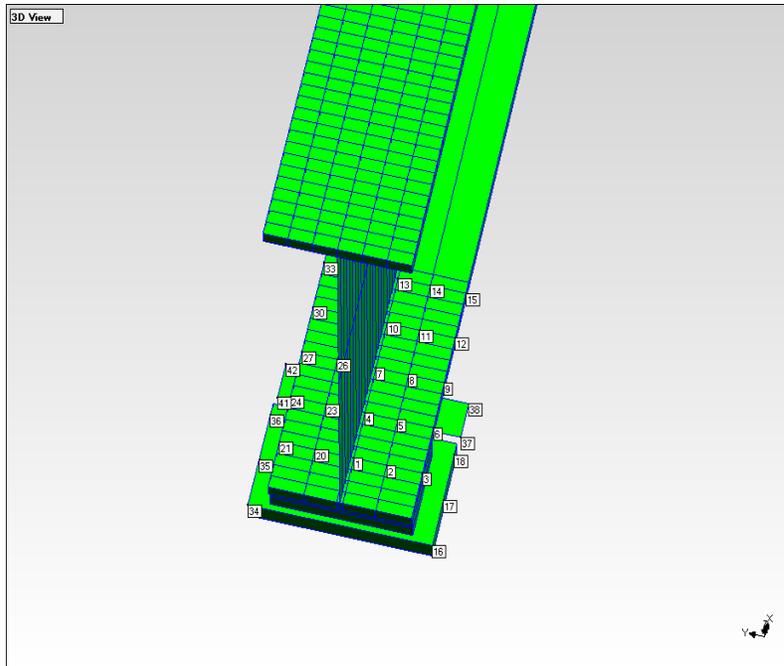
Figure 4.44 Rendering of a typical beam end and boundary condition with 42 response points

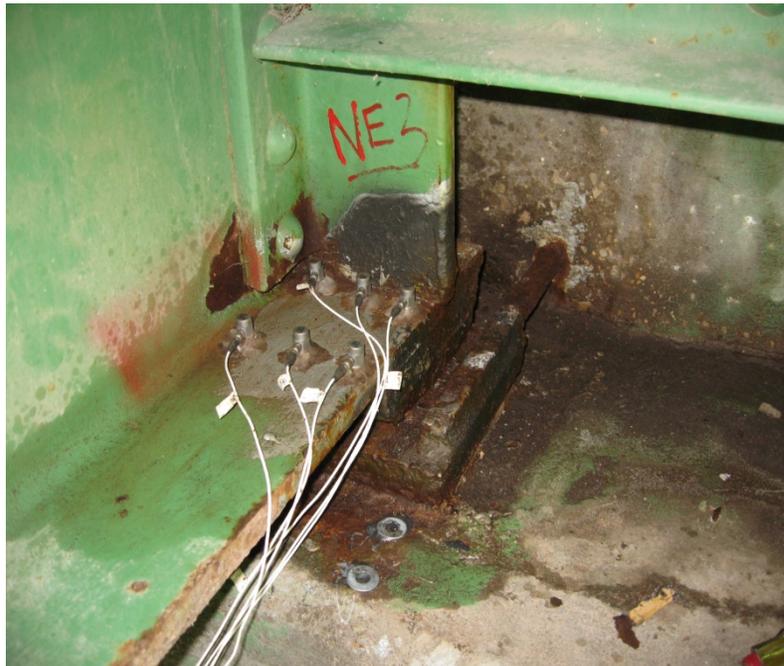
Figure 4.45 Forced vibration response measurement of northeast end and boundary condition of beam 3

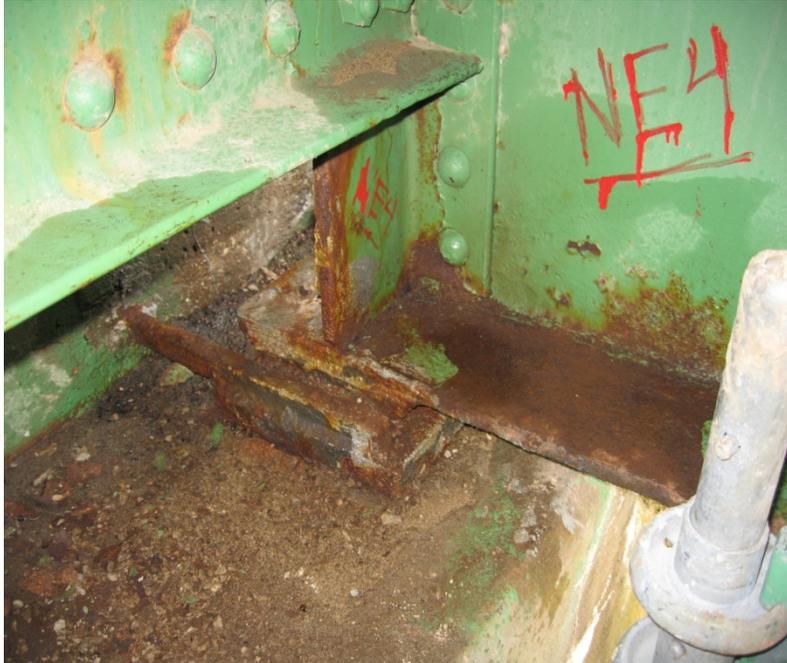
Figure 4.46 Forced vibration response measurement of northeast end and boundary condition of beam 4 with noticeable deterioration of the bottom flange

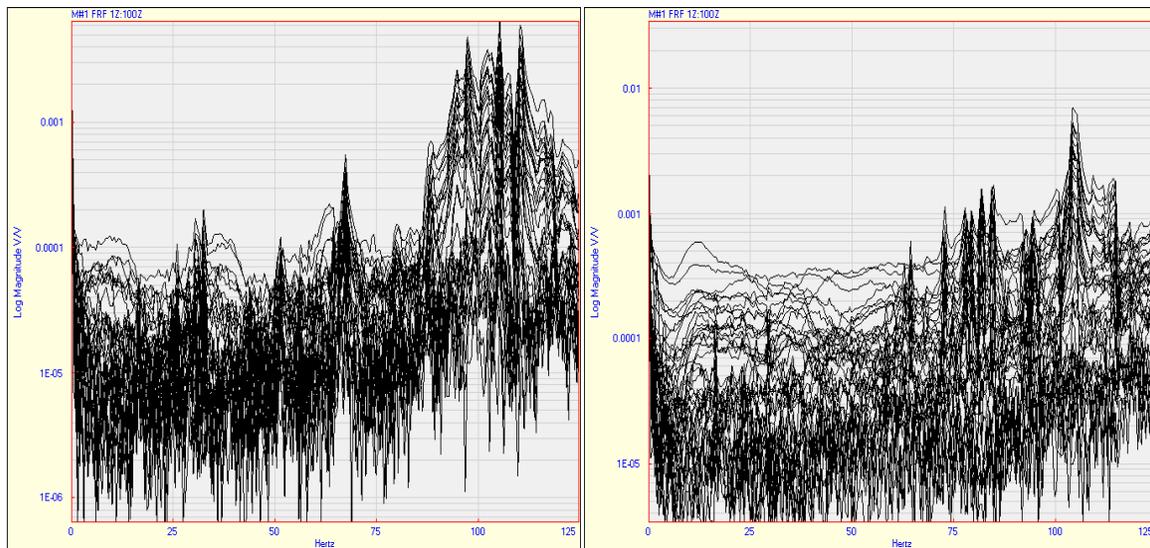
Figure 4.47 Overlaid FRFs from forced vibration test on northeast boundary condition and end of beam 4 and
Figure 4.48 Overlaid FRF's from forced vibration test on northeast boundary condition and end of beam 3

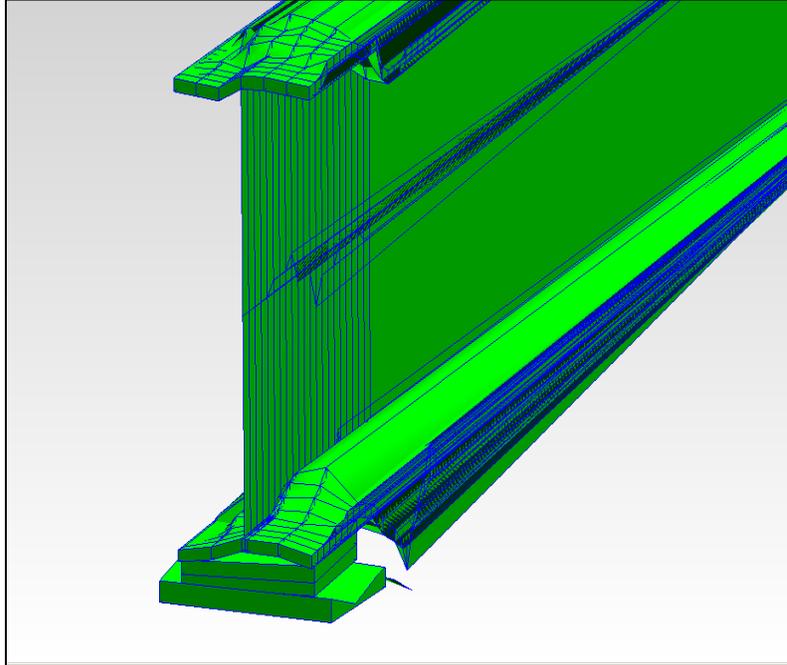
Figure 4.49 Screenshot of MEscape NE3 boundary condition animation of FRFs at 151 Hz

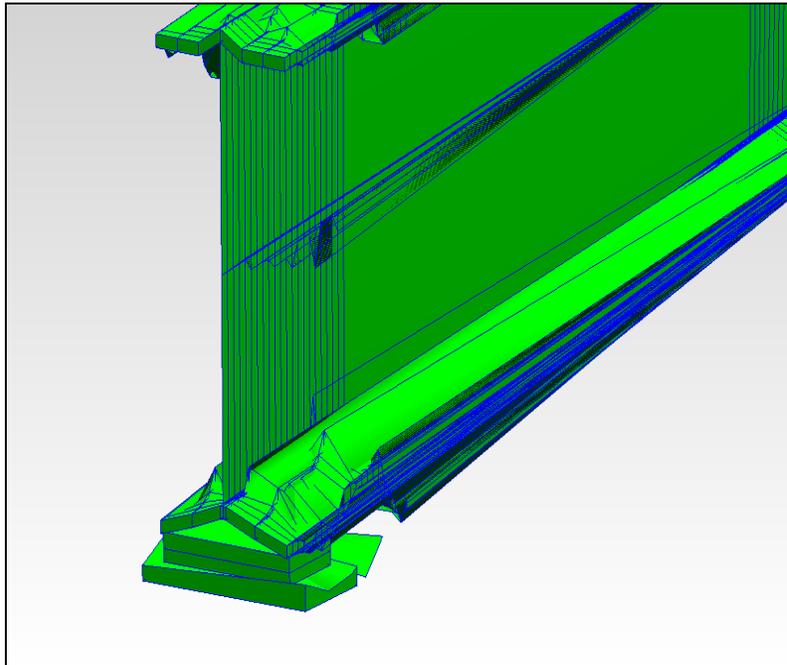
Figure 4.50 Screenshot of MEscape NE4 boundary condition animation of FRFs at 1 Hz

- Video 5: MEscape North east beam 4 (NE4) boundary condition animation of FRFs at 1 Hz (screenshot: Figure 4.50)
- Video 6: MEscape North east beam 4 (NE4) boundary condition animation of FRFs at 43.5 Hz (screenshot: Figure 4.51)

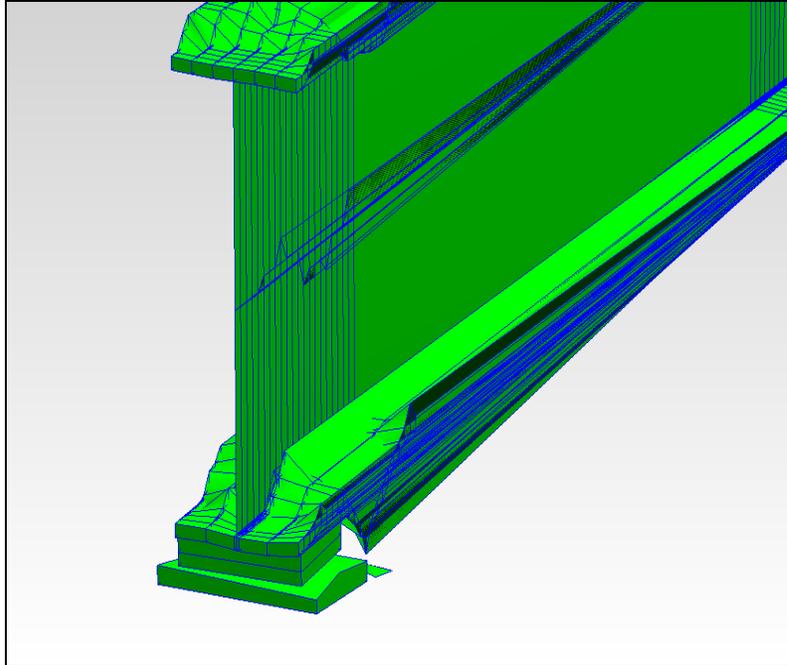
Figure 4.51 Screenshot of MEscope NE4 boundary condition animation of FRFs at 43.5 Hz

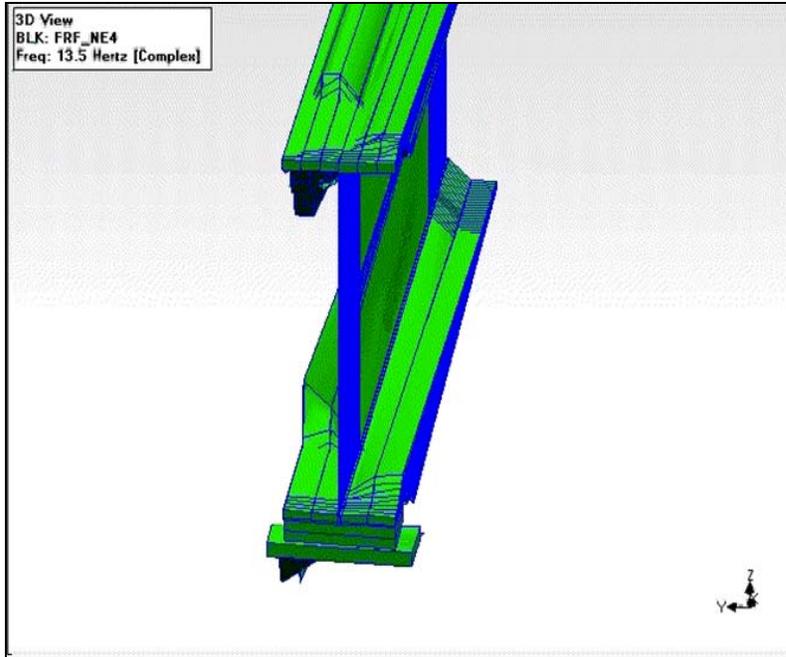
Figure 4.52 Screenshot of MEscape NE4 (exterior beam) boundary condition animation of FRF's at 13.5 Hz showing significant torsional motion

- Video 7: MEscape North east beam 4 (NE4) boundary condition animation of FRF's at 13.5 Hz showing significant torsional motion in exterior beam ends (screenshot: Figure 4.52)

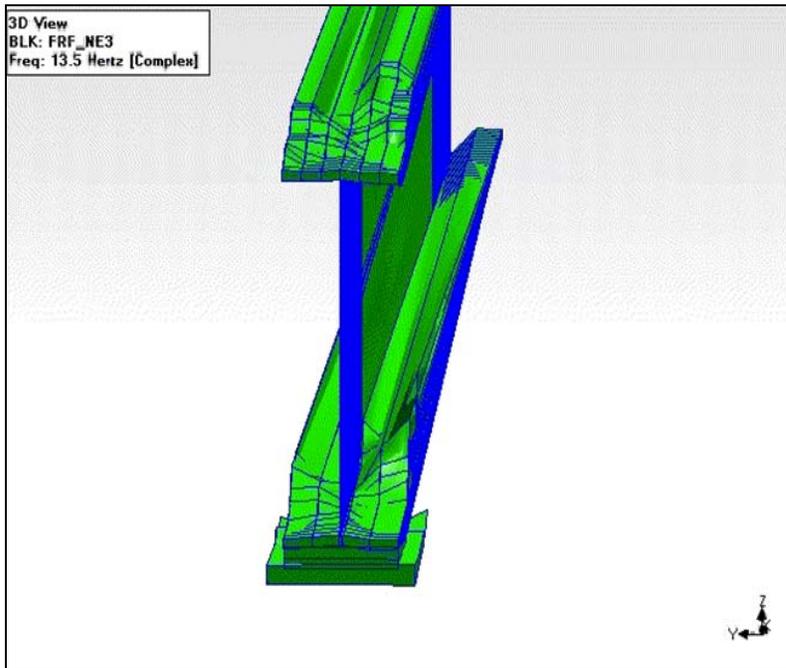
Figure 4.53 Screenshot of MEscape NE3 (interior beam) boundary condition animation of FRF's at 13.5 Hz showing very little torsional motion

- Video 8: MEscape North east beam 3 (NE3) boundary condition animation of FRF's at 13.5 Hz showing very little torsional motion in interior beam ends (screenshot: Figure 4.53)

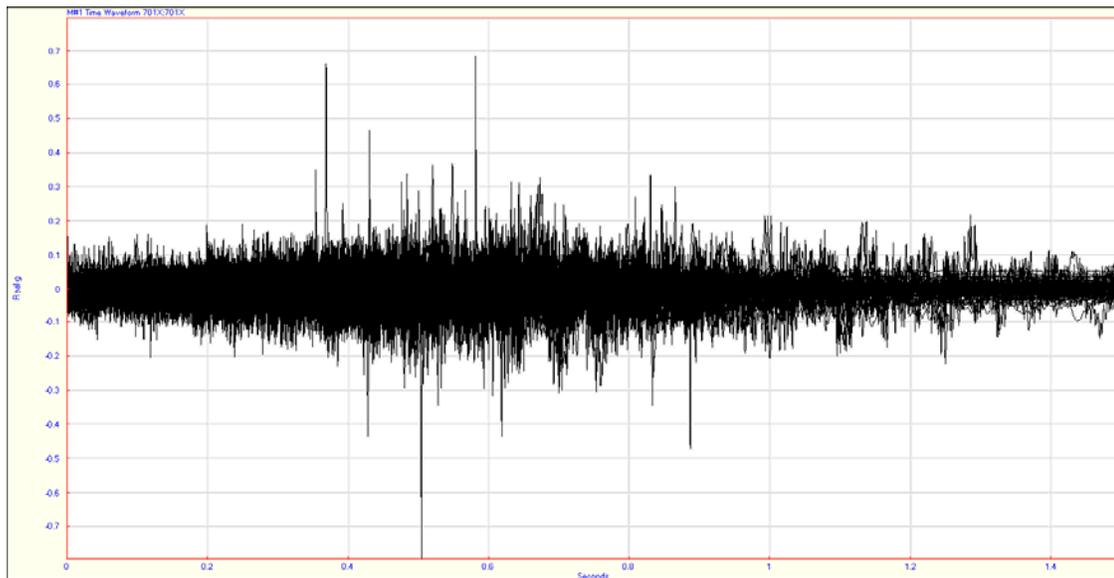
Figure 4.54 Overlaid time waveforms from 88 different automobiles

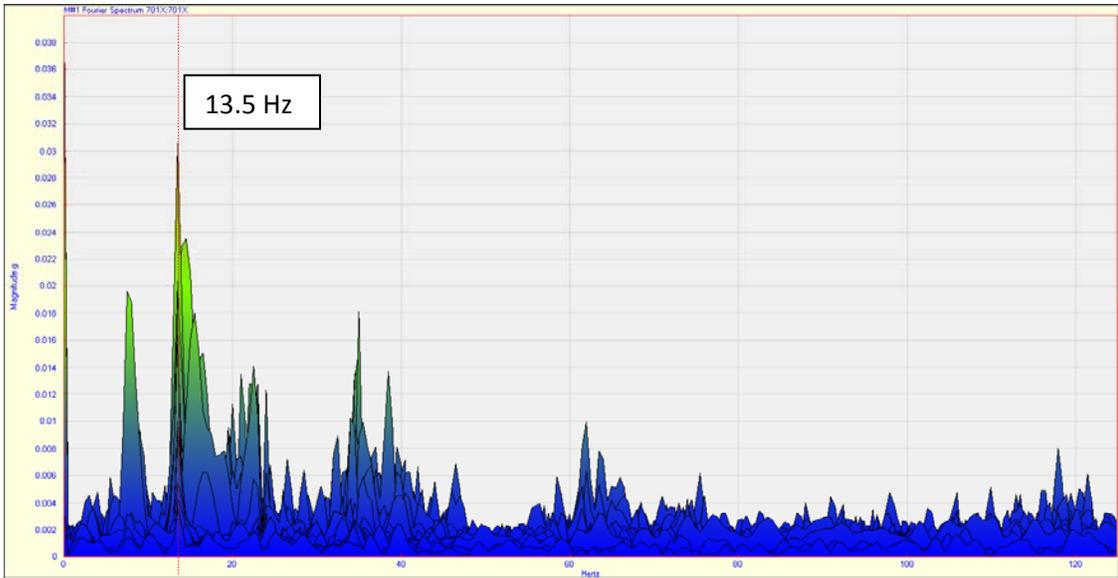
Figure 4.55 Overlaid frequency waveforms from 88 different automobiles
