Rubber Buffings for Bridge Approach Expansion Joints

**Final Report
For
MLR-01-1**

Highway Division

**Iowa Department
of Transportation**

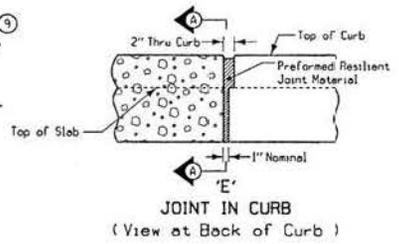
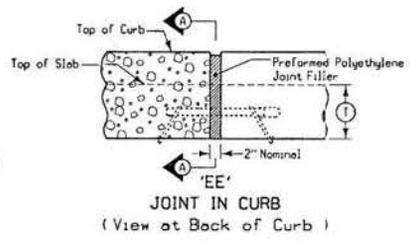
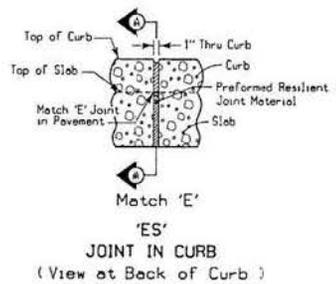
APPENDIX A
Expansion Joint Standard Plan

- 8 Preformed Joint Material 4" nominal width x pavement thickness - 1" deep. See Materials I.M. 436.05 for list of approved materials.
- 9 Place 'CF' Joint material 1" lower than top of pavement. Anchor with galvanized retainer forks at 24" centers; tie forks to reinforcing mat or place on support chairs.

Many of the bridges in the state of Iowa have type 'CF', 'EE', or 'EF' expansion joints installed in the bridge approach slabs (see Appendix A). These joints, which are typically 4" wide, are currently filled with a foam expansion joint material that is covered with a sealant. Over time the sealant begins to pull off of the walls of the joint and it ultimately fails. The joint, which is then exposed to the weather, is filled with water, and/or solids. The foam joint material, which is lighter than water, floats out of the joint onto the highway. This foam resembles a large 4" X 6" plank and poses a threat to motorists. A possible solution to this problem would be to replace the foam material with rubber buffings. Rubber buffings are heavier than water, a recycled material, and a by-product of the tire retread industry.

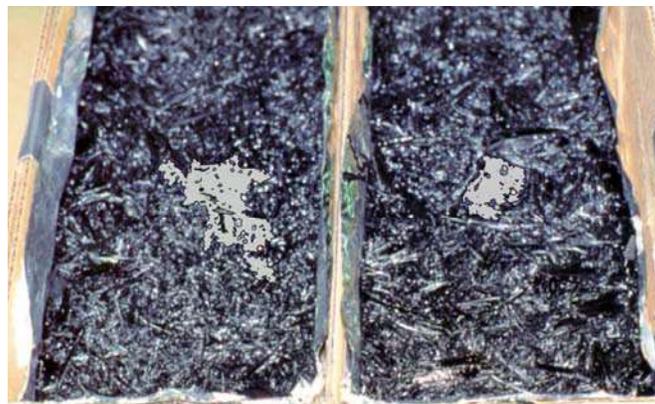
S: WRM, 2 Comp.
R: Baur Built Tire

S: WRM, 2 Comp.
R: Interstate Tire

Photograph of test samples 1 & 2 undergoing water penetration test.
Note: photograph altered to show water as gray area.

After the sealants had cured overnight the finished samples were subjected to several tests. The first test was for water permeability. Each 10” sample had 1 teaspoon of water placed on it in two locations and the amount of water that permeated through the sealant was recorded after 2 minutes. The results and photos for this test are located in Appendix C.

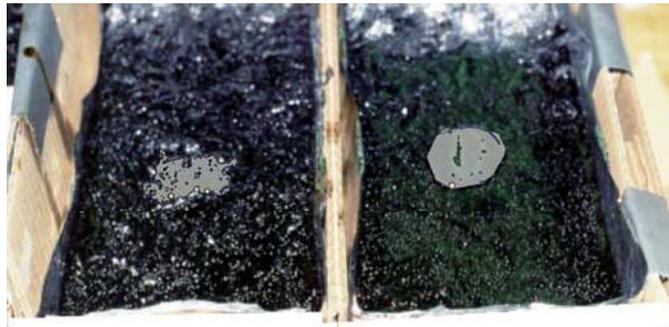
S: WR Meadows, Sof Seal
R: Baur Built Tire

S: Crafcoc, Road Saver 231
R: Baur Built Tire

Photograph of test samples 7 & 8 undergoing water penetration test.
Note: photograph altered to show water as gray area.

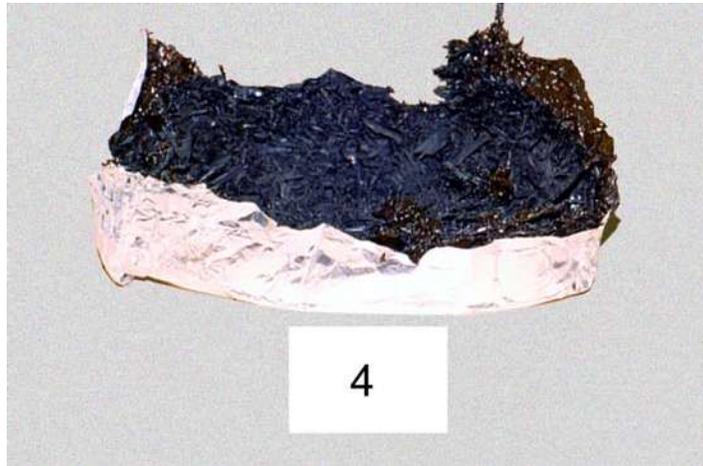
Photograph of sample 4 after removing the foil to determine the depth of sealant penetration.

After testing for water permeability each 10” sample was tested for sealant penetration. When the sealant was applied the majority of it ran down into the rubber buffings below. This test was to determine if this penetration was uniformly distributed across the sample, or if there was more penetration along the sides than in the center. To perform this test the sample was removed from the form, turned upside down, the aluminum foil was removed from the bottom, and the loose material was shaken off. The highest and the lowest depth of the remaining material was then measured and recorded (see Appendix D).

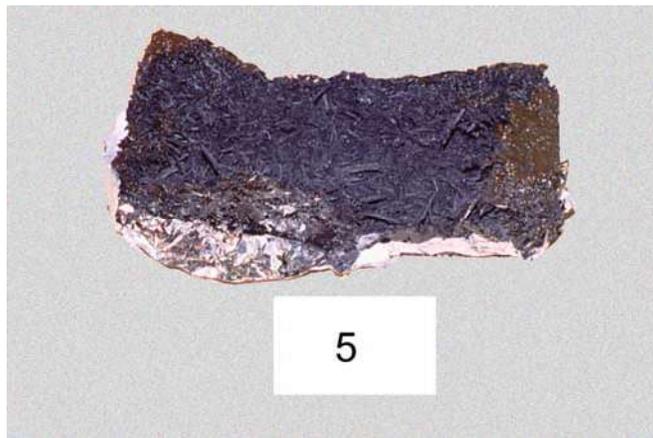
Photograph of sample 5 after removing the foil to determine the depth of sealant penetration.

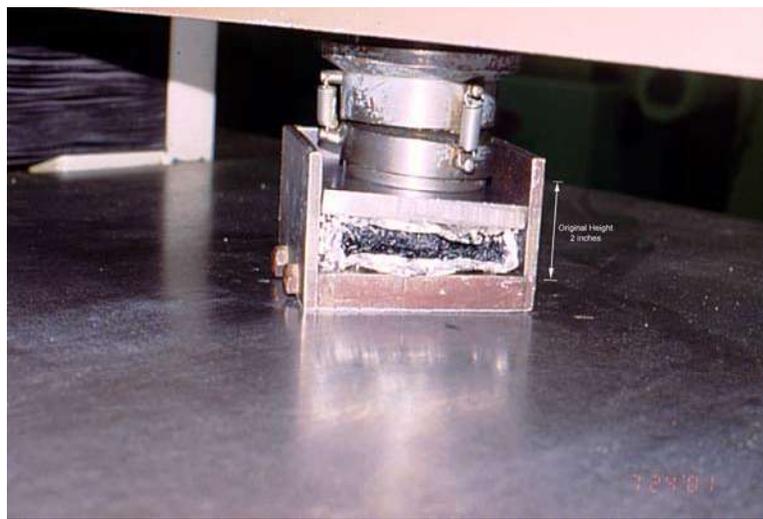
Photograph showing 2 inch thick specimen undergoing compression test.

Each 2” sample was subjected to a compression test. This test was used to determine the amount of load that was required to compress each sample to half of its original thickness, and to also determine if after the sample was compressed it would return to its original thickness. To perform this test each sample was placed in a special box that has a separate top to allow the load to be applied (see Appendix E). A sample was placed in the box and loaded at a rate of 0.25”/minute. The load and the deflection were recorded at 30 second intervals until 1” of deflection had been reached. After compression the samples were allowed to expand to a point of equilibrium. After 4 hours the amount that the sample expanded was determined as a percent of the original thickness. The results of these tests are located in Appendix E.

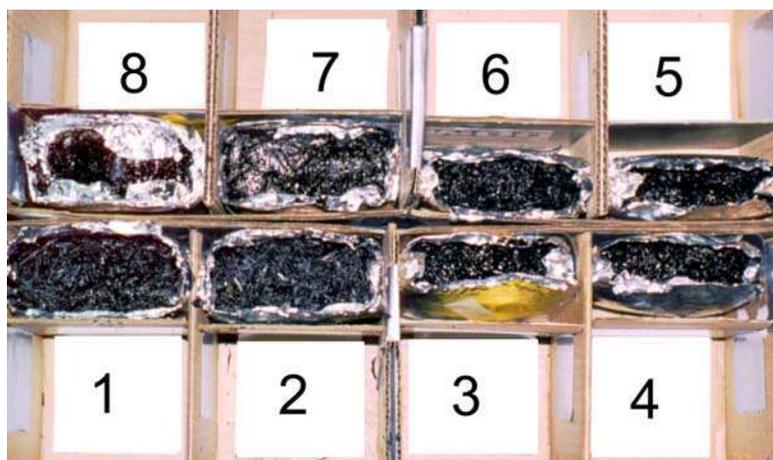
Photograph showing all of the compression test samples after compressing to $\frac{1}{2}$ original thickness.
