HIGH MOLECULAR WEIGHT METHACRYLATE SEALING OF A BRIDGE DECK

**Final Report for
Iowa DOT Project HR-2031
FHWA Project DTFH71-86-948-IA-25**

August 1988

**Iowa Department
of Transportation**

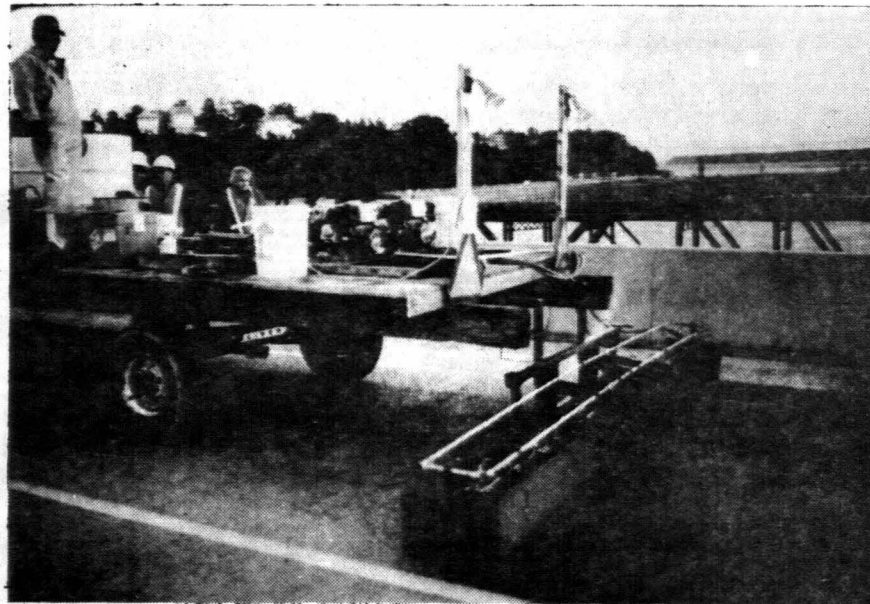
Figure 1

Spray Bar Mounting on the Flatbed Trailer

The system was transported on a four-wheeled flatbed trailer pulled by a small farm tractor. Barrels of resin and two positive displacement pumps were placed on the bed of the trailer and two spray bars were mounted horizontally parallel to each other across the rear of the trailer (Figure 1). Each bar had

12 nondrip, flat-fan nozzles spaced 12 inches apart. The nozzles of each bar were connected in series with flexible tubing and then connected to a pump. The positive displacement feature of the pumps was negated by a pressure regulated recirculation system.

The parallel spray bar mixed the HMWM in the air by having the nozzles tilted so that the fan shape of the front and rear opposing nozzles intersected about three inches above the deck surface. One bar sprayed from a barrel that had monomer mixed with the initiator required for two barrels and the other bar sprayed from a barrel of monomer mixed with the promoter required for two barrels.
