CRACK AND SEAT PCC PAVEMENT PRIOR TO RESURFACING US 59 - SHELBY COUNTY

**FINAL REPORT
IOWA DEPARTMENT OF TRANSPORTATION
PROJECT HR-527**

Shelby FR-59-4(22)--2G-83

Federal Highway Administration
Experimental Project IA 86-02

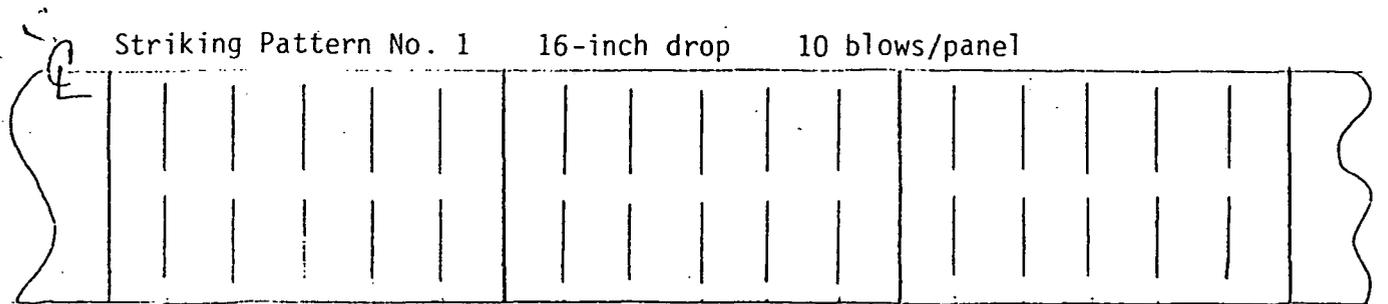
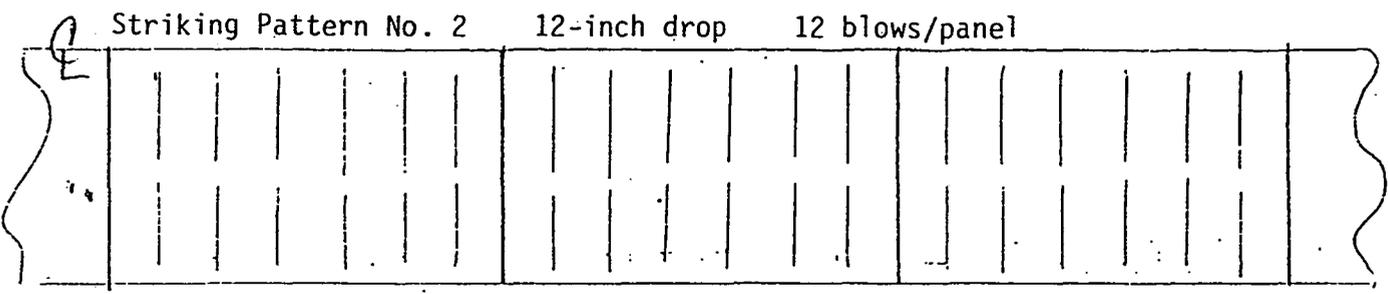
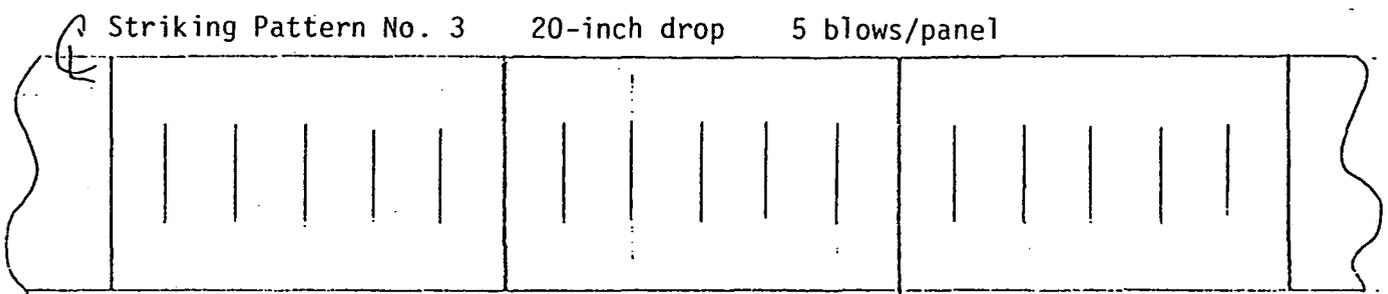
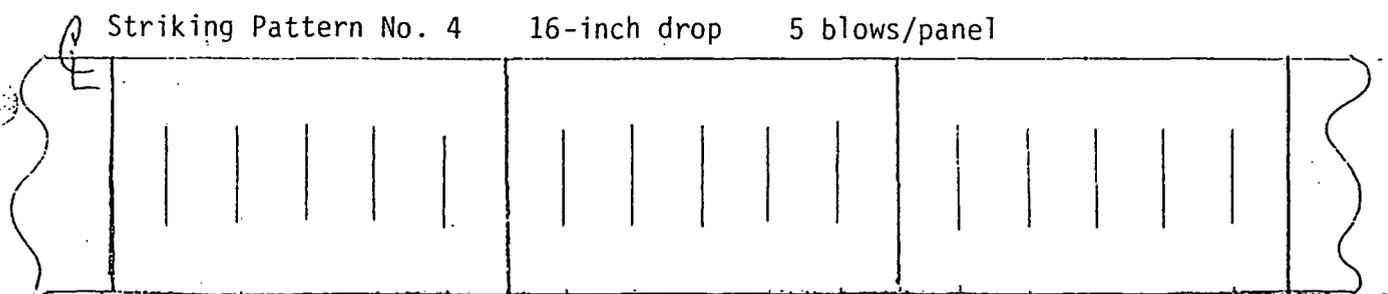
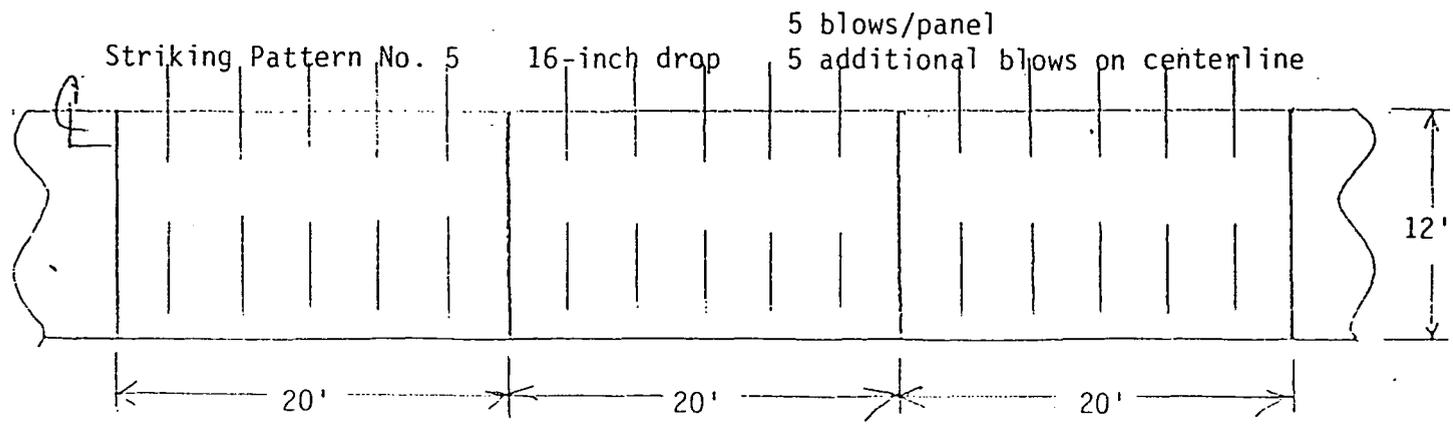
Pattern No. 1 (Figure 1) established a 16 in. drop with 10 blows between each transverse joint per lane. This pattern produced excessive continuous longitudinal cracks and the decision was made to reduce the energy input.

Pattern No. 2 utilized only a 12 in. drop but the number of strikes per lane (12 ft. wide) between transverse joints (20 ft. spacing) was increased to 12. This also appeared to be too much energy as there was excessive longitudinal cracking.

Pattern No. 3 was a series of drops positioned in the center of the lane with 5 blows between transverse joints. A drop of 20 in. was utilized for this pattern. Pattern No. 3 produced excessive force on the slab with unpredictable cracks in all directions. The pattern severely fractured the pavement.

Pattern No. 4 was essentially the same as pattern No. 3 except that the height of drop was reduced to 16 in. This pattern reduced the adverse cracking, however, the transverse cracks that developed seemed to propagate toward the outside of the pavement at a 45° angle.

Pattern No. 5 utilized three series of blows with a 16 in. drop per full width of pavement. One series of five blows was placed approximately 1 ft. from the outside edge which generally produced a transverse crack across the panel. Another corresponding series was placed 1 ft. from the other edge of pavement. A third row of impacts was located at centerline to assure that the full width of the panel had been cracked.

Pattern No 5 was selected for use on the project. The transverse cracks produced were not readily visible on the pavement surface.

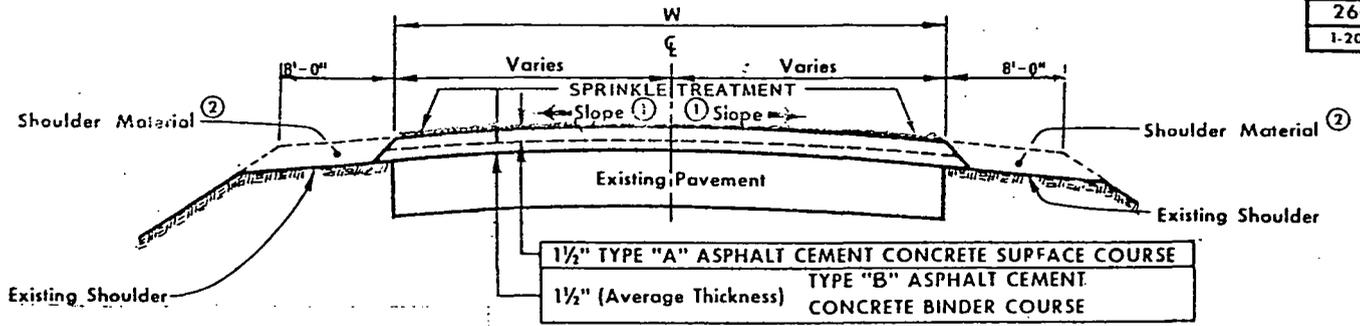
Figure 2

TYPICAL CROSS SECTION
ASPHALT CEMENT CONCRETE RESURFACING

Asphalt lay down operations began with the Type B binder course on August 26, 1986. The total thickness of asphalt concrete resurfacing varied from 3 in. to 6 in. (Table 1). The Type A surface course remained at 1 1/2 in. but the thickness of the Type B binder varied from 1 1/2 in. to 4 1/2 in. in thickness (Figure 2 & 3). All asphalt concrete was produced in an Aztec drum type mixer at Harlan, Iowa. The contractor achieved densities of approximately 97% in regard to the 2.33 laboratory density (Appendix C). This yielded voids of approximately 5%. The placement of all of the binder course was completed on September 16, 1986.

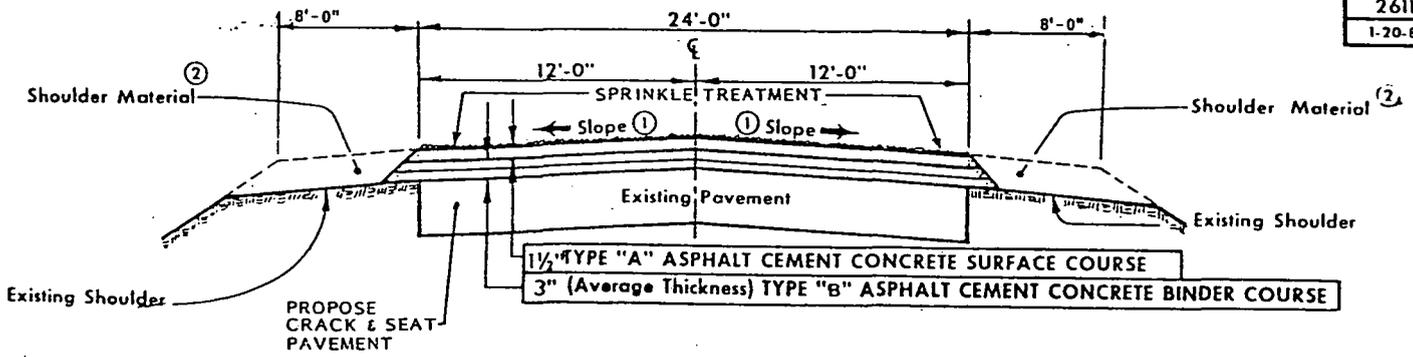
Figure 3

TYPICAL CROSS SECTION
ASPHALT CEMENT CONCRETE RESURFACING
