Dense Concrete Layer As Top Course of Bridge Deck Construction

**Final Report for
Iowa DOT Project HR-502**

**Federal Highway Administration
Project IA-74-01**

November 1990

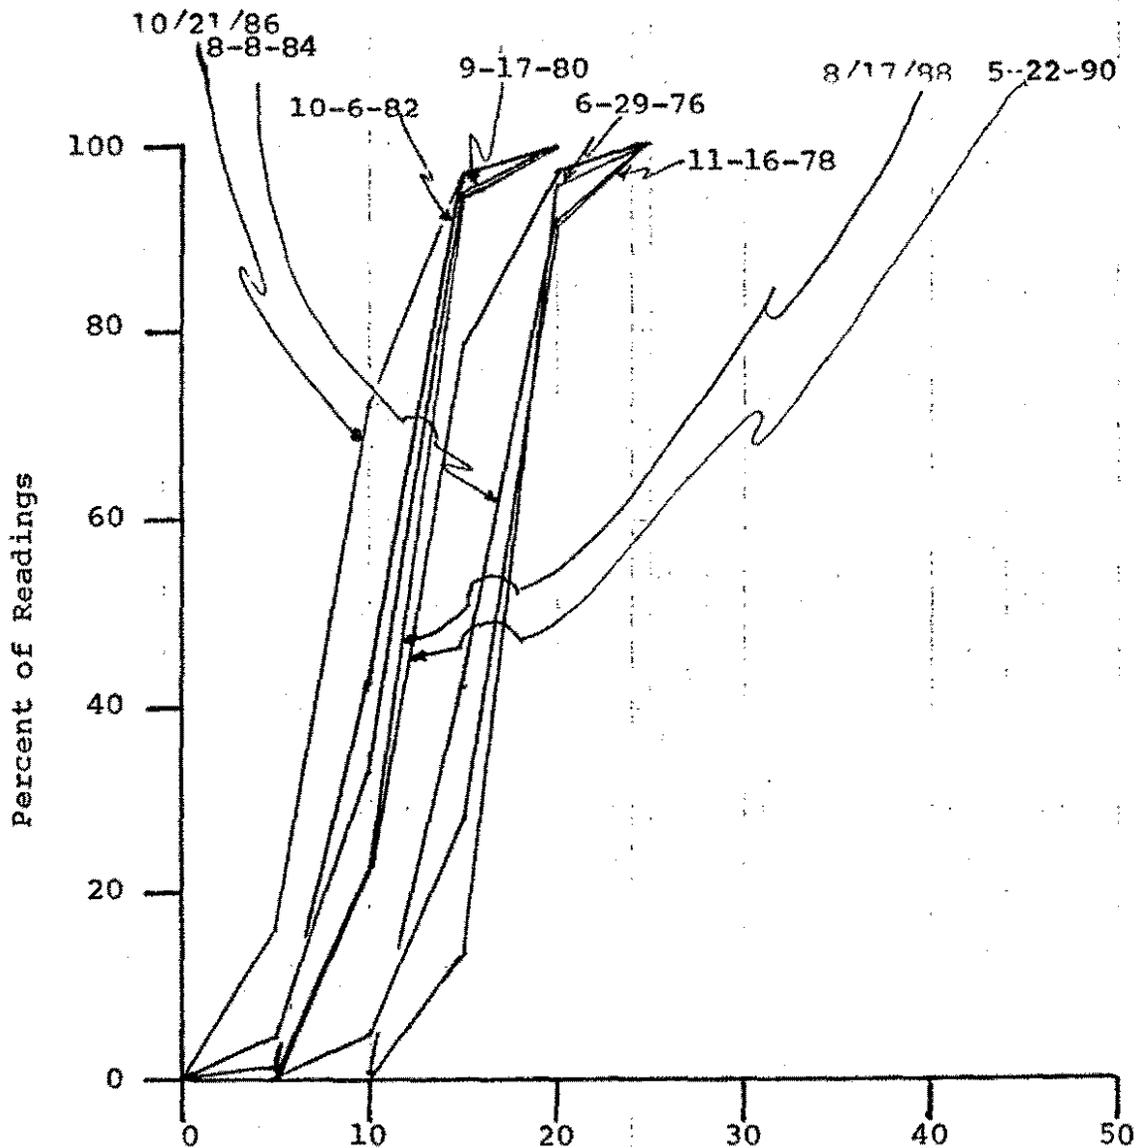
Electrical Potential (x .01 v)
 "A" Avenue Viaduct - Cedar Rapids
 Low Slump Dense Concrete

The electrical potential on all three bridges stayed well below 30 for the 14-year test period which would indicate no active corrosion of reinforcing steel.

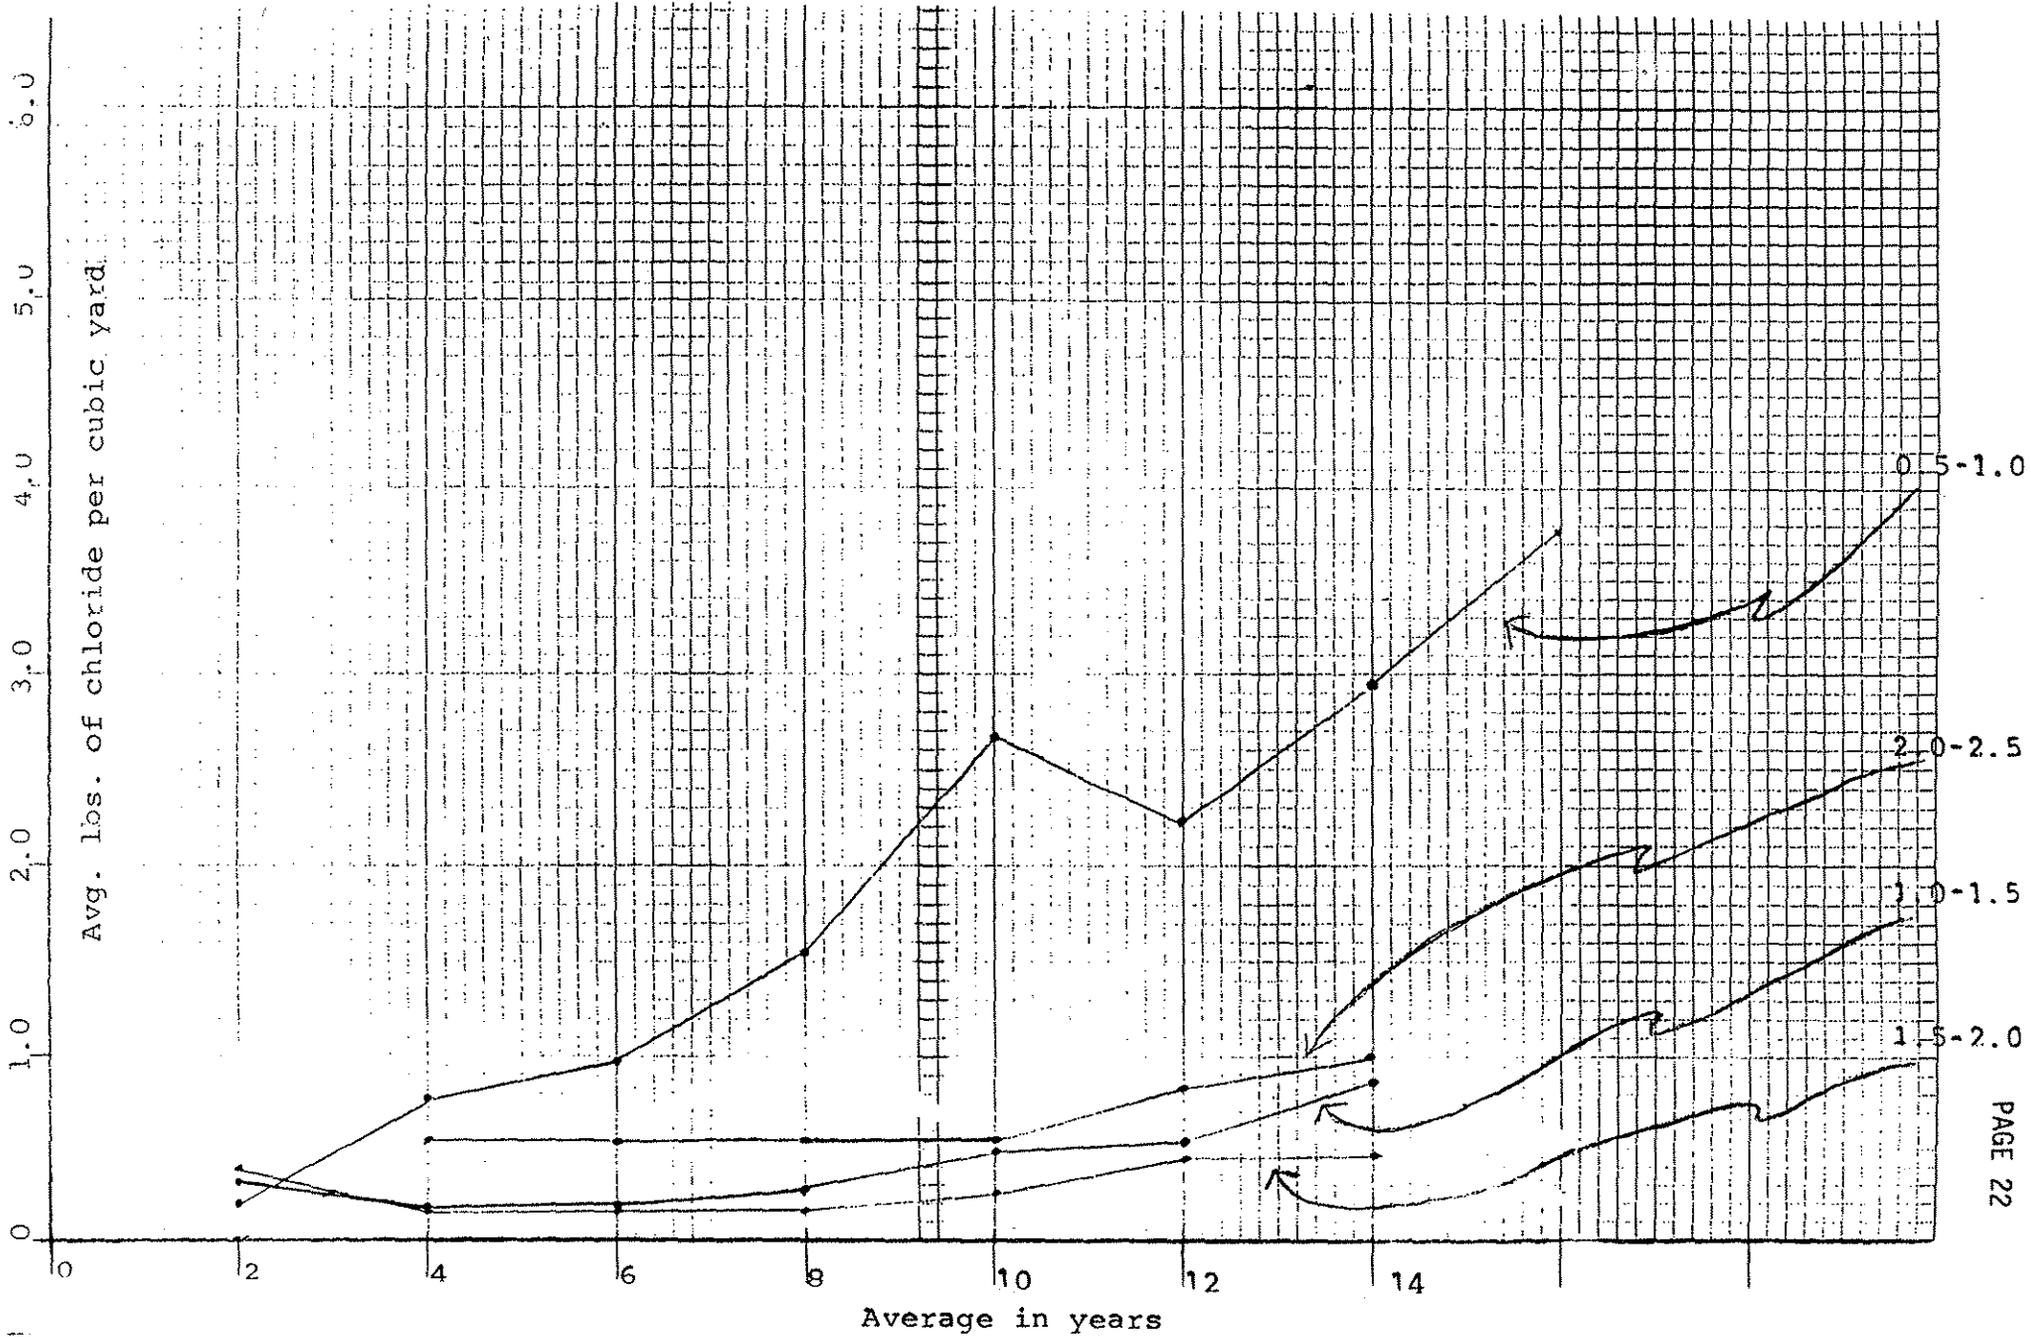
Appendix D
Average Chloride Content of 3 Bridges

Average chloride content at different levels in the three bridges associated with Project HR-502

The carbonate coarse aggregate used in these bridge decks had some chloride-ion content which contributed to the initial chloride-ion content of the new concrete. The initial chloride-ion content of the concrete was approximately 0.1 pounds per cubic yard in the dense concrete top course. Apparently, the carbonate coarse aggregate used in the underlying bridge deck had a higher chloride-ion content which yielded a concrete with an initial chloride-ion content of approximately 0.5 pounds per cubic yard. There was substantial variations in individual chloride-ion content test values with

The steel in these decks is, by design, suppose to have 2 1/2" of cover. Assuming this is true, the chloride content after 14 years of service is well below the threshold value.

Projecting this data, it will be approximately 28 years before the chloride content at the level of the steel will reach the 1.5 threshold value. This type of construction should protect the steel for about 30 years.
