Pilot Construction Project for Granular Shoulder Stabilization

tech transfer summary

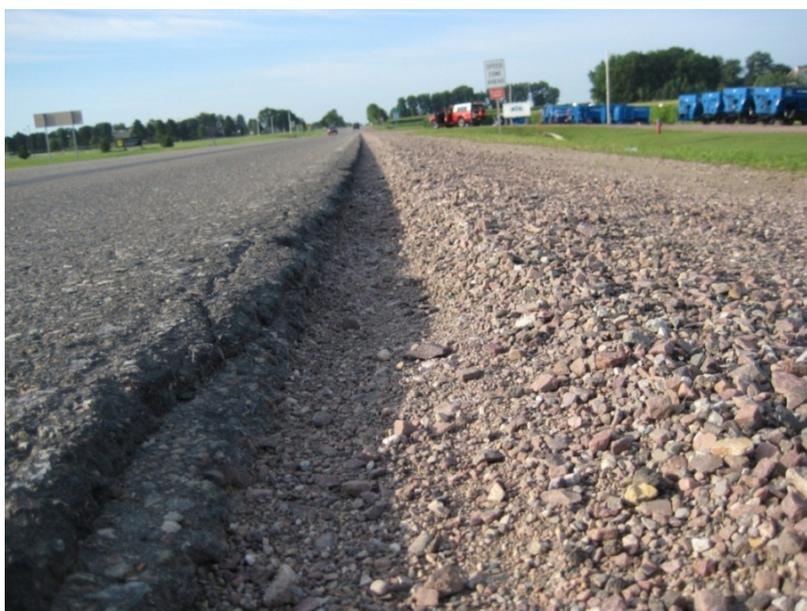
Edge rutting on granular shoulder (Jahren et al. 2011)

Edge rutting on granular shoulders is a serious traffic safety issue because it can cause vehicles to run off the road, which can lead to loss of control and even loss of life (Jahren et al. 2011). Edge rutting is caused by three factors: wind and air currents, vehicle off-tracking, and drainage.

Over time, wind and air currents from large vehicles blow fine material away from the shoulder, exposing large particles on the shoulder surface, which are removed more easily by vehicle off-tracking. Off-tracking refers to the situation where rear tires run a different path from front tires during vehicle turning movements. Pavement drainage accumulates along the pavement edge and makes shoulder materials unstable.

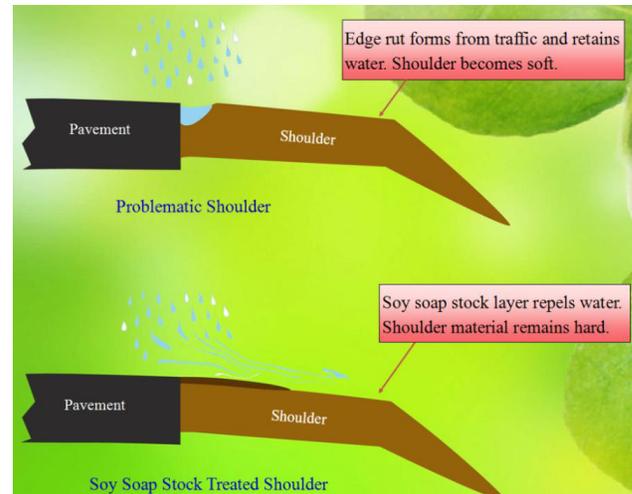
Stabilization of granular shoulders with soybean oil soapstock
