INVESTIGATION of HIGHWAY LIGHTING

IOWA HIGHWAY RESEARCH BOARD

PROJECT HR-154
Final Report

HR-154
Final Report

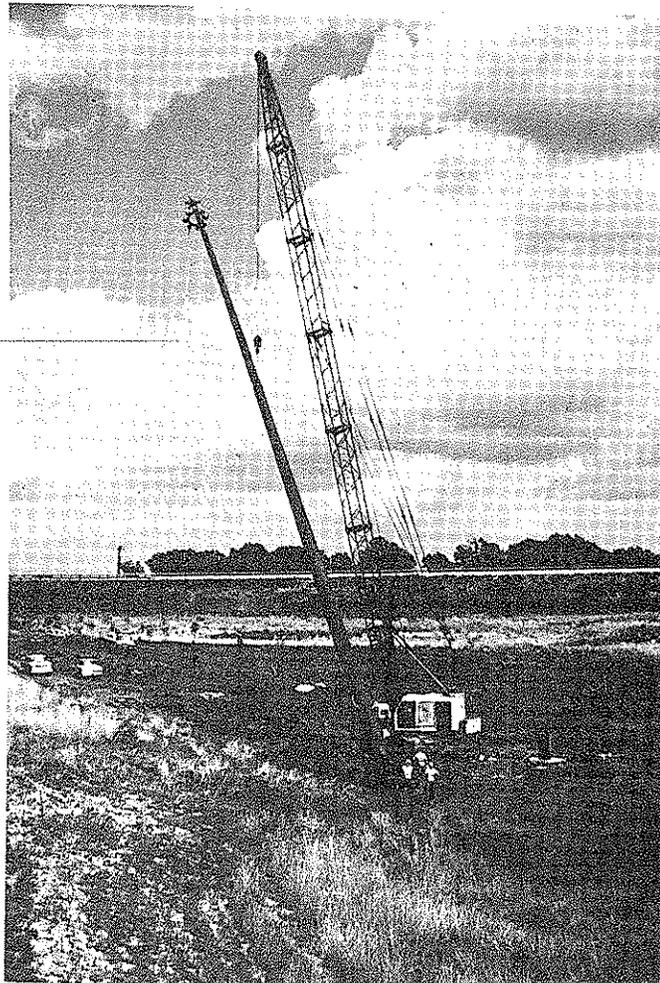
Figure 2. Erection of the largest tower
in the installation

Special equipment for the tower construction operations included pile driving machinery for footing construction, and a crane to erect the towers. The largest tower in this installation, shown in Figure 2, is 180 feet long and weighs approximately 12 tons. Some towers were located well outside the hazardous zone near the traffic lanes, and the construction operations could all take place outside this zone. Where towers were located at the minimum lateral clearance of 50 feet to the roadway, many operations were performed from the shoulder area, with need for traffic control.

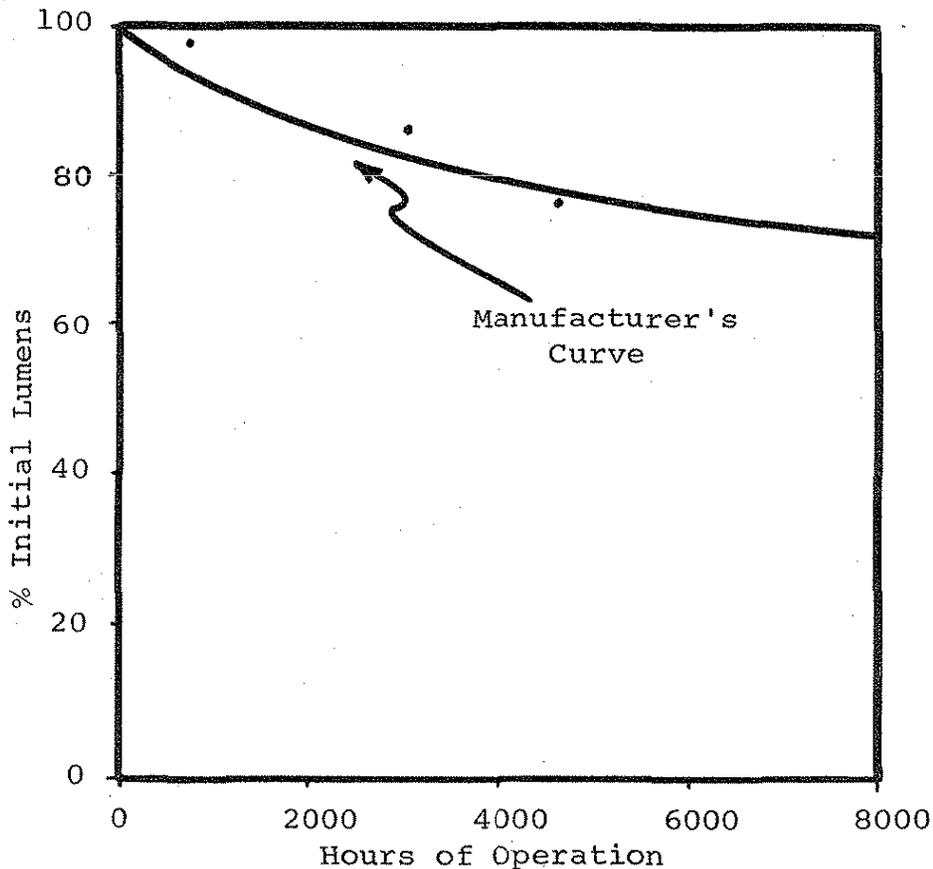
Figure 3. Manufacturer's maintenance curve vs. measured field data

reduction with respect to hours of operation. Also illustrated on the curve are results from the maintenance factor investigation, showing the reduction in average HFC for corresponding time intervals. The manufacturer's curve was verified for the period of time involved. This further shows that the reduction in light output was due to lamp output depreciation, and not to the effects of dirt or contamination on the luminaire optics.

September and were not completed until December. Therefore, a wide variation in burning time existed between towers. Tower No. 11 was totally out of service from September through December, 1974 due to a jamming of the lowering device. Further readings were considered to have little meaning since Tower No. 11 was centrally placed in the interchange and therefore affects most locations. The manufacturer's lamp output maintenance curve in Figure 3 shows the percentage of output

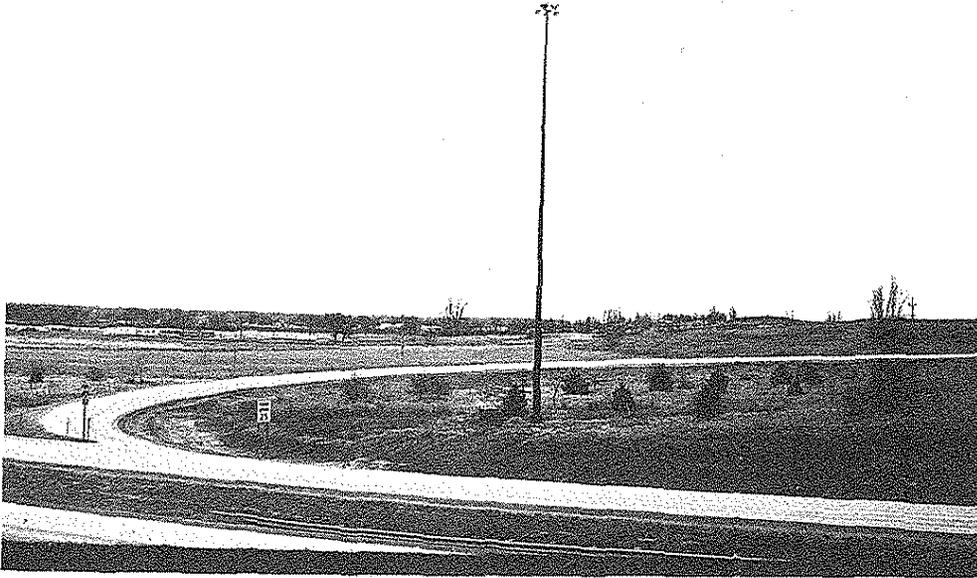
Figure 4. Typical tower installation

The uncluttered daytime appearance of the tower lighting installation was preferred over that of the conventional lighting installation. Figure 4 shows that one tower is used to light the entire loop of an interchange.

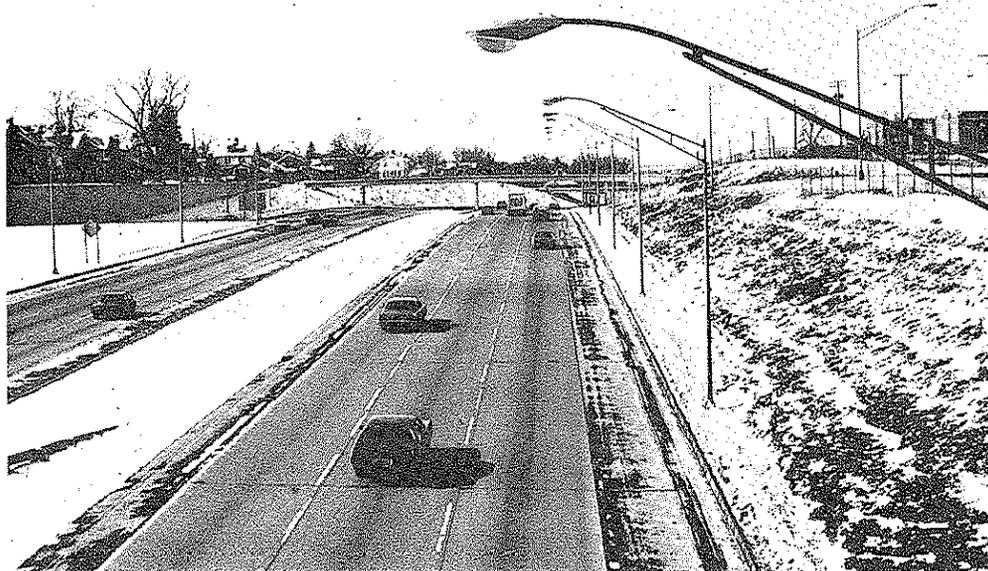
Figure 5. Typical Conventional Lighting

The number of poles required for a conventional lighting system is shown in Figure 5. Aesthetically, this is less pleasing. Further, the poles are a safety hazard because they are close to the traffic lane.

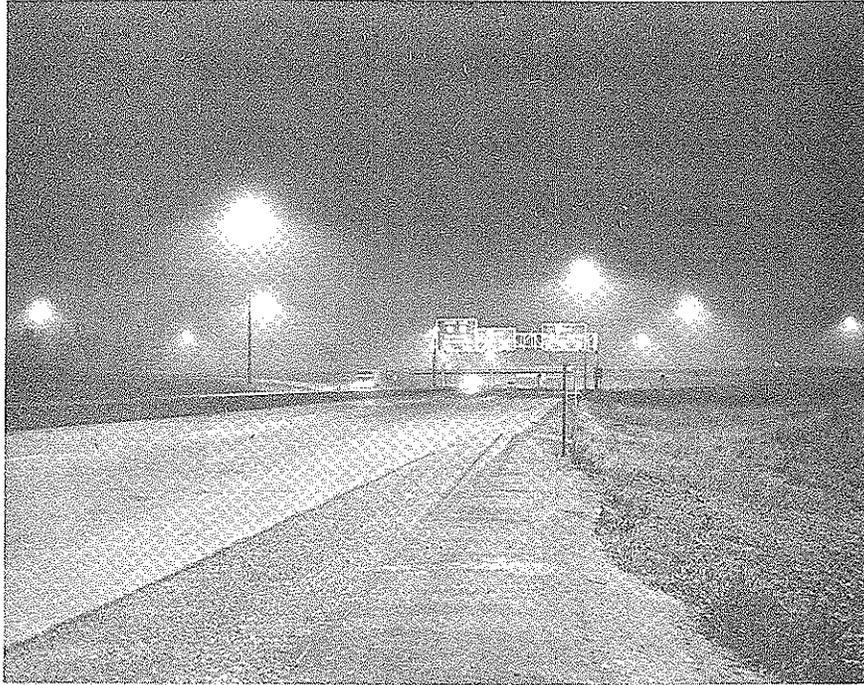
Figure 6. Illustration of overall visibility under tower lighting

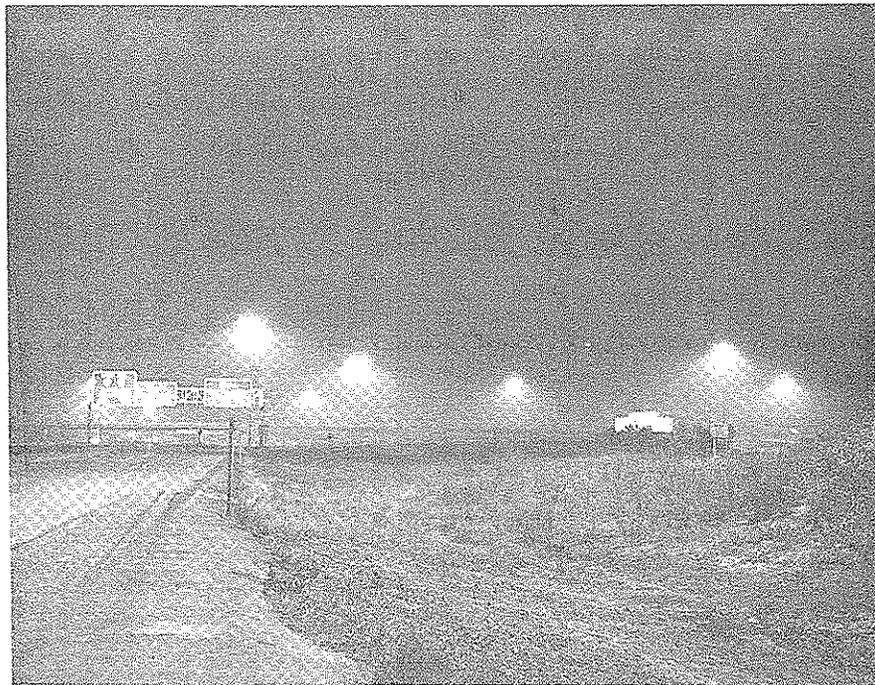
Figure 7. Illumination of adjacent areas with tower lighting
