Thermoset Composite Concrete Reinforcement

Project Number: HR-325

Part 2 final
report

Engineering Research Institute
Iowa State University

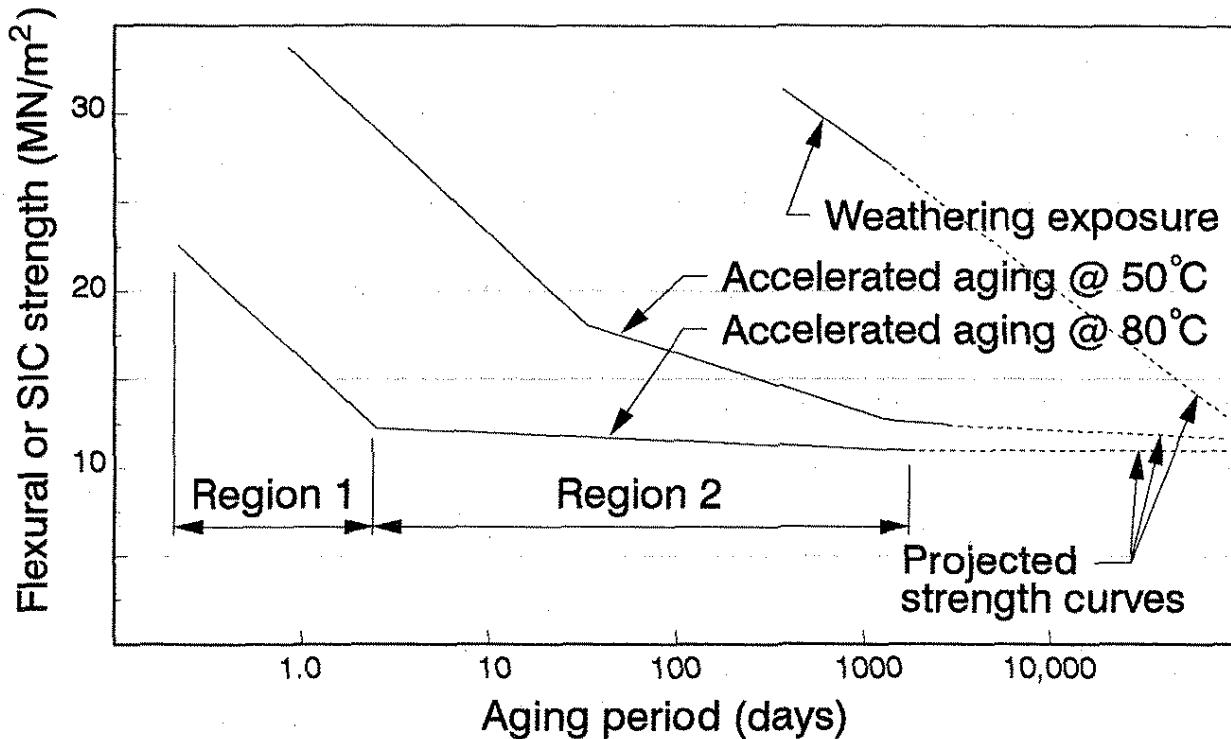
These aging studies show that the composite materials, when subjected to accelerated aging, exhibit two distinct regions as shown in Figure 2.2 [3]. Figure 2.2 compares the flexural strength of fiber composite sheets (5% to 6% AR glass fibers by weight in a 150 mm long by 50 mm wide by 6-8 mm thick concrete sheet) against the log of time in the accelerated aging baths [3]. Two curves with different aging bath temperatures are shown for comparison, as

Figure 2.2. Strength of GFRC composites in water and weather

well as a curve for composites aged in real weather conditions. Region 1 (see Figure 2.2) shows the initial loss in flexural strength (where this flexural strength loss is directly proportional to the fiber SIC strength). The initial rate of strength loss is dependent on the temperature of the aging solution and occurs more rapidly at higher temperatures. Similar strength losses occur at lower temperatures (the initial strength losses are parallel in Figure 2.2) but at a slower rate. The initial strength loss region is followed by Region 2 (see Figure 2.2) which shows a constant or nearly constant strength region for the remainder of the accelerated aging period [1,3].

The temperature-time dependence exhibited by composite materials has been covered extensively in Reference 1. The general slopes of the lines in Figure 2.2 are not effected by changes in climate (i.e., rainfall, humidity, periods of heat and cold) but rather depend on the mean annual temperature (MAT) occurring in a particular climate [1,3]. The rate of decrease in strength occurs more rapidly for a warmer MAT than for a cooler MAT (the same dependence exhibited by accelerated aging). This indicates that one set of temperature-time criteria for an accelerated aging test can not be used for two different climates (with different MAT's). Based on the MAT for a given climate, acceleration factors (AF) are used to adjust the temperature-time criteria and provide a way of estimating the real weather aging of composite materials. The accelerated aging temperature-time criteria's dependence on the MAT is covered in Section 3.5 of this report.

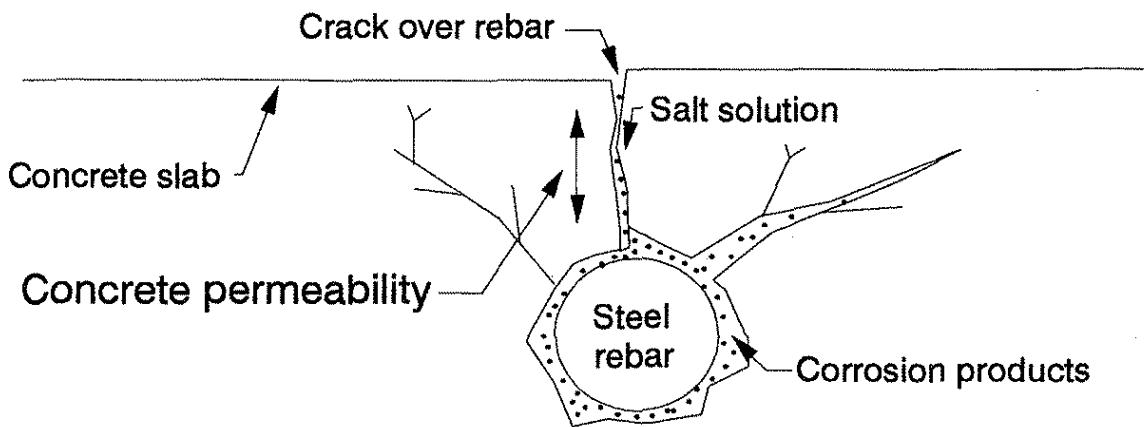
The use of deicing salts on bridge decks, in particular, has shortened their working life due to the corrosion of the reinforcing steel [12]. The dowel bars used in concrete pavement joints are also exposed to similar deicing salts and subject to corrosion. This process of corrosion due to deicing salts is shown in Figure 2.3.

In the presence of chloride and sufficient oxygen, carbonation will corrode steel [9]. Sodium and calcium chlorides, if present, can move through the concrete cover (by means of a crack in the concrete or concrete permeability) and corrode the reinforcing steel. With presence of moisture and air, corrosion of steel produces a red rust, which expands in volume and produces internal

Figure 2.3. Corrosion of steel [12]

forces on the concrete [12,13]. The rust formed from the corrosion of steel can occupy twice the volume as the original steel material applying a force of as much as 4700 psi on the concrete, exceeding the concrete tensile capacity [13].

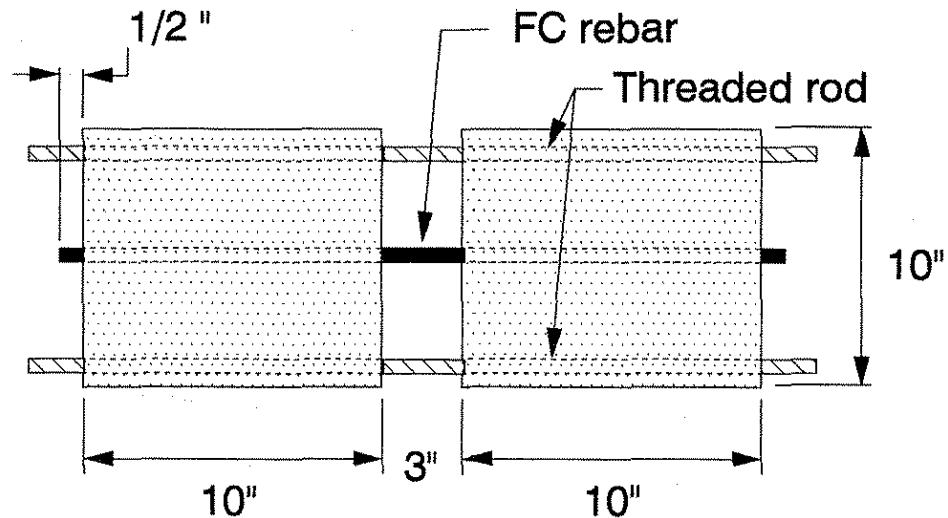
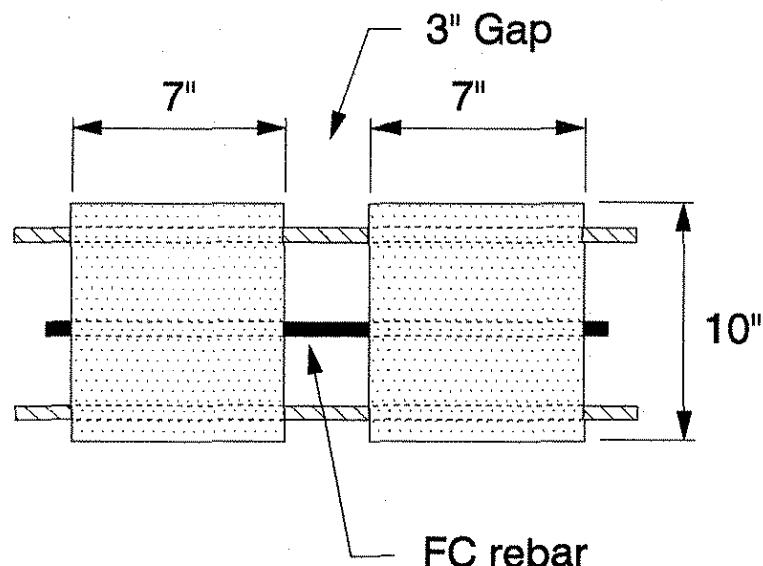
Pullout specimens were constructed as shown in Figure 3.1. The three-eights-inch FC rebars were embedded into the concrete a certain length (depending on the specimen type) on both sides of the gap (shown in Figure 3.1). Specimens containing Suppliers B and C FC rebar had out-to-out dimensions of 10 by 10 by 23 inches and 10 by 10 by 17 inches, respectively. These embedment lengths used in this research project were significantly less than the

Figure 3.1. Test assemblies for pullout specimens

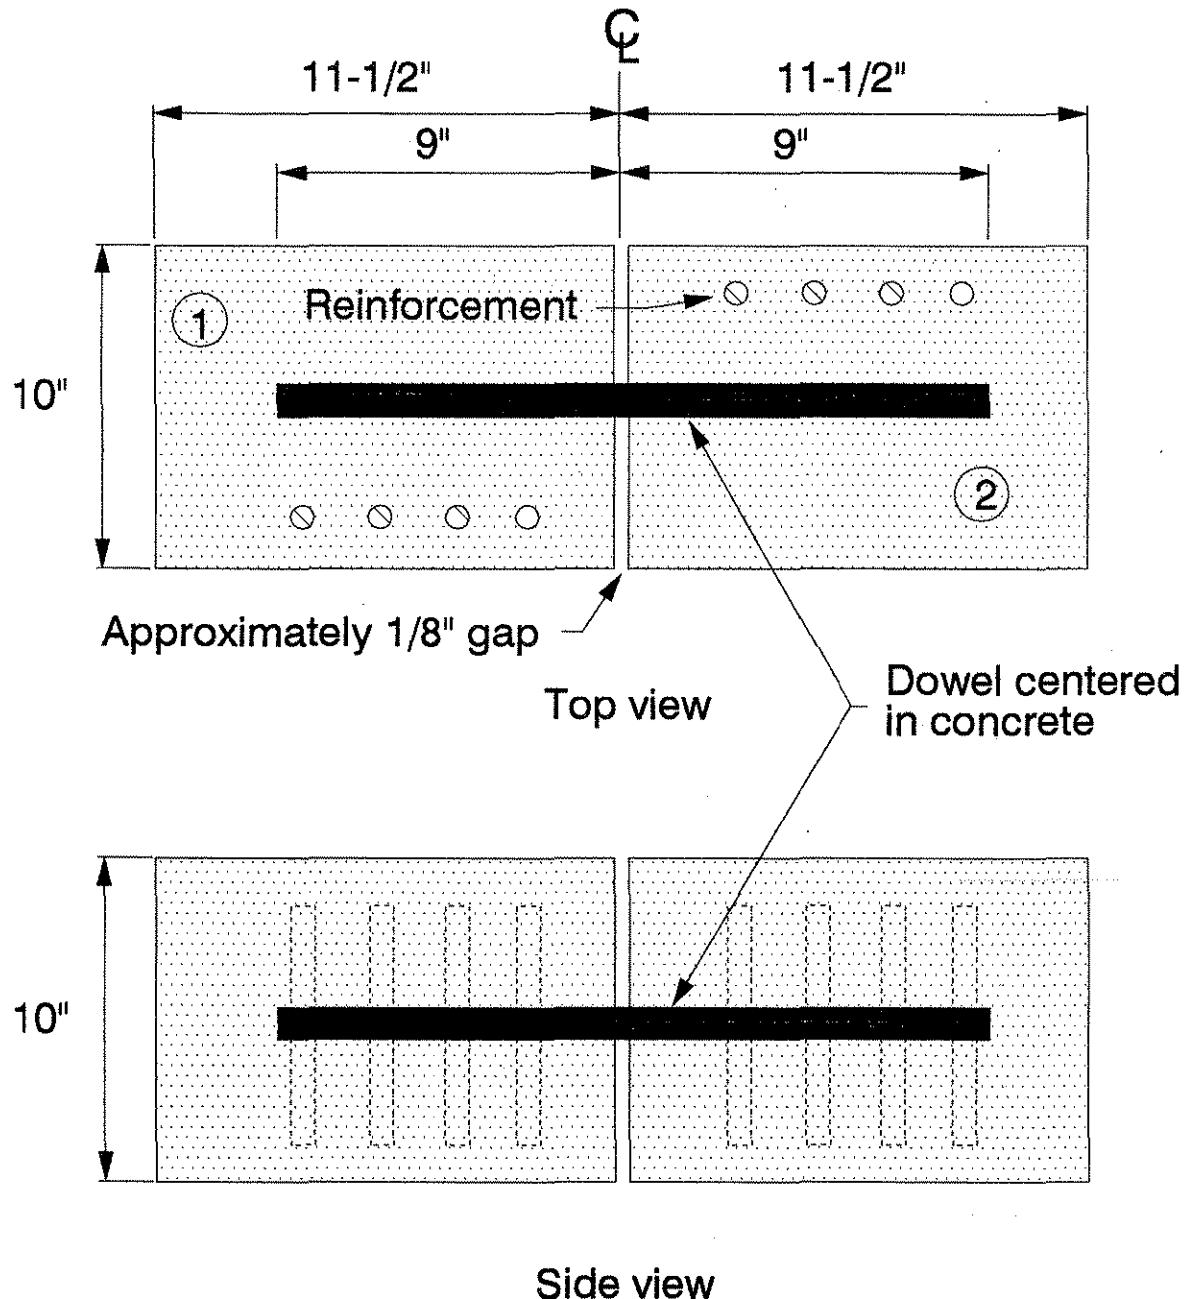
Figure 3.2. Dowel specimens

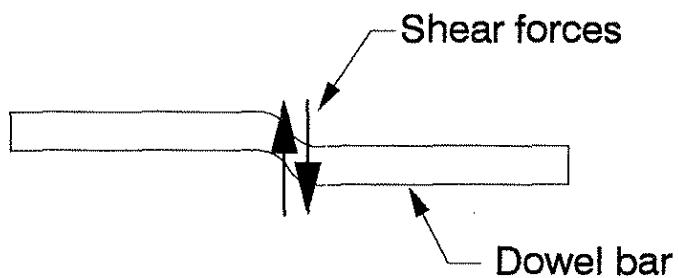
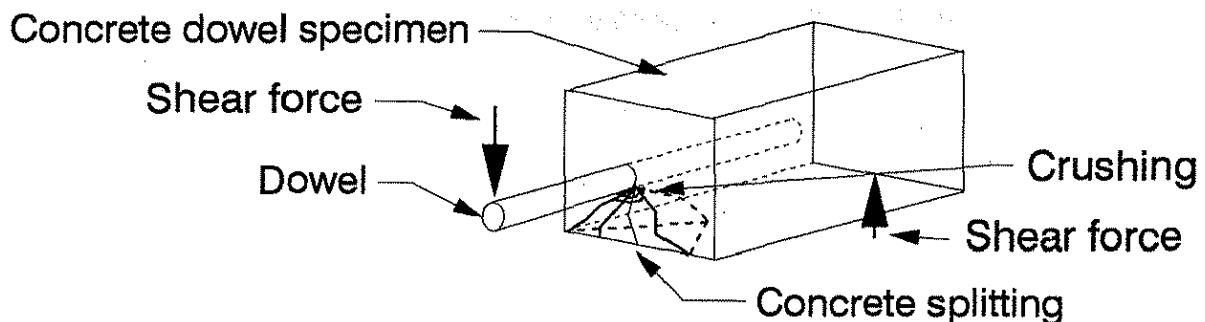
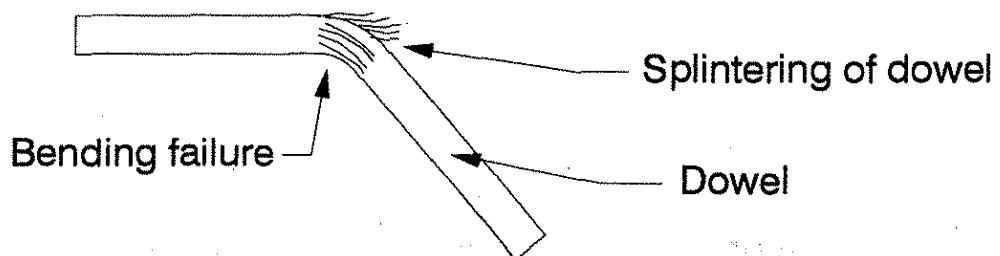
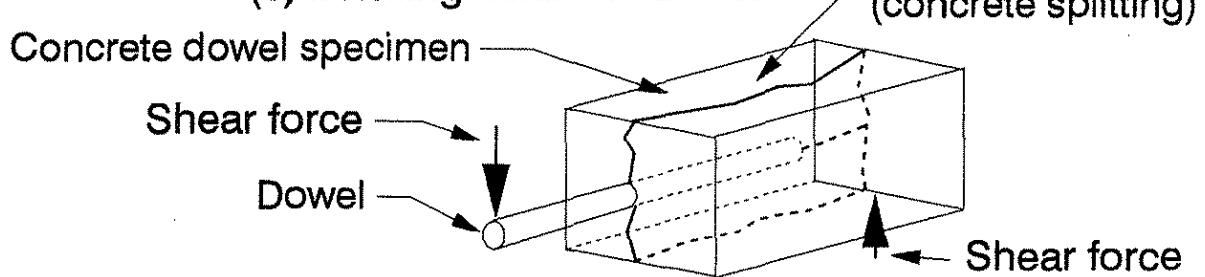
(a) shear failure of dowel

(b) bearing failure of concrete

(c) bending failure of dowel

(d) vertical shear of the concrete

Figure 3.3. Failure modes in dowel specimens

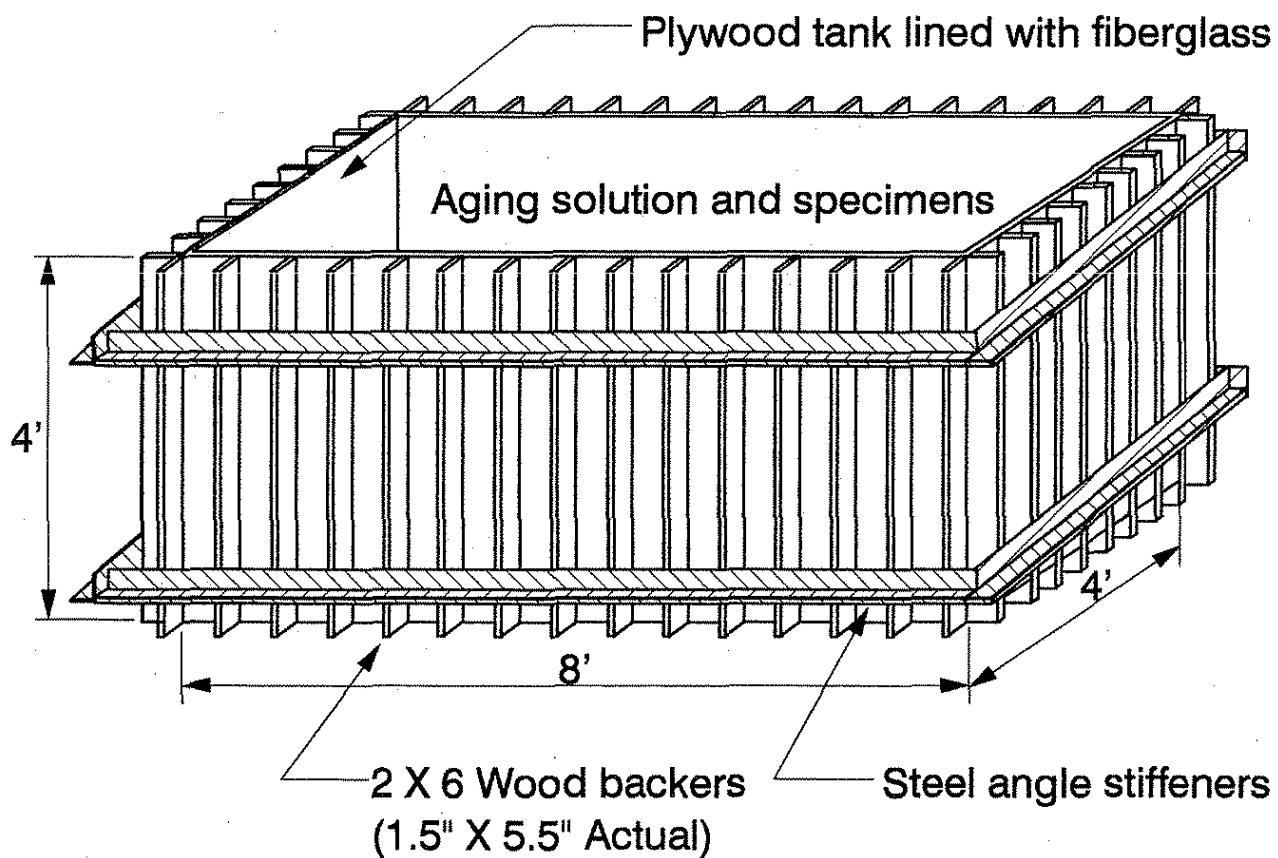
To age the specimens in a solution at an elevated temperature tanks had to be built that were large enough to hold the specimens. Three 1000-gallon wooden tanks with dimensions 4 by 4 by 8 feet were constructed as shown in Figure 3.4. The tanks were insulated on all sides by styrofoam to reduce heat loss. The bottom and sides of the tanks were lined with a fiberglass coating to protect the wood framing against the harsh solutions in the tanks. A immersion heater was mounted in the tanks to regulate and maintain the temperature.

Figure 3.4. Aging tanks

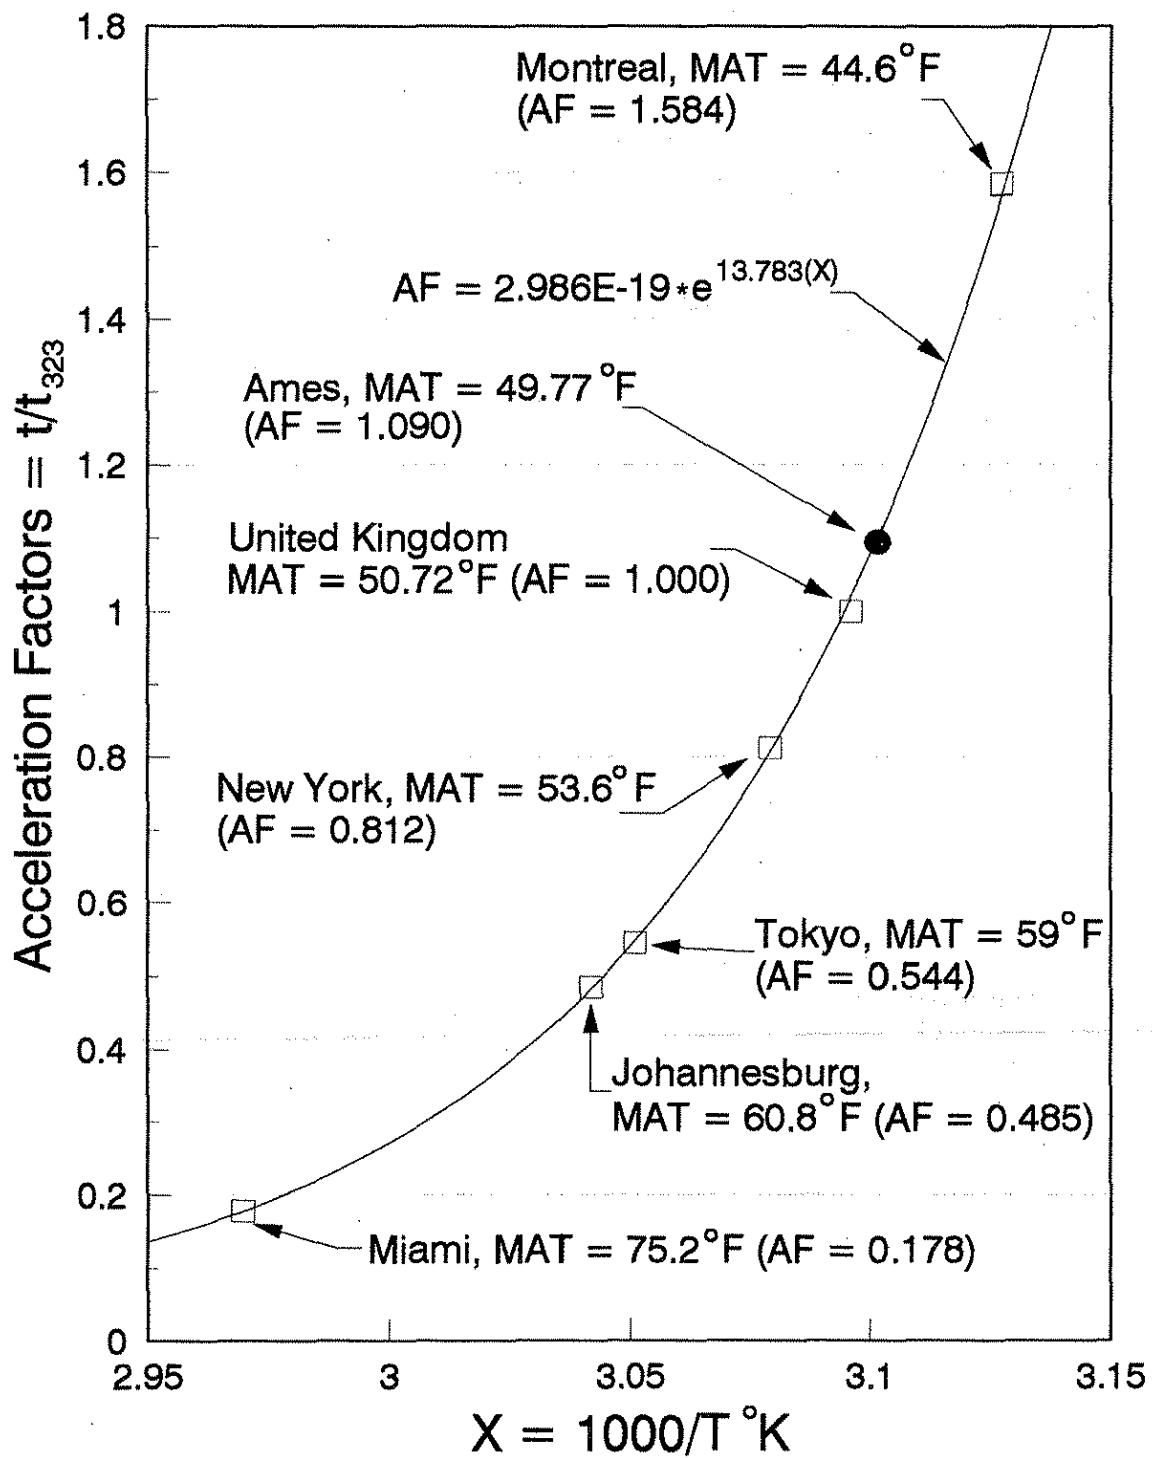
Figure 3.5. Acceleration factor curve

Using Equation 3.3 the time values given in Table 3.11 can be adjusted for any MAT to develop approximate real weather aging effects on FC materials. The MAT for central Iowa over the past 35 years is given as 9.87°C (49.77°F) [27,28]. Using Equation 3.3 the AF for this climate can be established as 1.09. This AF is then applied to the number of days aged per day in Table 3.11 and a new set of temperature-time data is determined for central Iowa as shown in Table 3.12.

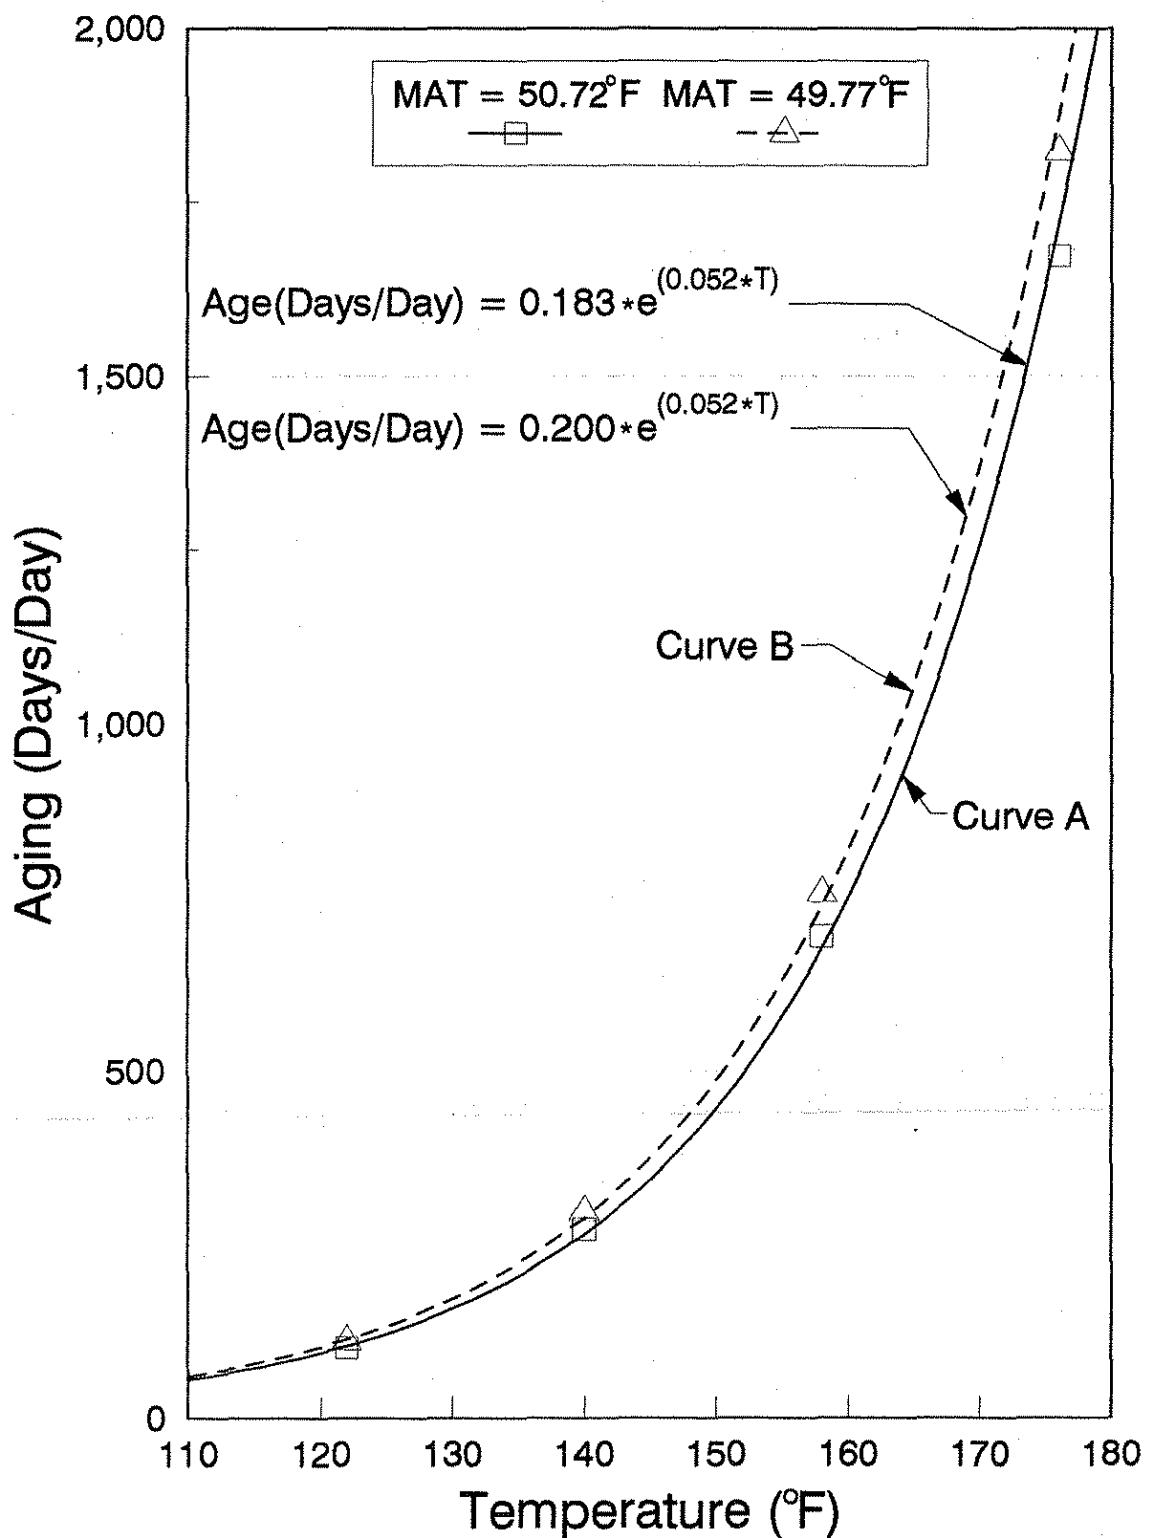
Figure 3.6. Temperature-time criteria curve

Equations 3.3 through 3.5 were developed by ISU researchers based upon data given in Reference 1. Equation 3.4 should be used for a MAT of 10.4°C (50.72°F) and Equation 3.5 was used to determine the temperature-time criteria for central Iowa (Ames). The temperature-time curve in Figure 3.6 (see Curve B) relates the temperature (in Fahrenheit) of the aging solution to the number of days aged per day. For example, a specimen in a solution at 130°F will age approximately 171.5 days for every day it remains in the solution (i.e., a specimen left in a solution at 130°F for 10 days will age approximately 1715 days or 4.7 years).

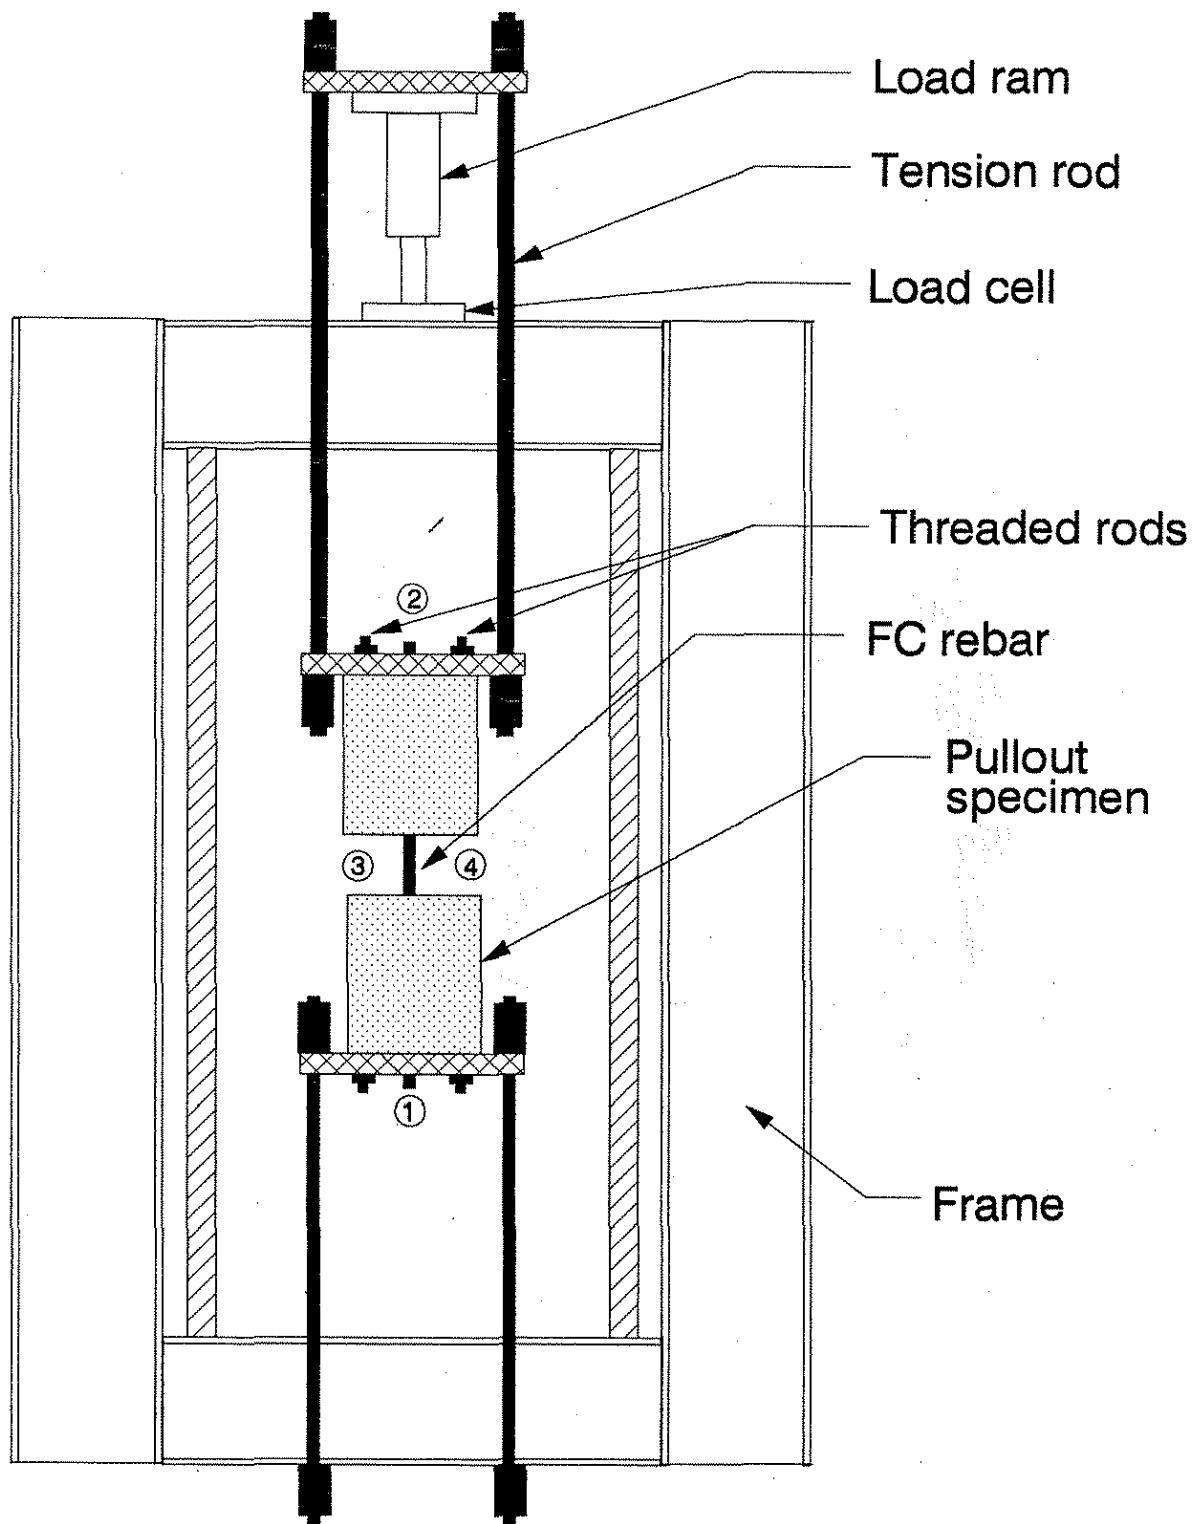
Figure 3.7. Pullout frame

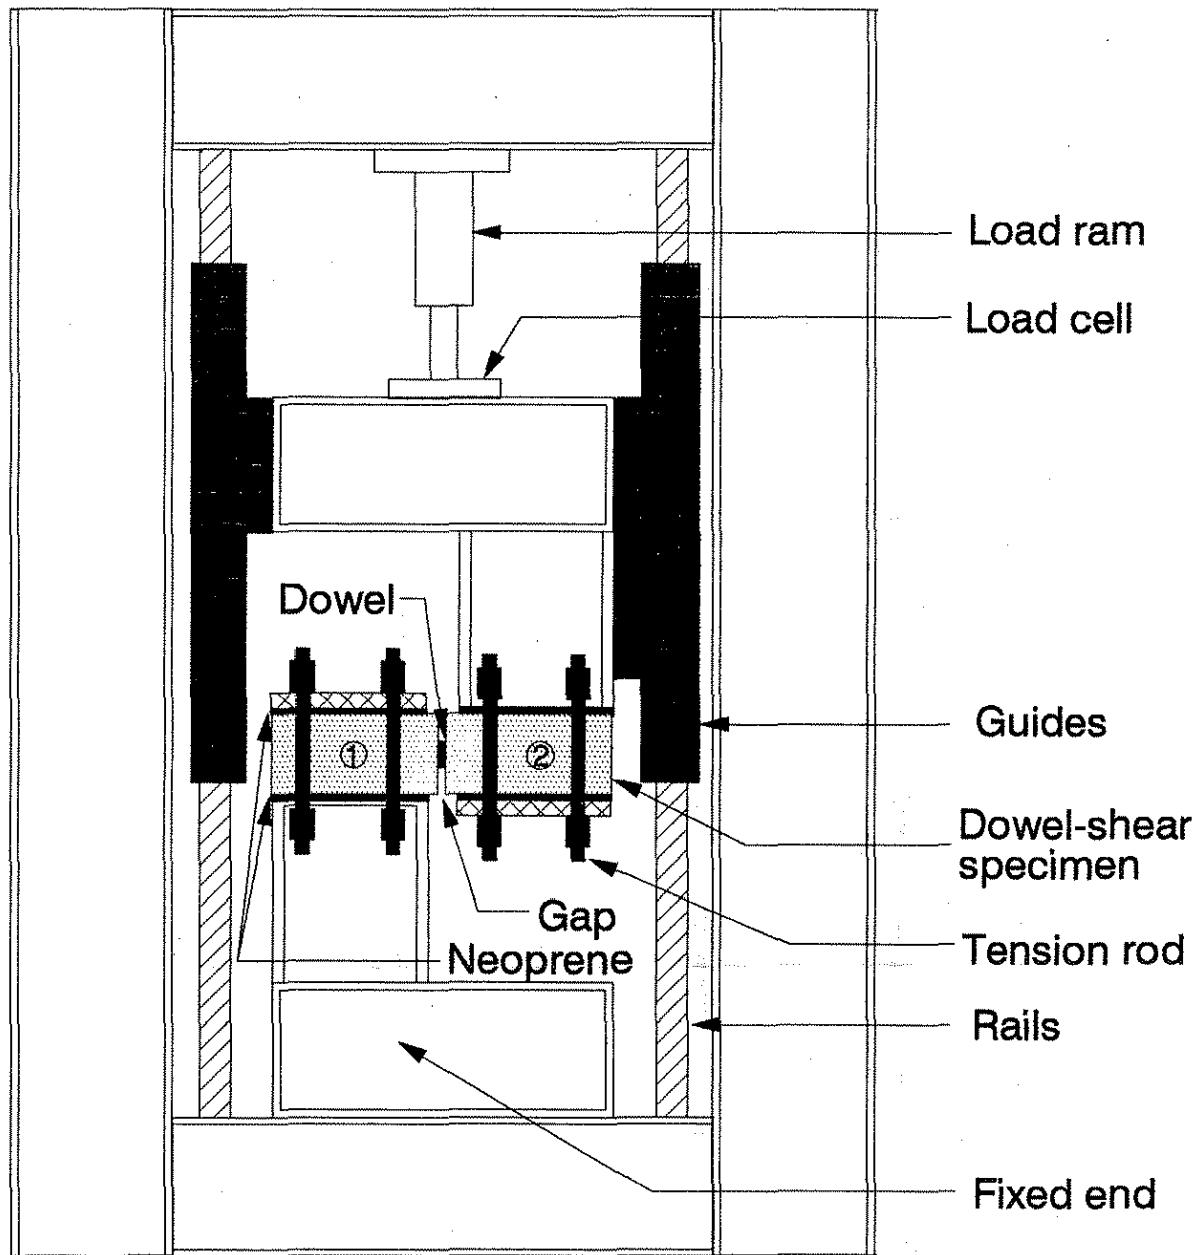
Figure 3.8. Dowel-shear frame

The graphs in Appendix A, for the dowel-shear specimens, reflect the differential deflection between Sides 1 and 2 (see Figure 3.8) versus load.

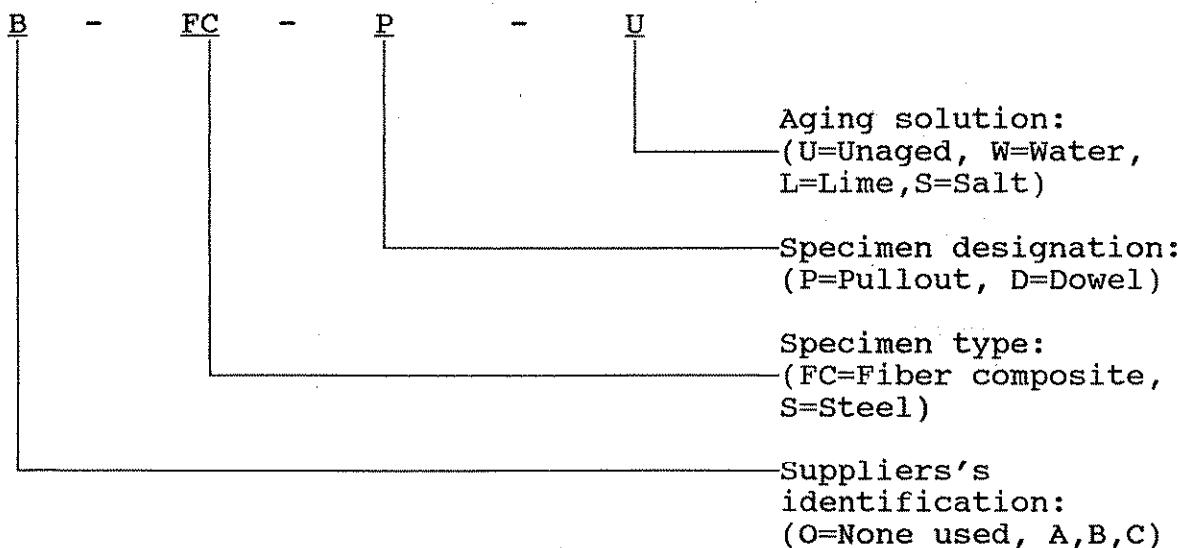
A description of the specimen identification system used for each test series is depicted in Figure 3.9. This identification system indicates the supplier, specimen type, specimen designation, and aging solution.

Figure 3.9. Specimen identification system

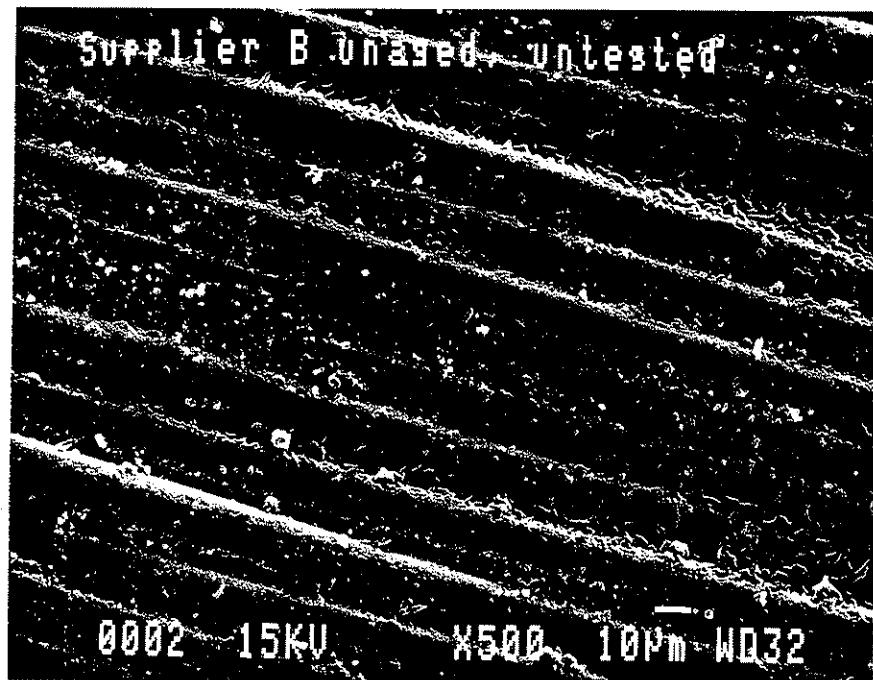
Figure 3.10. Surface microstructure of an unaged and untested B-FC-P rebar parallel to the long direction

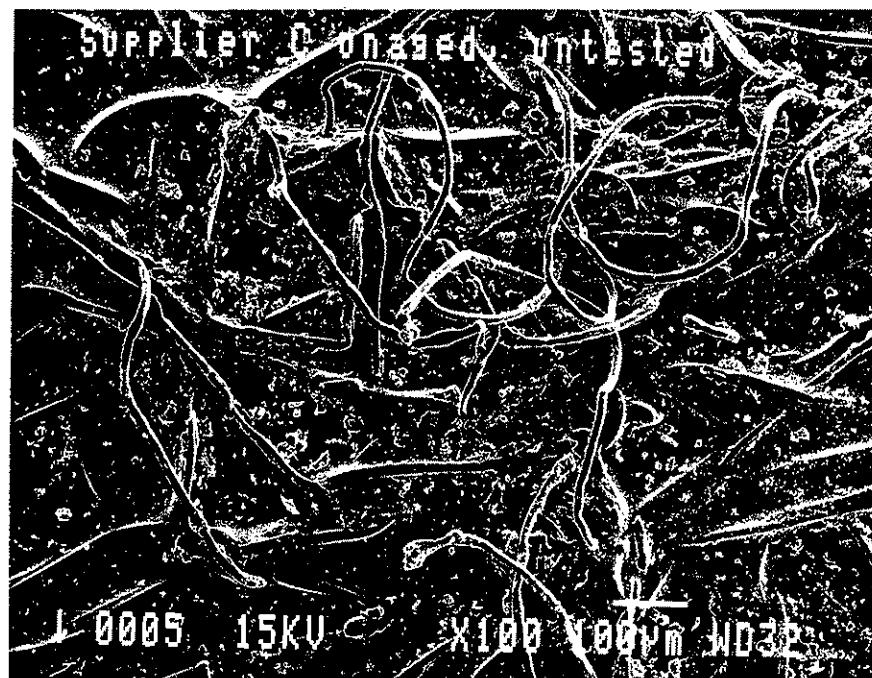
Figure 3.11. Surface microstructure of an unaged and untested C-FC-P rebar parallel to the long direction

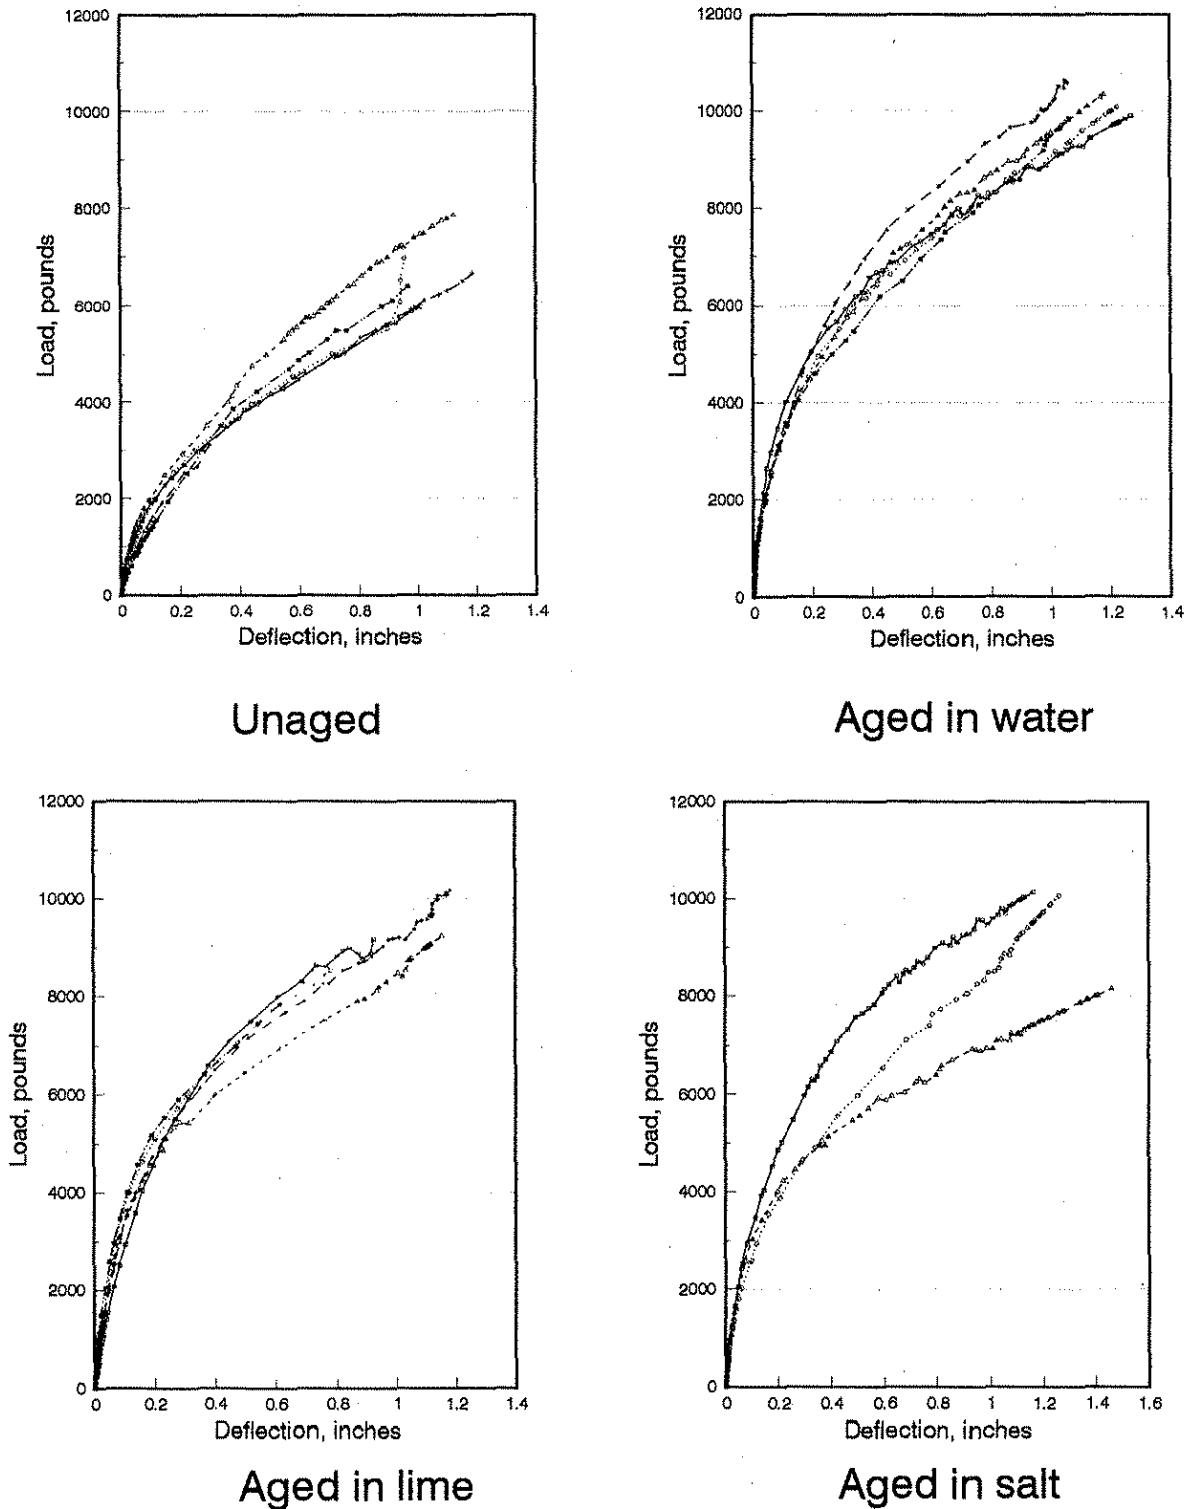
Figure 3.13. Comparison of aged and unaged B-FC-P assemblies

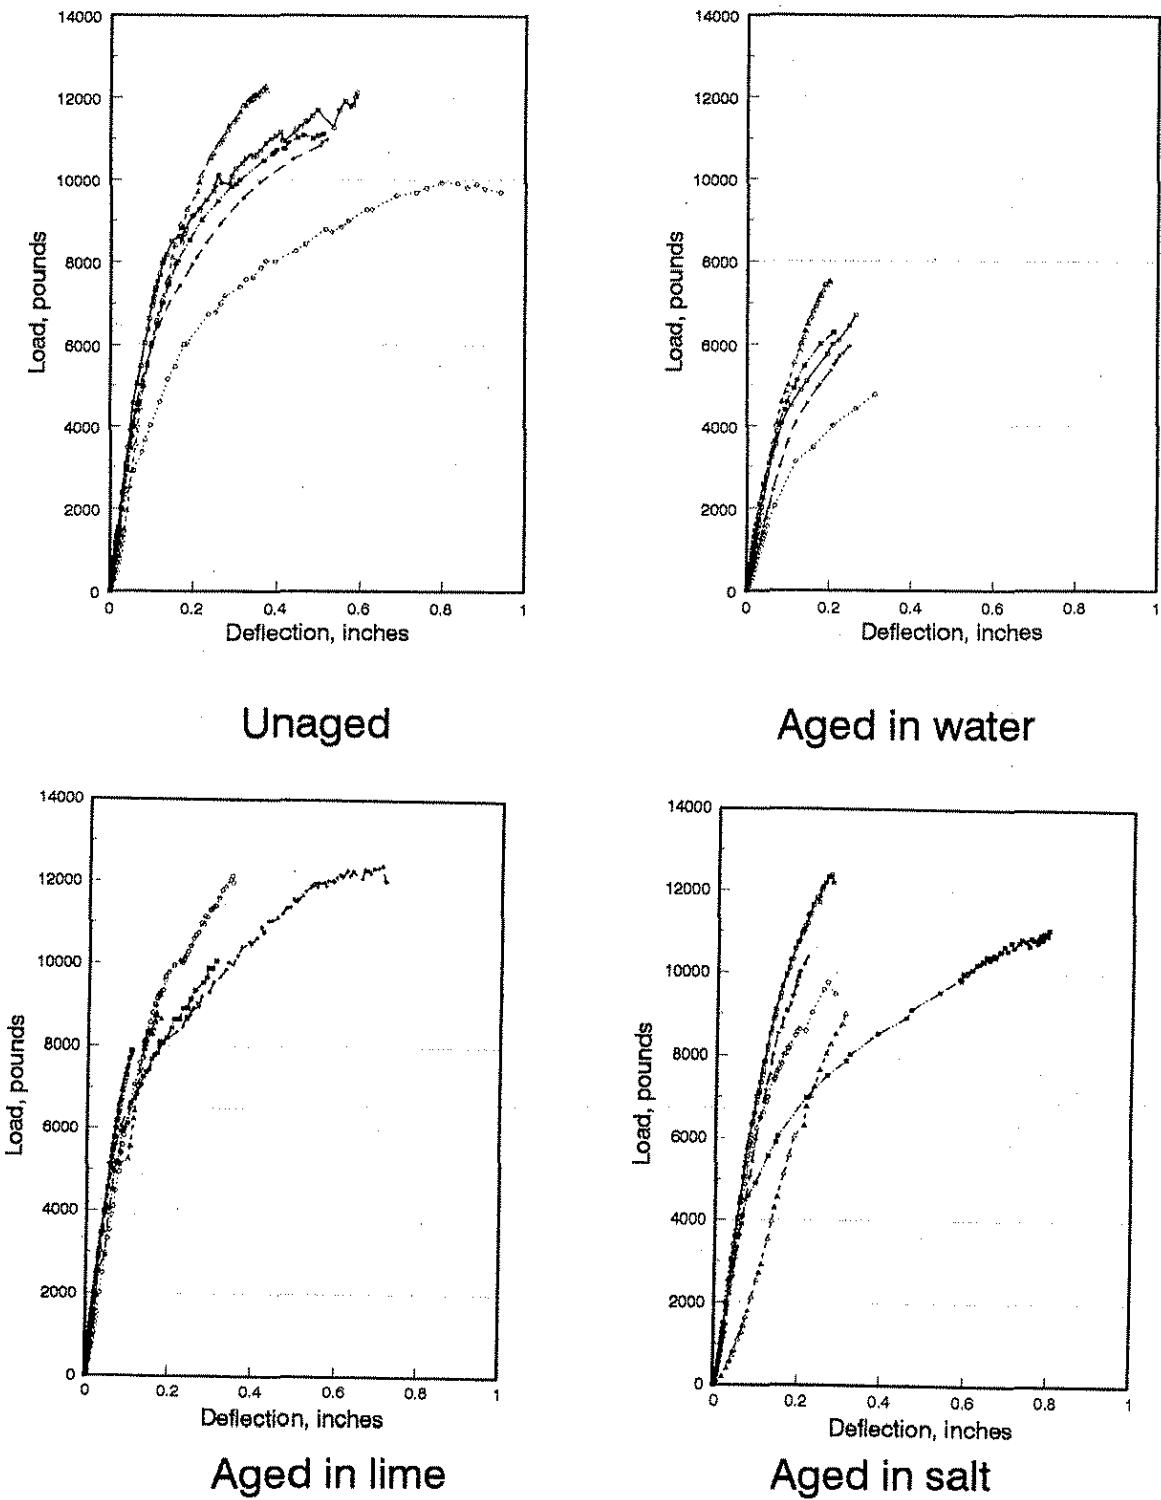
Figure 3.14. Comparison of aged and unaged C-FC-P assemblies

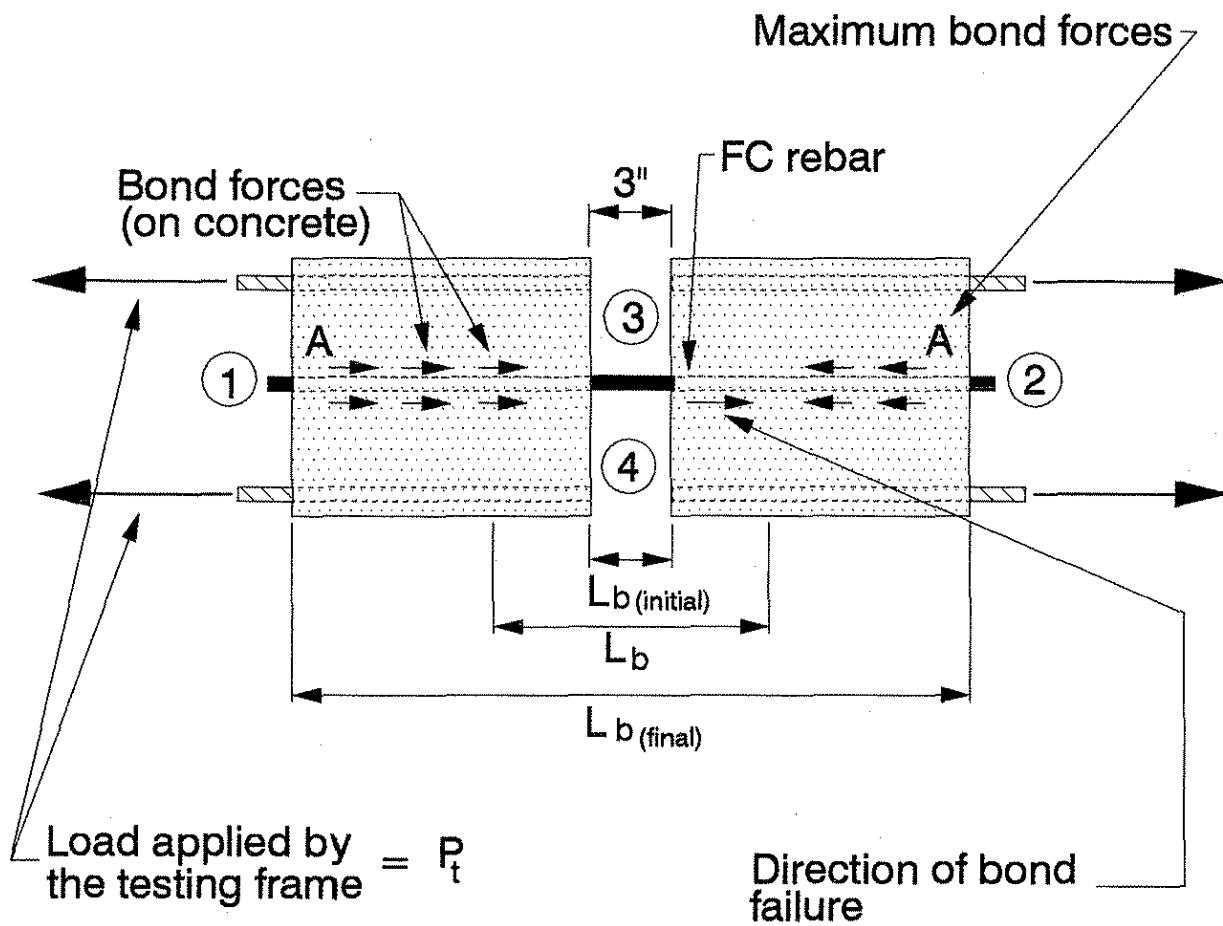
Deflection of pullout specimens:

$$\frac{\textcircled{3} + \textcircled{4}}{2} = \text{Gap deflection}$$

Figure 3.15. Bond failure for the pullout specimens

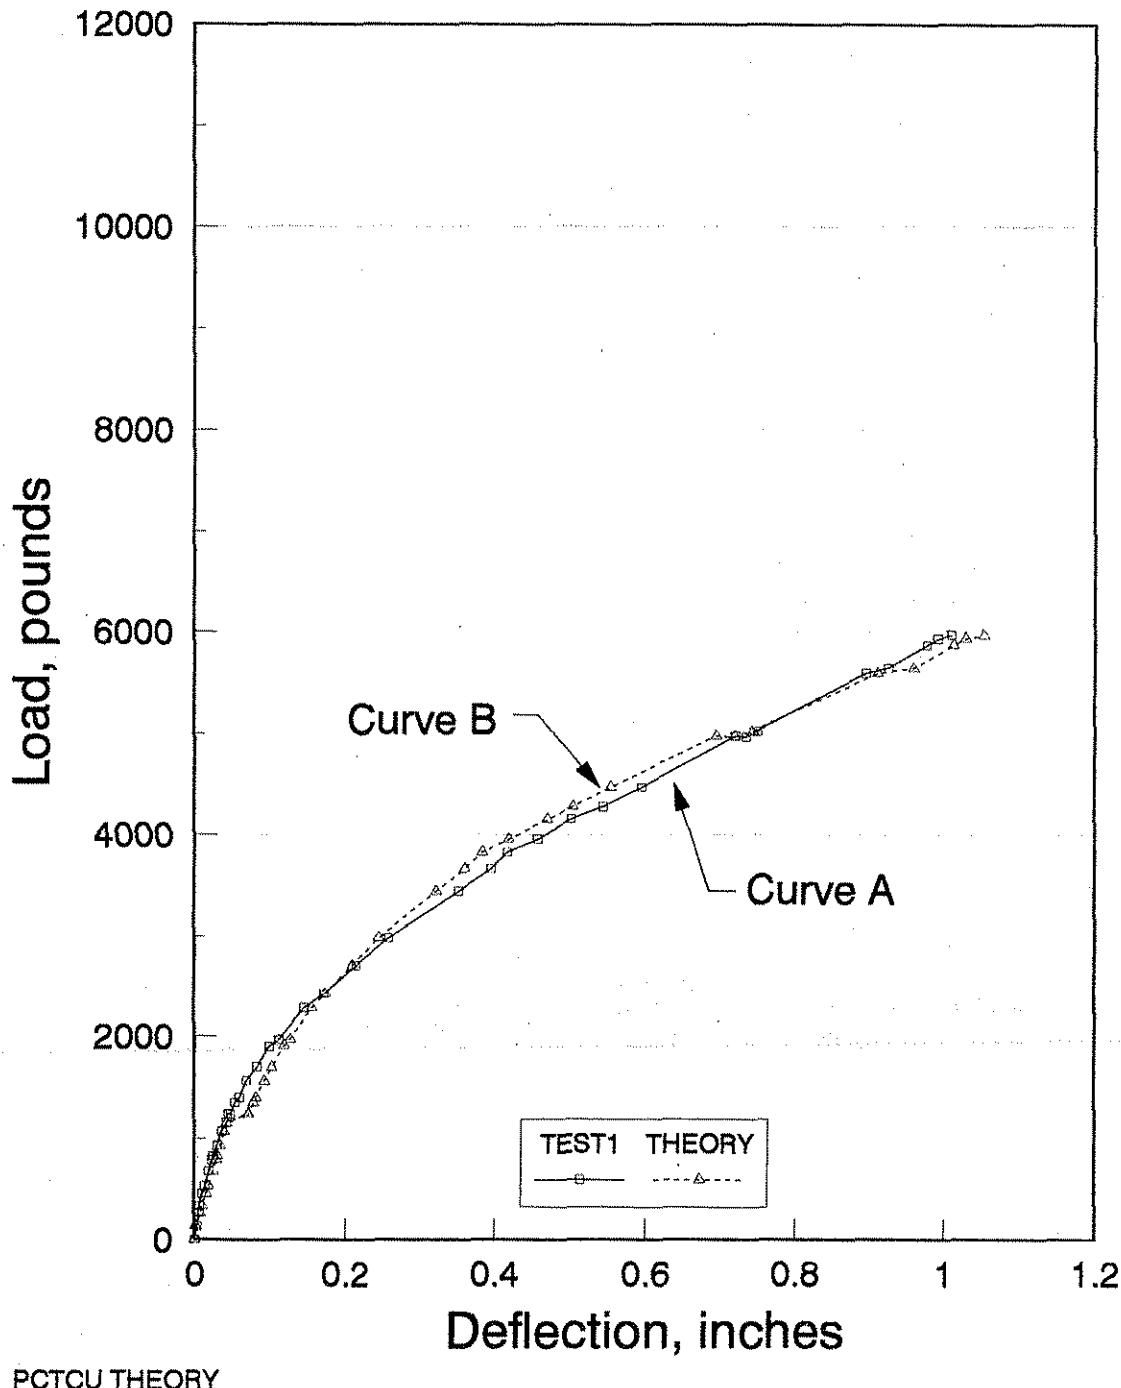
Figure 3.16. Comparison of approximated and experimental load-deflection curves for B-FC-P-U assembly
