Thermoset Composite Concrete Reinforcement

Project Number: HR-325

Part 2 final
report

Engineering Research Institute
Iowa State University

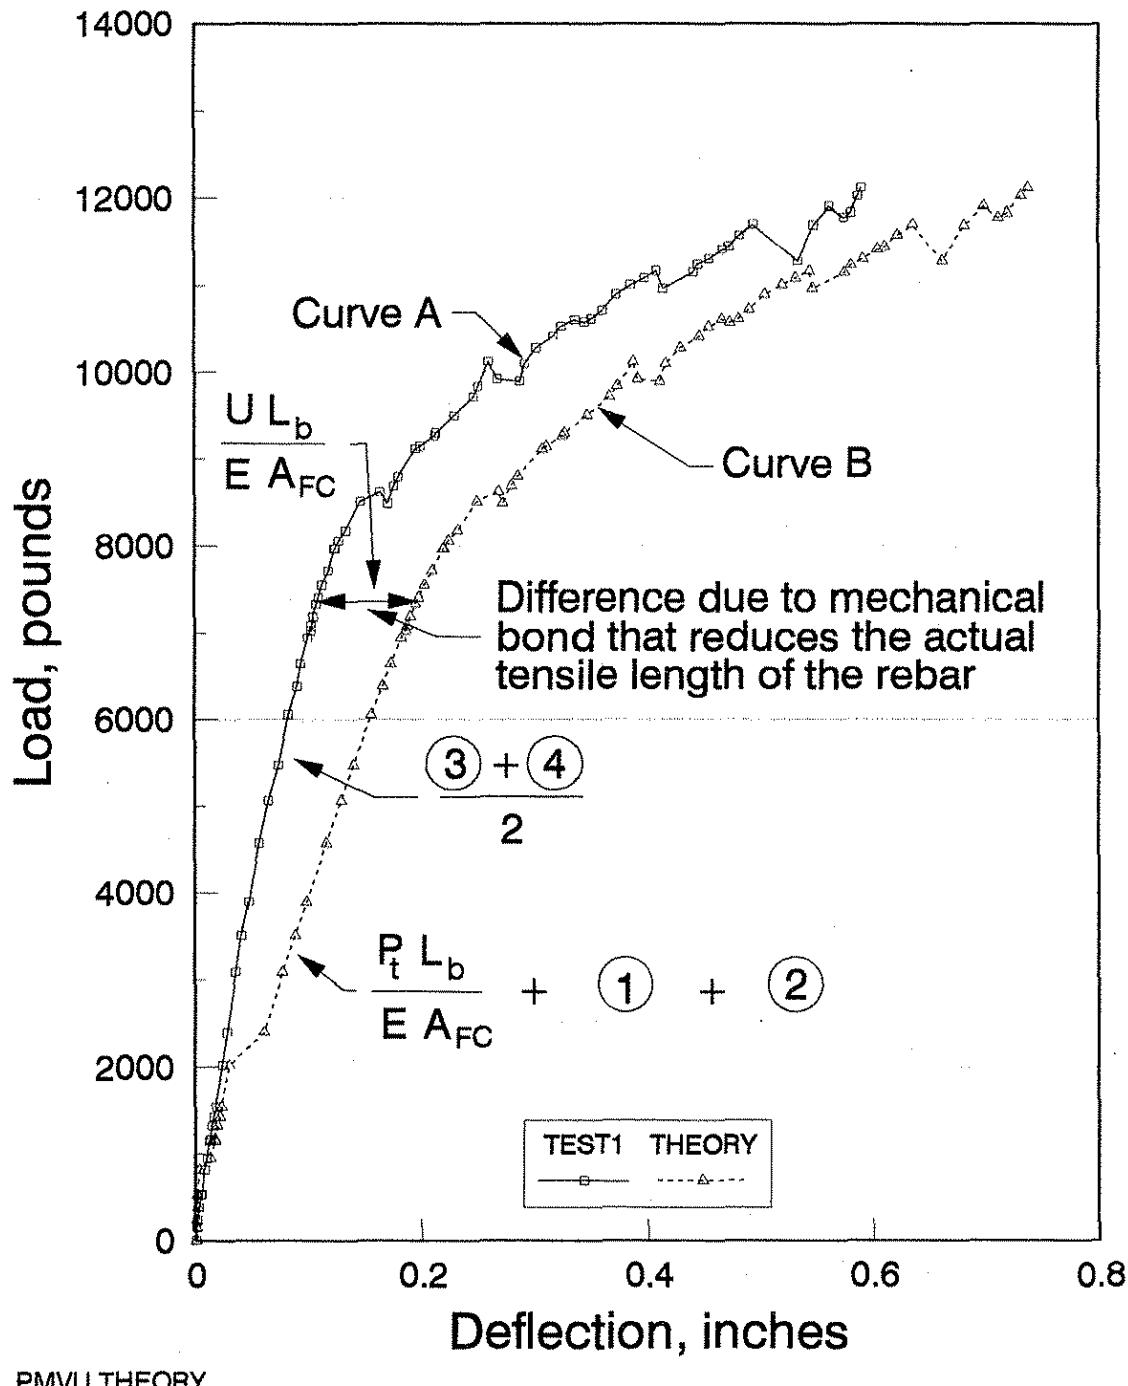
Figure 3.17. Comparison of approximated and experimental load-deflection curves for C-FC-P-U assembly

In Figure 3.17, the "Curve A" is found by Equation 3.8:

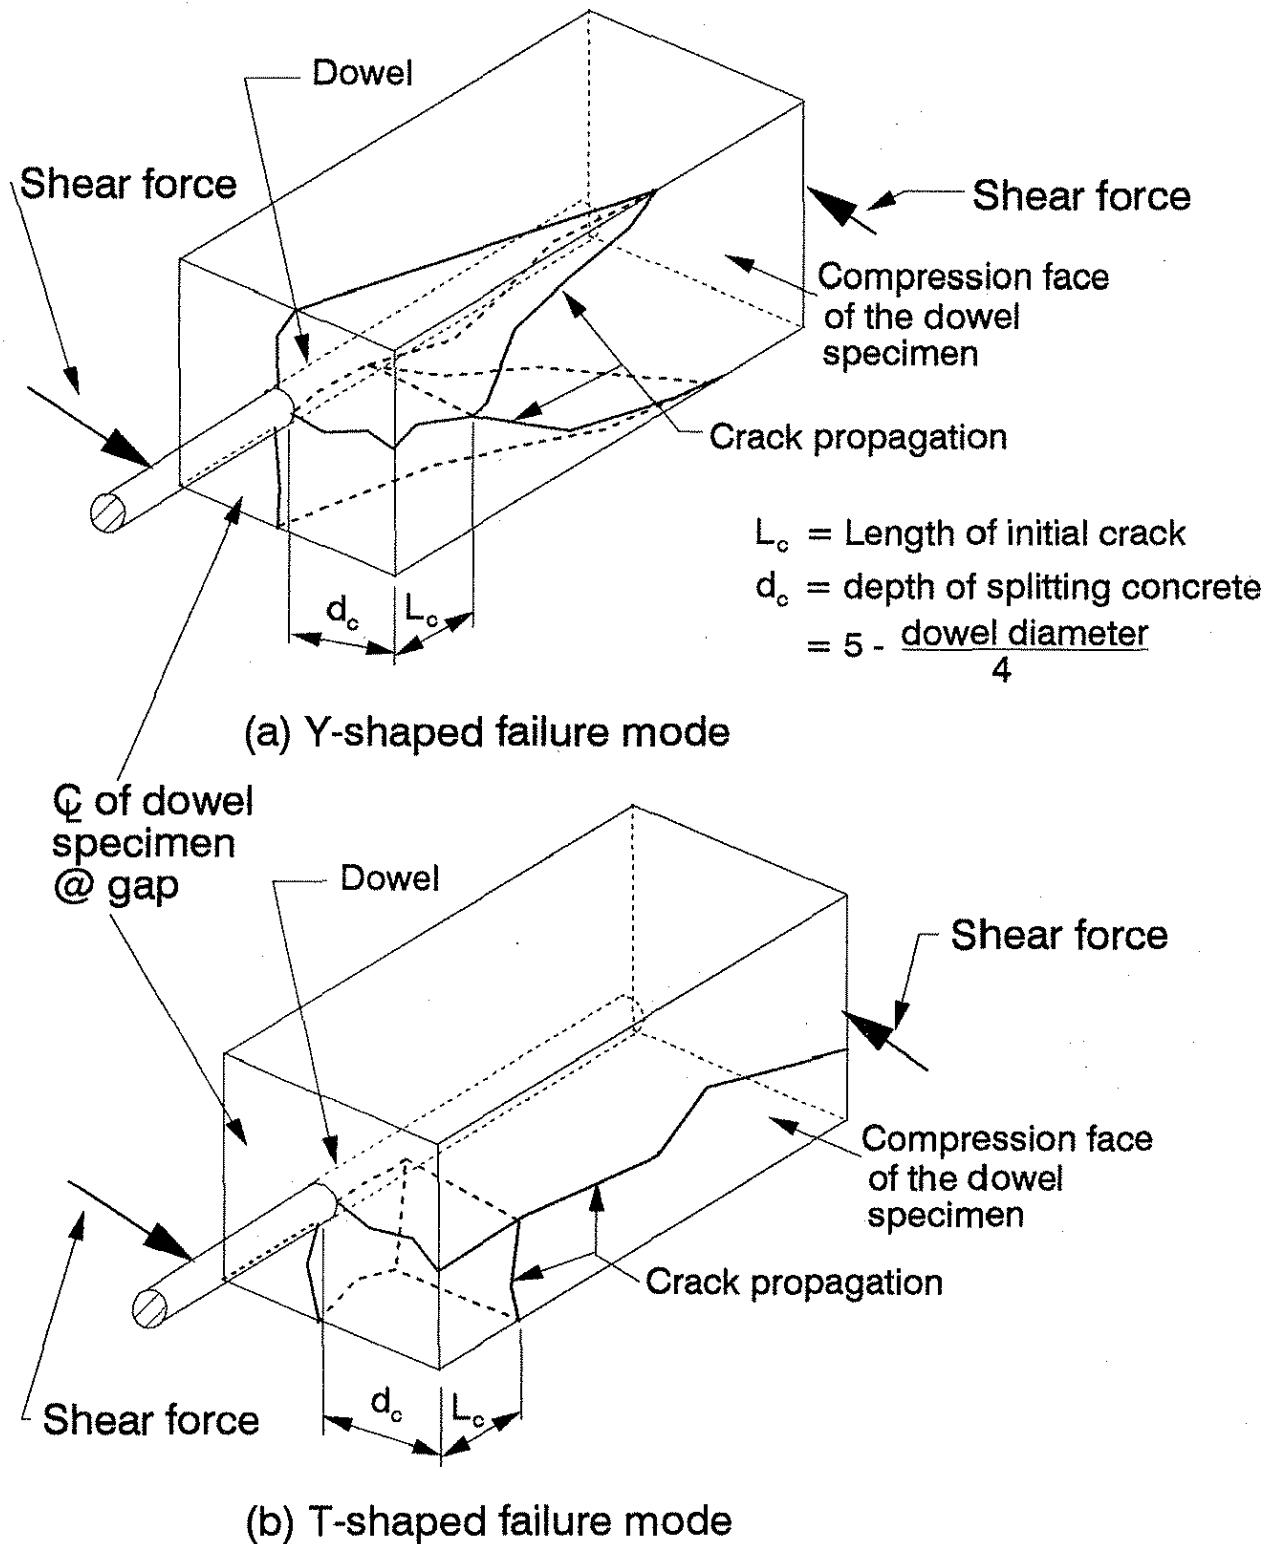
Figure 3.18. Splitting failure modes for the dowel specimens

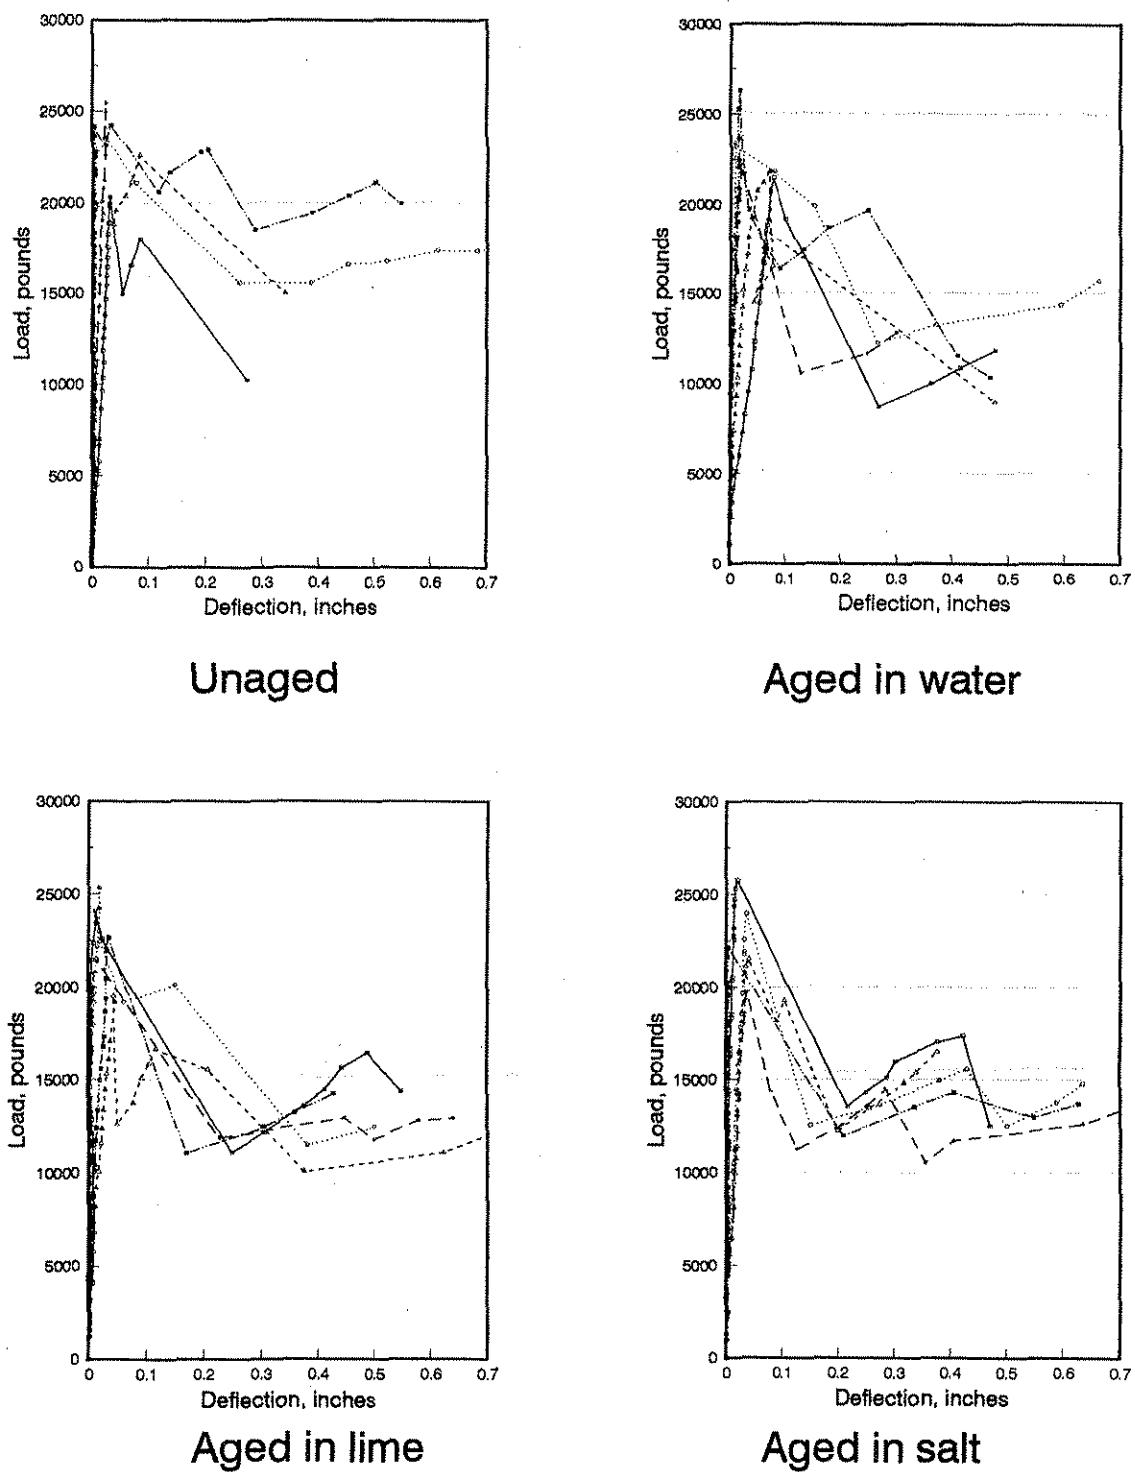
Figure 3.20. Comparison of aged and unaged O-S-D assemblies

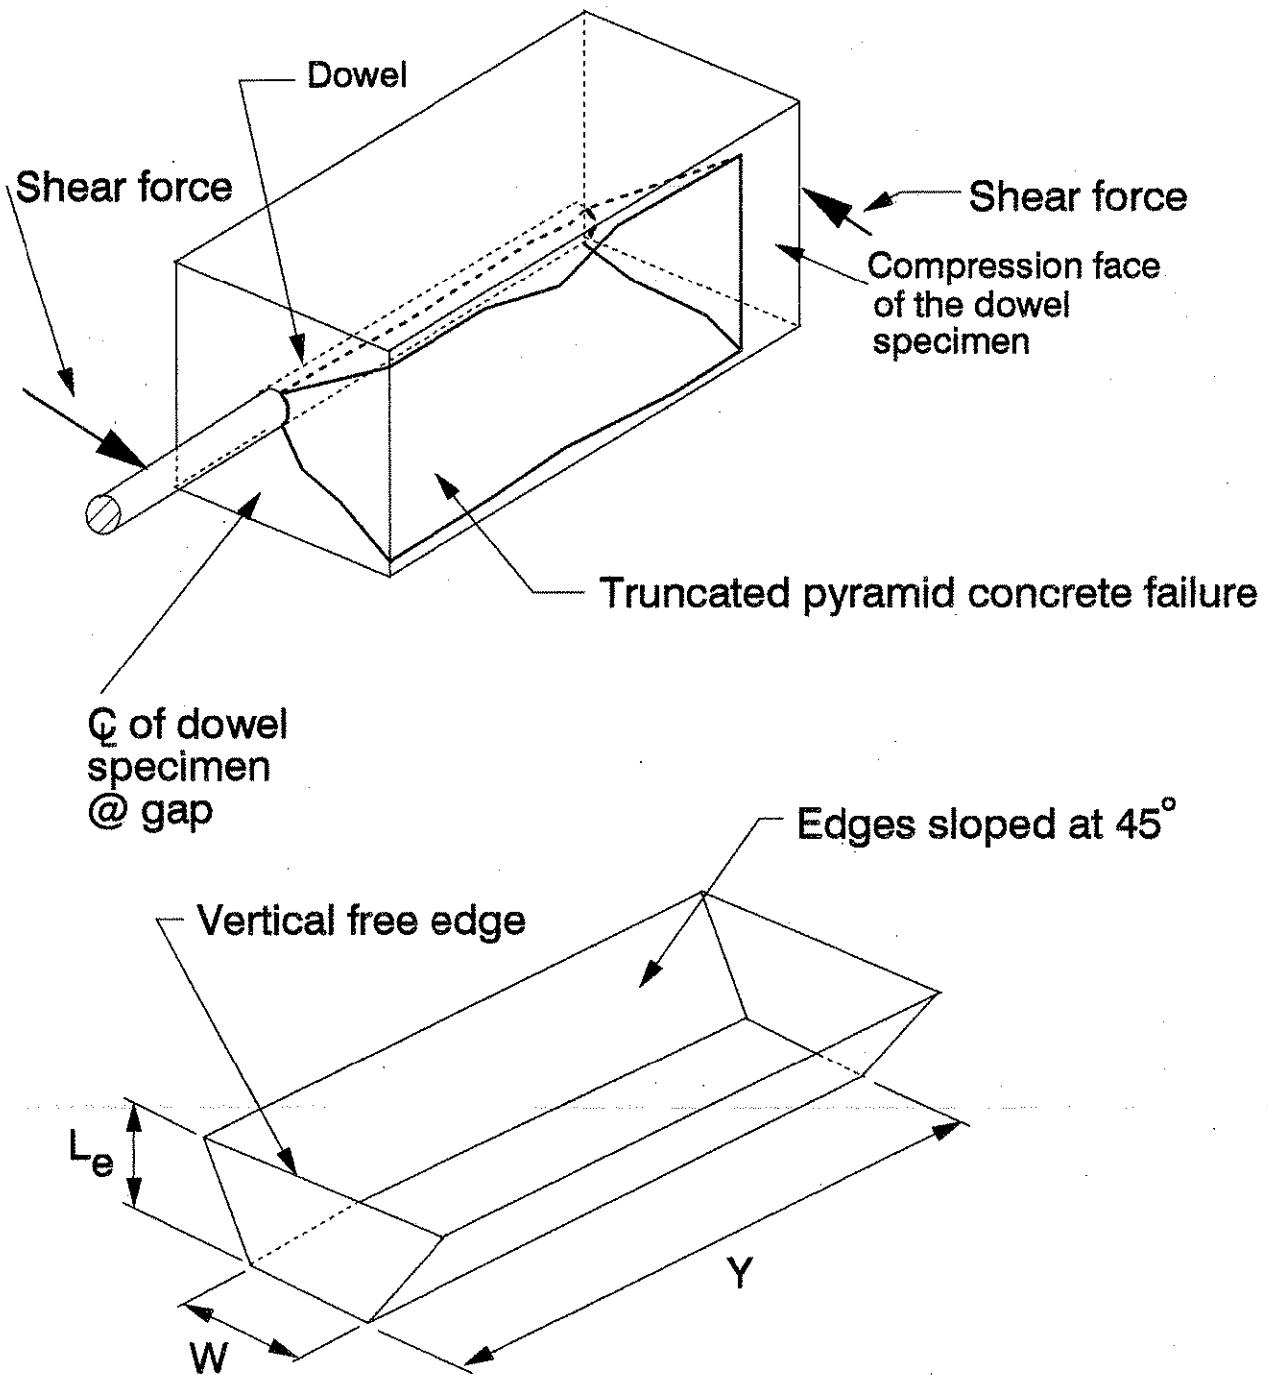
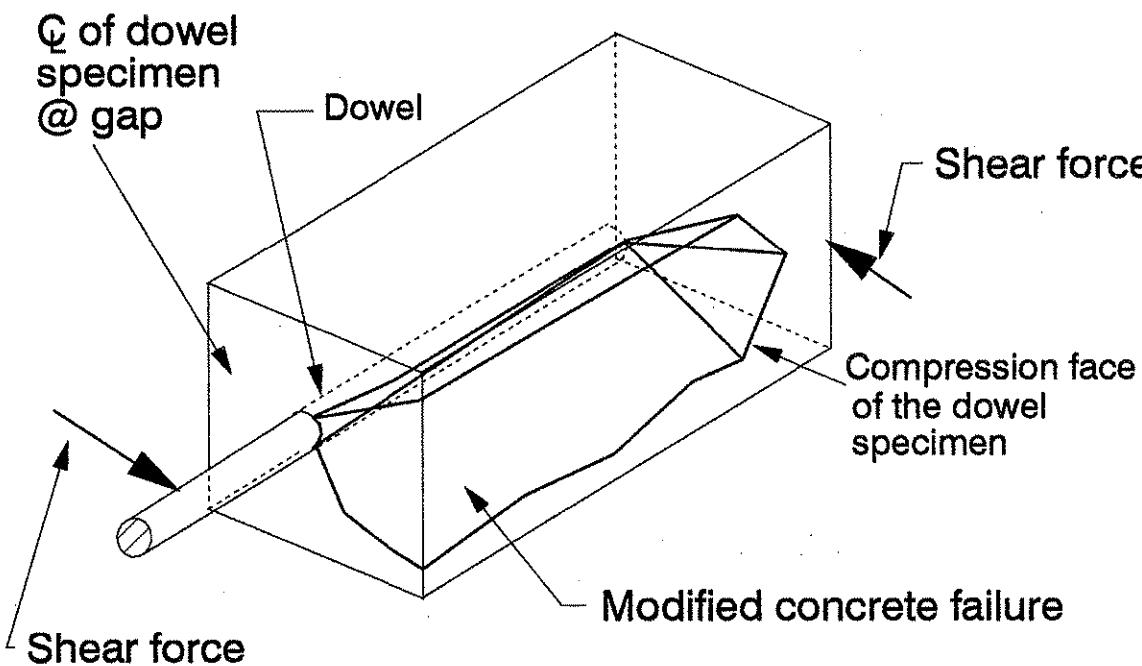
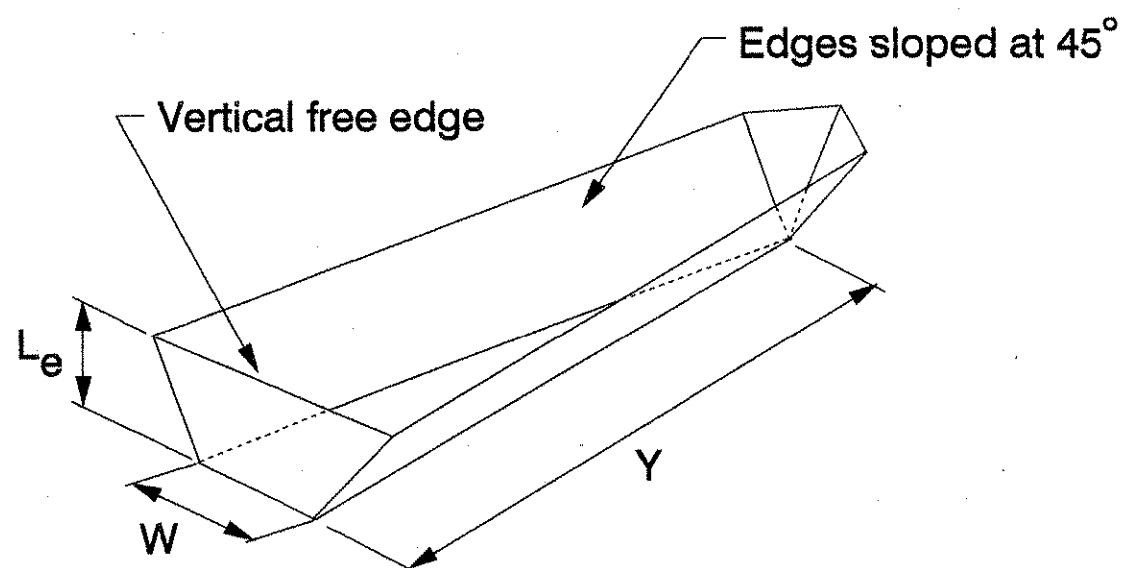
(a) Truncated pyramid concrete failure

Figure 4.1. Tensile-failure mechanisms for dowel bars

(b) Modified concrete failure

The area of the sloped portion of the truncated pyramid, excluding the vertical free edge, is given by Equation 4.3.

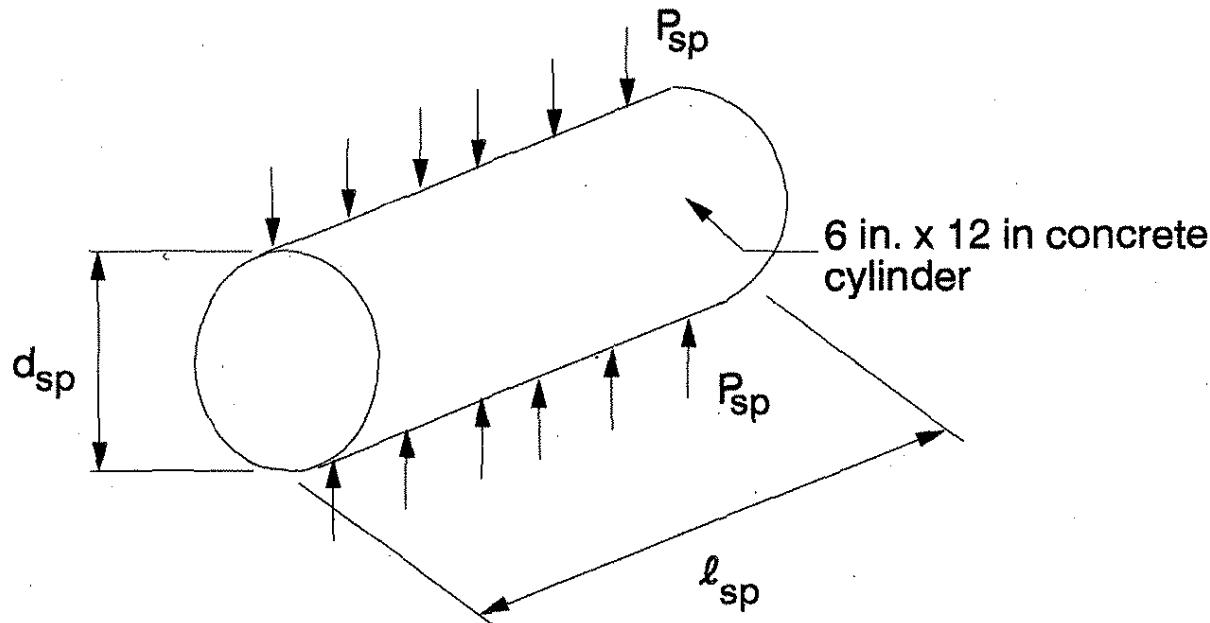
The split cylinder test (ASTM C496 [29]) is used commonly to determine the splitting tensile strength of concrete. Figure 4.2 illustrates the split cylinder test setup. The failure of the concrete in the dowel specimens during testing is considered to occur similar to that of the split cylinder test.

Figure 4.2. Split cylinder test [21]

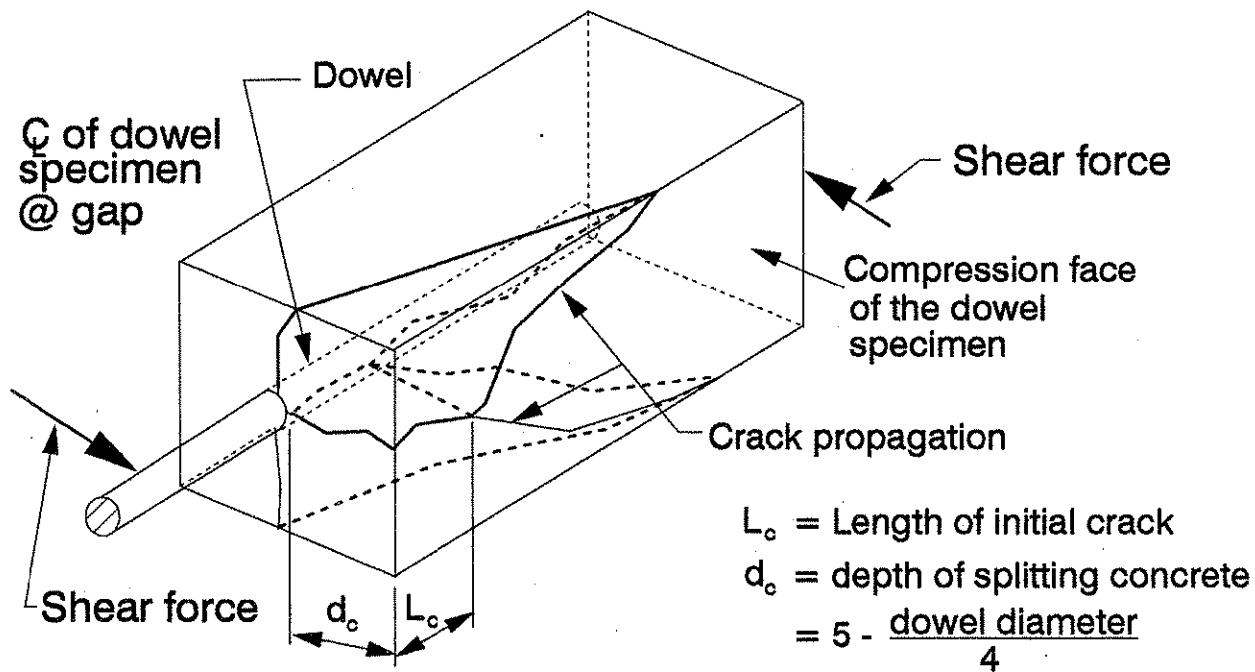
The split cylinder tensile strength was used as a value of tensile strength in developing a failure mode mechanism designated as the "splitting failure mode". The failure mode exhibited by the dowel specimens is shown in Figure 4.3. This failure mode was typical of both steel and FC dowel specimens. Different values of L_e , as shown in Figure 4.3, were observed for steel and FC dowel specimens.

Figure 4.3. Splitting failure mode for the dowel specimens

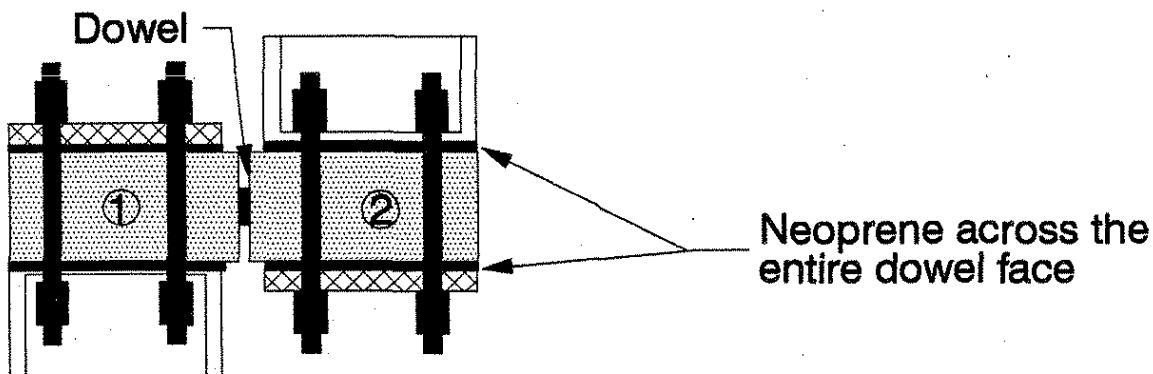
Three of the FC dowel specimens were tested using the testing procedure in Section 3.6. Figure 5.1 exhibits the corresponding clamping method. Neoprene covered the entire face of the dowel specimens to distribute the load evenly across the specimen as shown in Figure 5.1.

Figure 5.1. Clamping method for dowel specimens

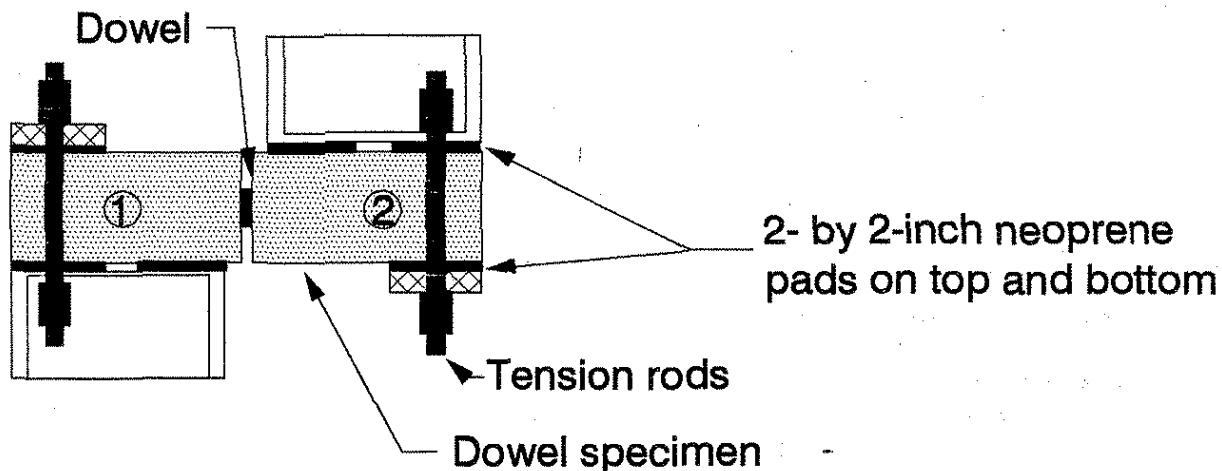
The remaining three dowel specimens were tested using a modified clamping method as shown in Figure 5.2. Neoprene pads were placed as shown in Figure 5.2. The neoprene did not cover the entire face of the dowel specimens which may restrict the failure mode.

Figure 5.2. Modified clamping method for dowel testing

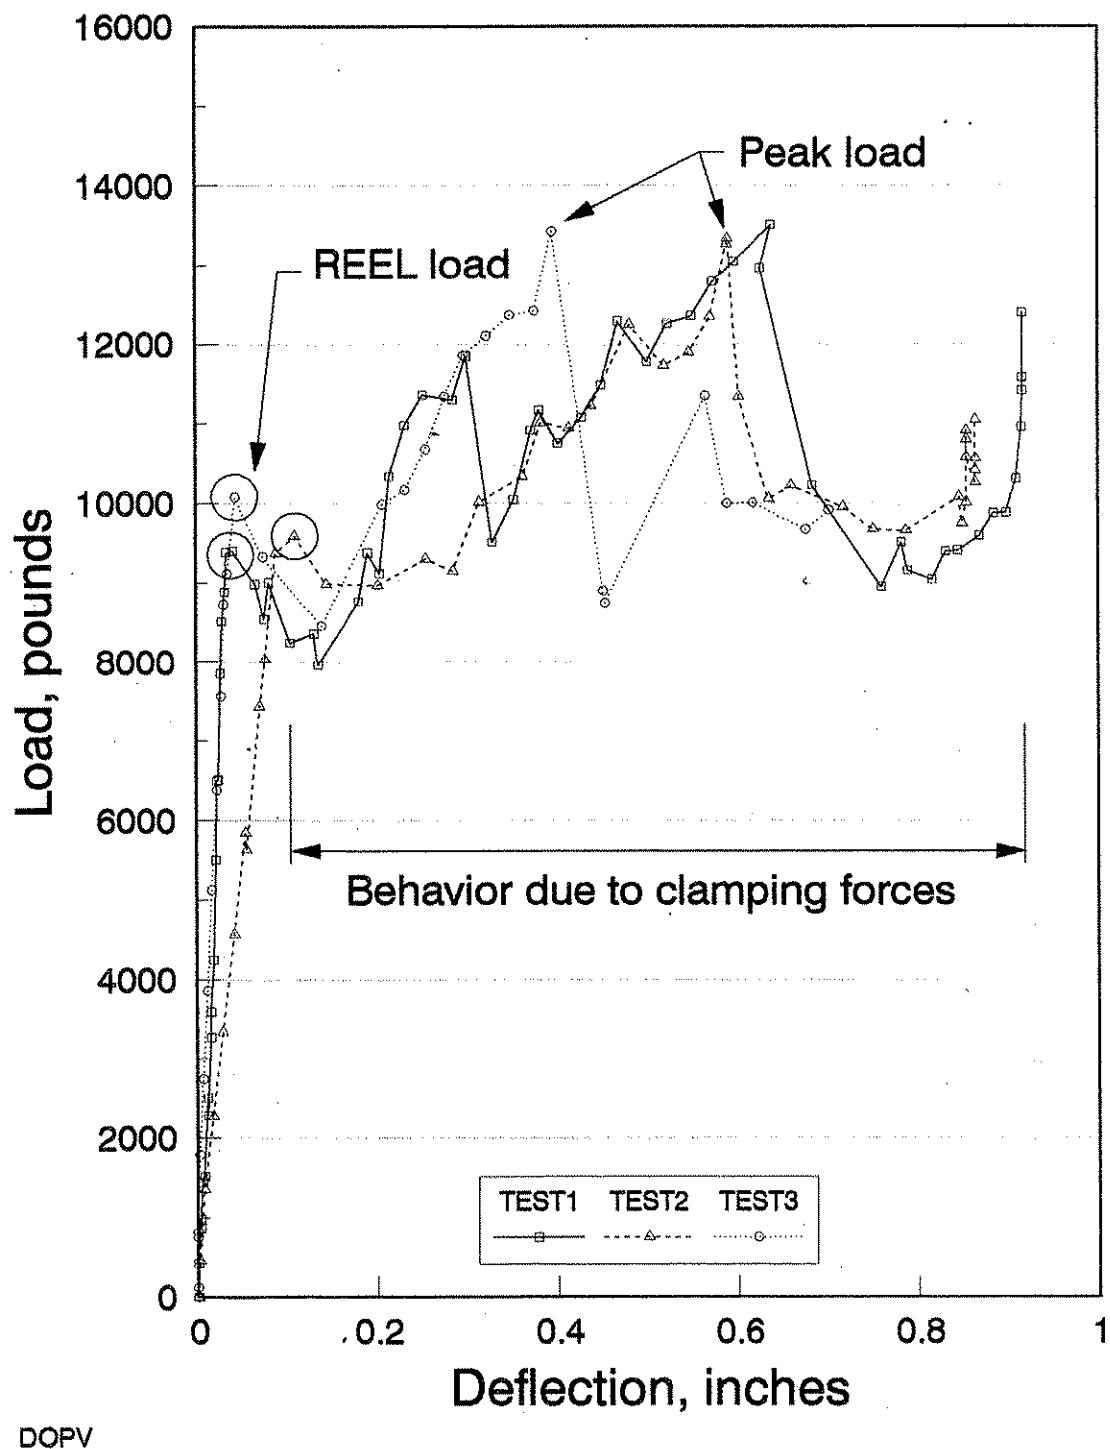
Figure 5.3. Tests on PV dowel bars

The REEL loads and deflections correspond very well and were not affected by the clamping method. Therefore, the authors feel that the test method used in Section 3.6 is a representative of the Iosipescu test method.

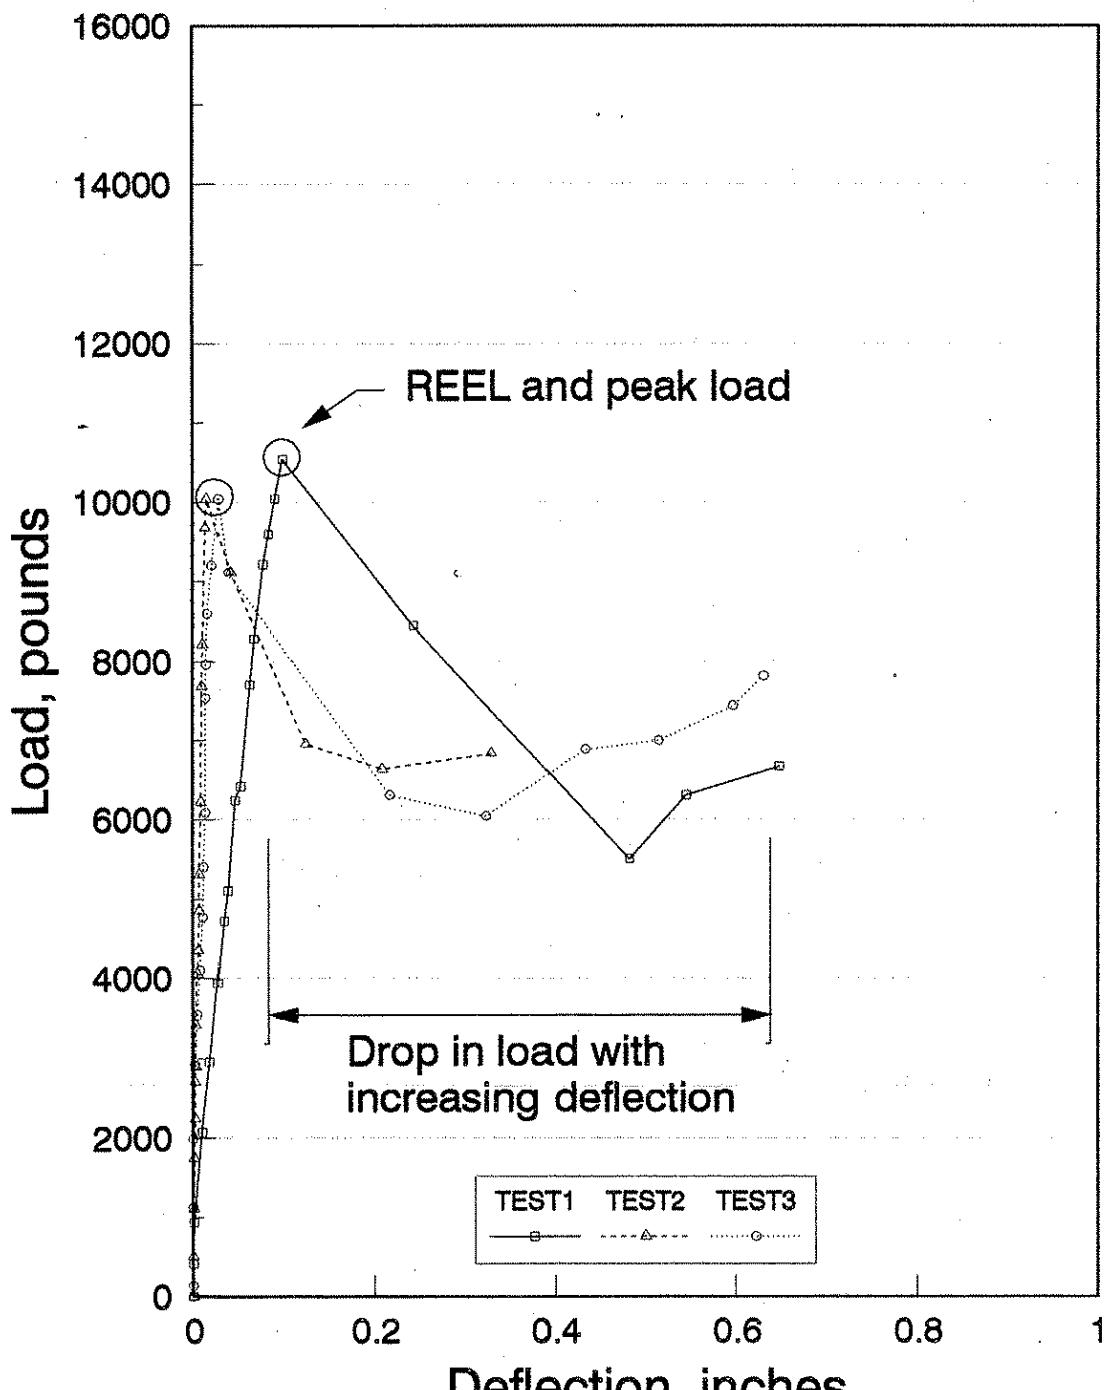
Figure 5.4. Tests of PV dowel bars using modified grips

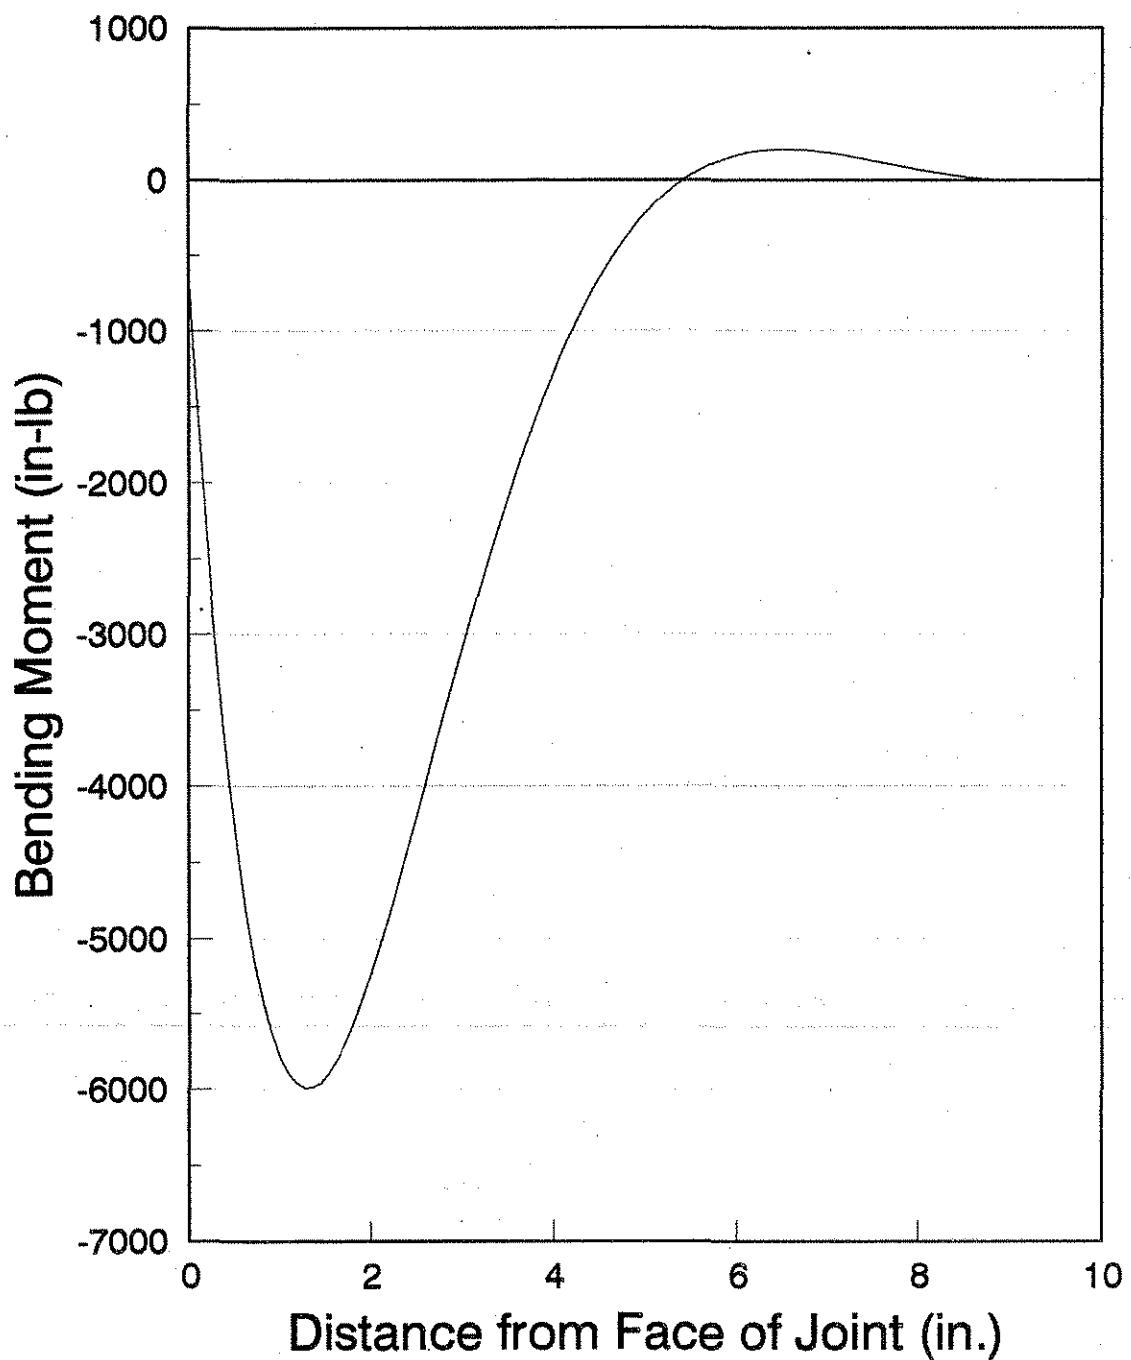
The theoretical moment distribution in Figure 6.1 exhibits a maximum moment of 6000 in-lb at one and one-half inches from the center of the dowel, an inflection point at about five inches, and a maximum positive moment at around six and one-half inches. To verify the theoretical model, dowel bars were strain gaged as shown in Figure 6.2. Strain gages were located at 1.5, 5.0, and 6.5 inches from the centerline of the dowel as shown in Figure 6.2 on either side of the gap. The strain gages were mounted on opposite sides of the dowel bar (1.5 inches apart) within the plane of the shear force.

Figure 6.1. Theoretical moment distribution along the dowel bar

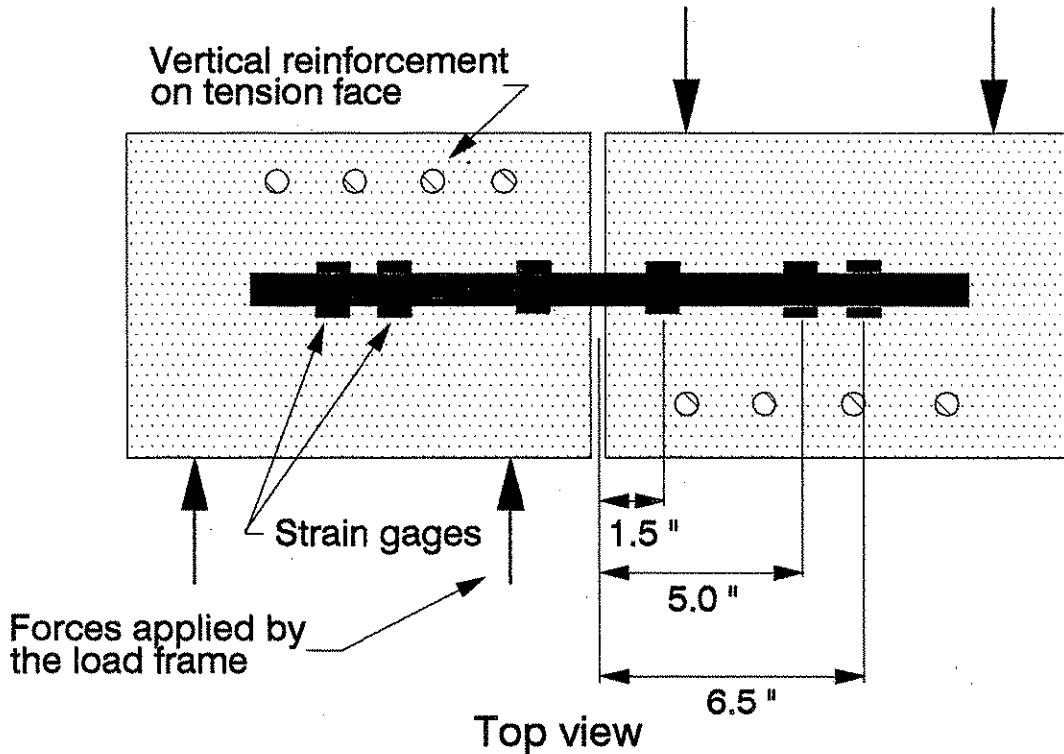
Figure 6.2. Strain gage locations on the dowel bar

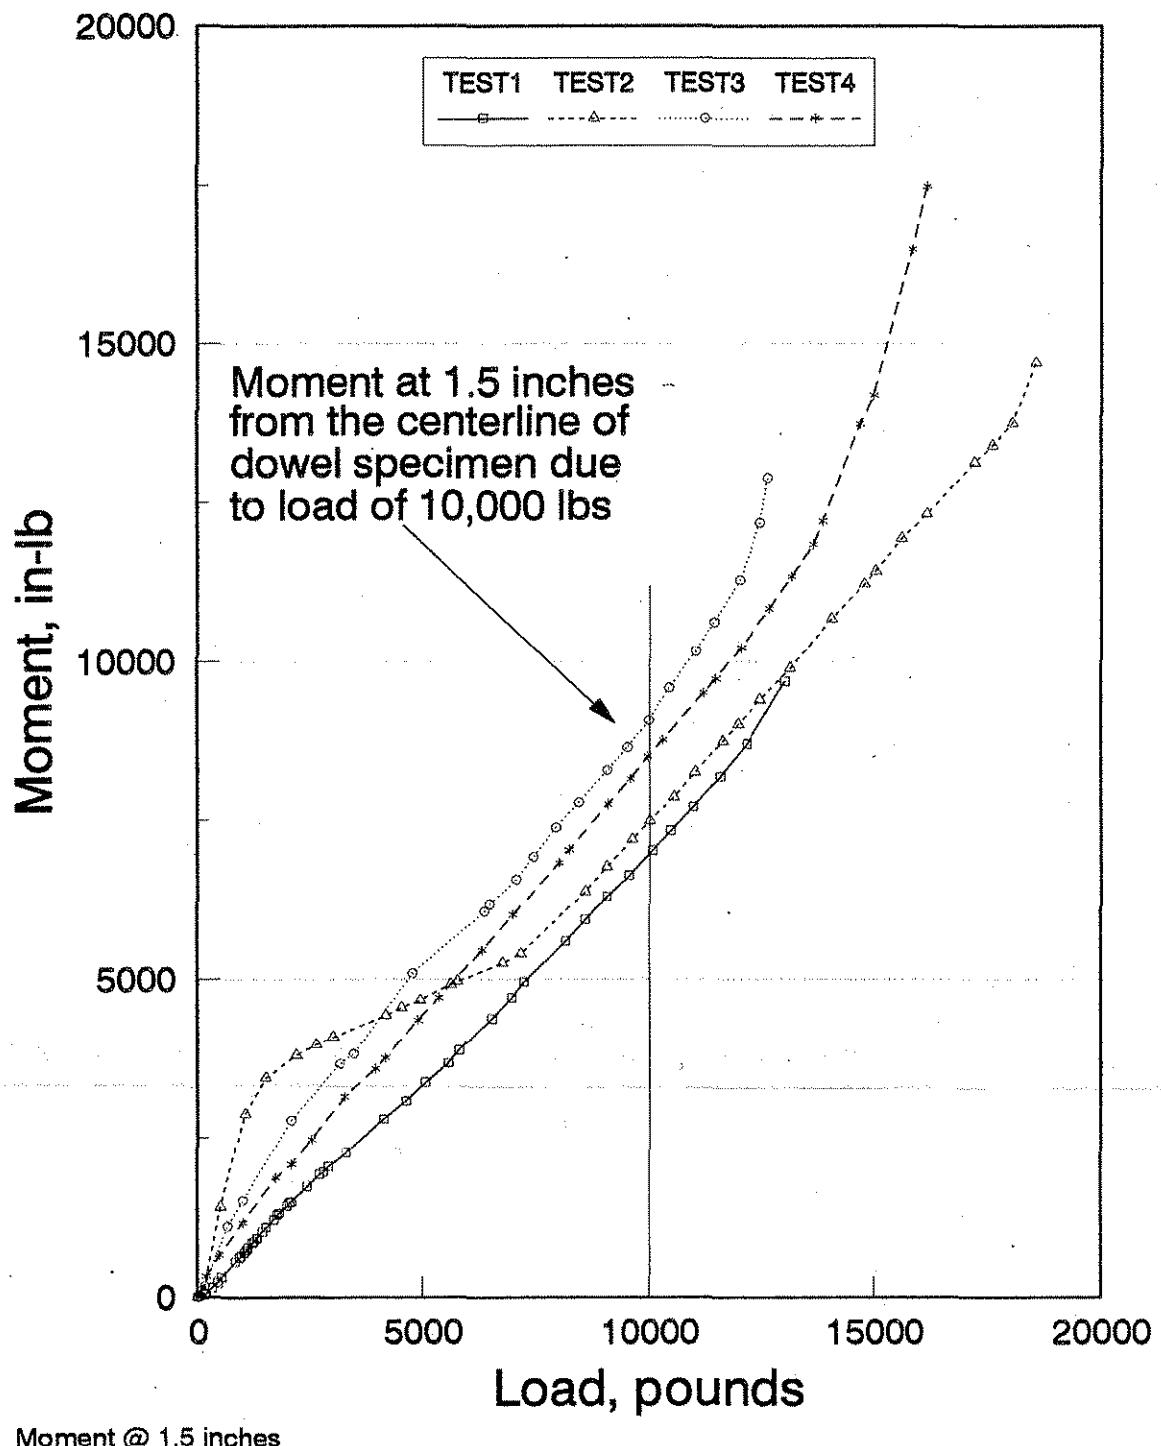
Figure 6.3. Load versus moment diagram at 1.5 inches from the centerline of dowel bar

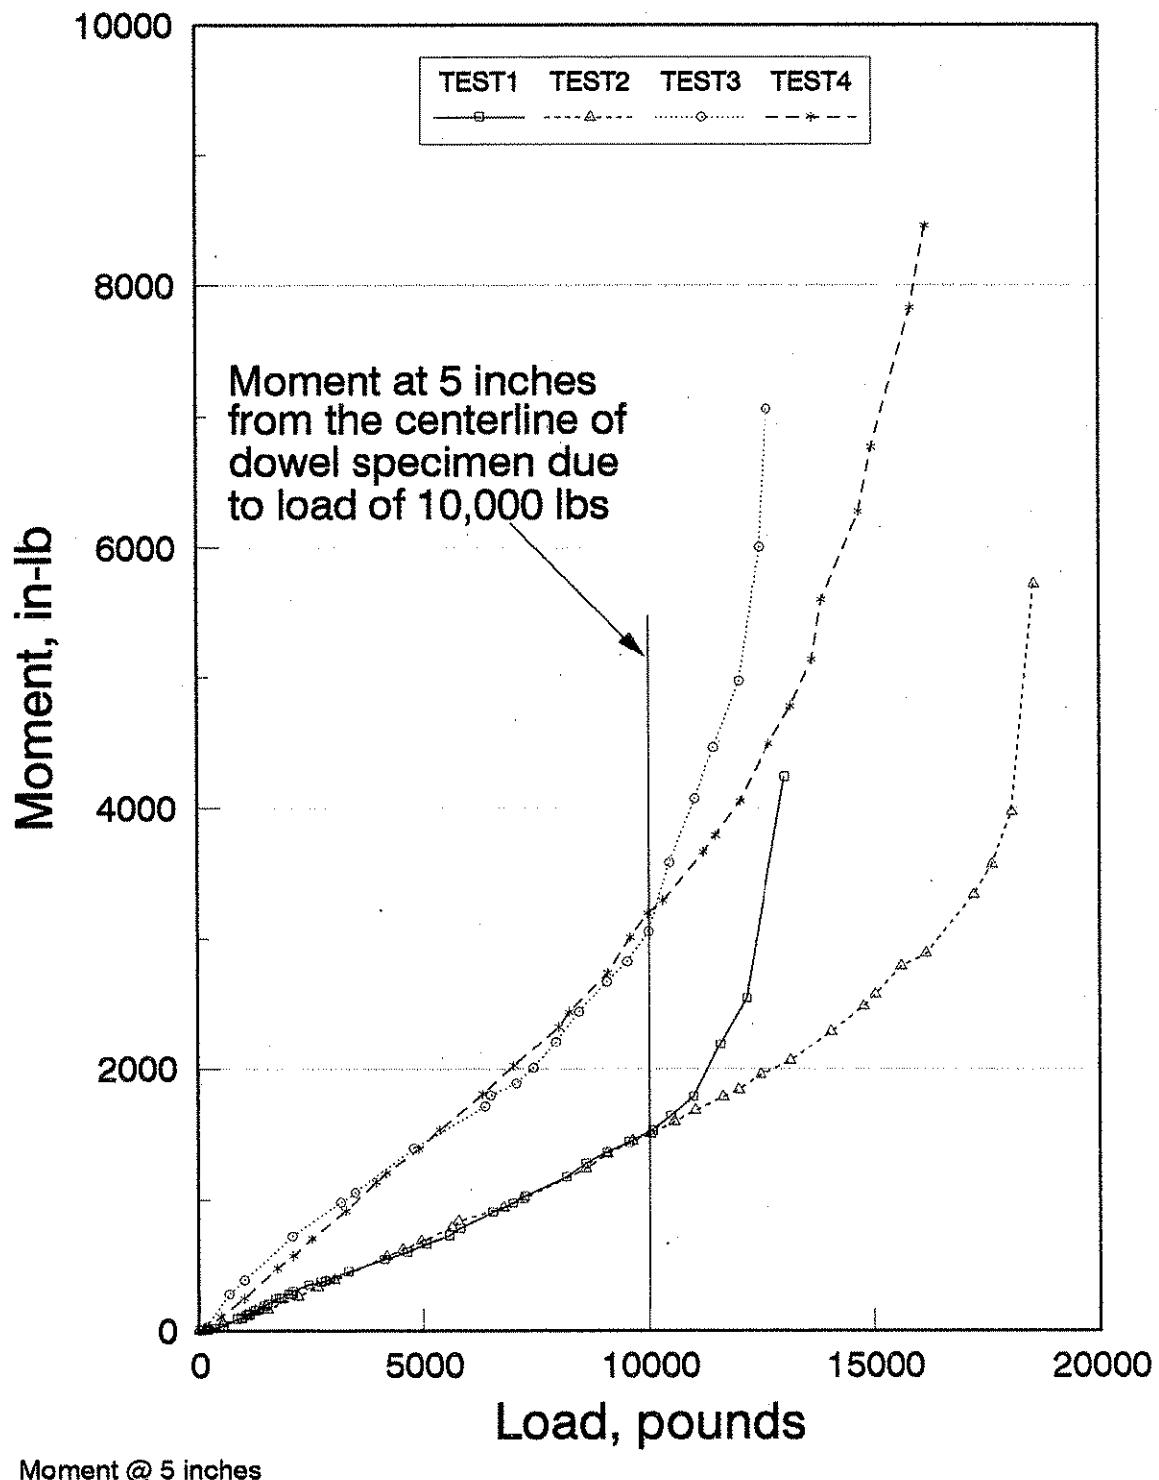
Figure 6.4. Load versus moment diagram at 5.0 inches
from the centerline of dowel bar

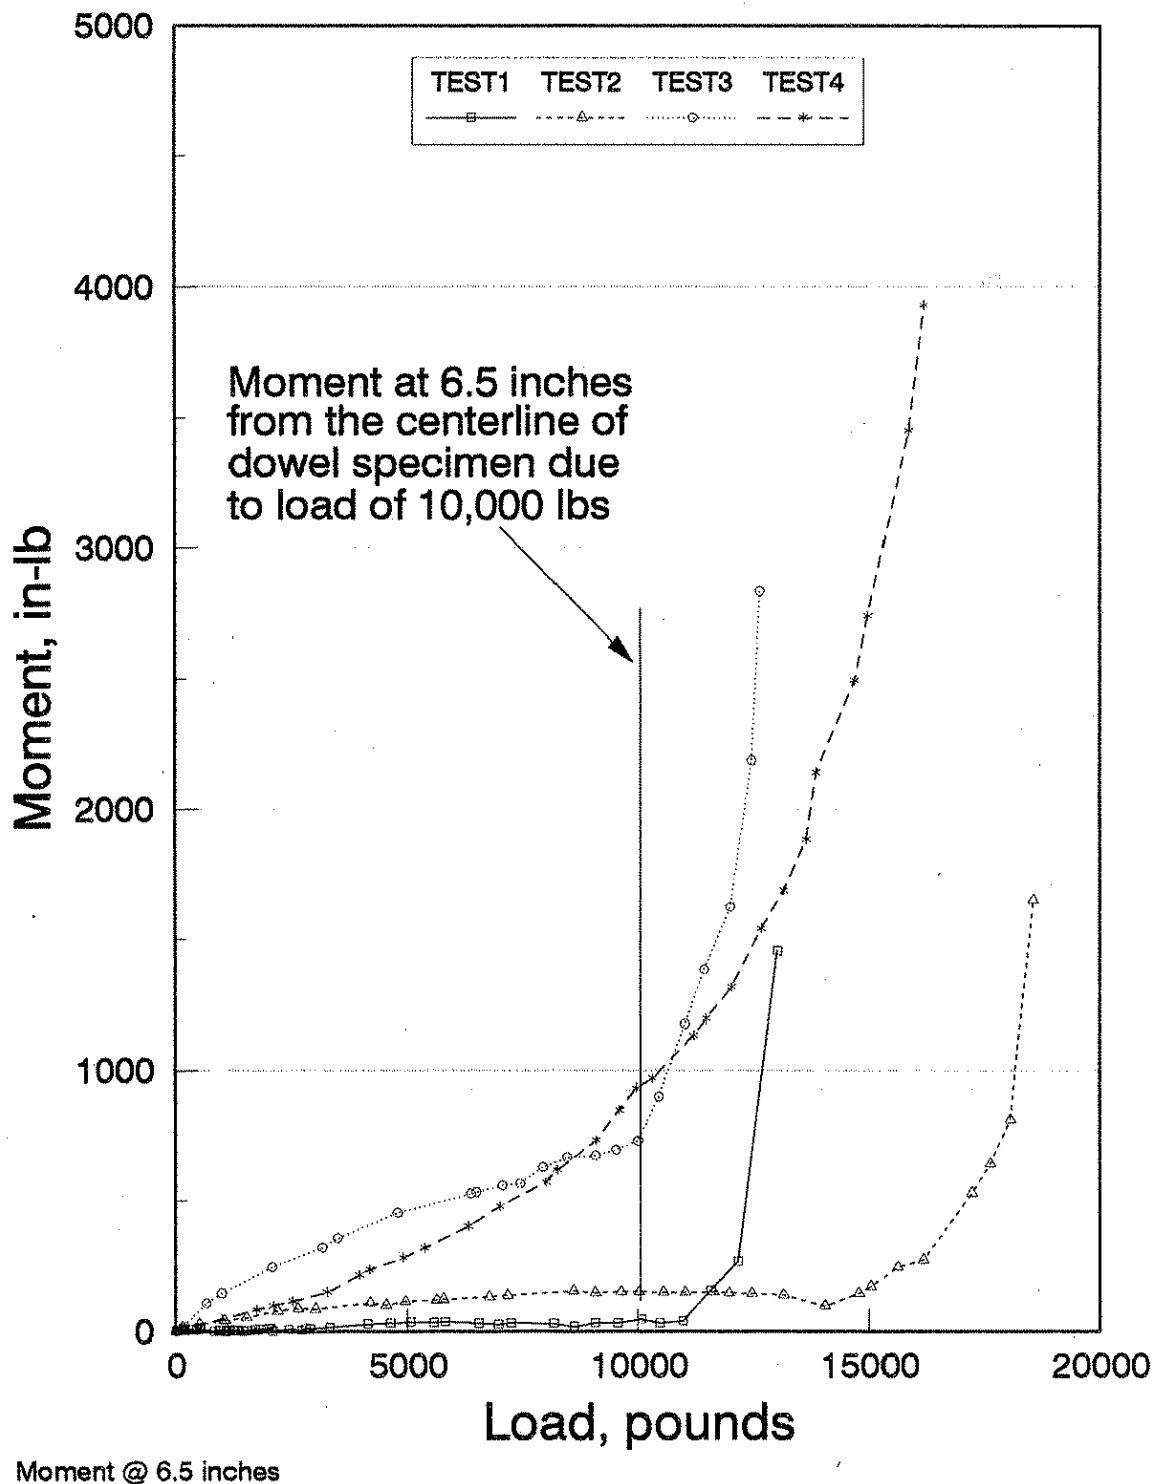
Figure 6.5. Load versus moment diagram at 6.5 inches from the centerline of dowel bar
