Thermoset Composite Concrete Reinforcement

Project Number: HR-325

Part 2 final
report

Engineering Research Institute
Iowa State University

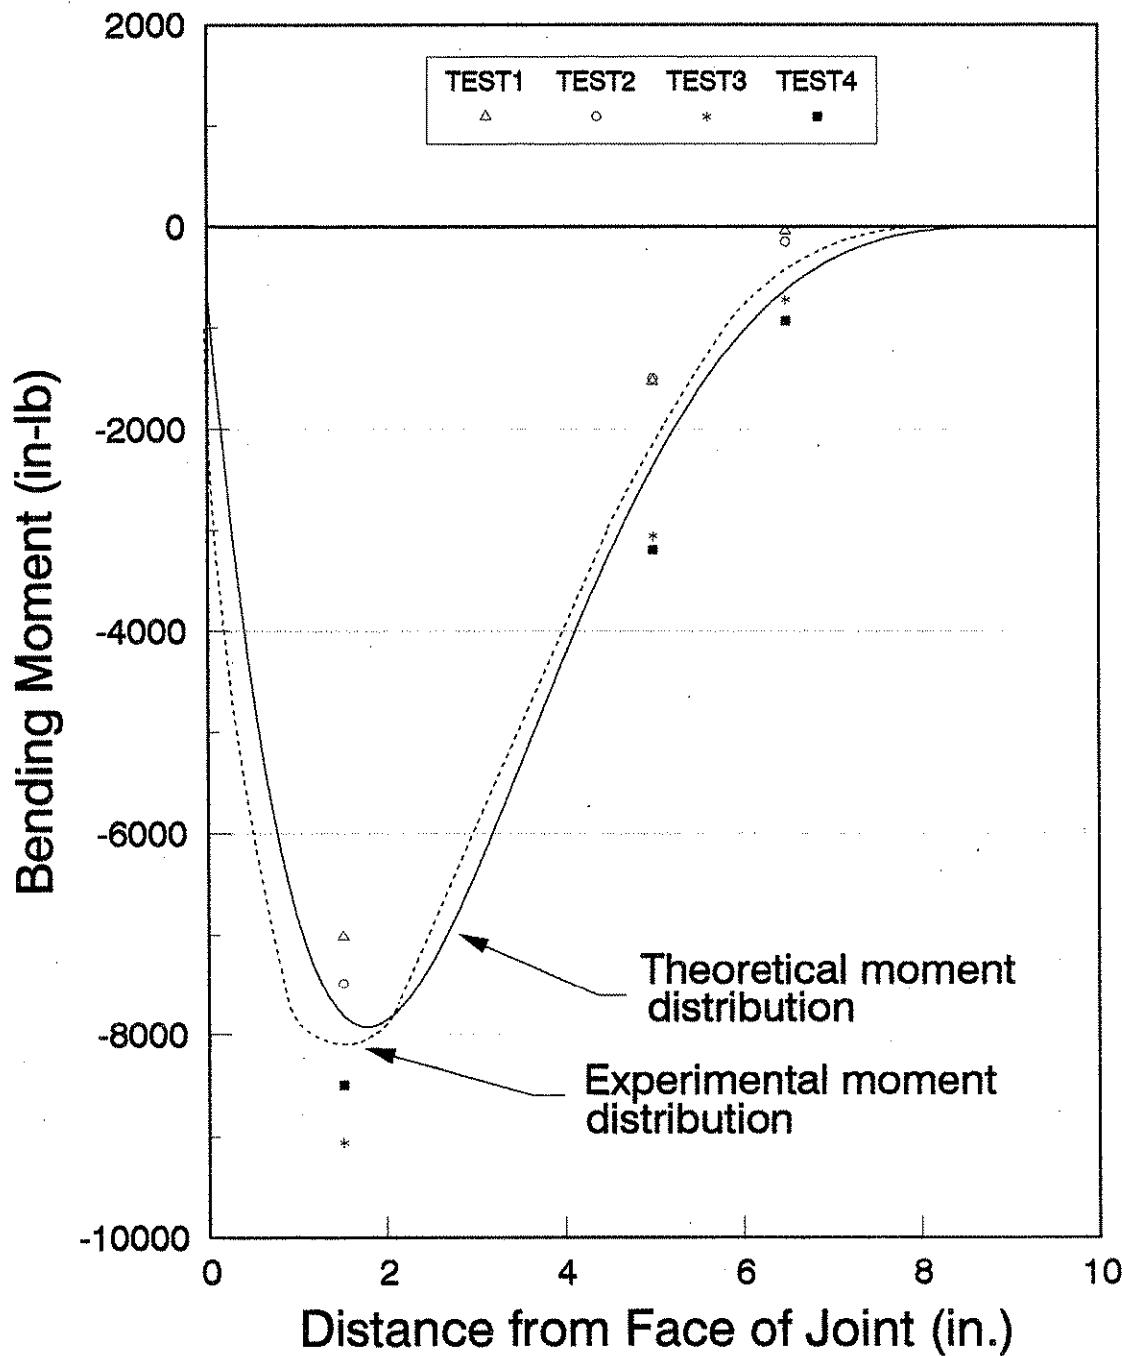
The values presented in Table 6.2 are plotted in Figure 6.6 as the experimental moment distribution curve. The strain gage results indicate that the dowel has no inflection point in the moment distribution curve. The experimental moment curve indicates approximately the same moment values as the theoretical distribution.

Figure 6.6. Theoretical versus experimental moment distribution along the dowel bar

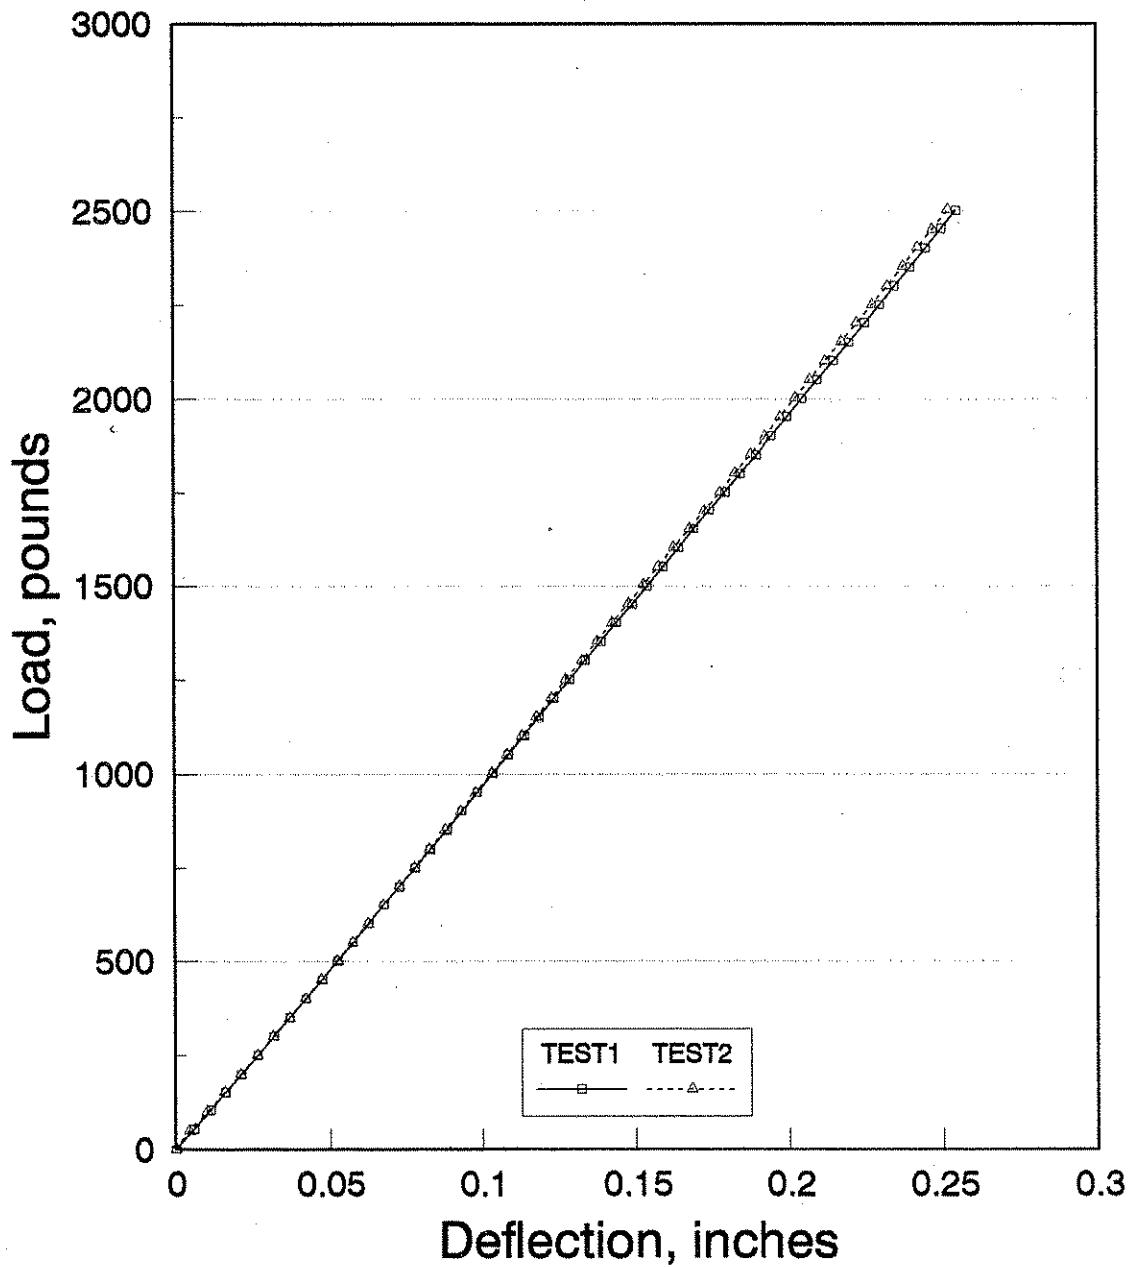
Figure A17. Modulus of elasticity curves for unaged 1.25-in. dowel

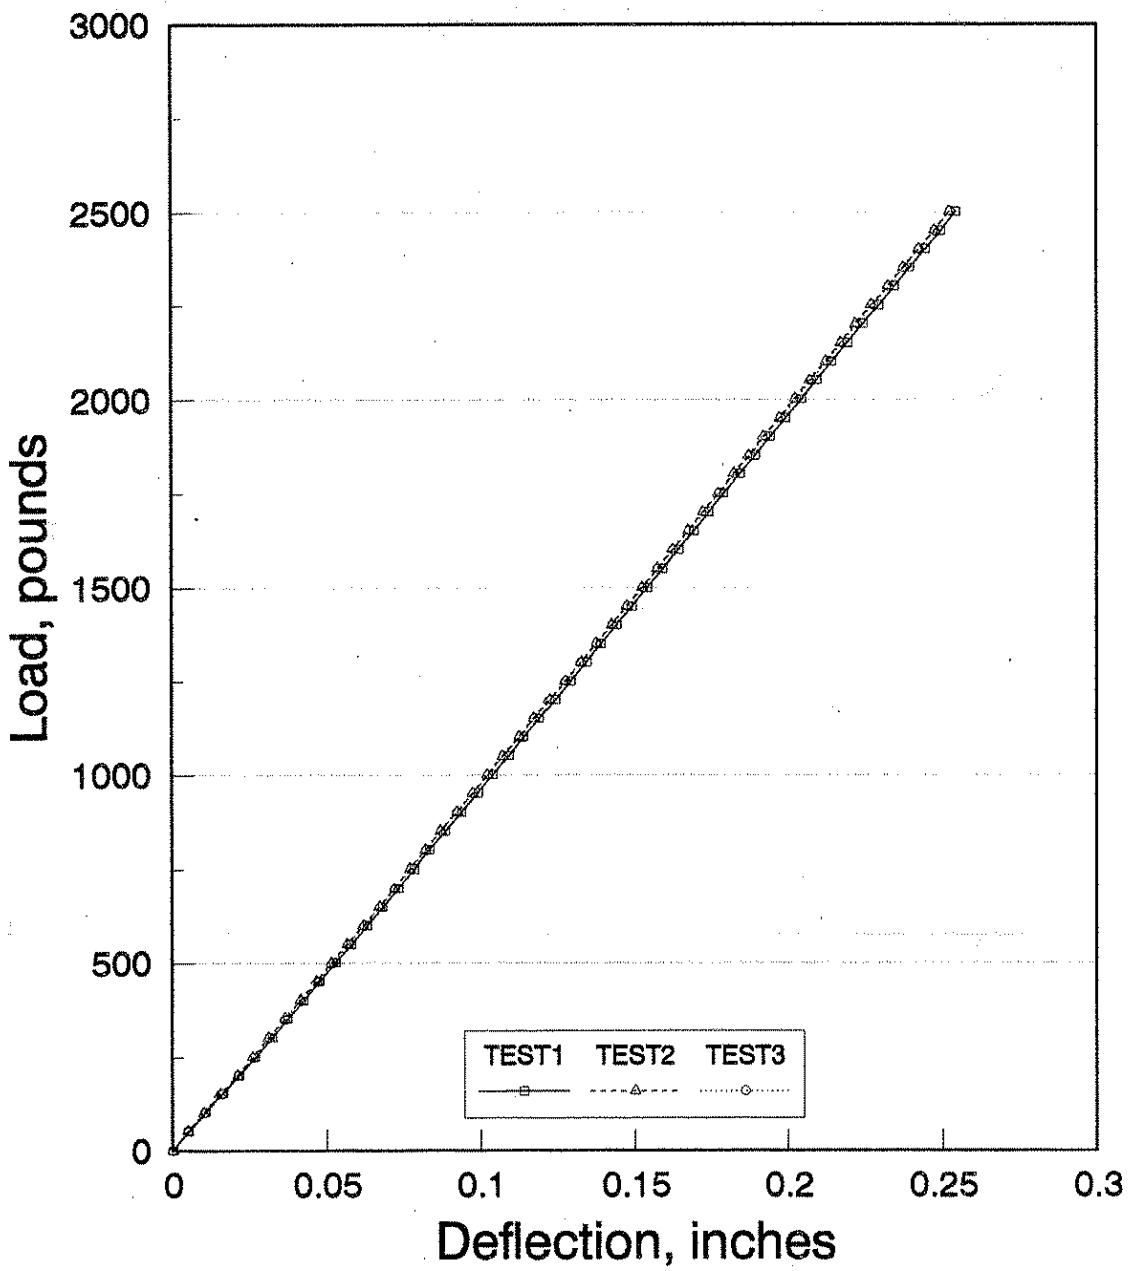
Figure A18. Modulus of elasticity curves for 1.25-in. dowel bars aged in water

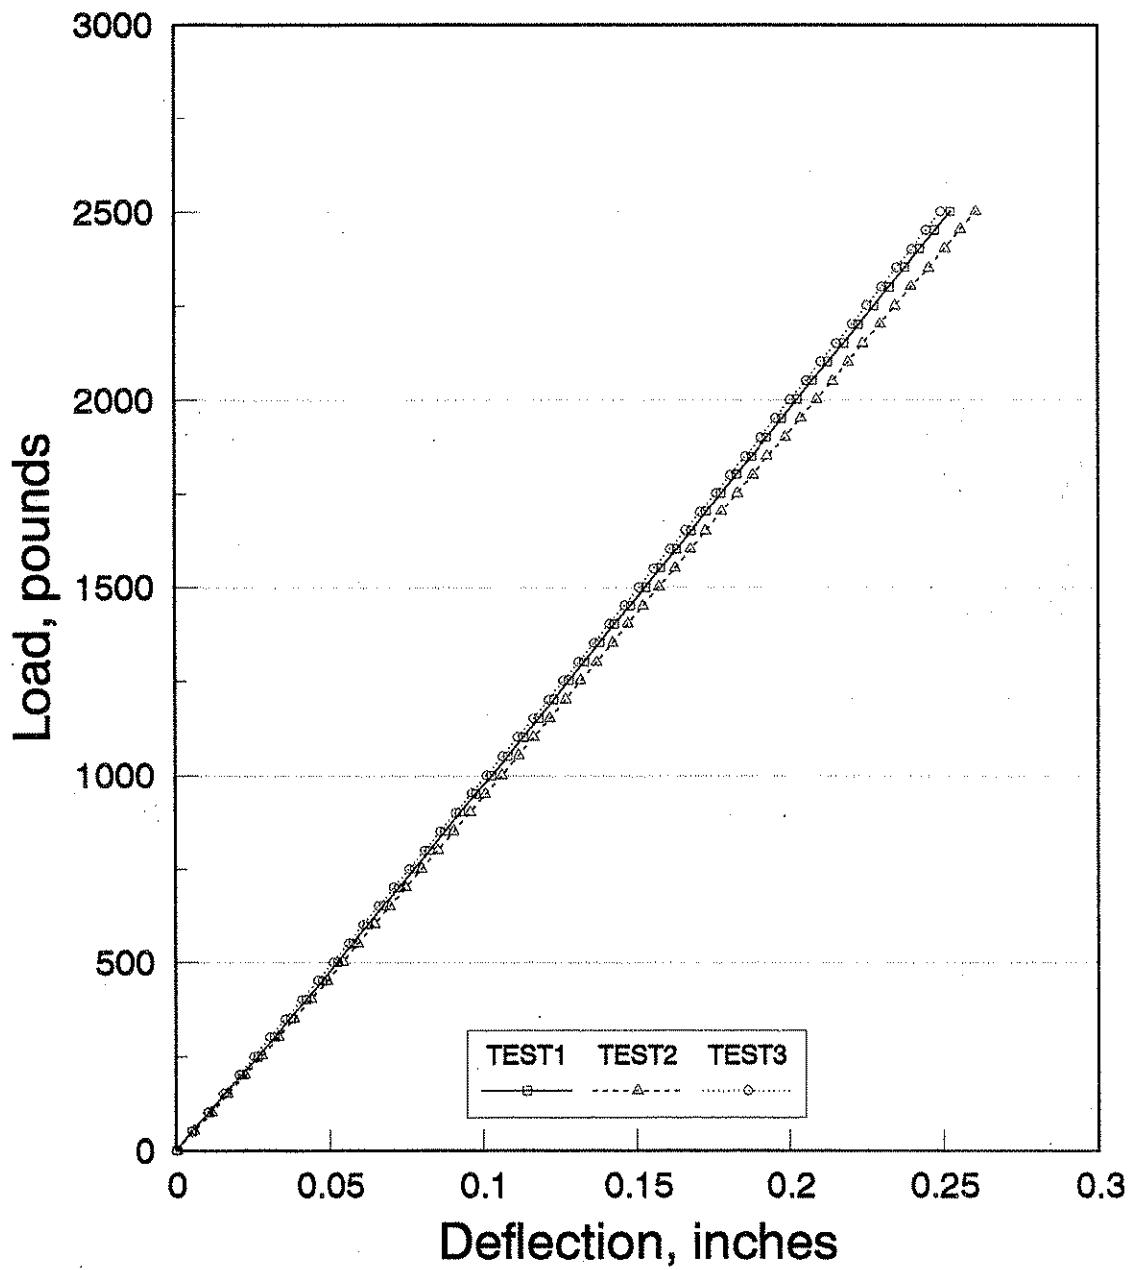
Figure A19. Modulus of elasticity curves for 1.25-in. dowel bars aged in lime

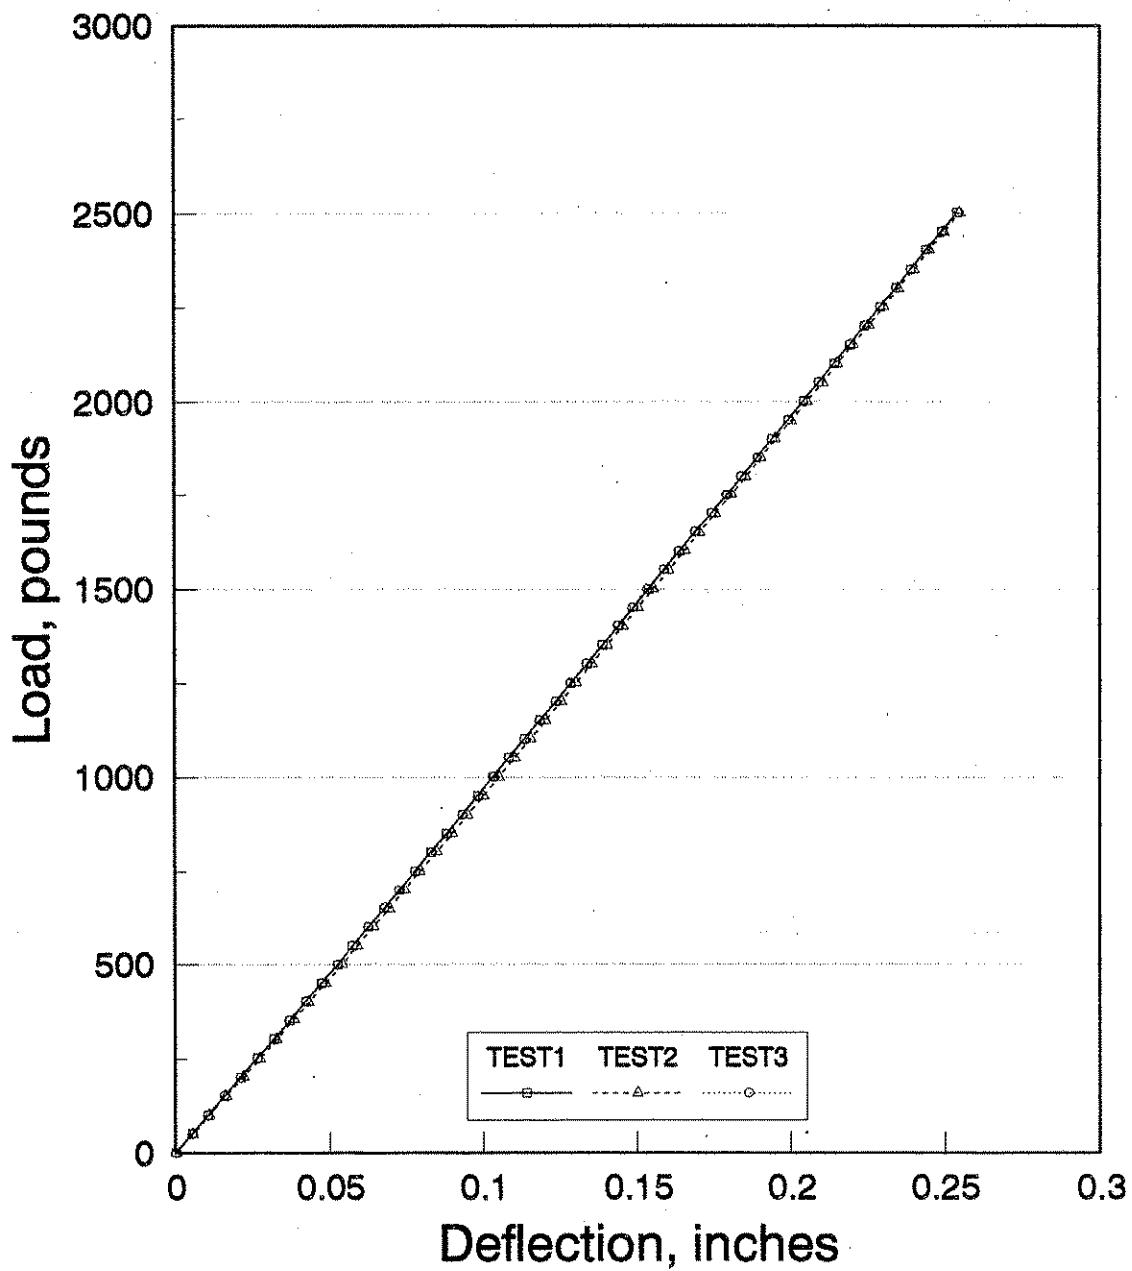
Figure A20. Modulus of elasticity curves for 1.25-in. dowel bars aged in salt

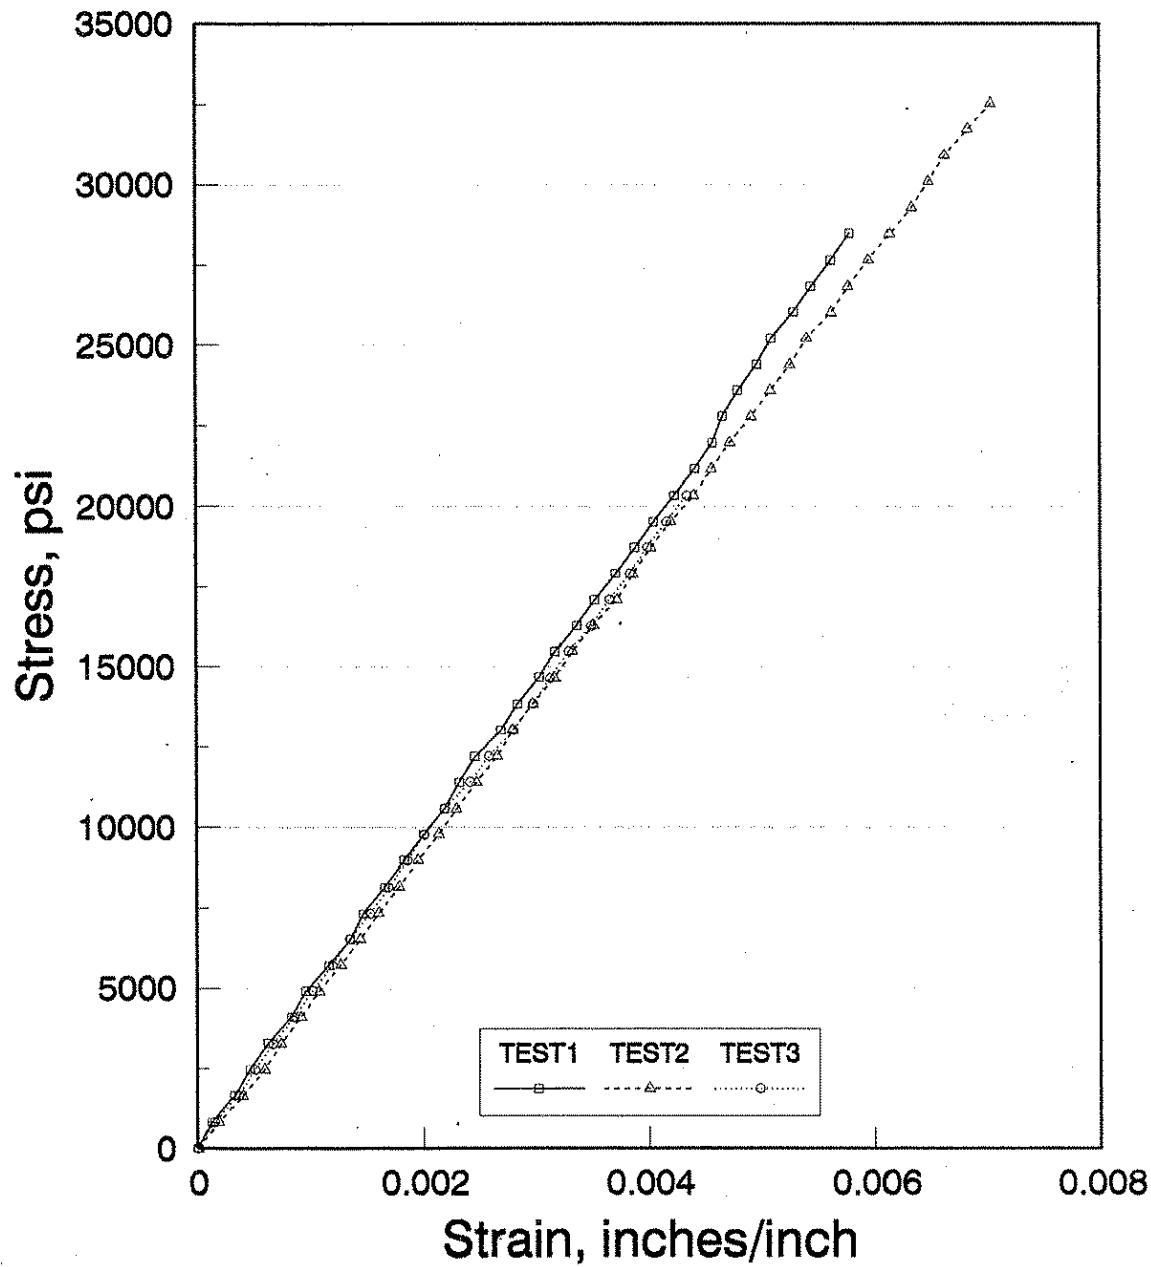
Figure A21. Tensile modulus for Supplier B three-eighths-inch FC rebar

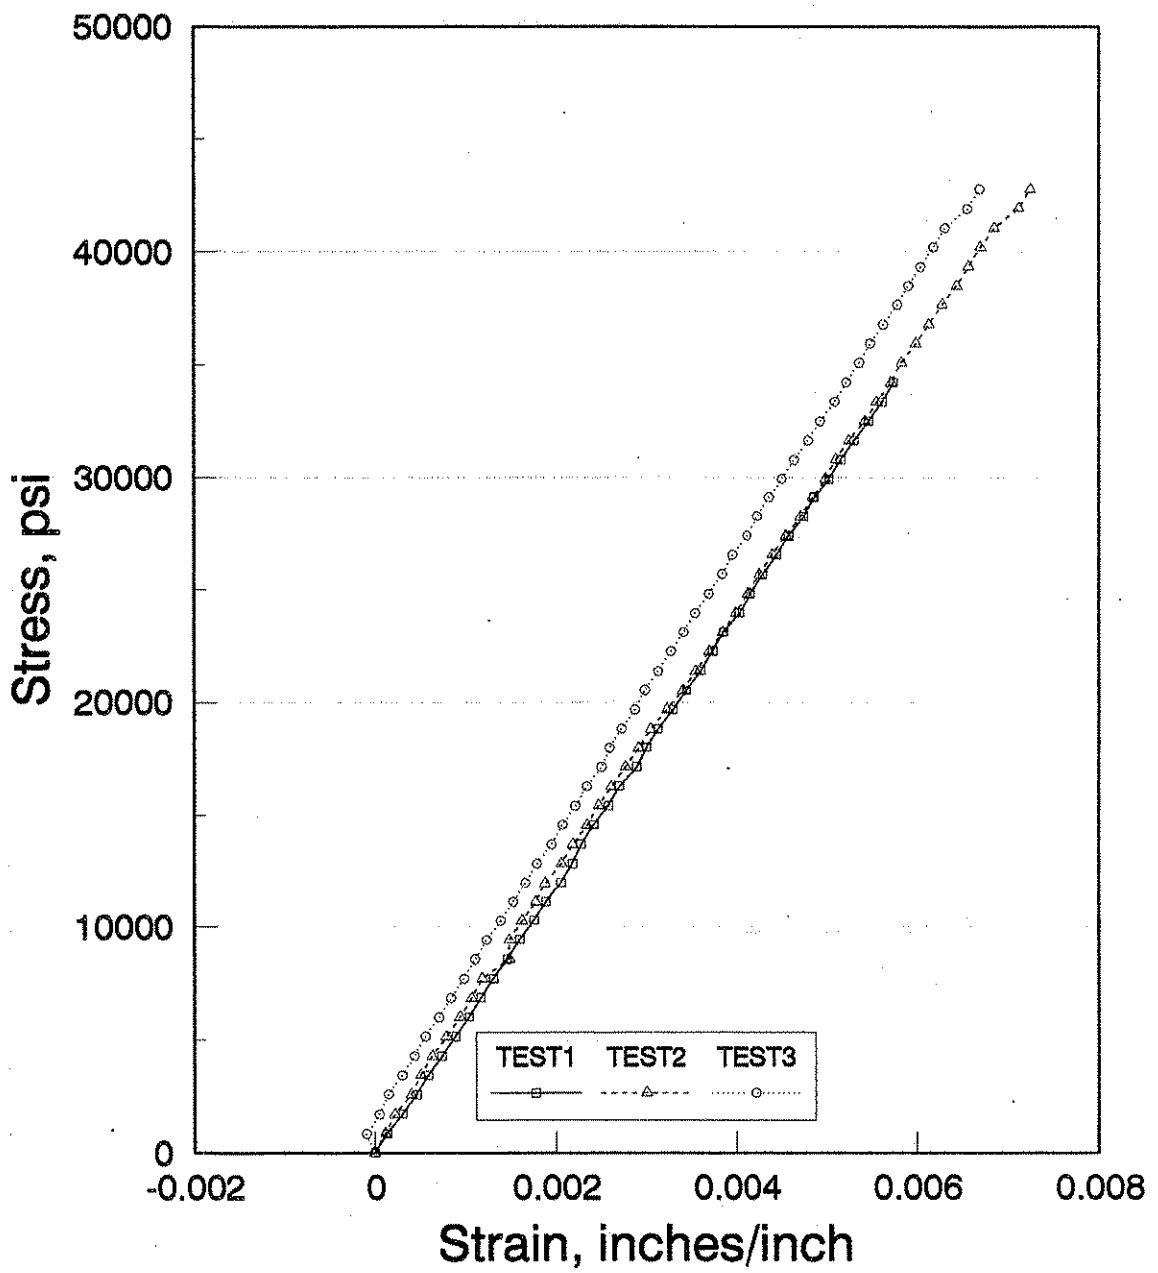
Figure A22. Tensile modulus for Supplier C three-eighths-inch FC rebar

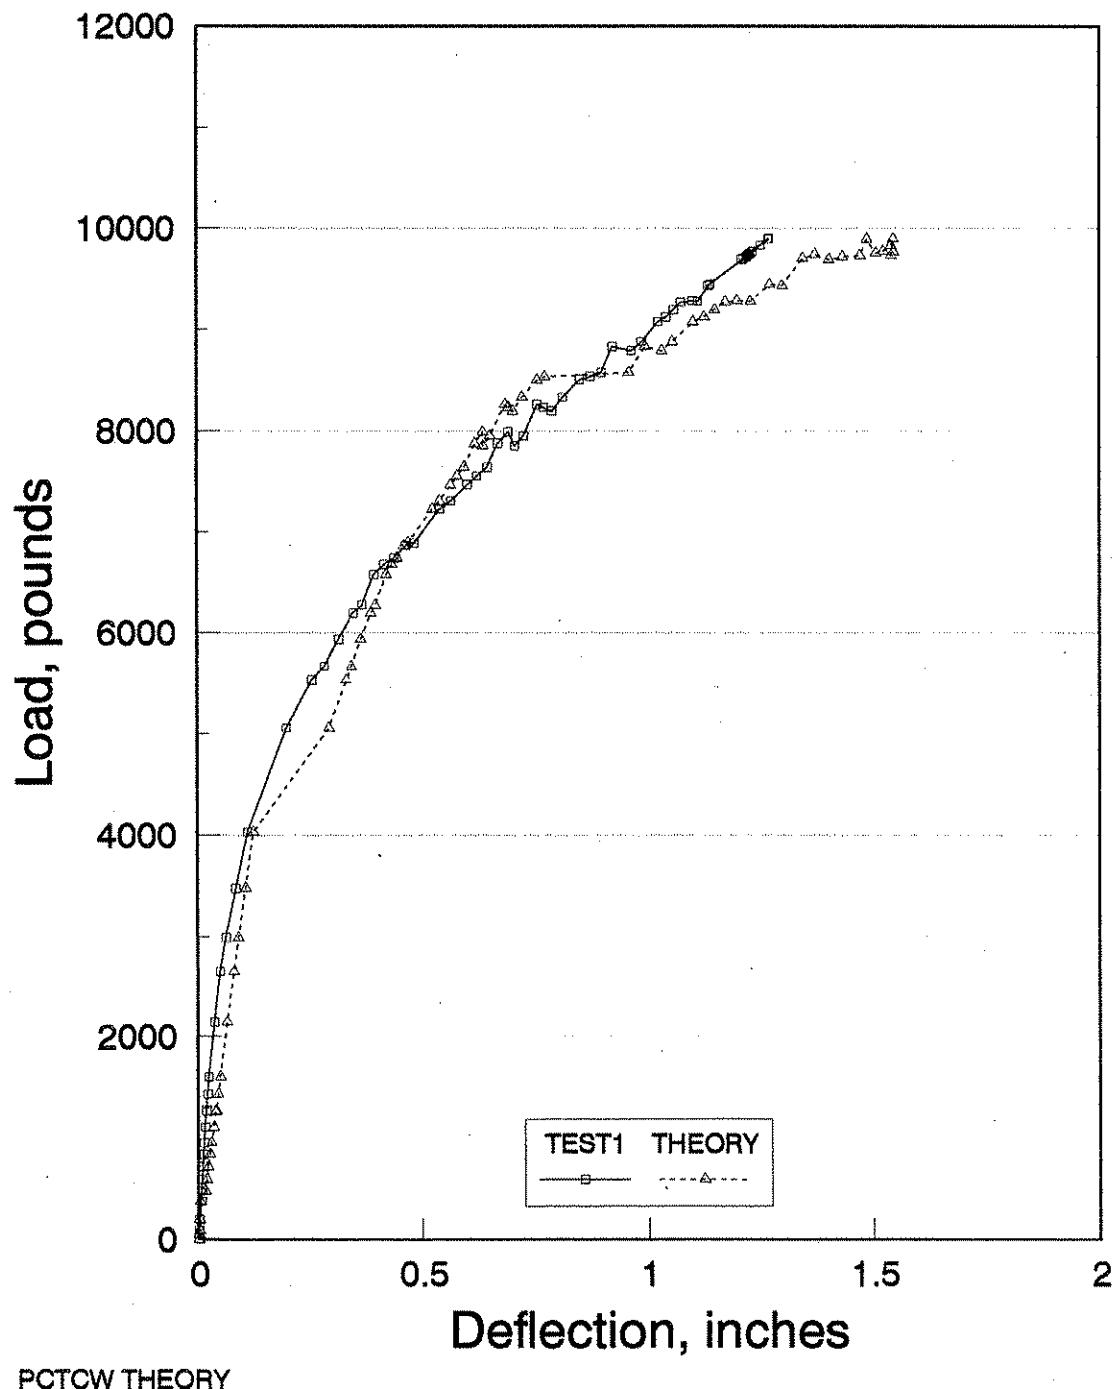
Figure A23. Comparison of approximated and experimental load-deflection curves for B-FC-P-W assembly

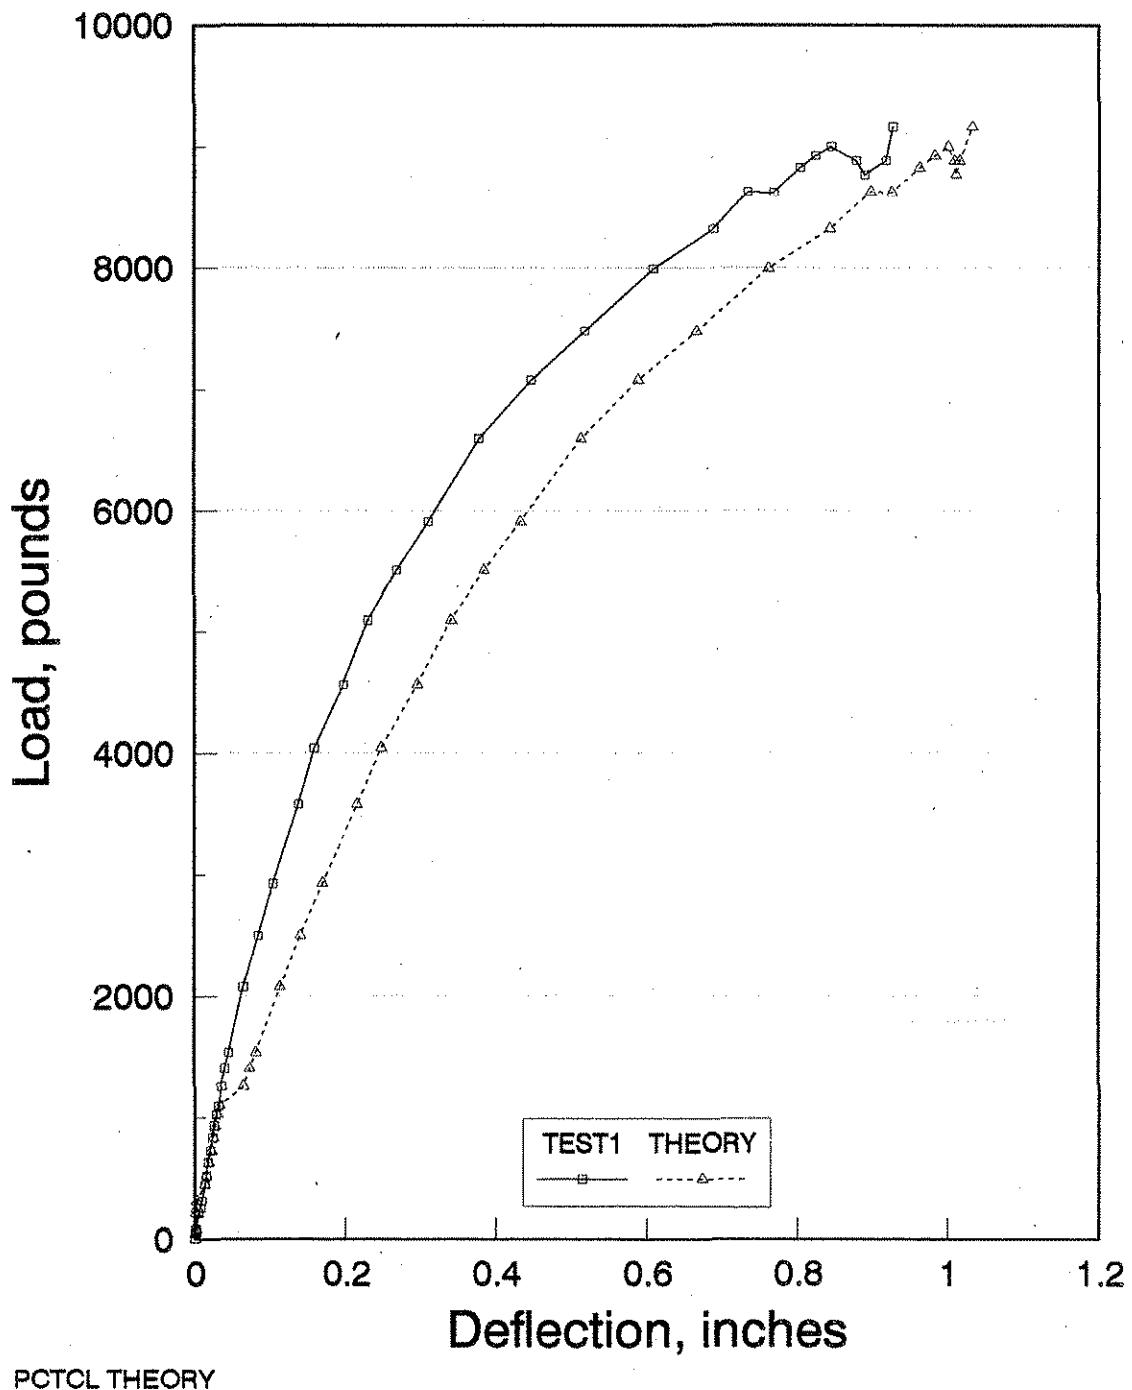
Figure A24. Comparison of approximated and experimental load-deflection curves for B-FC-P-L assembly

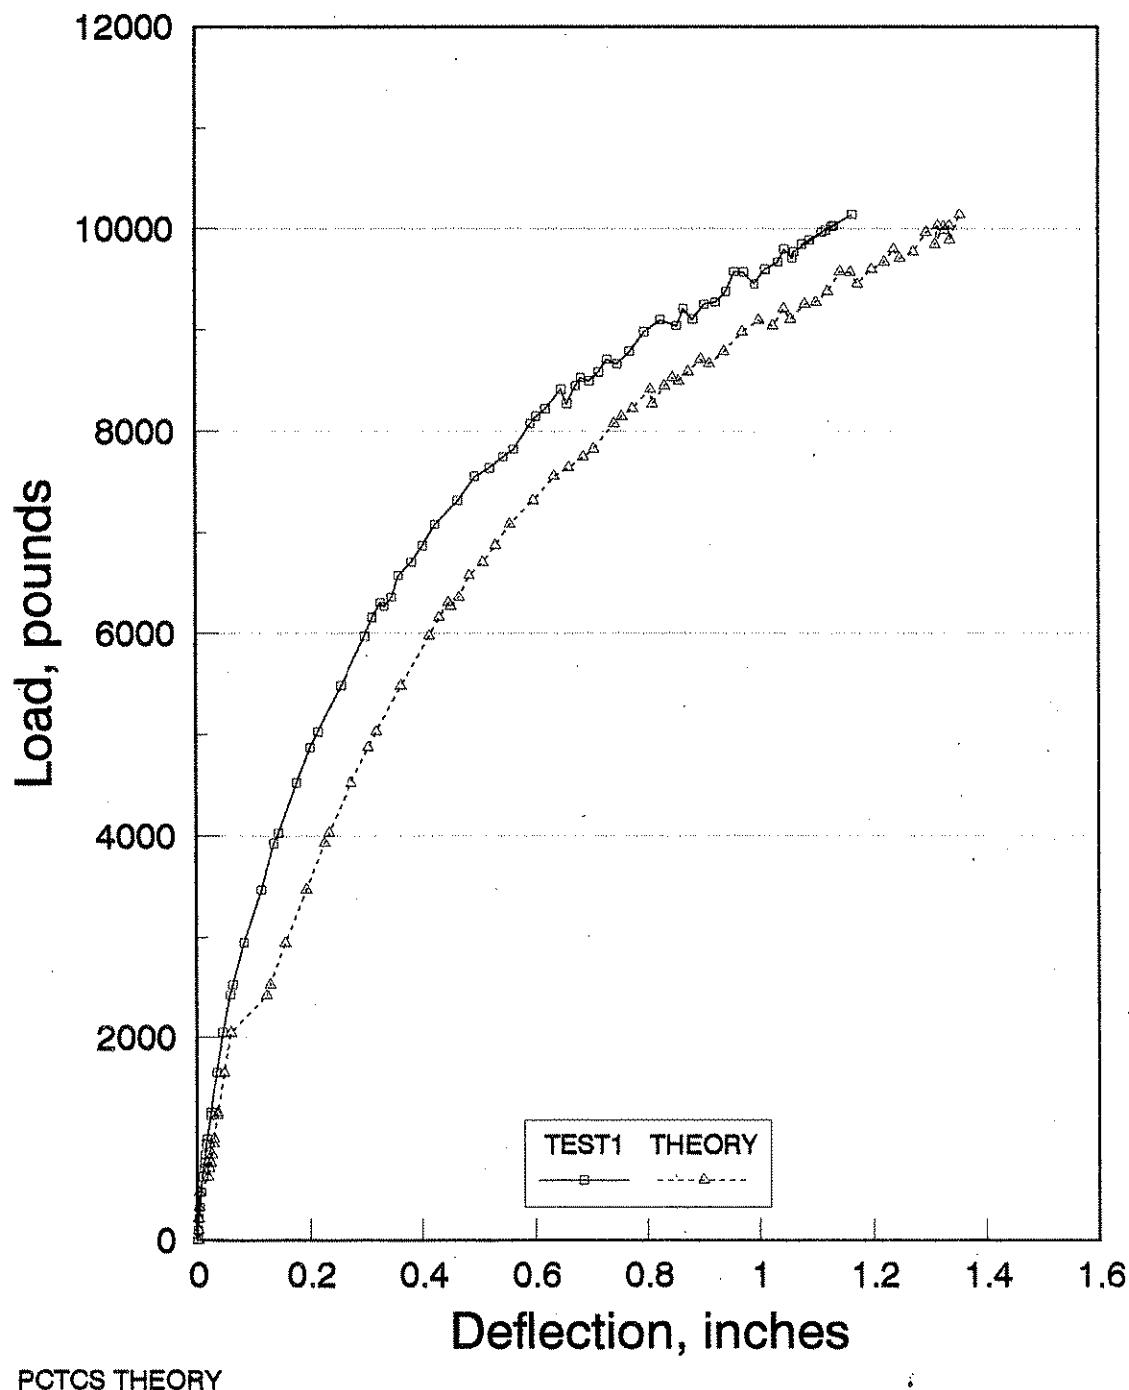
Figure A25. Comparison of approximated and experimental load-deflection curves for B-FC-P-S assembly

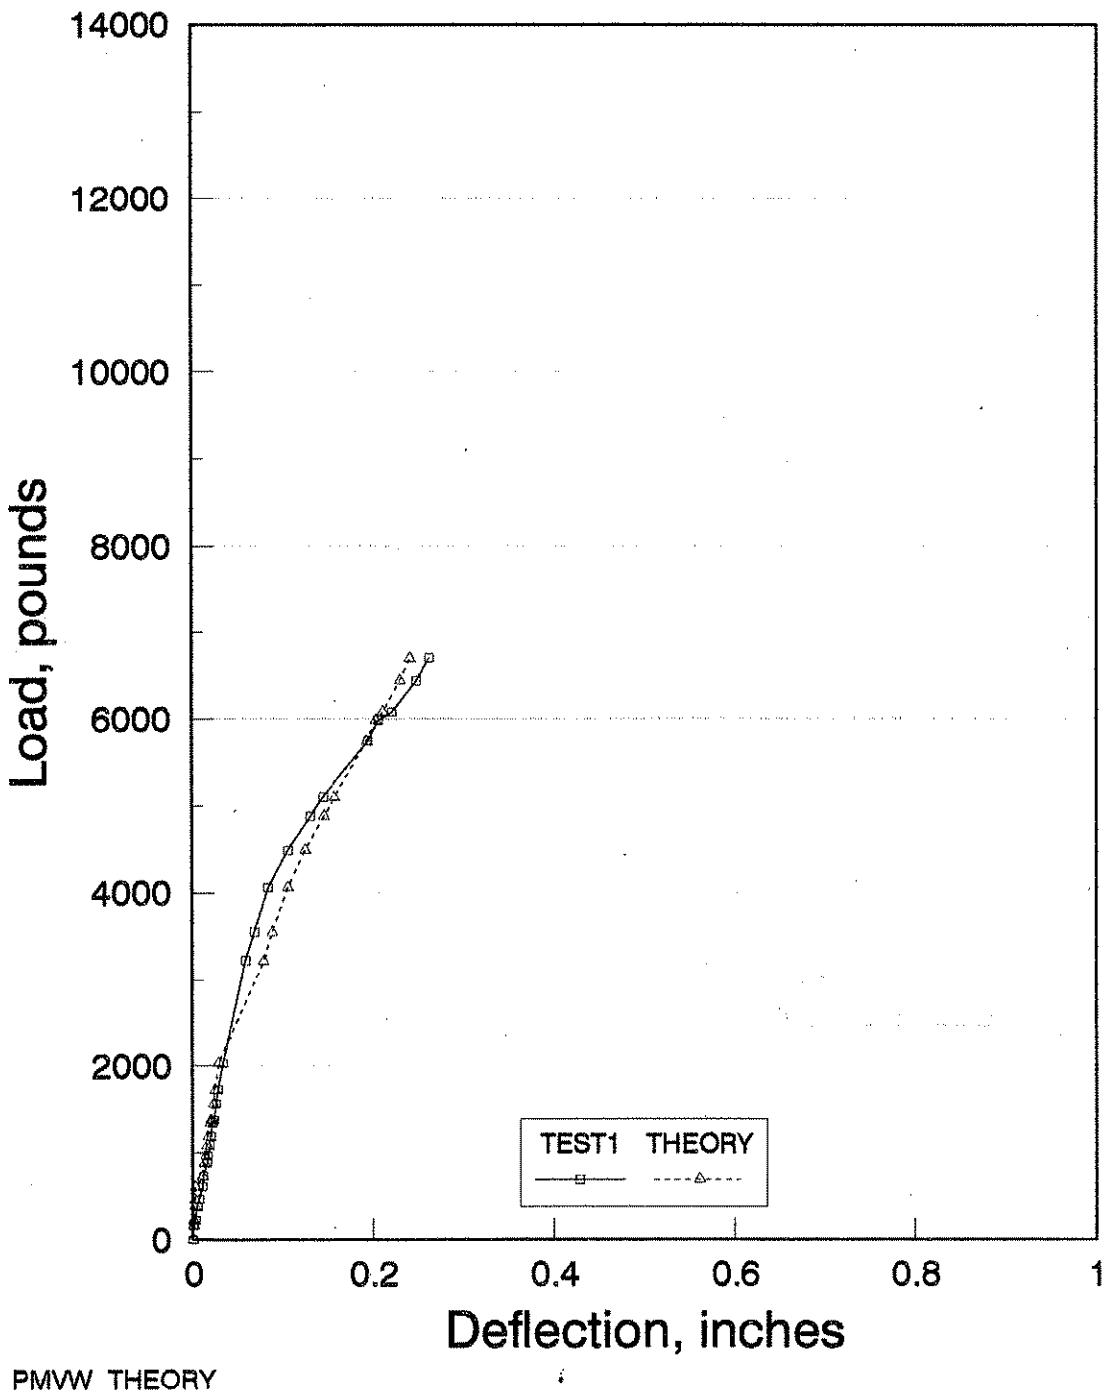
Figure A26. Comparison of approximated and experimental load-deflection curves for C-FC-P-W assembly

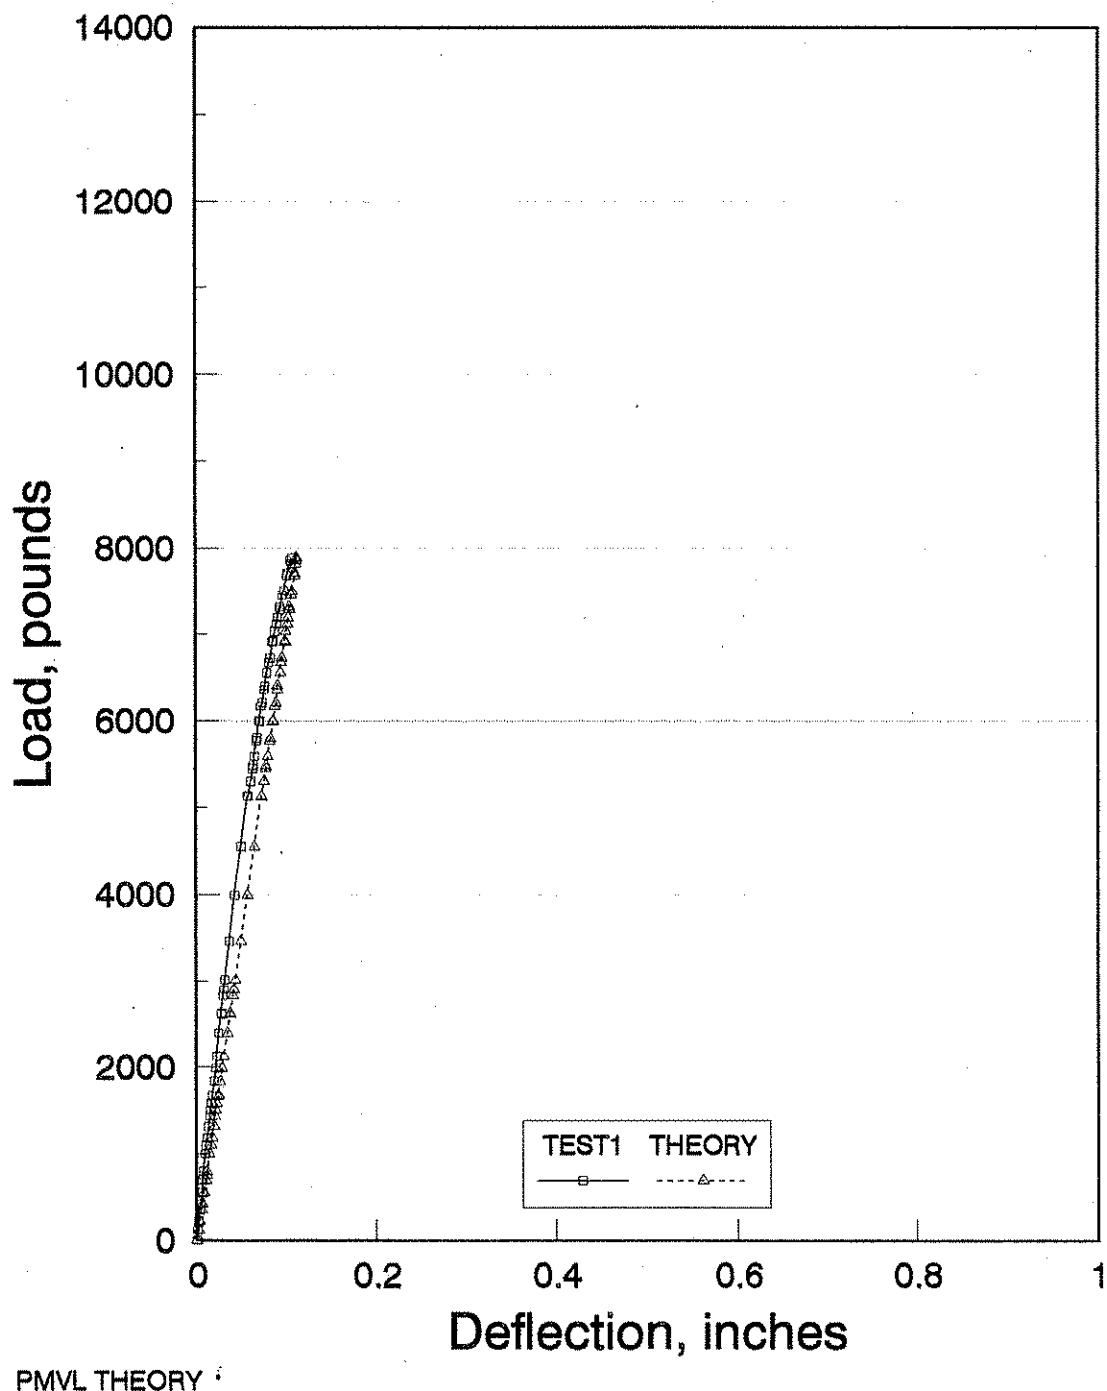
Figure A27. Comparison of approximated and experimental load-deflection curves for C-FC-P-L assembly

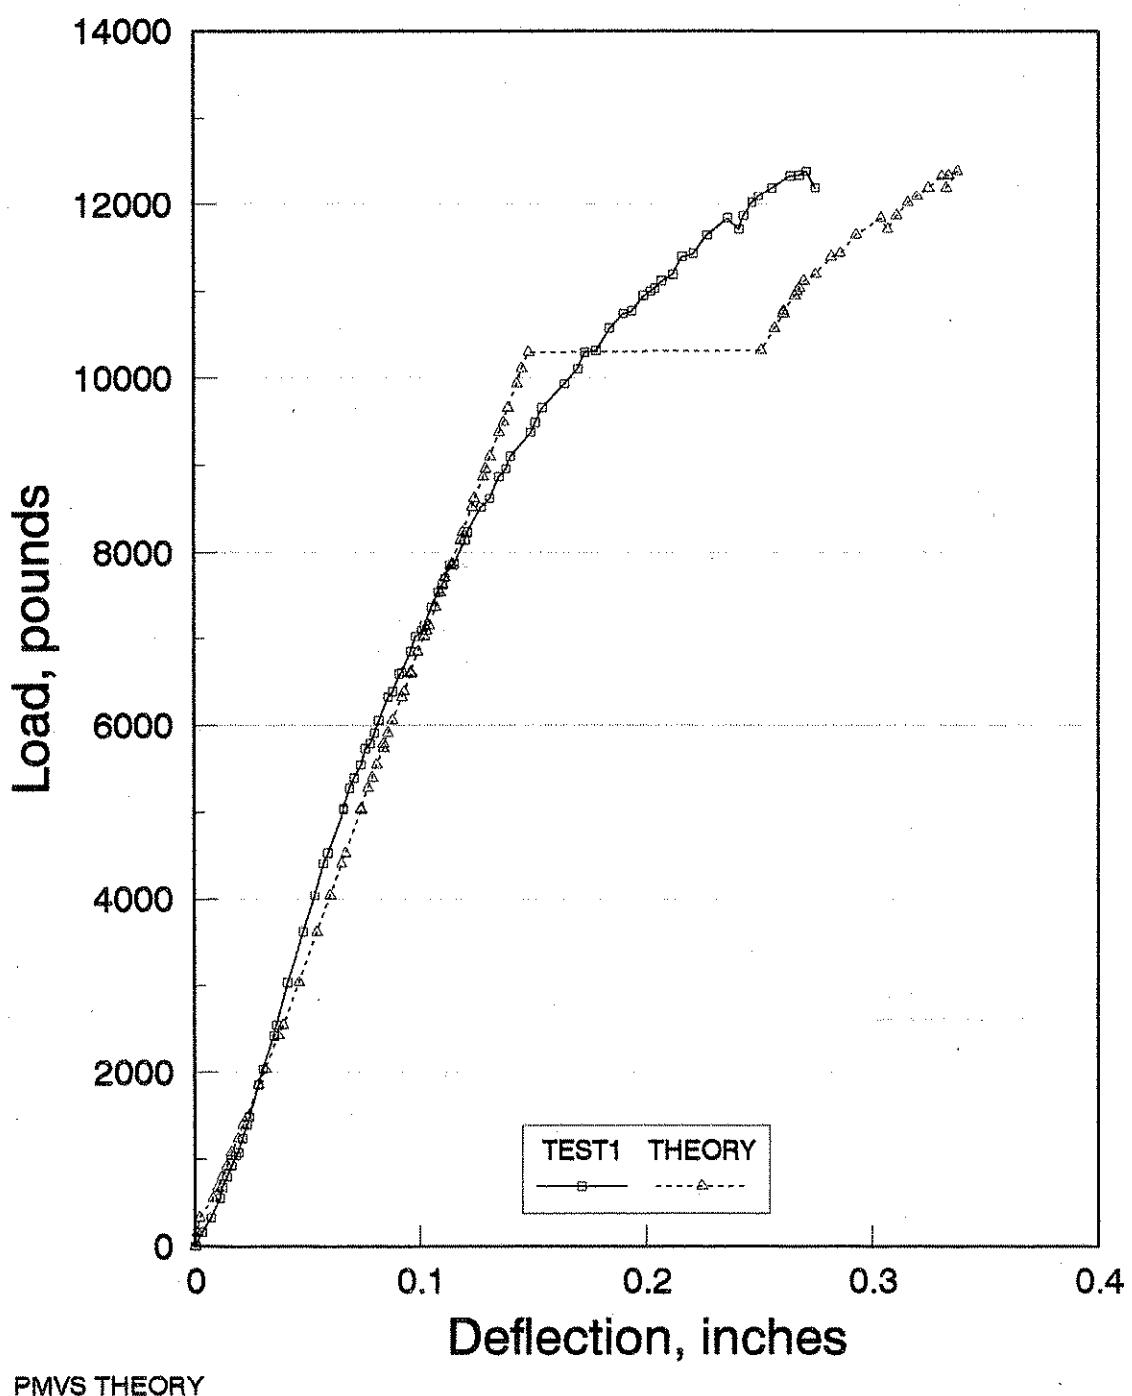
Figure A28. Comparison of approximated and experimental load-deflection curves for C-FC-P-S assembly
