LEXAN GATE ARM

EXPERIMENTAL PROJECT

IA - 86 - 09

INNOVATE CROSSING GATE ARM

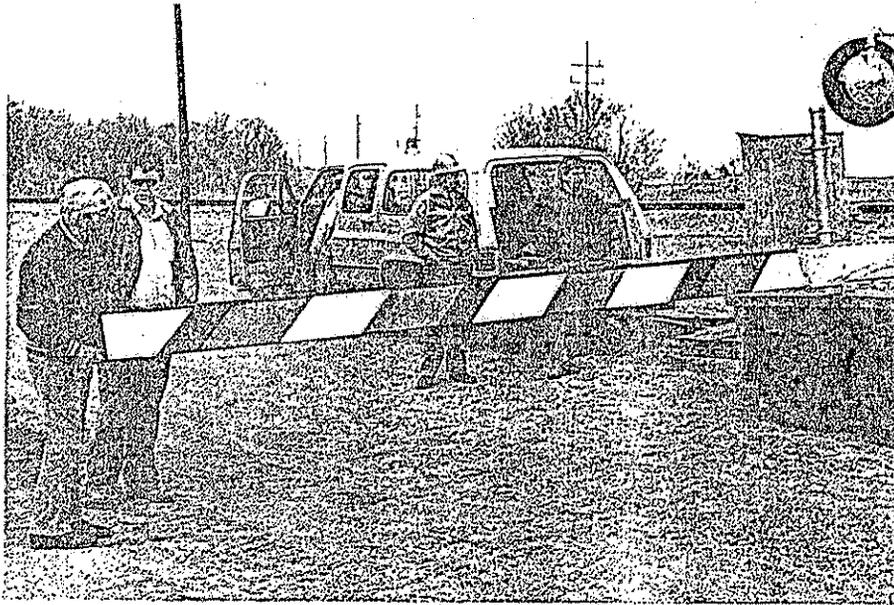
Lexan Gate Arm at 4/18/86 CNW Demonstration

On April 18, 1986, the Department observed a test of the material under field conditions with the Transportation Company. The gate received four mid-center strikes at 5 MPH by a company truck while in the lowered position, and showed no damage. In a fifth mid-center strike at 15 MPH, the gate was visibly damaged at the connection to its raising mechanism, but continued to function though at a 5-10 degree drop. Several pictures of the gate and its saddle mechanism are shown in Appendix A of this report.
