Performance Evaluation of Rubblized Pavements in Iowa

tech transfer summary

Rehabilitation of Concrete Pavements Utilizing Rubblization and Crack and Seat Methods (Phase II): Performance Evaluation of Rubblized Pavements in Iowa

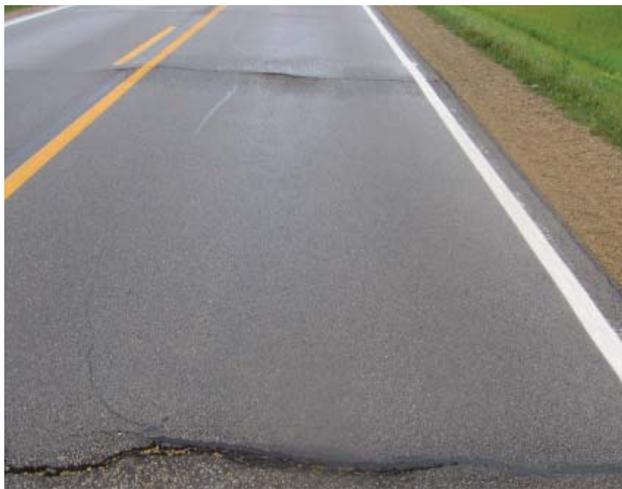
This PCC pavement overlaid with HMA without rubblization of the existing pavement slabs exhibited high levels of reflective cracking.

However, experience has shown that in order to prevent the occurrence of reflective cracking from joints and cracks in the PCC pavement and the reflection of other PCC distresses into the overlaying HMA layers, it is necessary to destroy the slab action of the PCC slabs. Rubblization is the process of breaking the existing pavement slabs into pieces and overlaying them with hot mix asphalt (HMA).

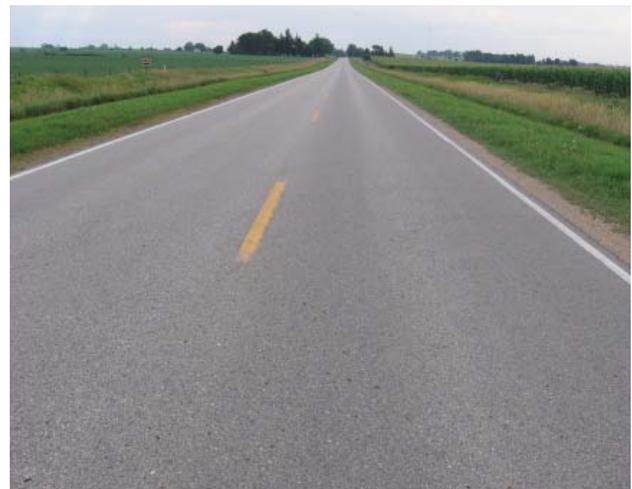
This rubblized PCC pavement overlaid with hot mix asphalt exhibited no cracking.

- Rubblization is a valid option to use in the rehabilitation of PCC under the good support or strength of the foundation.
- Iowa's rubblized pavement sections are performing very well. The predominant distresses exhibited on HMA-overlaid rubblized PCC sections are non-load associated distresses, such as low-temperature cracking and/or longitudinal cracking.
- The average rubberized PCC layer coefficient value in this study was found to be 0.19, which was consistent with that used by Arkansas, Michigan, Mississippi, Ohio, and Pennsylvania.
