**TR-612: Wind Loads on Dynamic Message Cabinets
and Behavior of Supporting Trusses**

**Final Report
May 2013**

George Constantinescu and M. Asghar Bhatti
Department of Civil & Environmental Engineering
and
IIHR-Hydroscience and Engineering Hydraulics Laboratory
The University of Iowa
Iowa City, IA

Terry Wipf and Brent Phares
Department of Civil, Construction, and Environmental Engineering
and
The Bridge Engineering Center at the Institute for Transportation.
Iowa State University
Ames, IA

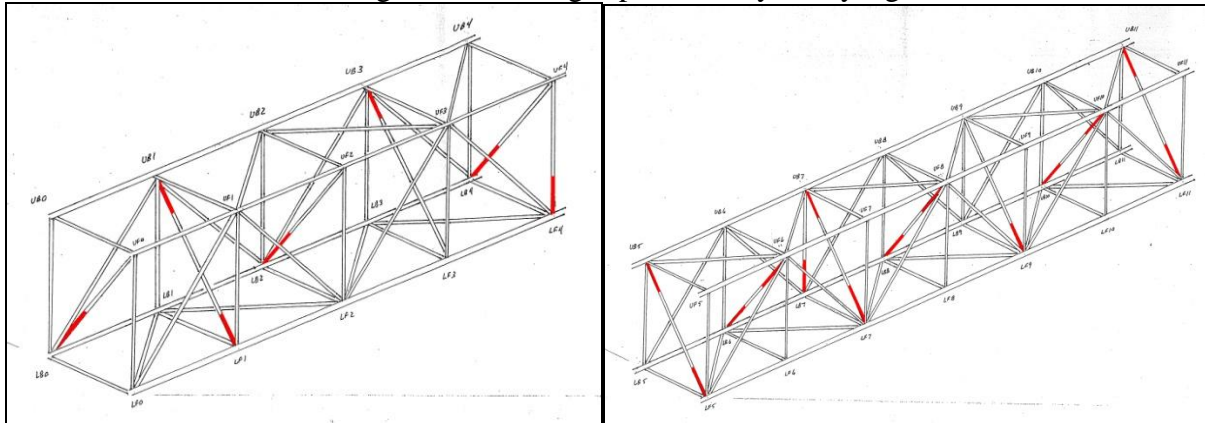
Fig. 1 Crack locations on typical truss structures (Brakke, 2007)

Typical overhead truss structures in Iowa have been made of aluminum alloy with fillet-welded tube-to-tube connections. Aluminum, favored for its light weight and corrosive resistance, however, has much lower fatigue resistance than structural steel. Welding heat reduces the strength of the material based on factors such as welding speed and cooling rate. Moreover, welding of typical aluminum alloy used at overhead truss structures in Iowa removes heat treatment near the welds and thus reduces aluminum properties locally. Geometric discontinuities at tube-to-tube connections also generate significant stress concentrations. The welded connections therefore have high risks of cracks. According to the Action Plan of DMS Trusses from Iowa DOT (Brakke, 2007), 36 trusses were erected from 1993 to 2006 and in 2007 cracks were found in 14 of 19 (74%) inspected DMS trusses. Figure 1 shows typical crack locations on a truss structure. It was found that most cracks occurred at the diagonal members while a few of them occurred on vertical members.

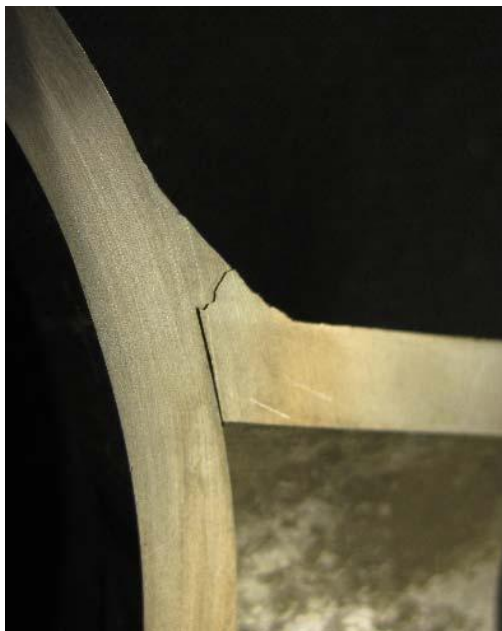
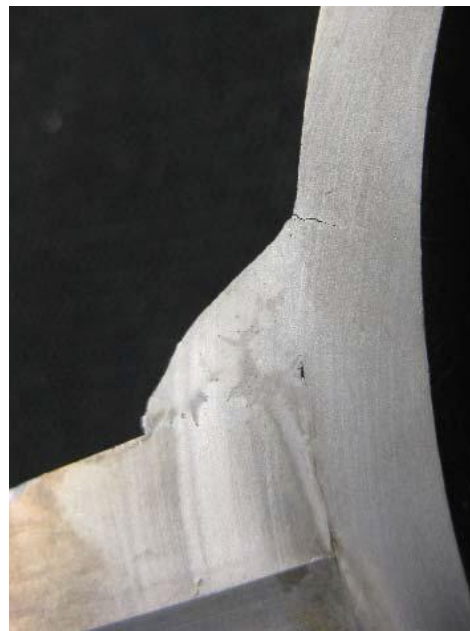
(a). Crack at throat

(b). Crack at toe

Fig. 2 Cracks observed through welded throat and toe (Bowen Laboratory, 2011)

In addition, an evaluation conducted by Purdue University (Bowen Laboratory, 2011) for one of cracked truss structures indicated that the cracks seemed to be brittle fractures caused by extreme loads. A detailed examination of the cracks is shown in Fig. 2. Figure 2a shows that failure occurred at the welding material, which then progressed through the entire weld throat. The diagonal and chord members were also found not to be completely merged. The crack in Fig. 2b occurred near the welding toe and propagated into the base material. In order to predict the behavior of a highway overhead truss structure, detailed understanding of the loads and the

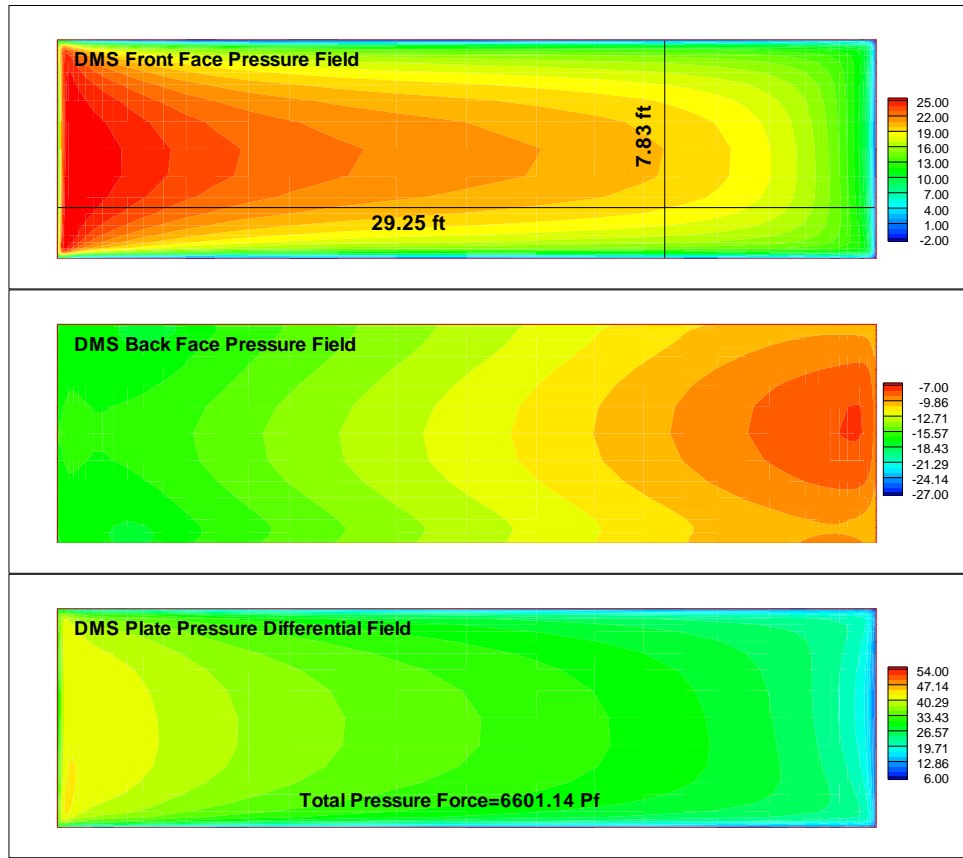
Fig. 5 Distribution of the pressure forces on the front and back faces of the DMS cabinet together with the net pressure force for Case 4 in which the wind direction makes an angle of 67 degrees with the front/back faces

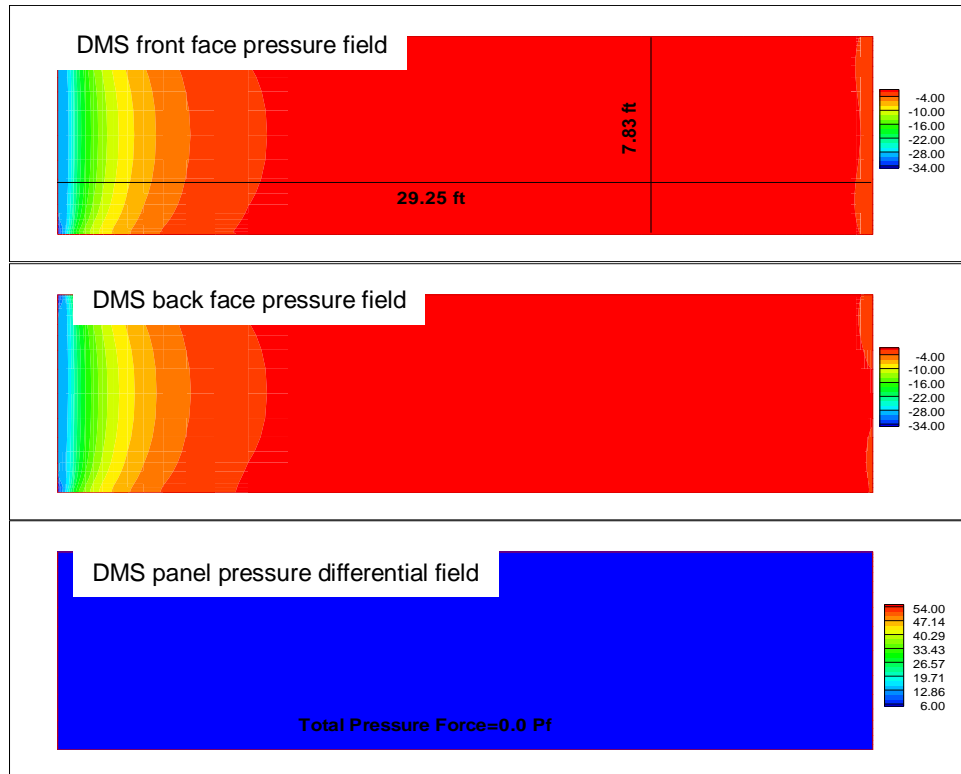
Fig. 6 Distribution of the pressure forces on the front and back faces of the DMS cabinet together with the net pressure force for Case 1 in which the wind direction is parallel to the front/back faces

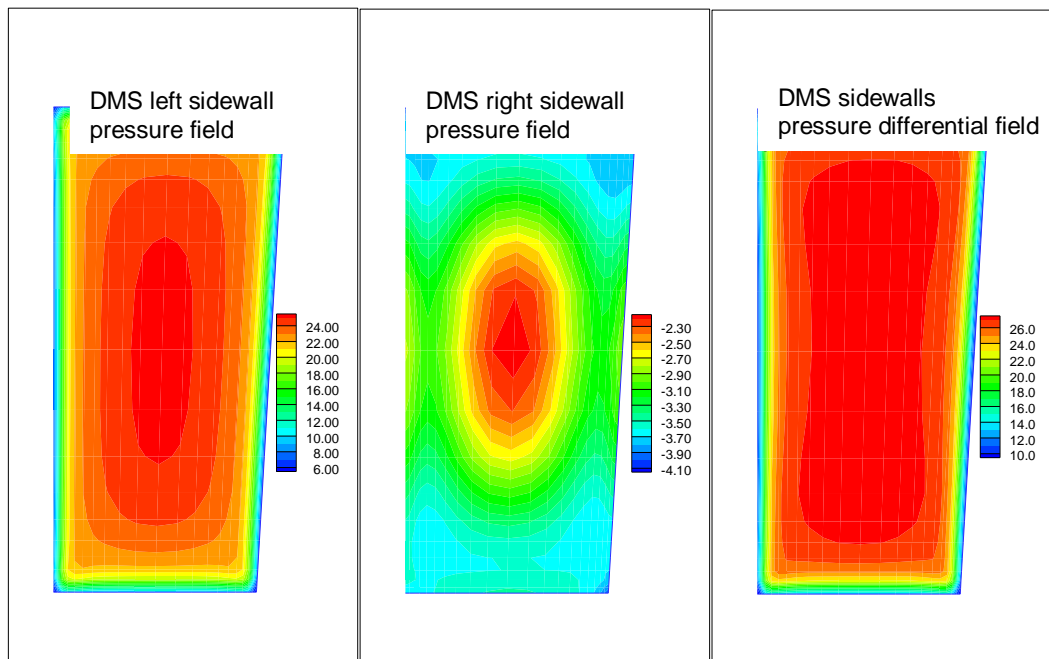
Fig. 7 Distribution of the pressure forces on the two sidewall faces of the DMS cabinet together with the net pressure force for Case 1 in which the wind direction is parallel to the front/back faces and perpendicular to the two sidewall faces

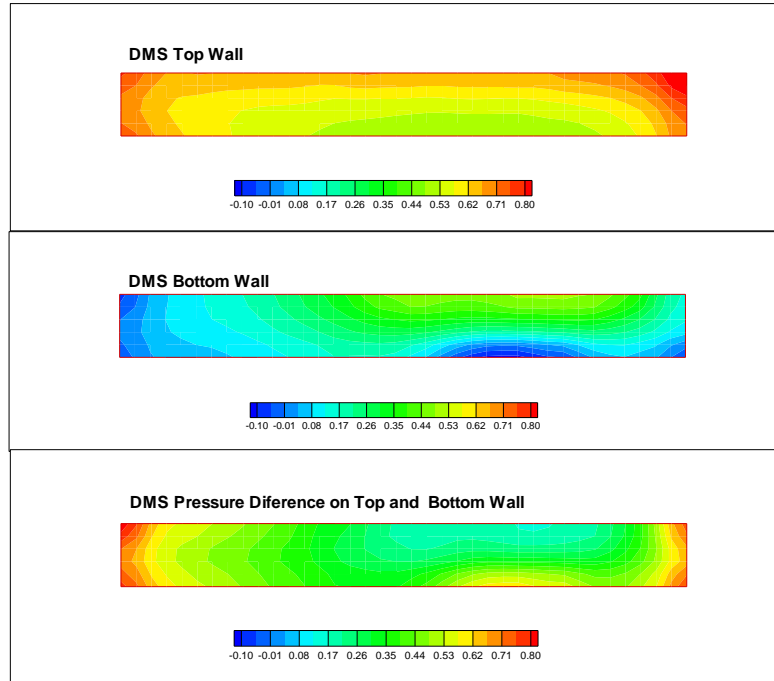
Fig. 19 Non-dimensional pressure distributions, $p/\rho U^2 \cdot 1000$, on the bottom and top faces of the DMS cabinet for the case of a ‘very long’ truck and no wind. Last frame shows the distribution of the non-dimensional pressure difference between the two faces, $\Delta p/\rho U^2 \cdot 1000$.

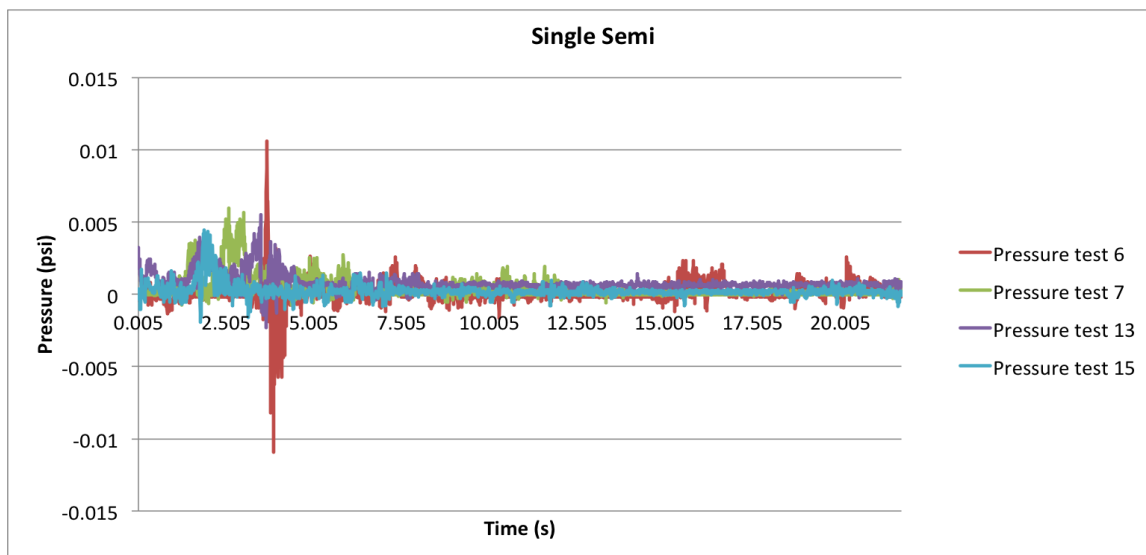
Fig. 21 Pressure data collected as part of the field experiment

A total of 10 cases were captured with varying results. The interstate was not being controlled and many of the cases involved multiple trucks that had a lesser effect on the pressure than a single semi. The trials gathered could be narrowed to 4 instances when a single truck passed underneath the DMS cabinet. Figure 21 shows a plot of the pressure on each of these runs.

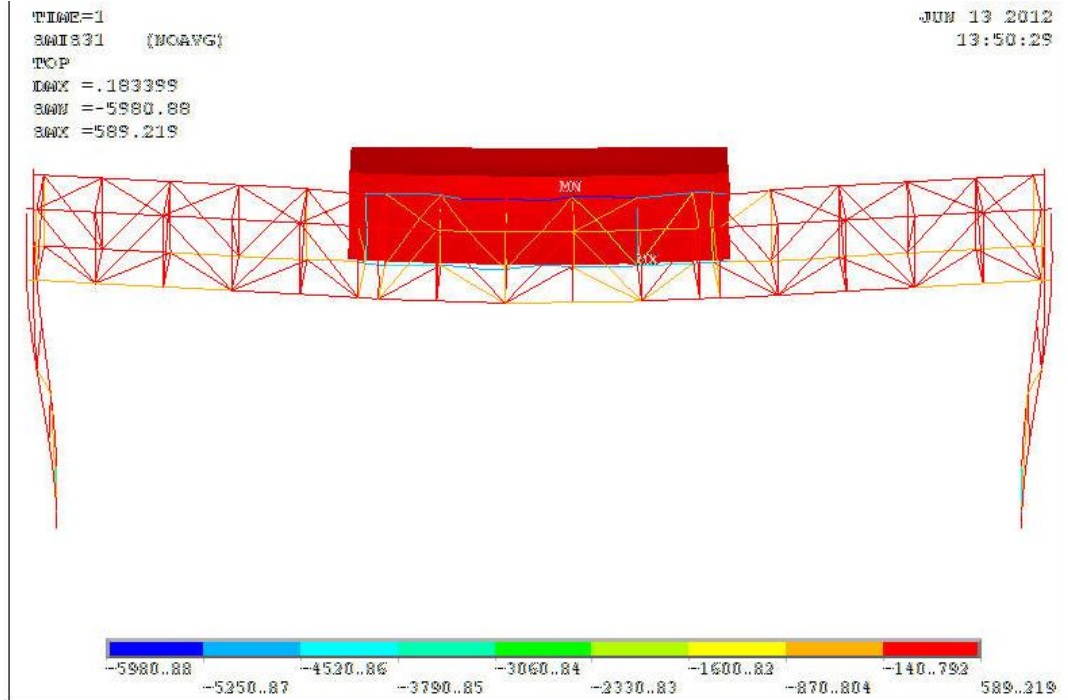
Fig. 25 Axial stress due to thermal expansion (back view)

The largest stress points are directly behind the sign (Fig. 25) and at the first rung of the main supports (Fig. 26). These values range from 500 psi in tension to 6000 psi in compression.

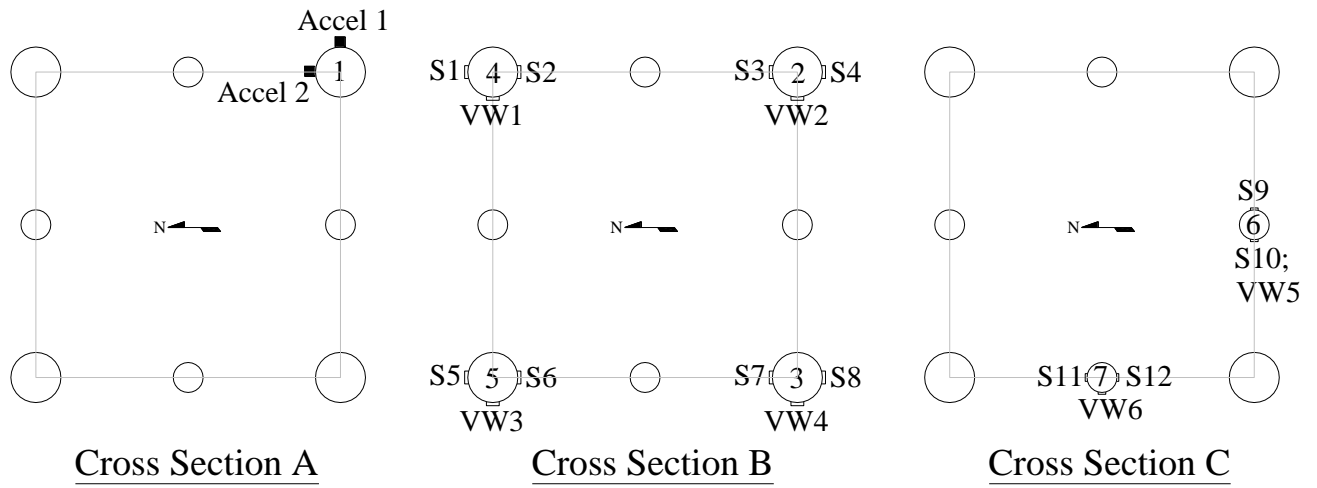
Fig. 32. Ames DMS Truss chord instrumentation configuration.

There were a total of 18 strain gages installed on the Ames DMS truss. At Cross Section B near midspan, shown in Figs. 31 and 32, 12 strain gages were installed on the chord members. Each chord member was instrumented with two Hitec strain gages and one VW strain gage. The remaining six strain gages were installed at Cross Section C and consisted of two Hitec strain gages and one VW strain gage on a diagonal in the vertical plane of the South truss and two Hitec strain gages and one VW strain gage on a diagonal in the horizontal plane of the bottom truss.
