Lake Hendricks
Watershed Project
#1118-007

Final Report

January 1, 2012 to June 30, 2013

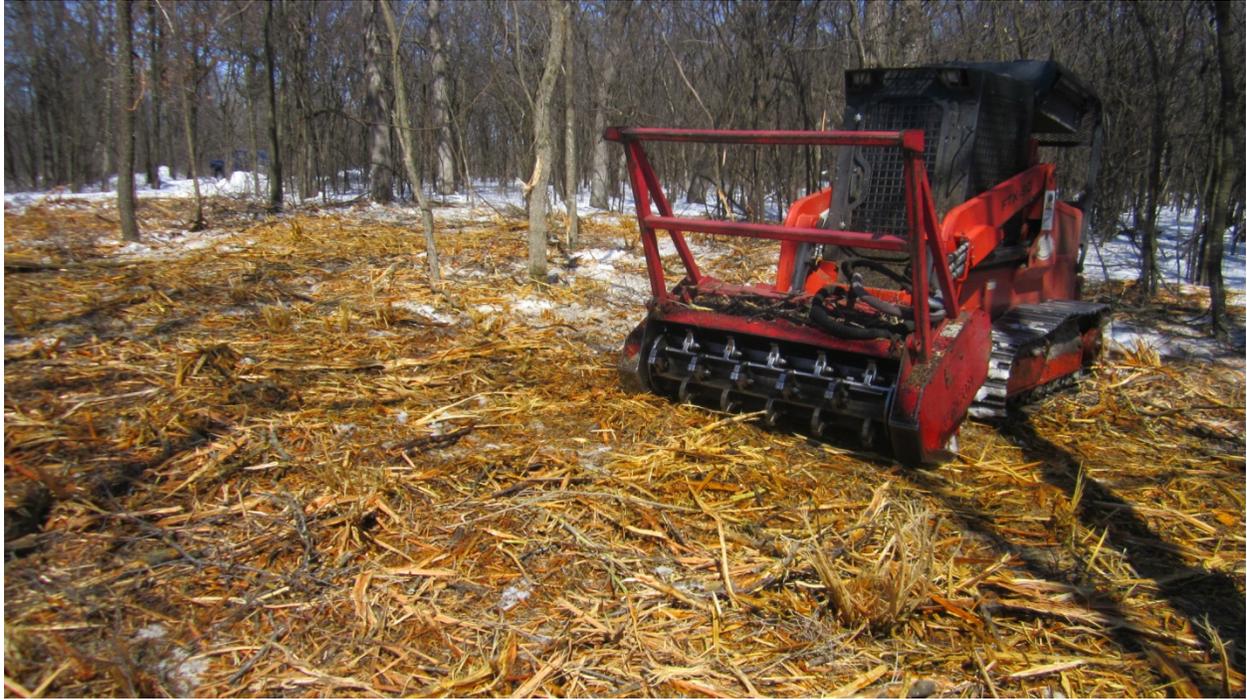
Photo 1: Forestry Mower Grinding Common Buckthorn

The limited availability of a forestry mower and adverse weather conditions were the greatest challenges of this project. At the onset of the project the main goal was to locate a forestry mower to grind down the invasive common buckthorn as a method of removal. The project planners had seen the machine used to eradicate brush at a forestry field day but finding one in the area was a challenge. A machine and contractor were located but with only one known forestry mower in the area scheduling became the next challenge.

Unfortunately by the time the contractor was available to come to Lake Hendricks the winter weather made a turn for the worse and the accumulated snowfall made accessibility nearly impossible. We had to wait until the snow receded before the contractor was able to work. The conditions were not ideal so some of the steeper slopes that were part of the proposed area were inaccessible but the rest of the planned acres were completed in a quality manner.

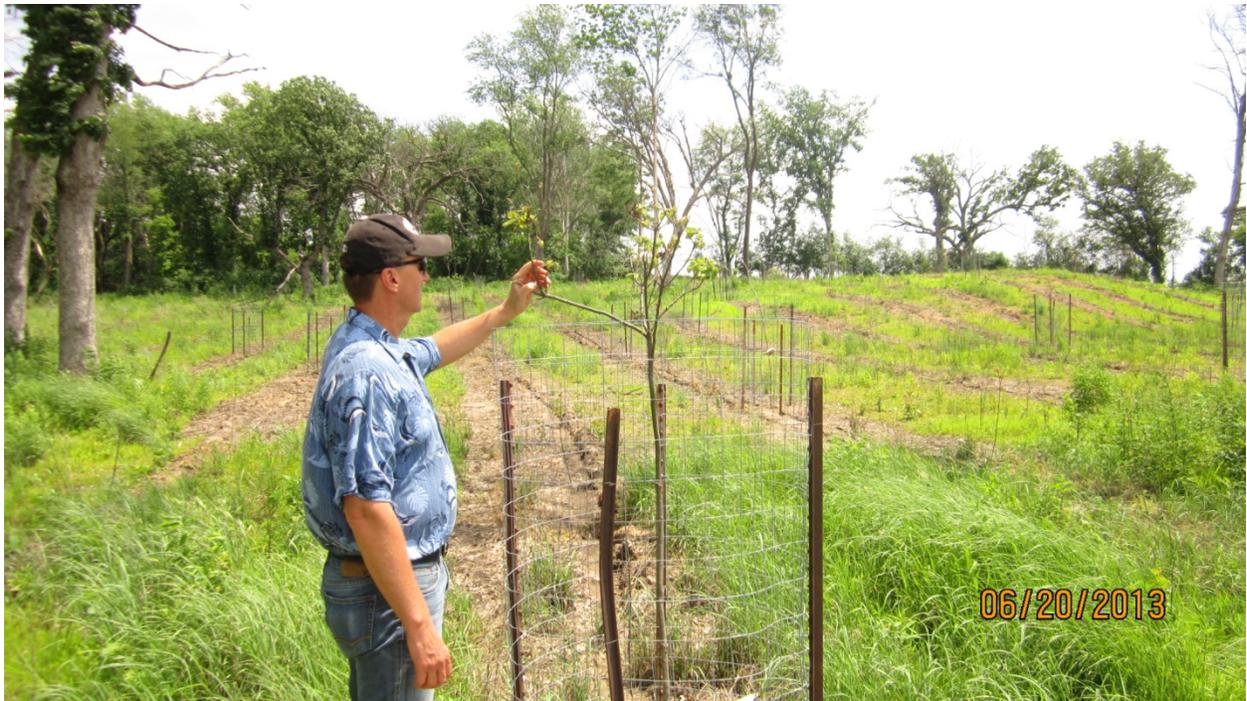
Photo 2: The 7.2 acre tree planting

The TSI practices differed from the initial approved application by including 7.2 acres of tree planting and 6.0 acres of invasive species removal as part of an agreed amendment between WIRB and the Howard SWCD. The approved application budget planned for 25 acres of mechanical invasive species removal. Snow accumulation restricted the contractors from accessing several planned removal sites with the forestry mower so the HCCB and IDNR District Foresters met to discuss the active forestry plan to see where other practices could be applied. It was proposed that 6.0 acres of invasive trees could safely be removed with the forestry mower and a separate 7.2 acre clear-cut could be planted with trees to provide native woodland cover. The 7.2 acre previously clear cut area was planted with 105 5’-6’ tall swamp white oak, burr oak, and red oak trees, 35 4’-5’ white oaks trees, and 2,100 seedlings of the same four species.

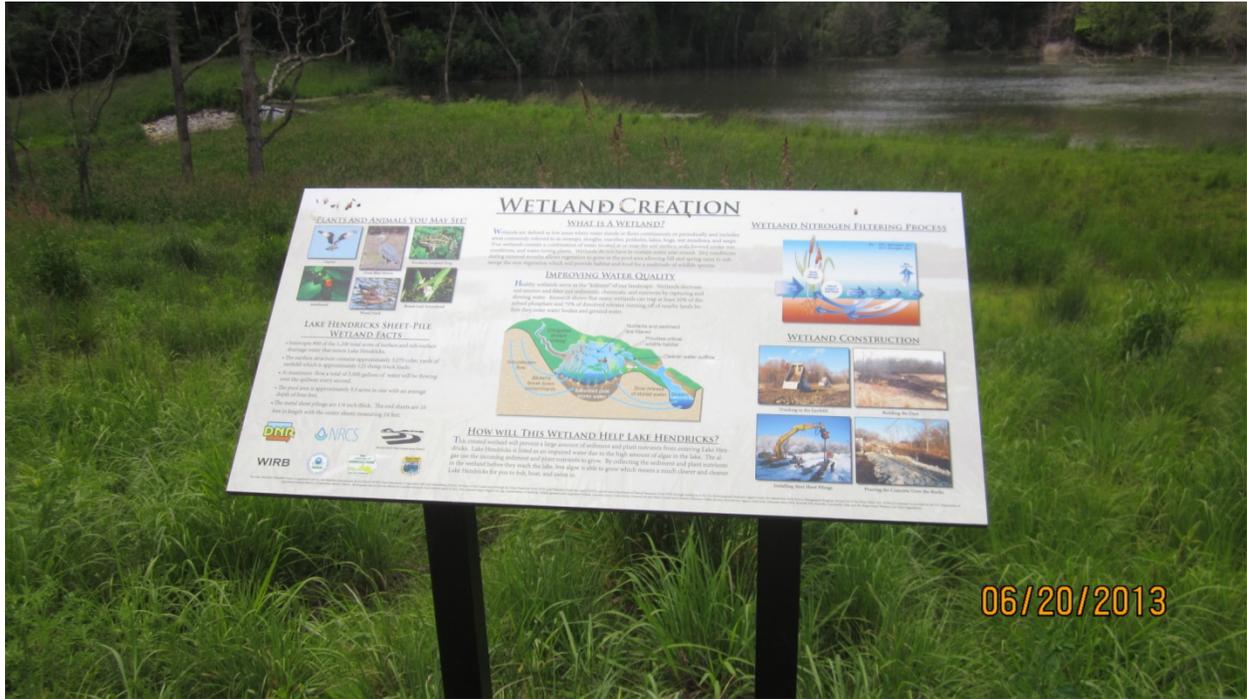
Photo 3: The “Wetland Creation” Interpretive Kiosk Panel

The completed interpretive kiosk panels, publications, and public outreach efforts are continuing to work to increase the public awareness of the water quality improvement efforts of the LHWP. The kiosk panels provide park users with information about the implemented conservation practices at Lake Hendricks as well as knowledge about preserving Iowa’s native habitat. The multiple field days that were held worked show project partners and community members firsthand the positive impact that partnerships can have in improving water quality.
