Norfolk Creek Subwatershed Project

#6001-001

Final Project Report

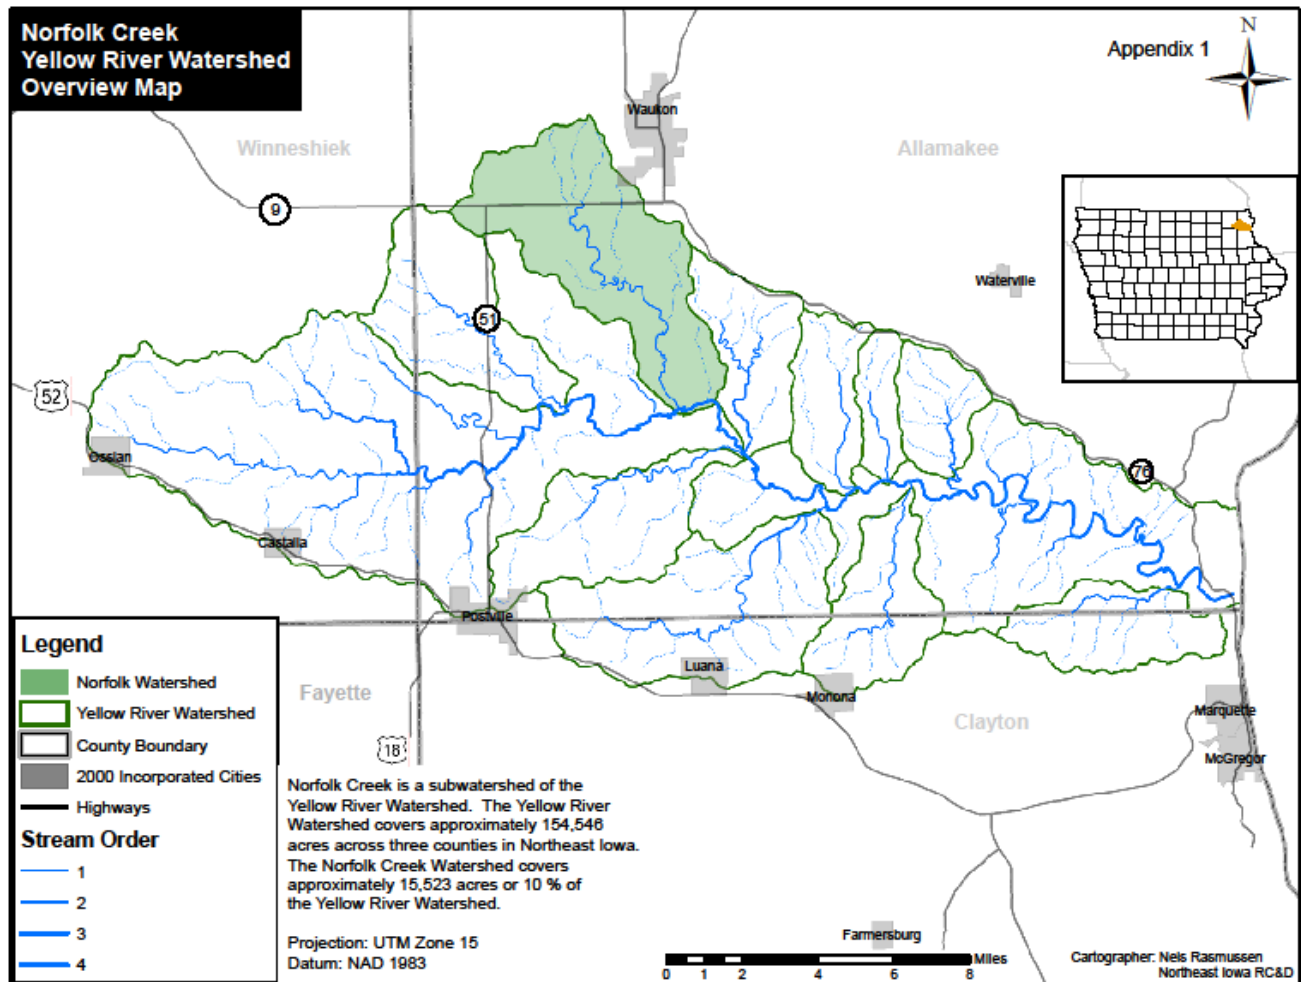
Figure 1: This chart shows the installed practice totals in the Norfolk Creek Subwatershed Project.

The goal of the Norfolk Creek Subwatershed Project was to install 11 grade stabilization structures, 13 sediment control basins, and 68,000 feet of terraces. A total of 3 grade stabilization structures, 5 sediment control basins, and 37,675 ft of terrace were constructed.
