Measuring Pavement Profile During Construction

tech transfer summary

Measuring Pavement Profile at the Slip-Form Paver

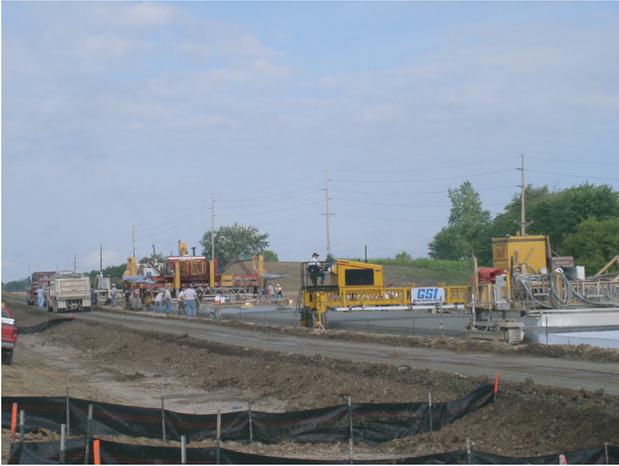
Measuring pavement profile during construction using the GOMACO Smoothness Indicator (GSI)

The GSI is a noncontact pavement profiler that can be used to measure the pavement profile of either wet or hardened concrete. The system includes a computer and wheel path sensors that can be mounted on the slip-form paver or on a GSI vehicle that follows the paver. The computer displays and records the data as they are collected by the sensors. The GSI provides the data in a variety of useful formats, including as International Roughness Index (IRI) and Profilograph Index (PI) values.

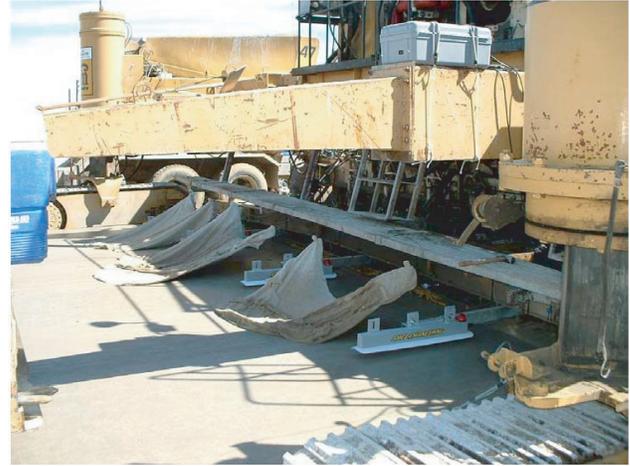
Measuring pavement profile during construction using the Ames Engineering Real Time Profiler (RTP)

The RTP is a laser-based profiler system that uses wheel path sensors and a computer to measure and record the pavement profile during construction. The sensors can be mounted on the slip-form paver or other equipment such as the curing and tining machine in a number of different arrangements. A laptop computer on the paver displays and records the data as they are collected. The RTP provides the data in a variety of useful formats, including as International Roughness Index (IRI) and Profilograph Index (PI) values.
