BOND ENHANCEMENT TECHNIQUES FOR PCC WHITETOPPING

**Final Report
Iowa Highway Research Board
Project HR-341**

Final Report
for
Iowa Highway Research Board
Project HR-341

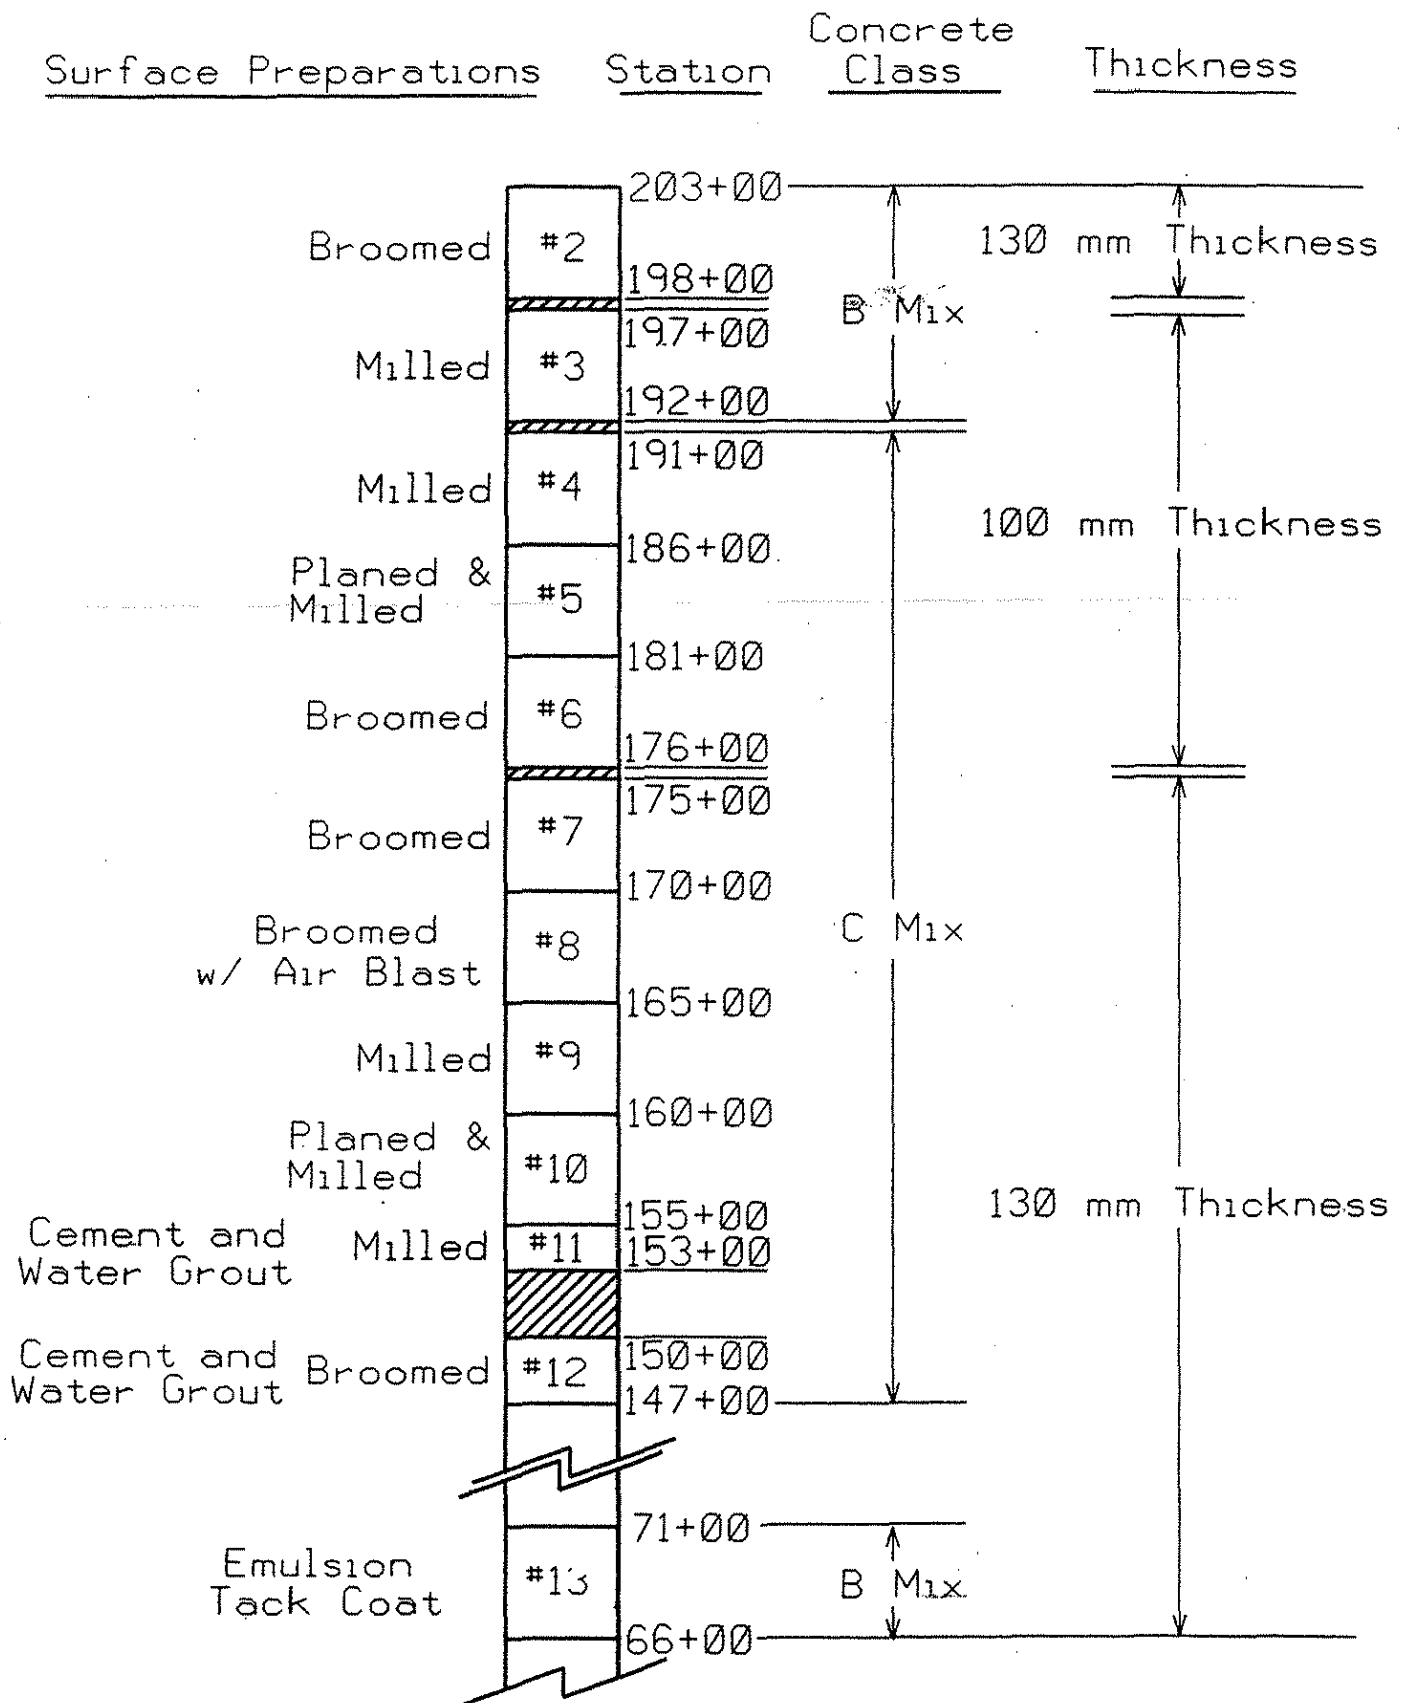
FIGURE 1
Test Sections Layout

The research test sections were developed to evaluate several factors. Eight variables were tested. Figure 1 lists the makeup and layout of each of the twelve test sections. A description of the variables appears below. Note that the test sections are numbered from 2 to 13; they were initially 1 to 12. Unfortunately, the tack coat (originally section 1) was not available at the start of paving. As a result, that section was moved to the end of the project and relabeled section 13.

Refer to the descriptions of test sections and layout in Figure 1 to assist in understanding each variable combination. Complete data and worksheets for these analyses are provided in Appendix B.

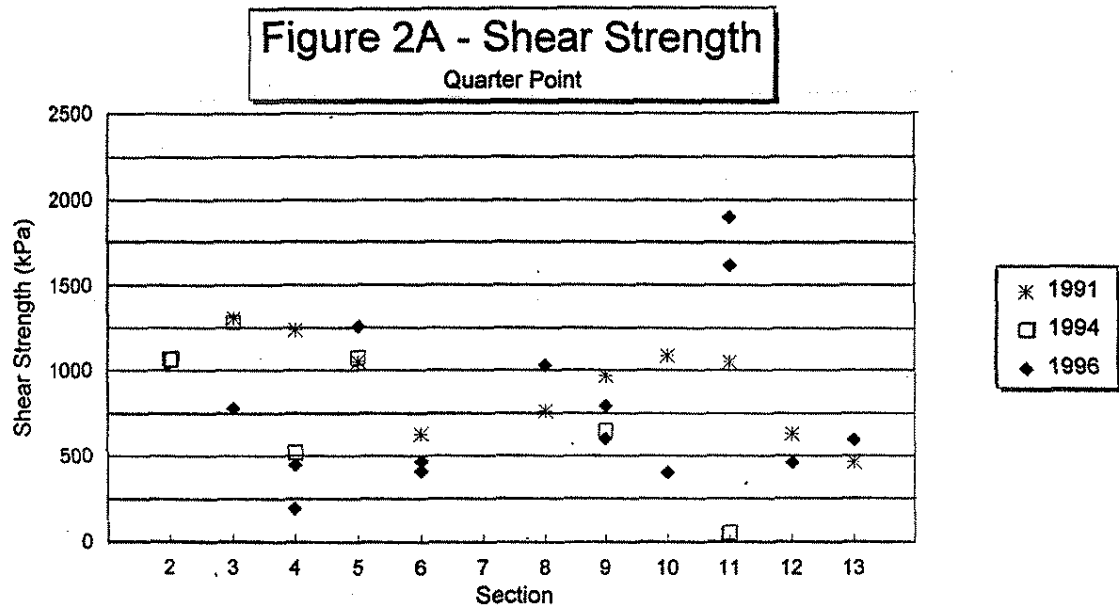
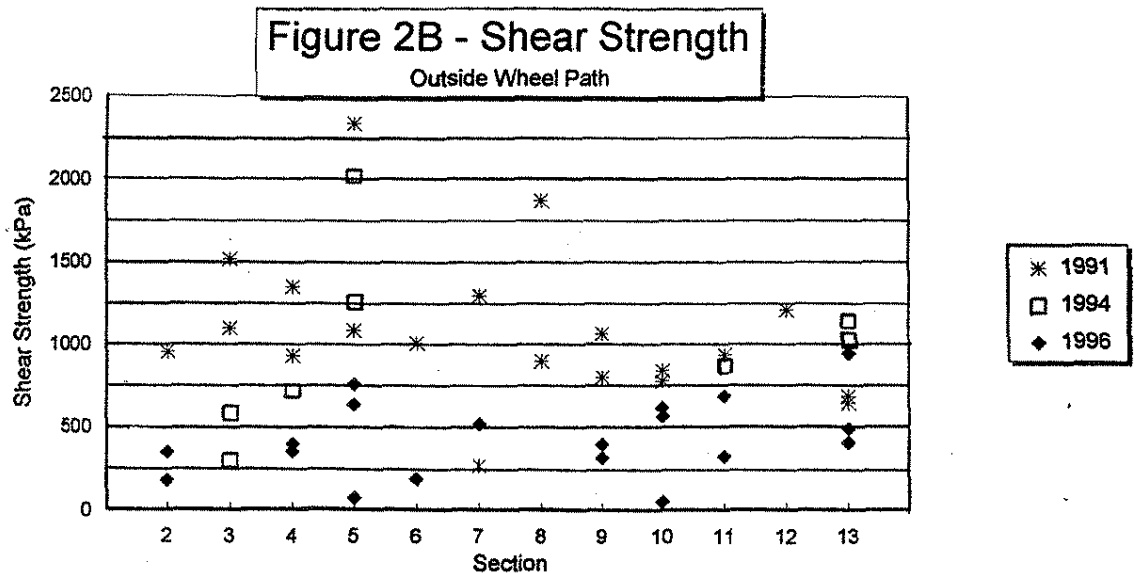
Data for shear strengths are graphed in Figures 2A, 2B, 3A and 3B, and are listed in Appendix B. Figures 2A and 2B show shear strength for quarter point and outside wheel path locations respectively, divided by test section. It is interesting to note the qualitative differences in the two graphs.

Shear strengths vary widely for the quarter point data, but without any significant differences between the test dates (1991, 1994, 1996). However, the data for the outside wheel path cores suggest significantly lower shear strength for all sections for the 1996 test. Figures 3a and 3b show the same data segregated only by date for quarter point and outside wheel path locations respectively. These results indicate that the two layers are becoming unbonded at the wheel path location over time.

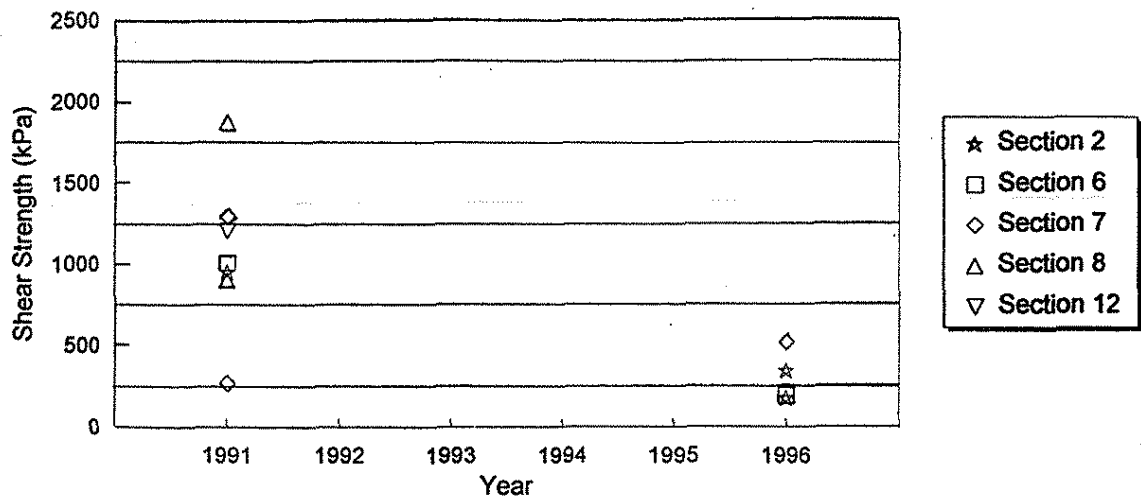
Figure 3C - Shear Strengths by Year

Figures 3C through 3F show shear strengths broken down by both year and test regimen. Note that except for section 13, all of the sections began with higher shear strengths in 1991 that degraded with time. Section 13 had a low initial shear strength, but didn't degrade significantly with time.

Broomed Sections - OWP

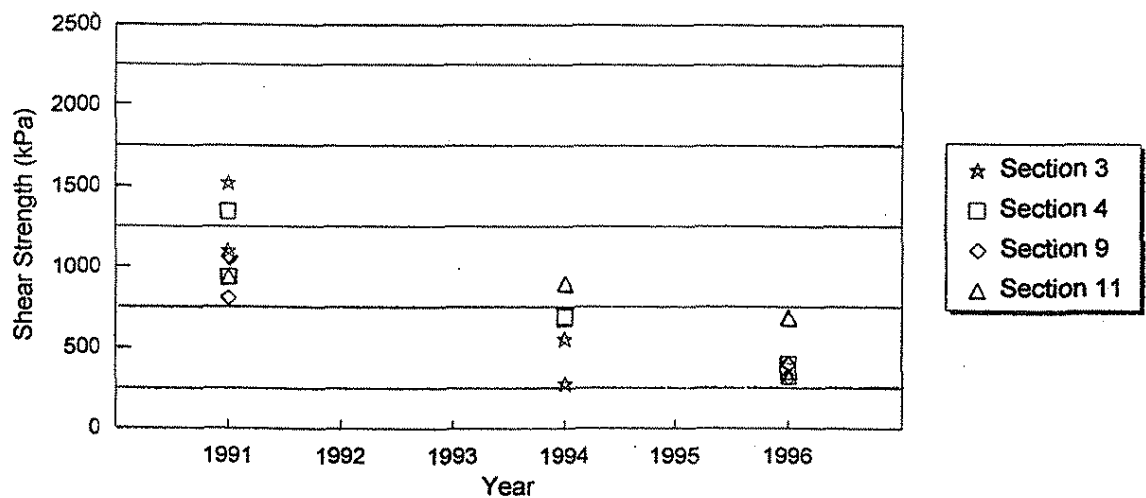
Figure 3D - Shear Strengths by Year

Milled Sections - OWP

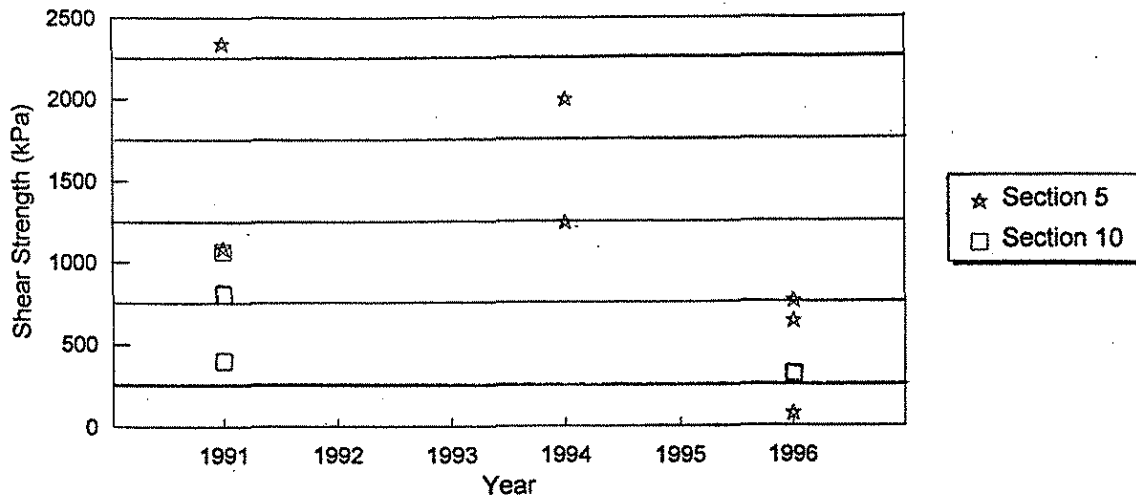
Figure 3E - Shear Strengths by Year

Milled & Planed Sections - OWP

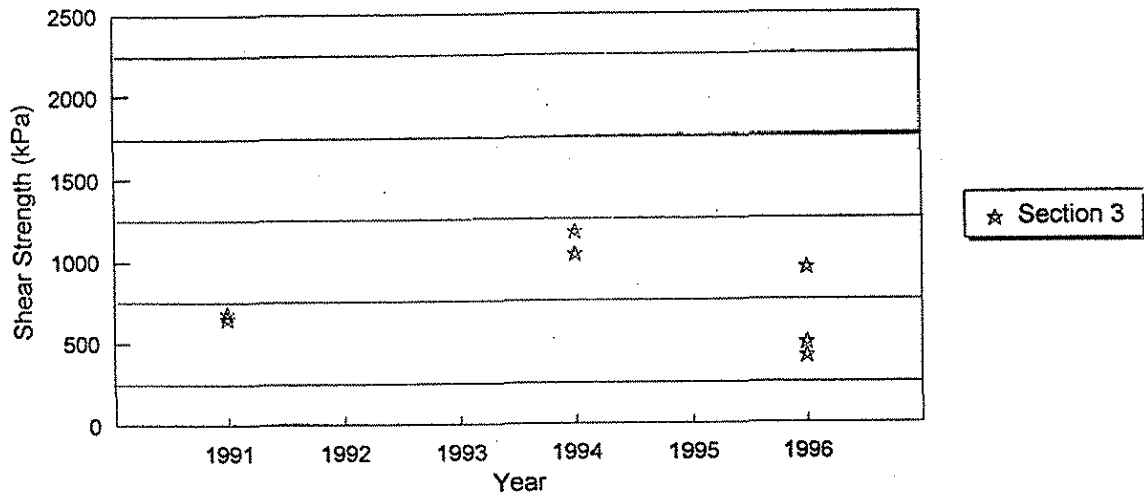
Figure 3F - Shear Strengths by Year

Tack Coat Section - OWP

Section 13 received a tack coat prior to paving. The comparison section for this case is section 2. There is an indication of improved shear strengths from section 13 and a stronger indication from the percent unbonded figures. Note that this section had no unbonded cores from the wheel path. It was also the only regimen that didn't have a strong indication of bond degradation over time.

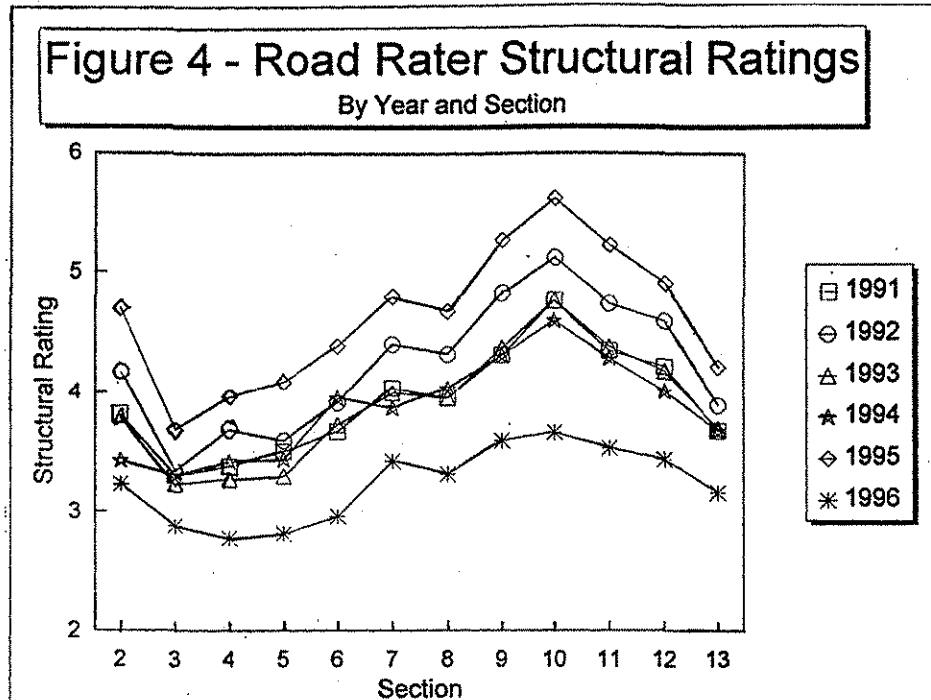
A graph of the Road Rater results is shown in Figure 4. Data is provided in Appendix C. Note that the values track very closely from year to year with vertical offsets for some years. These offsets are due to seasonal variations and are common for structural rating measurements. How wet, warm or frozen the subgrade is has a big impact on the actual measurement. The important point is that the data tracks very well from year to year.

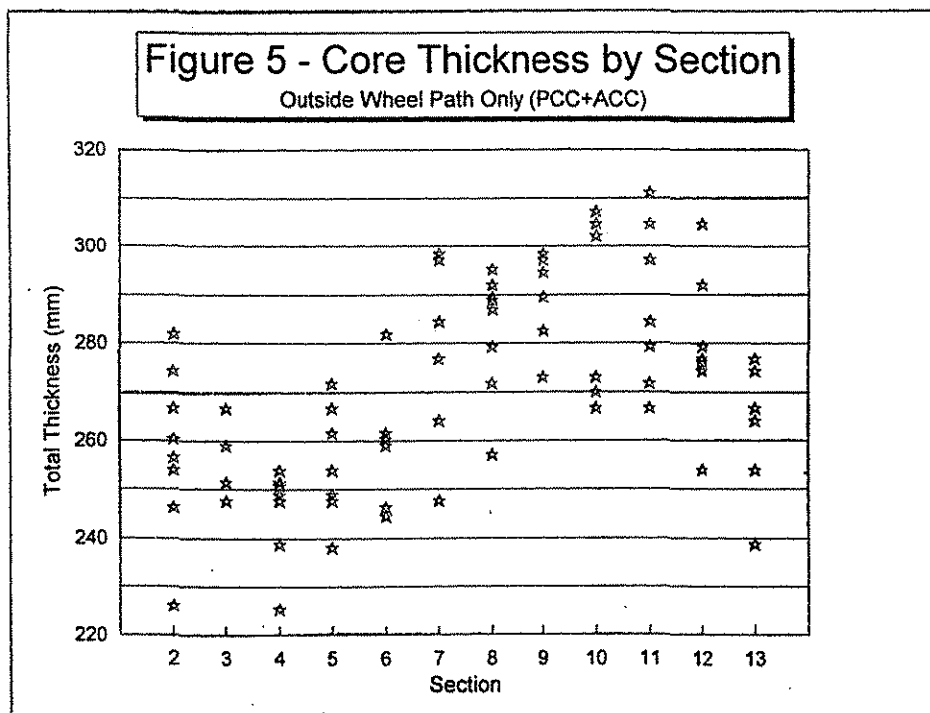
A graph of actual full pavement thicknesses are shown below. The PCC and ACC depths are shown in Figures 6A and 6B. Overall pavement thickness and PCC thickness correlate well with the Road Rater results.

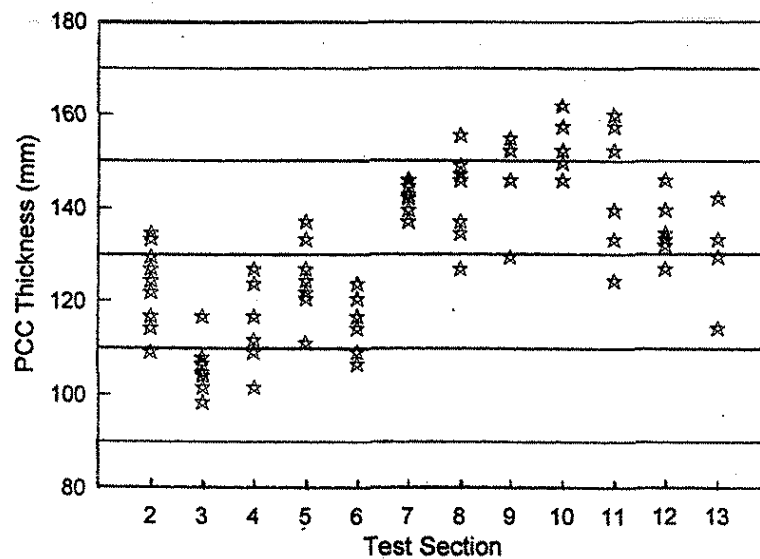
Figure 6A - Core Thickness by Section
Outside Wheel Path Only, PCC Only

Generally speaking, the structural numbers can be converted to an equivalent pavement depth for each type of pavement. As stated above, the coefficient of sound PCC is estimated to be a structural number of 0.02 per mm (0.5 per in.) of thickness. Using the road rater results (from an average of data over the five years) and the known PCC and ACC pavement thicknesses (from cores), we can get an idea of the fraction of support being provided by the PCC and from the ACC and sub-base below. What is not readily apparent from the data is any indication of bond strength or the percentage of contribution from ACC and subbase respectively. Additionally, the actual pavement depths (both PCC and ACC) vary considerably within most sections (see Figures 6A and 6B).

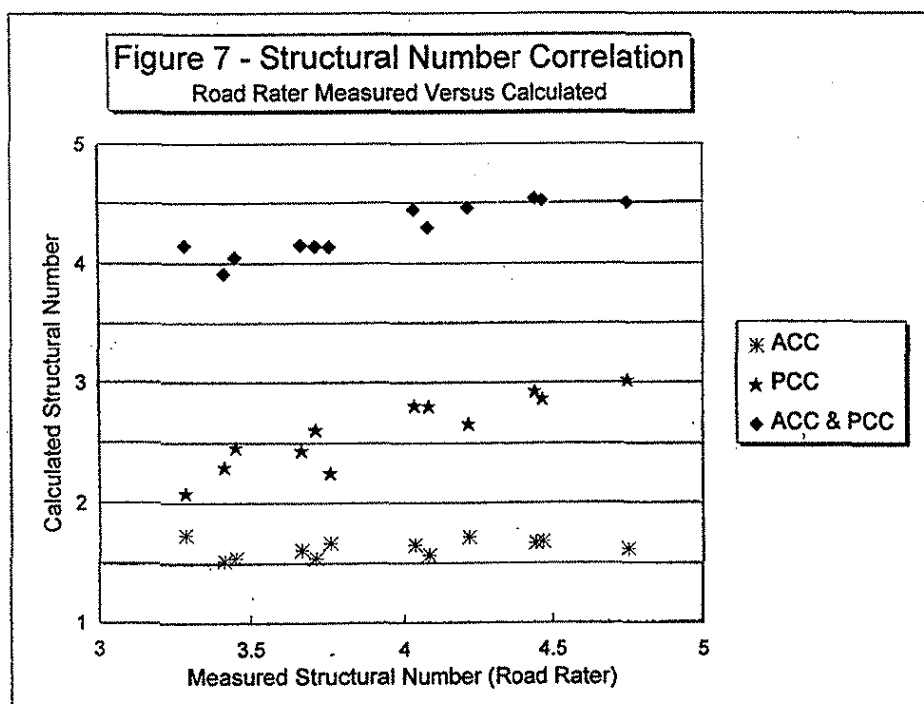
Another approach can be used to test the support of the ACC. Figure 7 shows values of averaged Road Rater measurements for each section plotted versus the expected structural numbers obtained from actual pavement thicknesses. The latter values were calculated by applying the appropriate coefficients (0.5 for PCC, 0.3 for ACC in English units) to the average actual thicknesses in each section. Correlations among the data sets are shown below.

The data indicate that the ACC layer is not providing a significant improvement in correlation between actual and predicted structural numbers. In essence this is another way to look at the comparison between Figures 4, 5 and 6: the Road Rater data are tracking strongly with PCC thickness and overall thickness but not with ACC thickness. As a result the Road Rater data is not providing evidence for the level of support being provided by the ACC.

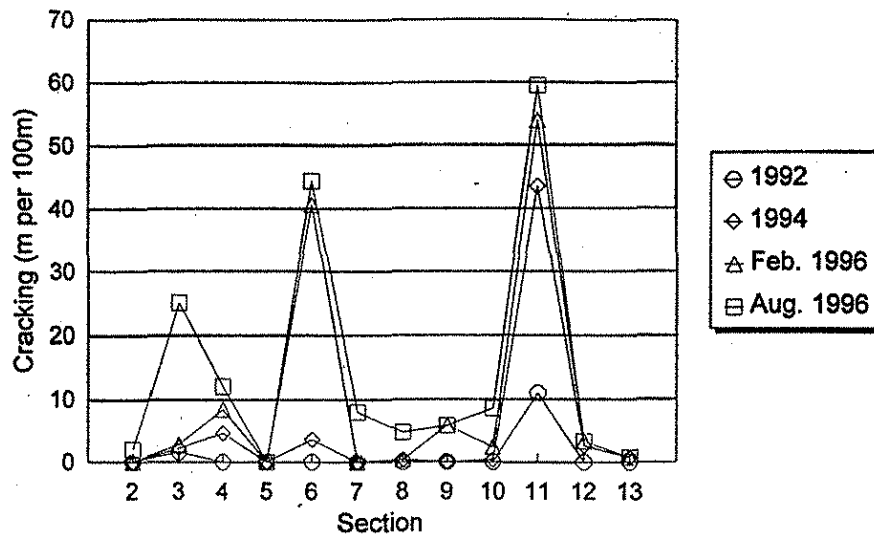
Figure 8A - Crack Survey Results

Crack surveys were performed in 1992, 1994 and 1996. The results are shown in Figures 8A and 8B (pavement thicknesses in these two graphs are actual not design). Two items are notable.

- The majority of cracking was longitudinal, implying base weakness.
- The cracks are concentrated in sections 11, 6, 3 and 4 (in decreasing order).

By Section

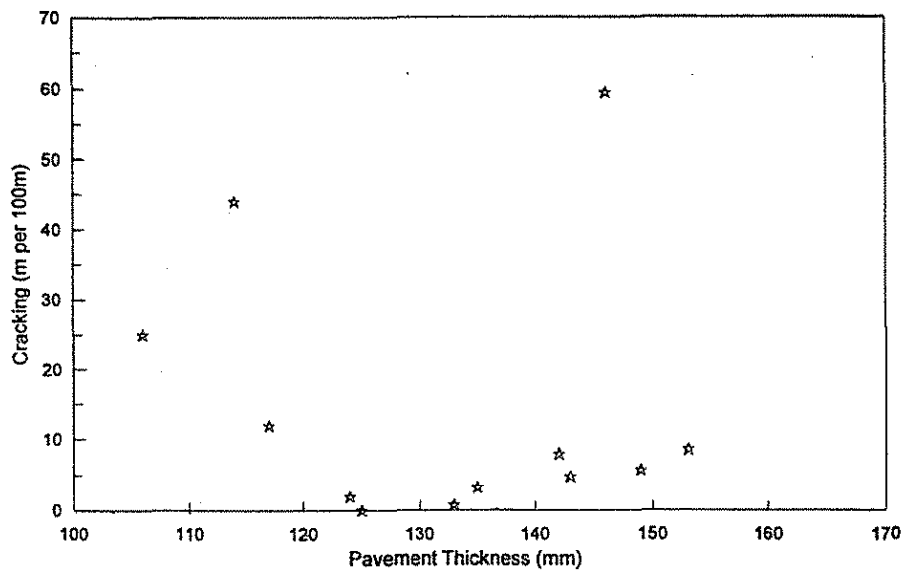
Figure 8B - Cracking Versus PCC Thickness

There is no obvious connection between the cracking and any of the surface preparations involved in the project. Cracking does correlate to actual PCC thickness and to planing. This is apparent from Figure 8B. The three thinnest PCC sections are 3, 4 and 6. These are also the sections (ignoring for a moment section 11) that have the majority of longitudinal cracking. Section 5 is specified as nominally 100 mm thick but is actually closer to the nominal 130 mm specified for the "thicker" PCC; it was also planed. Section 5 had exhibited no cracking as of summer 1996.

Total as of Summer 1996

Of the remaining sections only section 11 shows any significant cracking (note the highest point of graph in Figure 8B). However, (1) it was exhibiting this cracking during the first year after paving when none of the other areas were cracking appreciably, and (2) the longitudinal cracks are localized within about ± 10 meters. This indicates that there are probably significant subgrade problems under that portion of section 11.

Correlation between the PCC thickness and cracking remains when the data is stratified between quarter point and outside wheel path. The conclusion from all of this is that significant longitudinal cracking is occurring for PCC thicknesses less than about 120 mm (5 in.).
