Investigation of Improved Utility Cut Repair Techniques, Phase II

# Investigation of Improved Utility Cut Repair Techniques to Reduce Settlement in Repaired Areas, Phase II

tech transfer summary

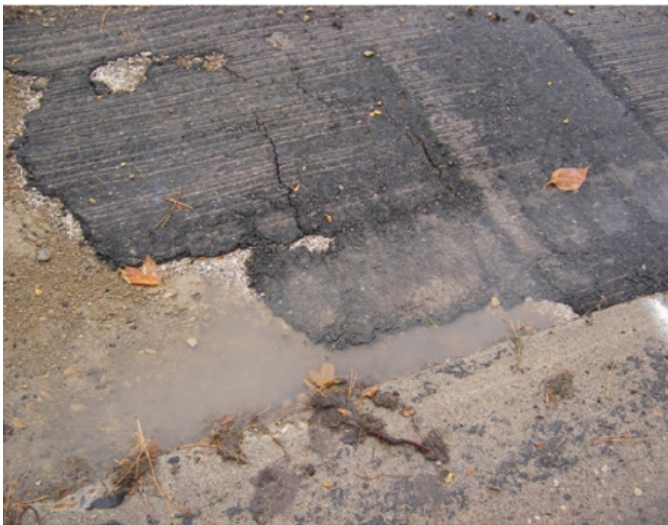
*Cracks on temporary patch covering city practice trench indicating settlement (collapse) due to rain*

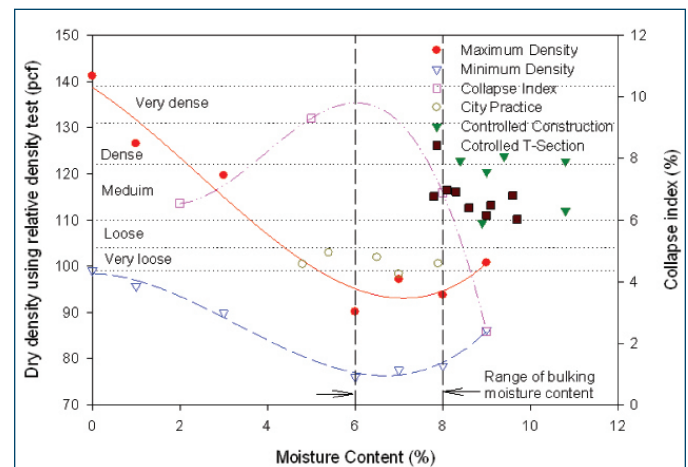
*Vibratory compaction test, collapse index, and measured moisture content from instrumented trenches*

- Relative density test (i.e., vibrating table compaction) is recommended for any potential granular backfill.
- Simple column test is recommended to determine the collapse potential (i.e., reduction in volume or settlement) of different backfill materials.

- The range of moisture content around the smallest density and highest collapse potential is known as the bulking moisture content. Backfill materials installed at moisture content higher than the bulking moisture content and at relative density of medium to dense show good performance in the field.

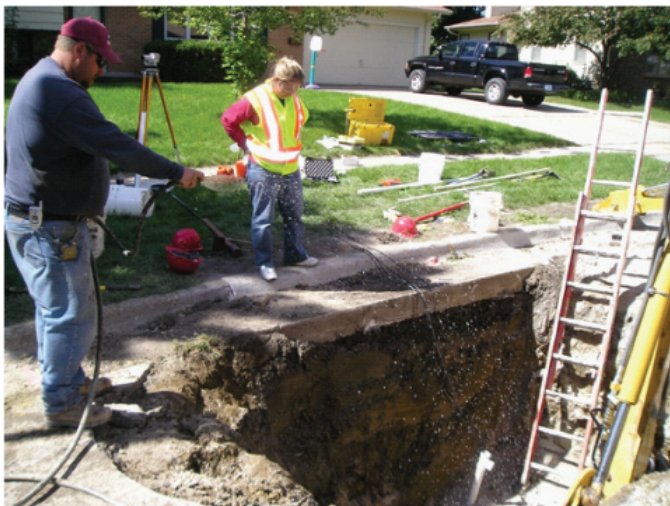
*Watering backfill material to increase the moisture content beyond the bulking moisture content*

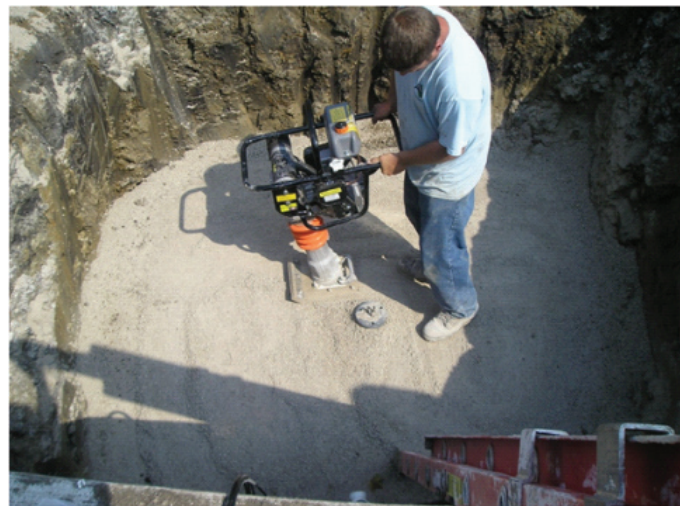
*Compaction to achieve relative density higher than 35% (medium to dense material)*

- When comparing trenches constructed with 1 inch clean, the trench constructed with highest relative density showed the smallest settlement and highest uplift movement. The trench with the lowest relative density showed the highest settlement.

- Smaller settlement was measured in trenches with higher relative densities, and smaller FWD deflections corresponded to higher California Bearing Ratio (CBR) values estimated from the dynamic cone penetration (DCP) test.

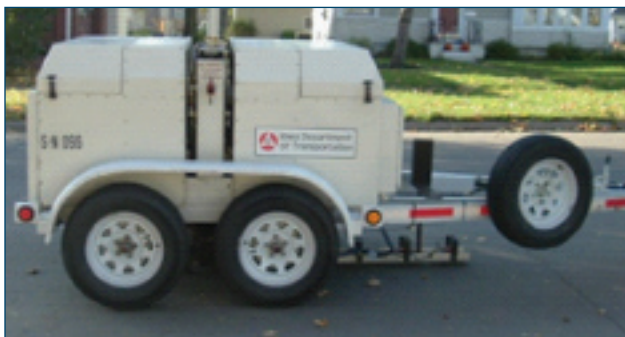
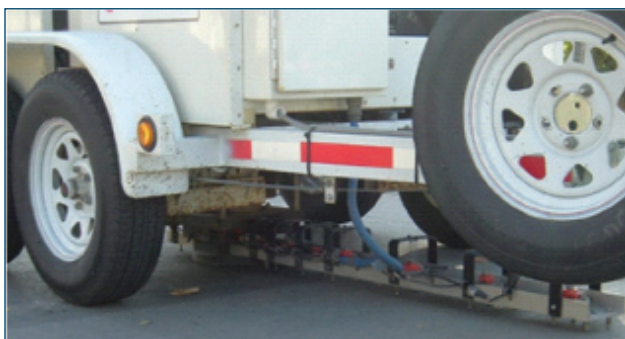
*FWD equipment used to test and monitor trench restoration performance*

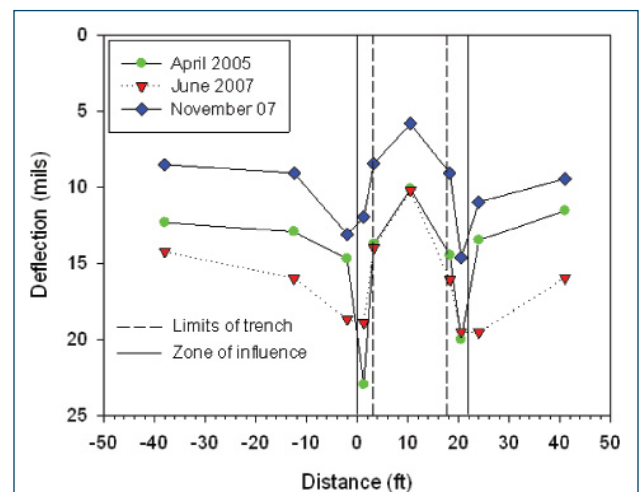
*Zone of influence using FWD*

Phase I survey results indicated that many restored utility cut restorations fail in less than two years. Field and laboratory tests of backfill indicated inadequate compaction, moisture content, and density of the backfill are factors that contribute to utility cut trench restoration failures. FWD tests indicated weakened subgrade soil around the utility cut trench restorations. This weakened soil is known as the zone of influence.

- When comparing FWD test results, the trenches with T-sections showed reduced measured deflections within the zone of influence. However, the T-section may have caused a shift of the zone of influence.
