Watershed Improvement Fund Final Project Report
8009_005_LPA for Storm Lake

Project Name: Storm Lake Watershed
Project Sponsor: Lake Preservation Association for Storm Lake, Inc.
Length of Project: February 1, 2009 – January 31, 2013

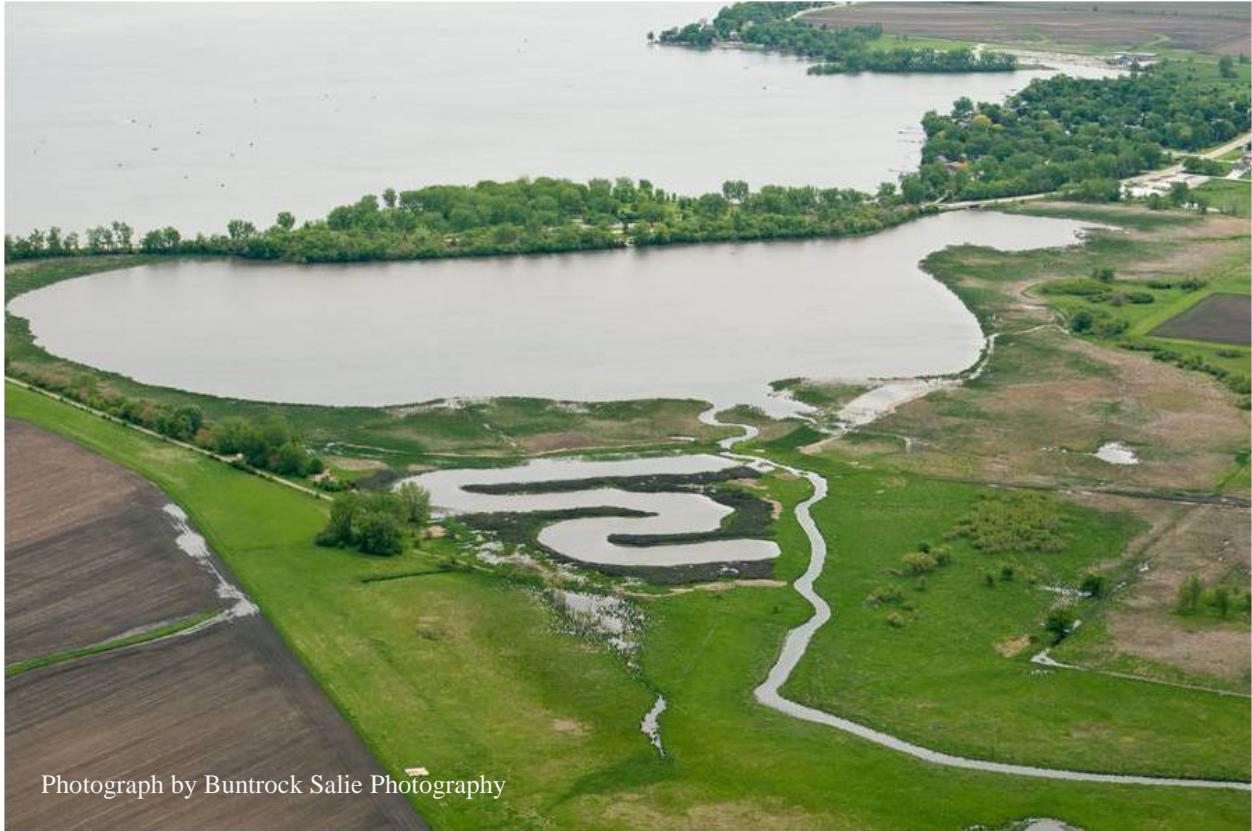
Aerial view of the Little Storm Lake area in May 2011. The serpentine channel had been constructed but the berm and the water control structures had not been constructed. This shows the open pool area of Little Storm Lake.

Through an engineering contract with Ducks Unlimited an alternative plan including a serpentine channel, 3 water control structures, a permanent berm, a pump station, and a settling basin was developed that allowed the objectives to be met with no impact on water flows or water level on adjacent land owners. The construction of these features will provide water level management to improve the quality of the water flowing from Little Storm Lake in to Storm Lake. Rough fish are kept out of the basin by the berm and by the grating on the water control structures. Rough fish that enter the basin during high flow events will be eliminated during dewatering.

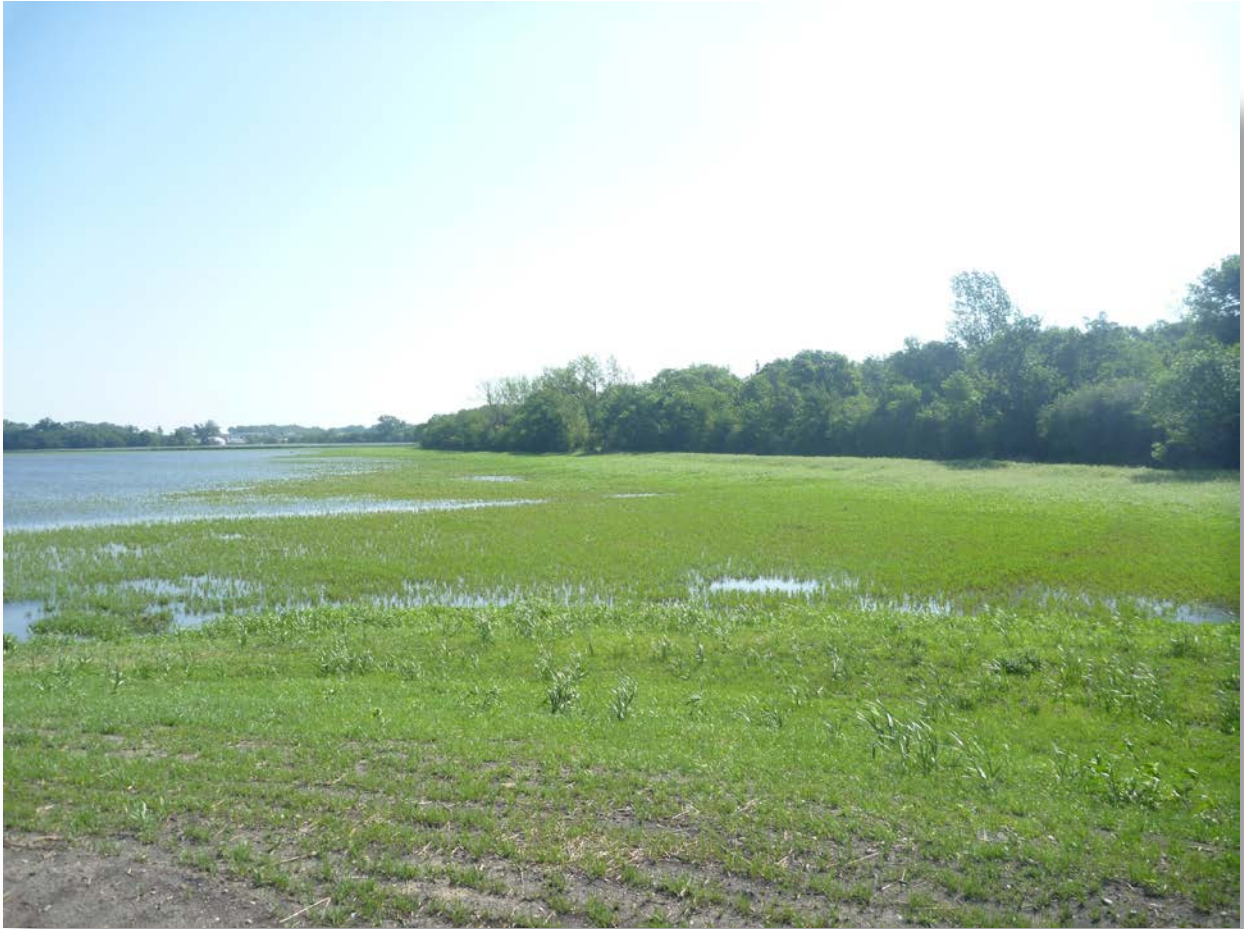
View of area in June 2012 showing the start of the revegetation. This was taken prior to the testing of the pump structure so there is water in the Little Storm basin.

There were several construction challenges due to the weather conditions at the beginning of the project. The construction began and was halted due to wet conditions. Due to the dry conditions in the fall and winter of 2011 into 2012, construction was successfully completed. Due to the 2012 drought, the Little Storm pool remained dry and is now vegetated.

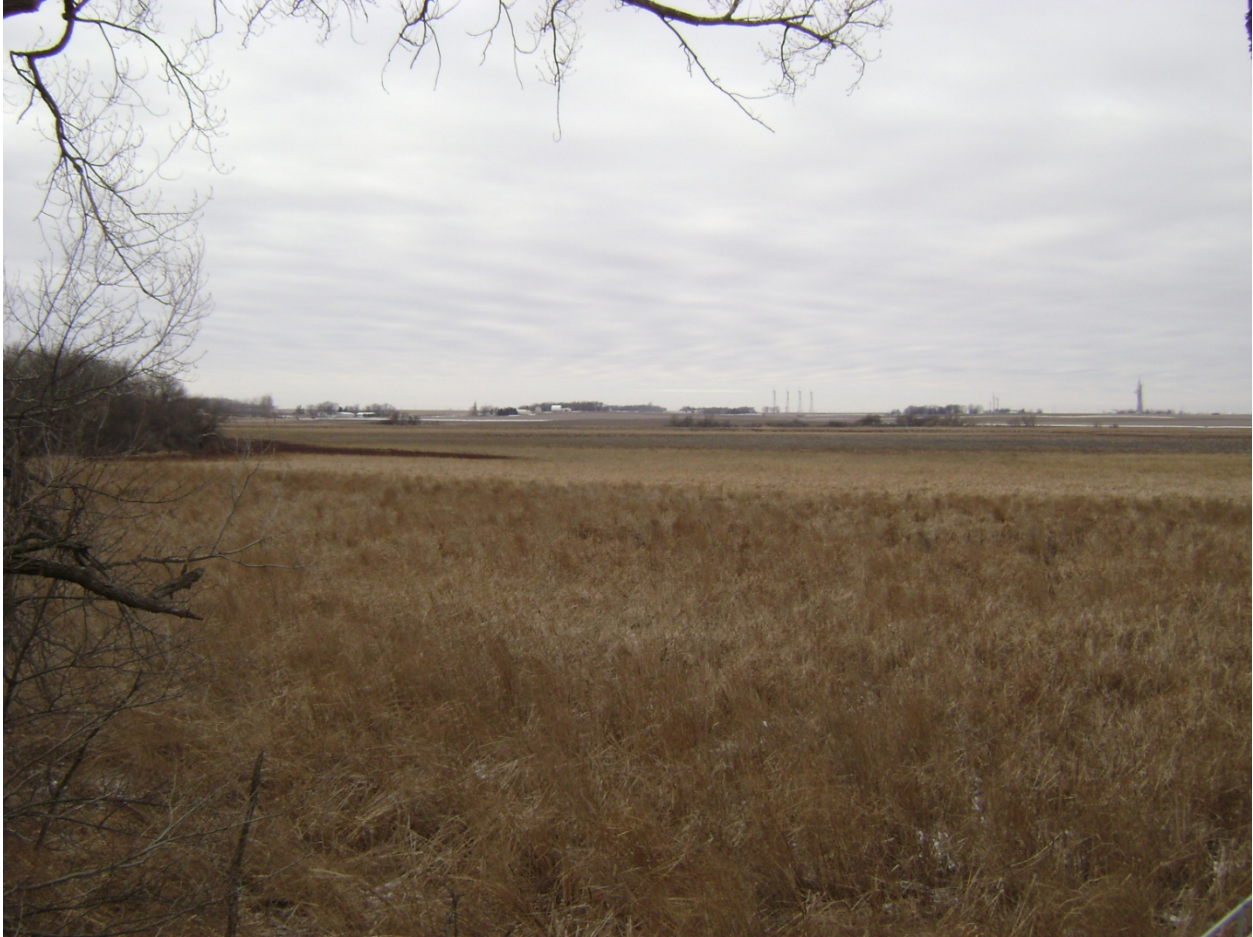
View of the area in January 2013 showing the revegetation.

possible in 2012, however, the post construction monitoring was very limited due to the dry conditions and no flow from Powell Creek into Little Storm and no flow from Little Storm into Storm Lake. Additional monitoring is recommended for the post construction pollutant loading reduction determination. The project is expected to have a positive impact on sediment movement as the entire Little Storm area is now vegetated.
