# Center Islands with Raised Curbing for Rural Traffic Calming

A number of traffic-calming devices were evaluated to determine their effectiveness in reducing speeds along the main road through a small rural community. Five different treatments were selected and installed in six rural Iowa communities. This tech brief highlights use of temporary curbing to create center islands.

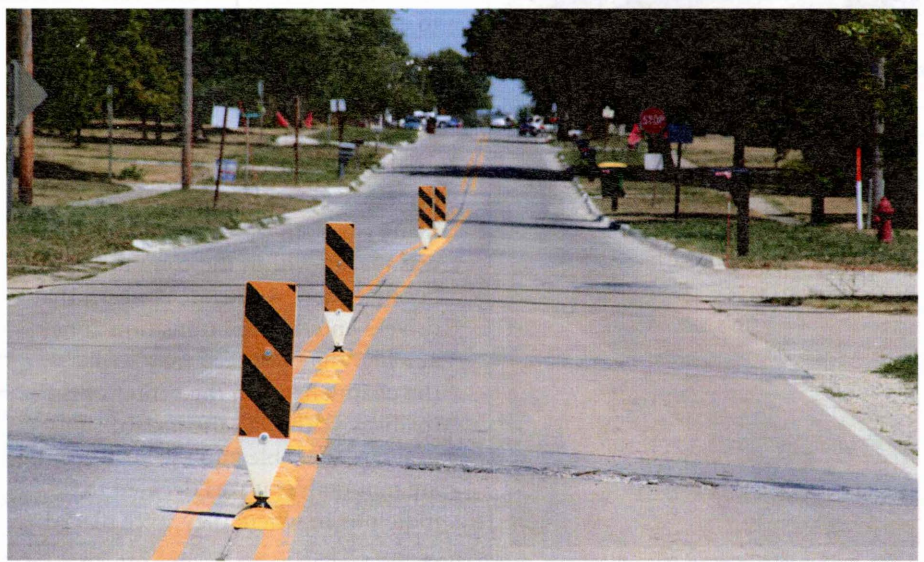
Mountable curbing at south entrance to St. Charles

Temporary islands were created using mountable curbing at the north, west, and south entrances. (A different treatment was placed at the east entrance to St. Charles). Mountable curbing was not appropriate for the east entrance given a horizontal curve, which may lead to some sight-distance issues for drivers being able to see the curbing in time.

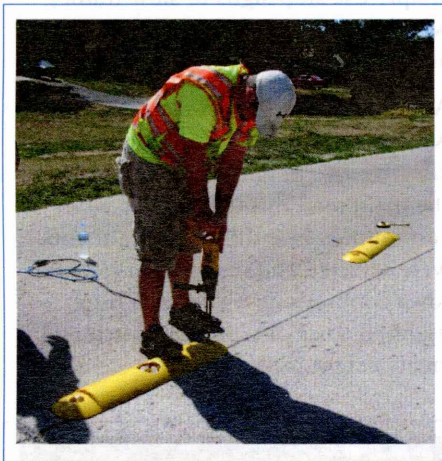
Installation of raised curbing using bolts

The treatment was affixed to the pavement using bolts. As a result, the treatment could be removed and replaced as needed. This was important given the treatment needed to be removed for the winter months so city and county snowplow operators did not need to worry about maneuvering around the treatments during winter storm events.

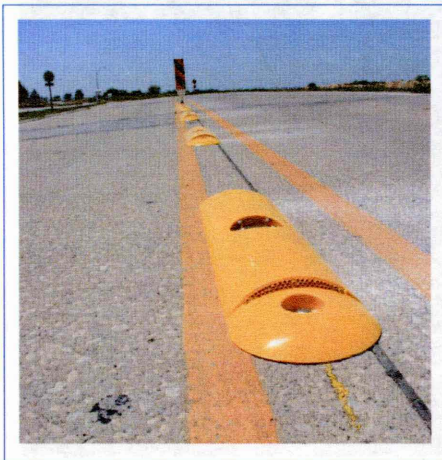
Close-up of mountable curbing

The temporary curbing that was purchased is approximately 2 inches high by 40 inches long by 8 inches wide. The curbing has a rounded design that can be mounted by errant vehicles.

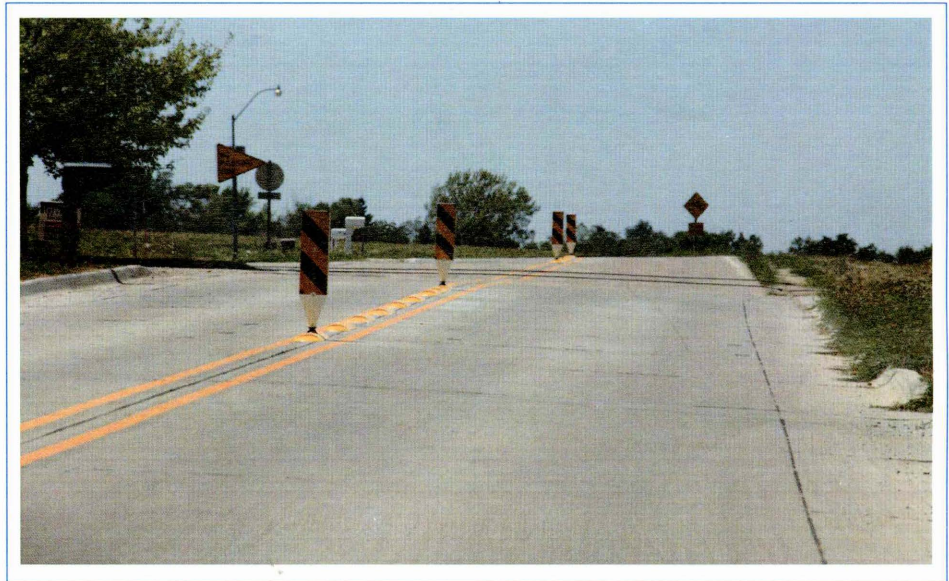
*Mountable curbing installed at west St. Charles community entrance*

Speeds decreased at two sites with decreases up to 2.2 mph in mean speed and up to 3 mph in 85th percentile speed. The fraction of vehicles traveling 5 or more mph over the posted speed limit decreased by 29 percent and the fraction of vehicles traveling 10 or more mph over decreased by 29 to 46 percent. A large decrease (up to 71 percent) resulted in the fraction of vehicles traveling 15 or more mph over the posted speed limit. The fraction of vehicles traveling 20 or more mph over the posted speed limit decreased by 50 to 100 percent. At the third site, little change in any speed metrics occurred.

St. Charles North	St. Charles South	St. Charles West
Mean Speed	-2.2	-1.9	0.4
85th Percentile Speed	-3	-1	0
Fraction of Vehicles Traveling Over Posted Speed Limit			
≥ 5 mph	-28.6%	-23.4%	5.9%*
≥ 10 mph	-45.8%	-28.6%	11.1%*
≥ 15 mph	-71.4%	-28.6%	0.0%*
≥ 20 mph	-100.0%	-50.0%	0.0%*
