Cold In-Place Recycling Project Selection and Guidance for Iowa Roadways

tech transfer summary

July 2023

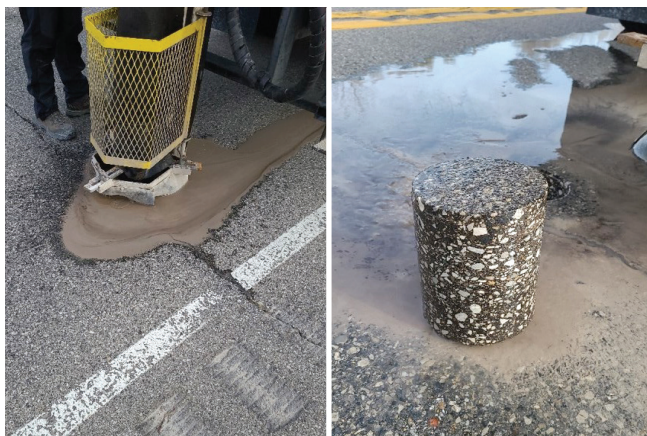
Field cores were collected in November 2021 from CIR pavement sections featuring HMA overlays on US 34 in Mills and Wapello Counties, Iowa. From the cores, the thickness, cracking resistance, binder contents, and gradations of both the CIR and HMA layers were determined.

Collection of cores from US 34

- Laboratory testing of the US 34 cores indicated that the HMA layers had lower FI values than the CIR layers. This suggests that HMA overlays are more brittle and less flexible than CIR layers, which confirms previous assessments in the literature. The asphalt contents among CIR samples varied noticeably, and CIR specimens with higher asphalt binder contents exhibited higher FI values.

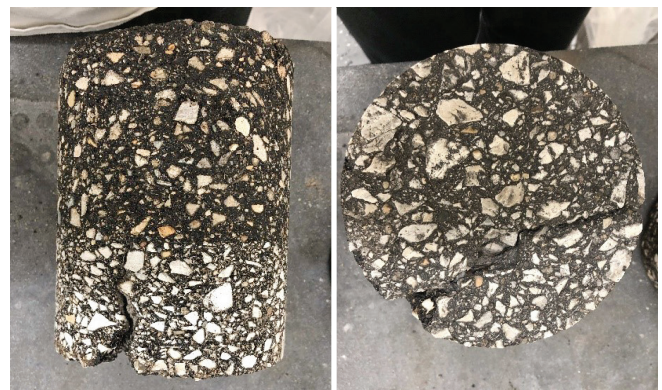
Side view (left) and top view (right) of a cracked core with an insufficient HMA layer thickness

- The forensic case study indicated that performance targets were not met for three reasons: (1) pavement layers were thinner than the plans required, (2) CIR gradations were finer than the plans required and finer than typically expected in Iowa, and (3) the pavement structure was inadequate given the likely subgrade strength.
