**FULL-SCALE 1,800 LB. VEHICLE CRASH TEST  
ON THE  
IOWA W-BEAM APPROACH GUARDRAIL  
TO THE  
CONCRETE SAFETY SHAPE BRIDGE RAIL**

TRANSPORTATION RESEARCH REPORT TRP-03-23-90

February 1991

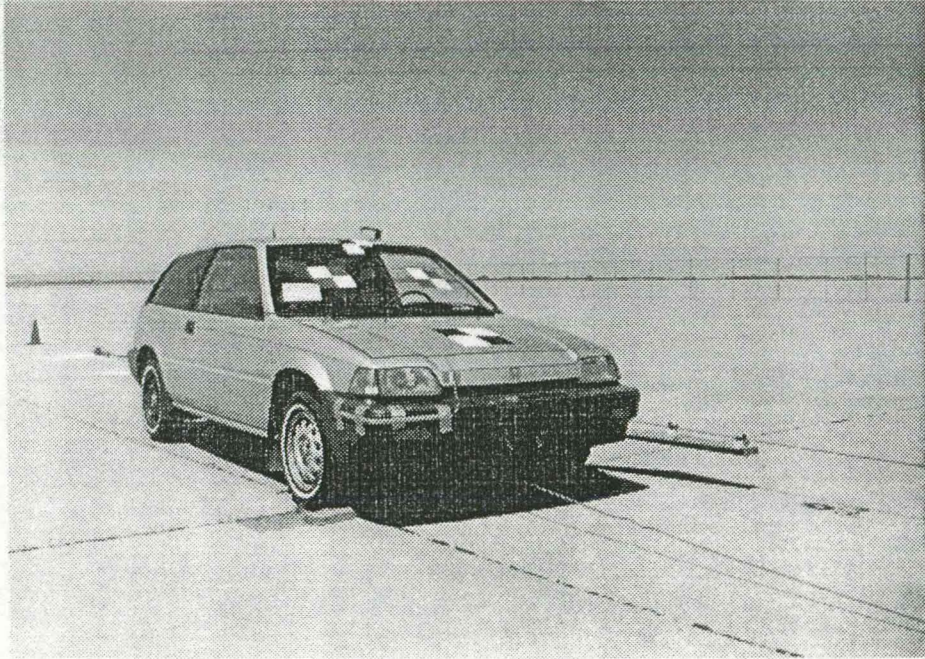
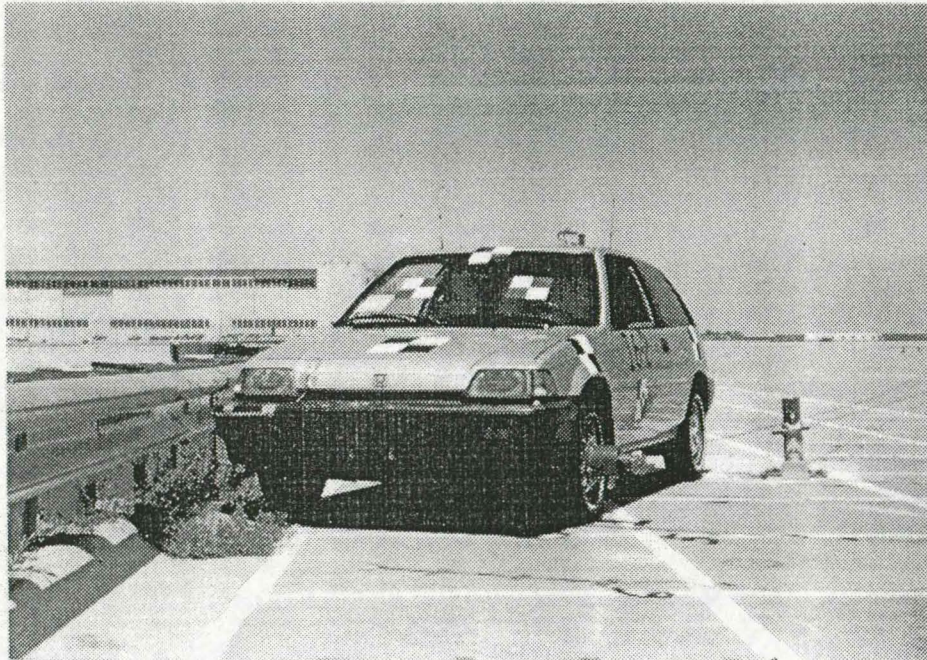
FIGURE 15. PHOTOGRAPHS OF TEST VEHICLE.

Three 8-in. square, black and white checkered targets were placed on the centerline of the top of the test vehicle. The middle target was placed over the center of mass. Additional roof targets were placed ahead and behind the center of mass. The targets were used in the analysis of the high speed film. In addition to the roof targets, side and rear targets were also placed at known positions to aid in the evaluation process.

Two 5B flash-bulbs were mounted on the roof of the test vehicle to record the time of impact with the w-beam approach guardrail on the high-speed film. The flash bulbs were fired by a pressure tape switch mounted on the front face of the bumper.

Test I6-2 was conducted at a target impact speed of 60 mph with an impact angle of 20 degrees. A 1986 Honda Civic weighing 1,840 lbs. was used as the crash test vehicle. The location of impact was 15 ft. upstream from the end of the concrete end-section between posts 5 and 6.
