**FULL-SCALE 5,400 LB. VEHICLE CRASH TEST  
ON THE  
IOWA W-BEAM APPROACH GUARDRAIL  
TO THE  
CONCRETE SAFETY SHAPE BRIDGE RAIL**

TRANSPORTATION RESEARCH REPORT TRP-03-21-90

January 1990

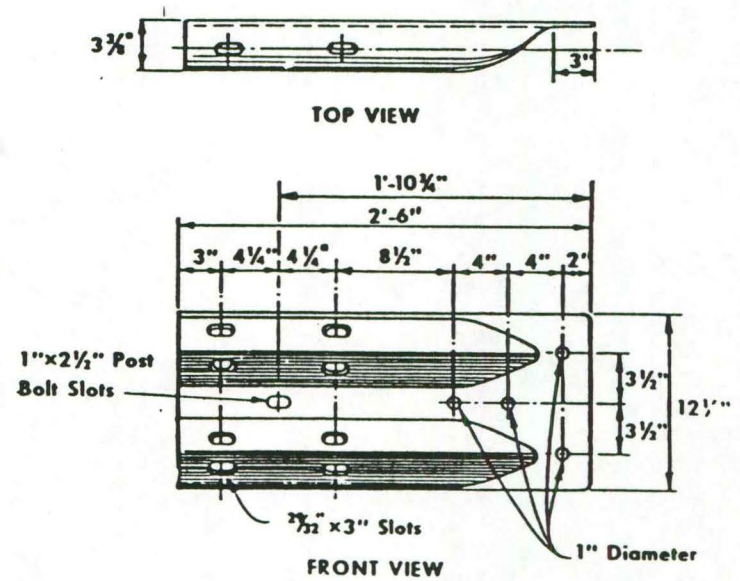
FIGURE 9. SKETCH OF FORMED STEEL TERMINAL SECTIONS.

FORMED STEEL BEAM RAILING  
TERMINAL SECTIONS

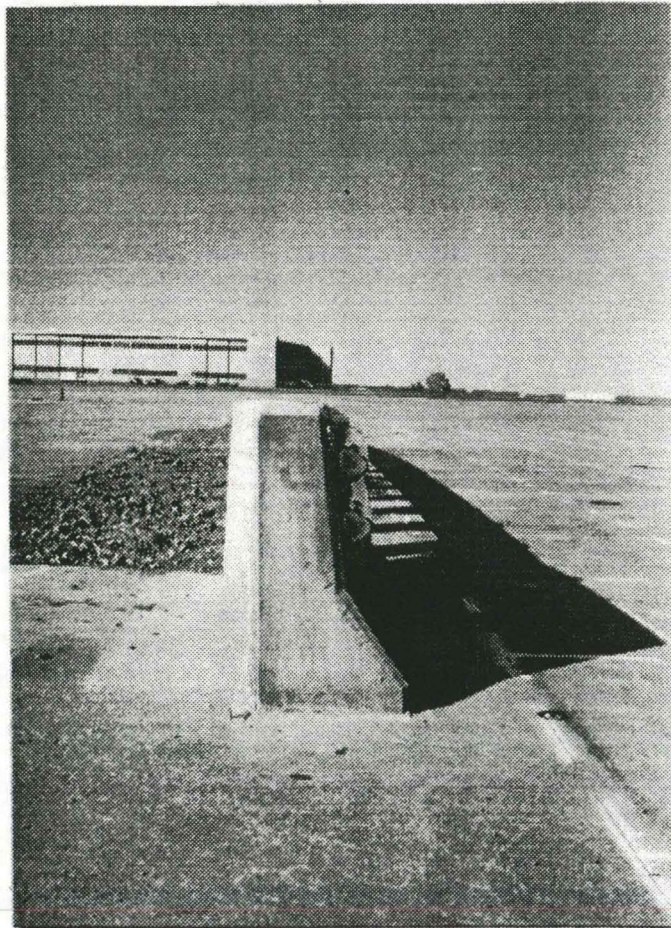
FIGURE 14. PHOTOGRAPHS OF W-BEAM GUARDRAIL APPROACH INSTALLATION.

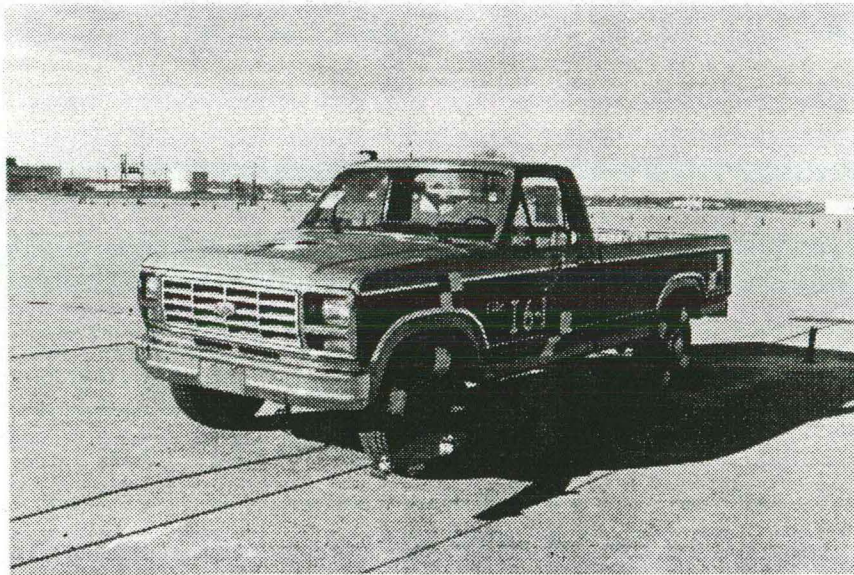
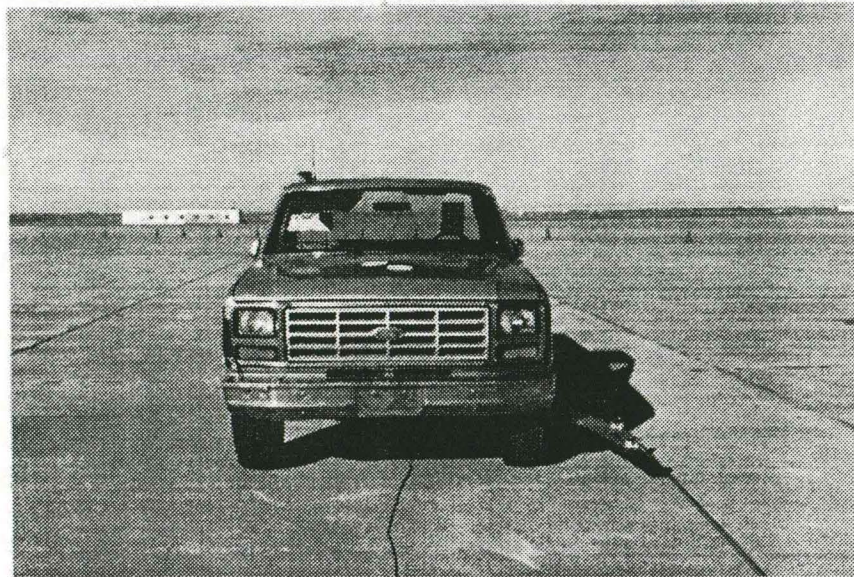
FIGURE 15. PHOTOGRAPHS OF TEST VEHICLE.

The front wheels of the test vehicle were aligned to a toe-in value zero-zero so that the vehicle would track properly along the guide cable.

Three 8-in. square, black and white checkered targets were placed on the centerline of the top of the test vehicle. The middle target was placed over the center of mass.

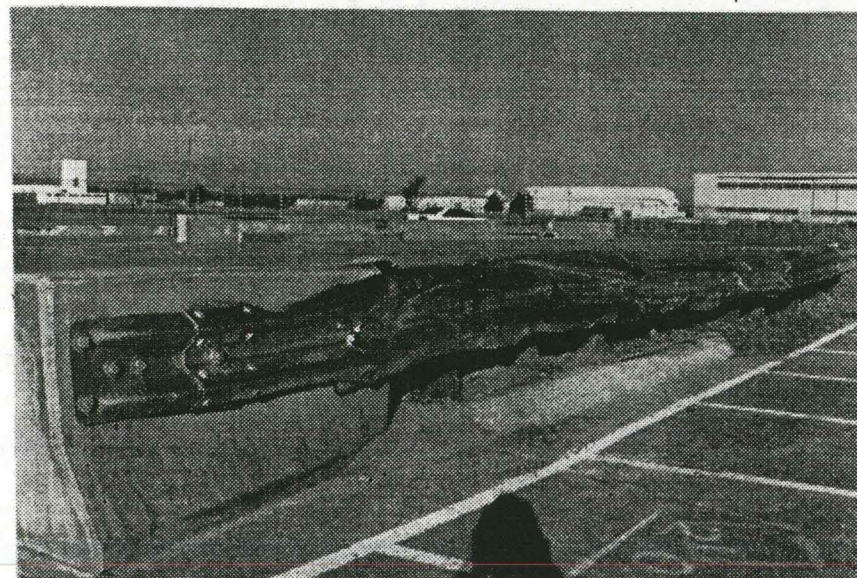
Photographs of the marginal damage to the approach guardrail transition section are shown in Figures 23 through 26. After viewing the damaged guardrail, there was evidence that slight snagging occurred at post 1 and minor concrete spalling at the top of the concrete end-section.

FIGURE 25. PHOTOGRAPHS OF DAMAGE TO APPROACH GUARDRAIL TRANSITION SECTION.

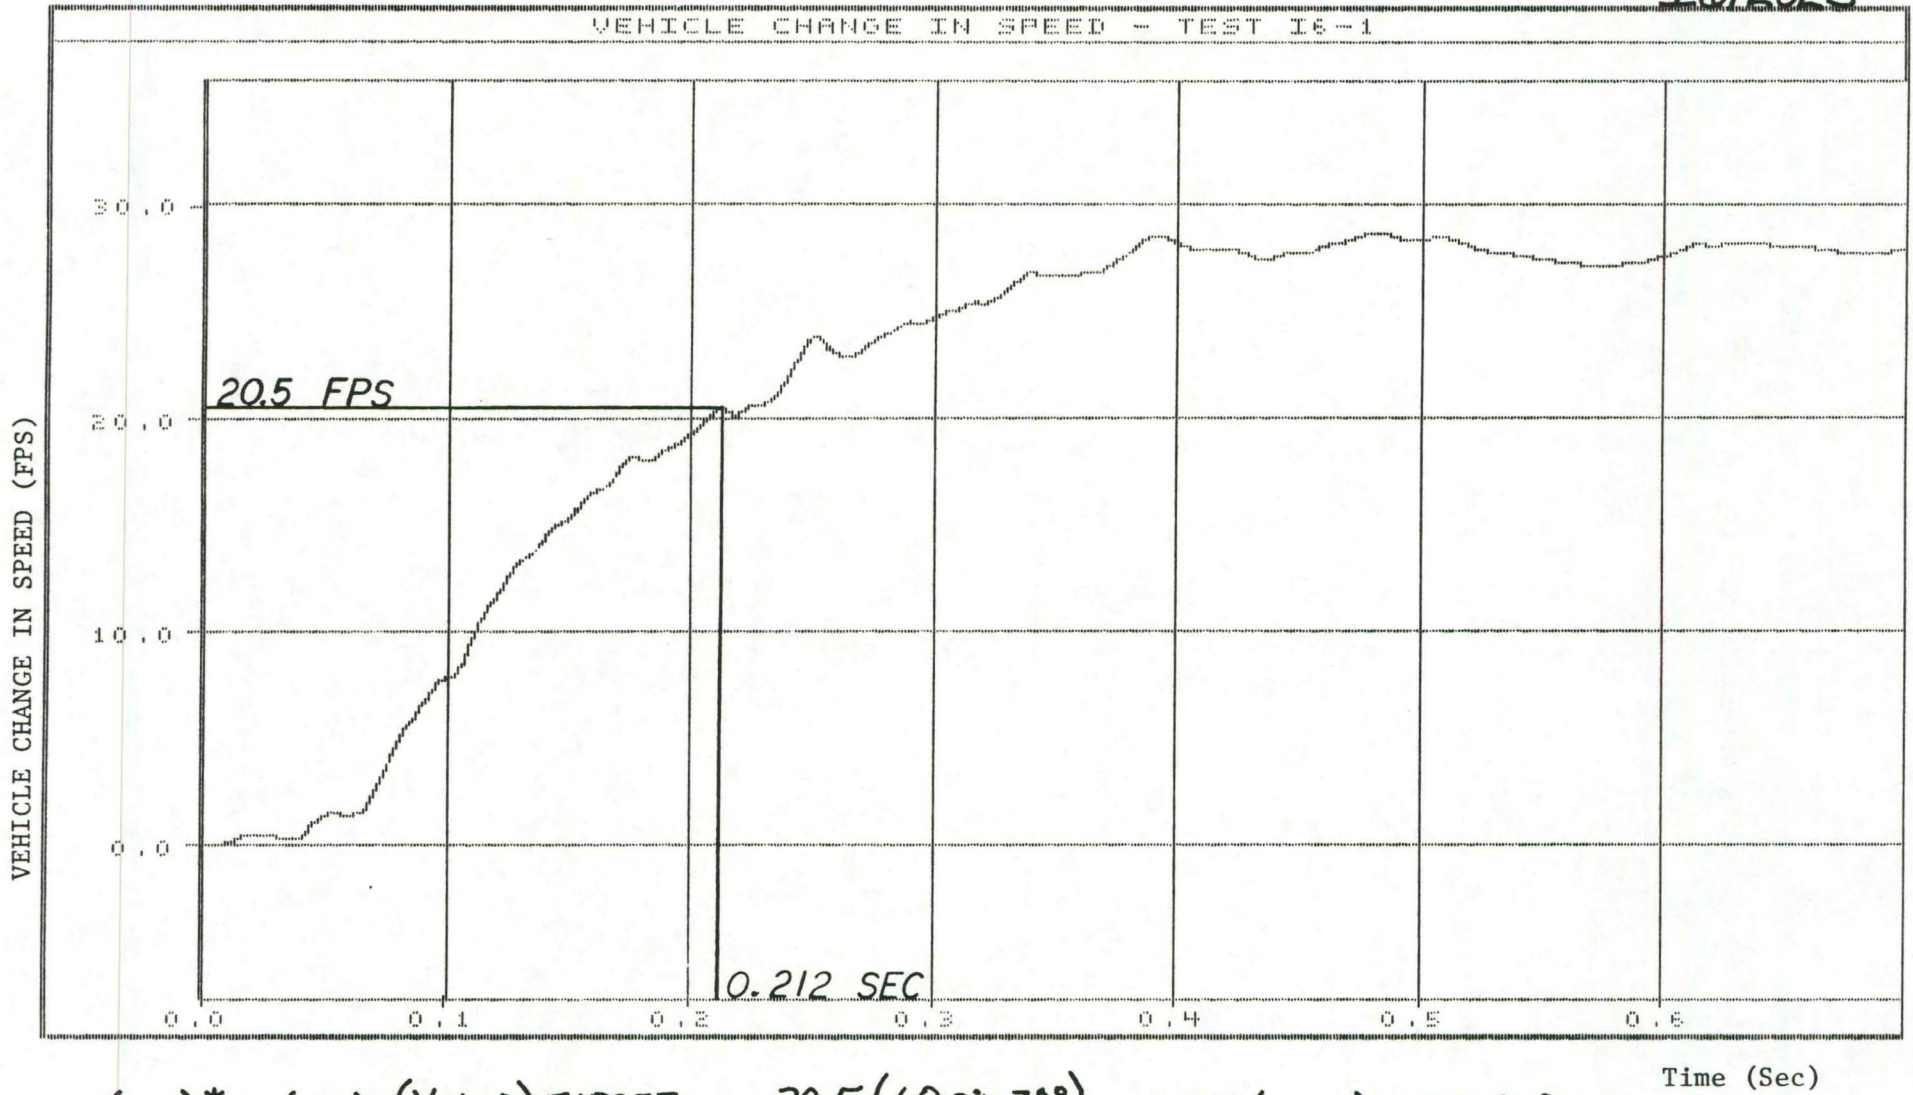
$$(\Delta V)^* = (\Delta V) \frac{(V \sin \theta)_{\text{TARGET}}}{(V \sin \theta)_{\text{ACTUAL}}} = \frac{20.5 (60 \sin 20^\circ)}{(61.45 \sin 20^\circ)} = 20.5 (0.9764) = 20.0 \text{ fps}$$

FIGURE C-3. GRAPH OF VEHICLE CHANGE IN SPEED, TEST I6-1.

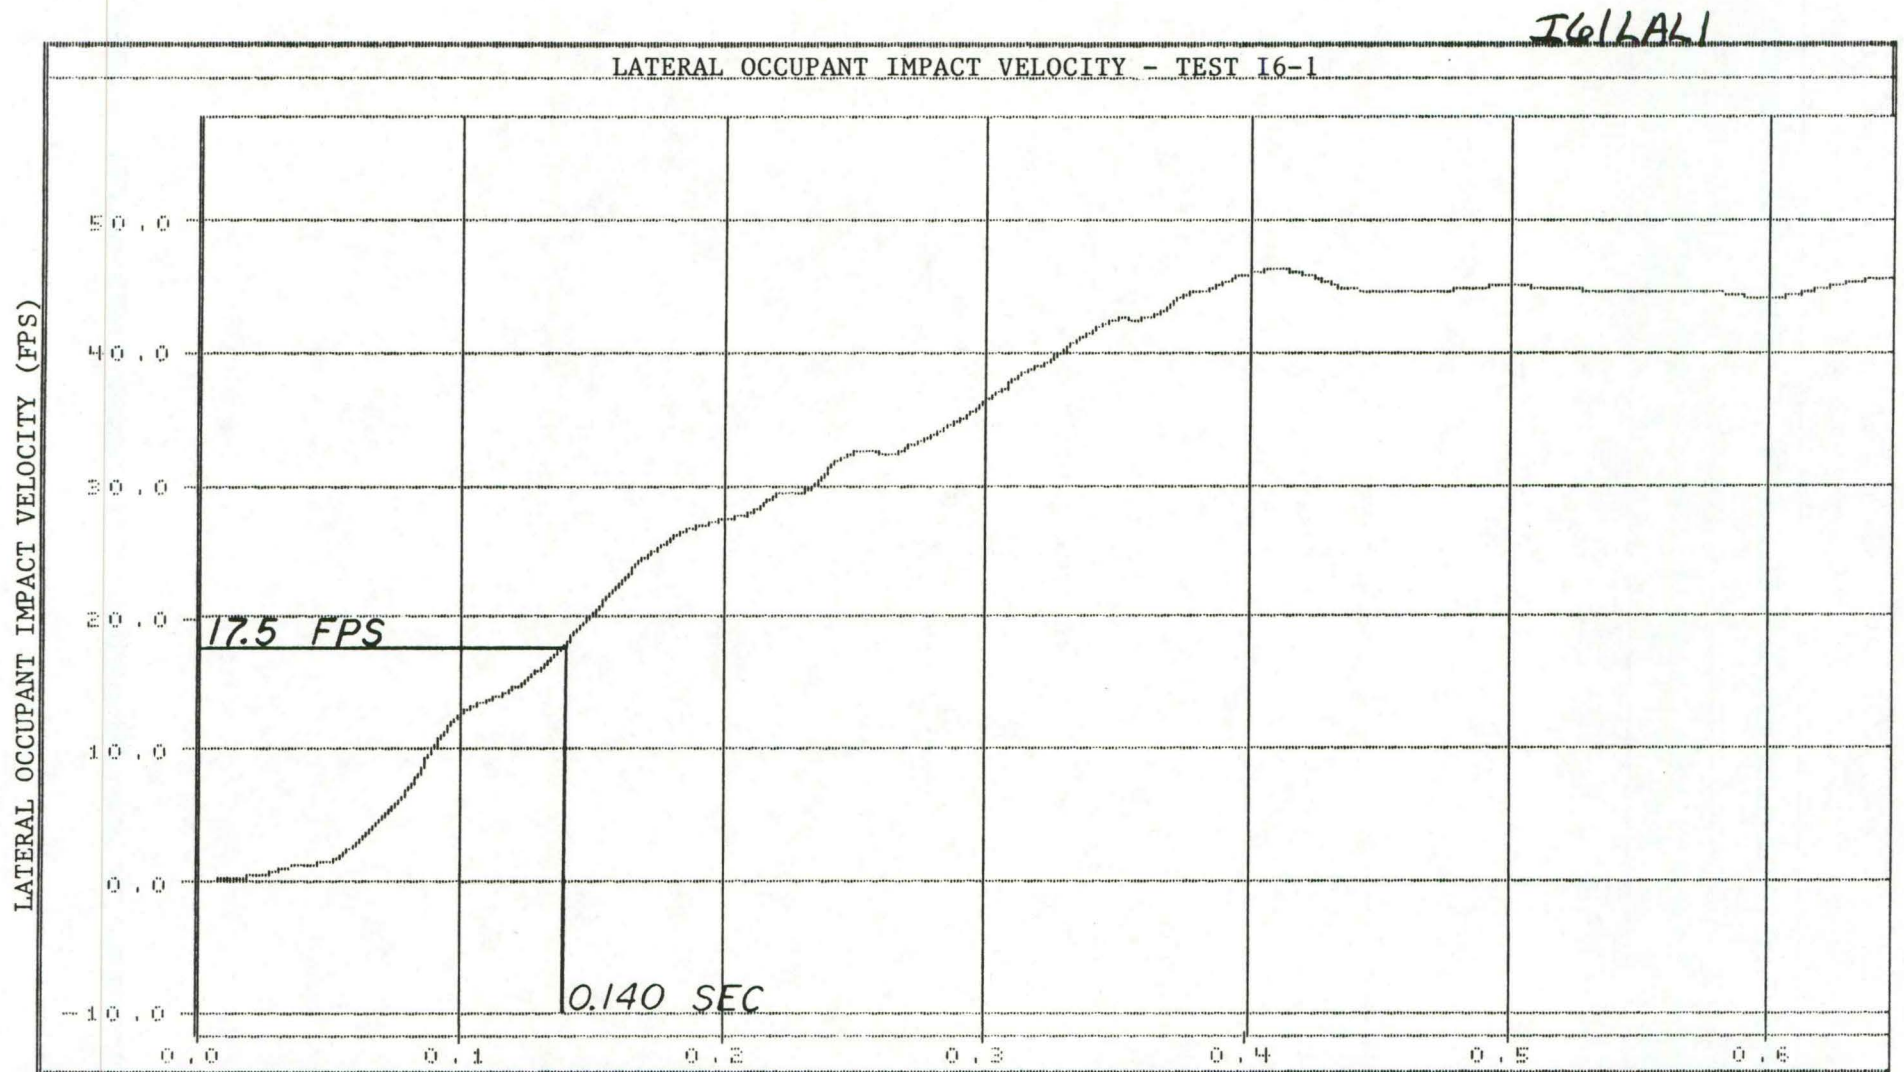
$$(\Delta V)^* = (\Delta V) \frac{(V \sin \theta)_{\text{TARGET}}}{(V \sin \theta)_{\text{ACTUAL}}} = \frac{17.5 (60 \sin 20^\circ)}{(61.45 \sin 20^\circ)} = 17.5 (0.9764) = 17.1 \text{ fps}$$

FIGURE C-8. GRAPH OF LATERAL OCCUPANT IMPACT VELOCITY, TEST I6-1.
