ASSESSMENT OF WEATHERING STEEL BRIDGE PERFORMANCE IN IOWA AND DEVELOPMENT OF INSPECTION AND MAINTENANCE TECHNIQUES

Final Report
SPR 90-00-RB17-012
February 21, 2013
WJE No. 2011.1671

Sponsored by:
Iowa Department of Transportation
Office of Bridges and Structures
800 Lincoln Way
Ames, IA 50010

Prepared by:
Wiss, Janney, Elstner Associates, Inc.
330 Pfingsten Road
Northbrook, Illinois 60062
847.272.7400 tel | 847.291.4813 fax

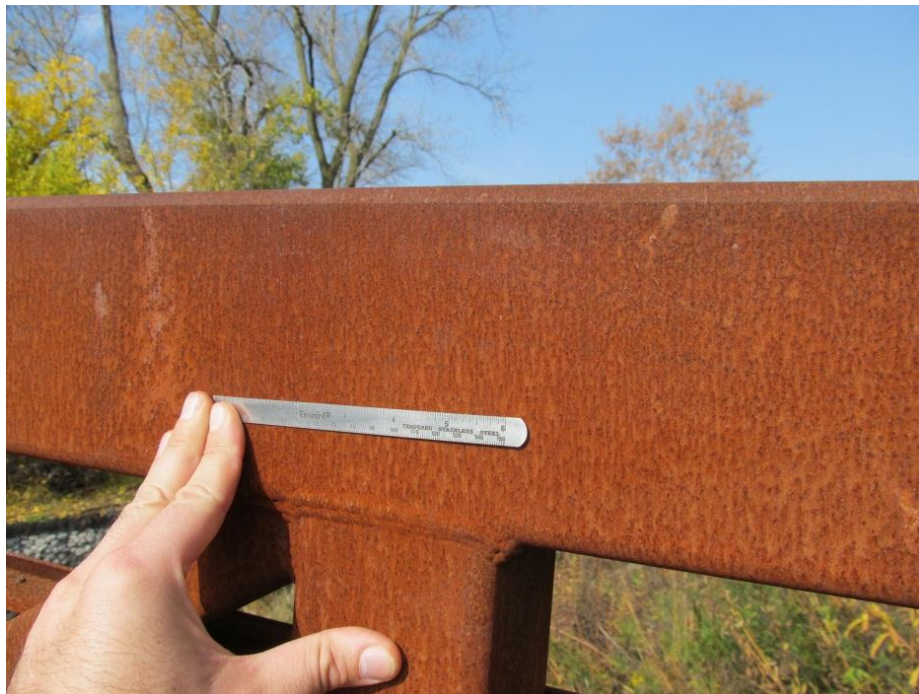
Figure 5. Developing patina on pedestrian bridge in a suburban Illinois park. Note the adherent, small size of the patina rust particles, and the reddish coloration.

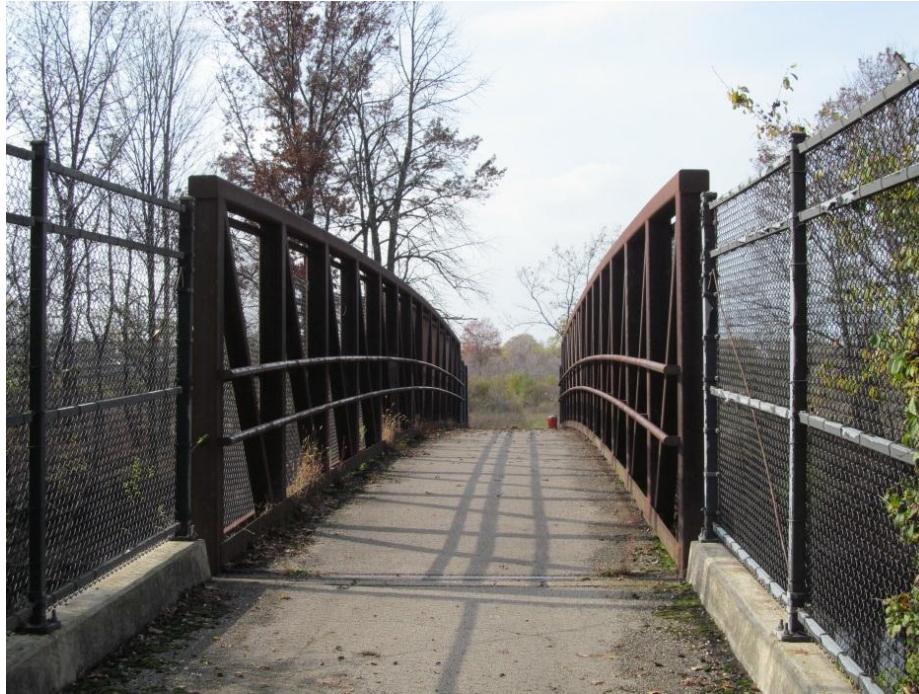
WJE also made notable observations during the inspection of a pedestrian bridge over the Des Plaines River located on an unpaved trail in a forest preserve. Figure 6 shows its general arrangement and environment. Though considerably older than the other local structures observed (aerial photographic records indicate the structure predates 1993), a combination of proper detailing and no salt exposure promoted excellent patina development and long-term performance of this truss bridge. A close-up photograph of a typical area of patina is shown in Figure 7.

Figure 6. Pedestrian bridge carrying a trail over the Des Plaines River in an Illinois forest preserve, with no apparent salt exposure.

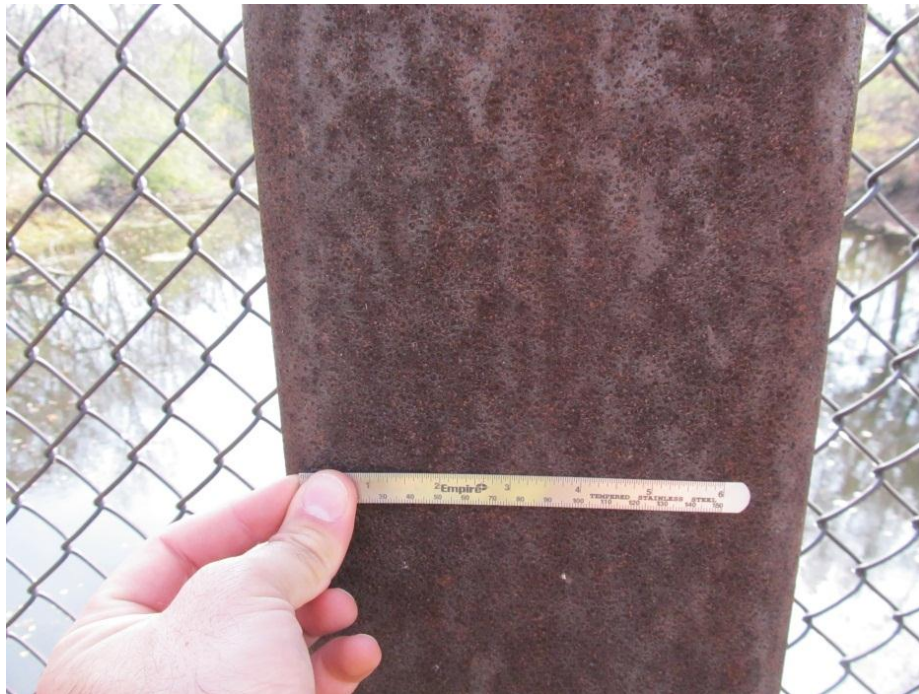
Figure 7. Close-up photo of patina performance on the Des Plaines River pedestrian bridge; patina is dense and adherent, with small constituent rust particles.

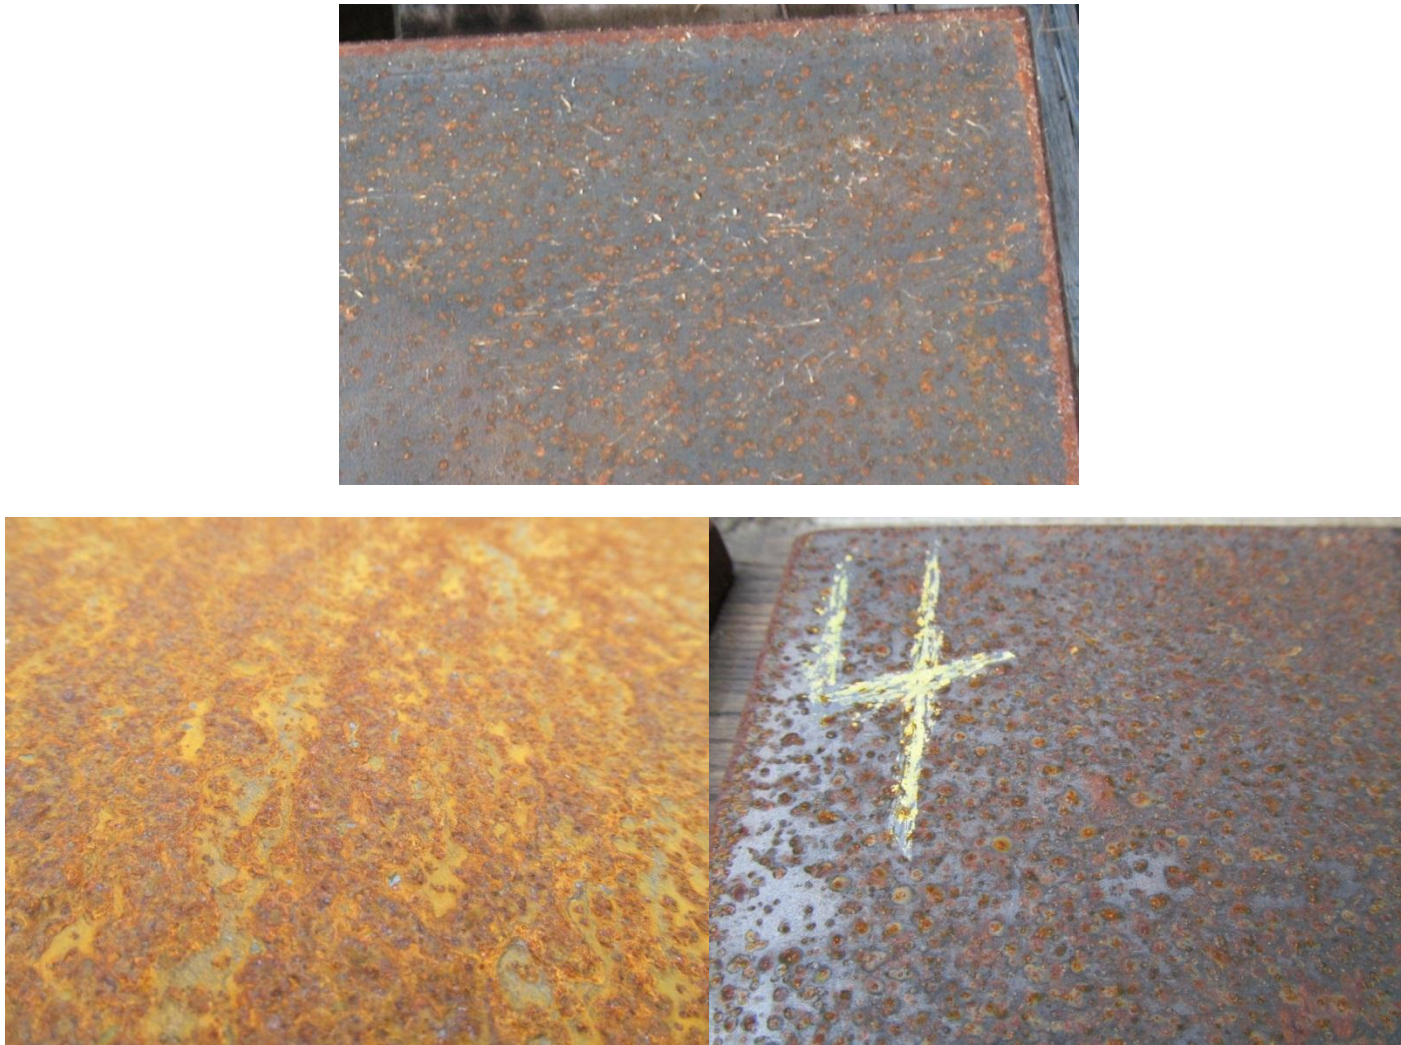
WJE photographed the plates before initiating testing on October 15, 2012 and again on December 7, 2012. In general, the plates exposed only to natural moisture and deionized water showed minor advancement in patina development, but the rust forming on the steel surface did appear to be consistent with good patina performance. In contrast, the heavily salted plates began to exhibit reddish, streaky surface rust formation after only a few spray cycles. This rust progressed more aggressively despite intermittent natural washing by rain and showed beginning signs of distress. At the time of final photographs, 17 days had passed since the last spray application, with several natural wetting cycles in the interim. Figure 8 shows representative conditions of the plates before and after testing.

Figure 8. Close-up photos of plate condition before testing (top center), after salt spray (bottom left), and after deionized water spray (bottom right).

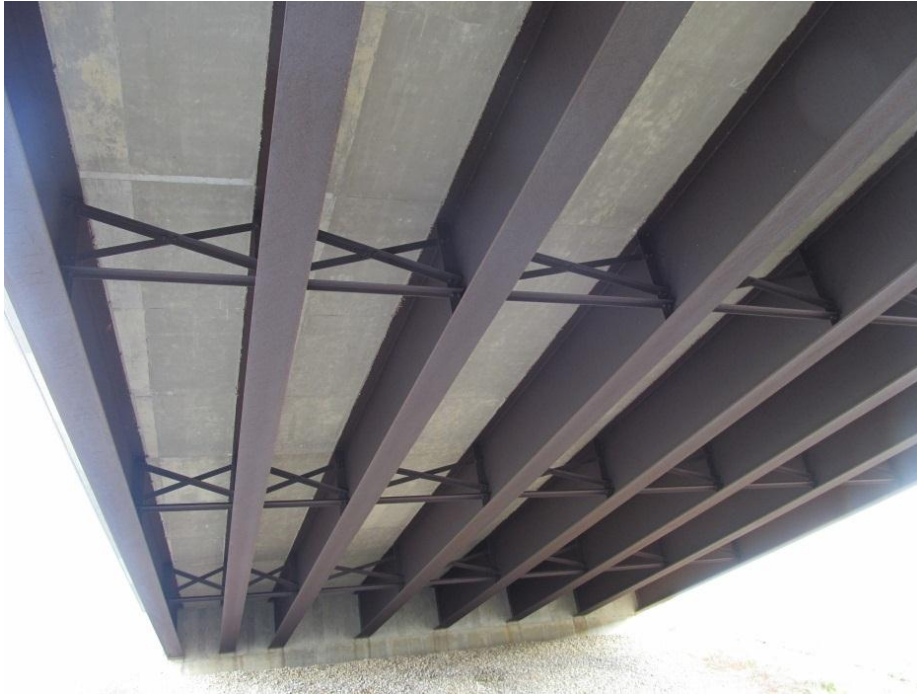
Figure 10. Typical framing for weathering steel bridges in Iowa, note narrow flange width, minimal use of transverse stiffeners, and lack of longitudinal stiffeners and bottom flange lateral bracing.

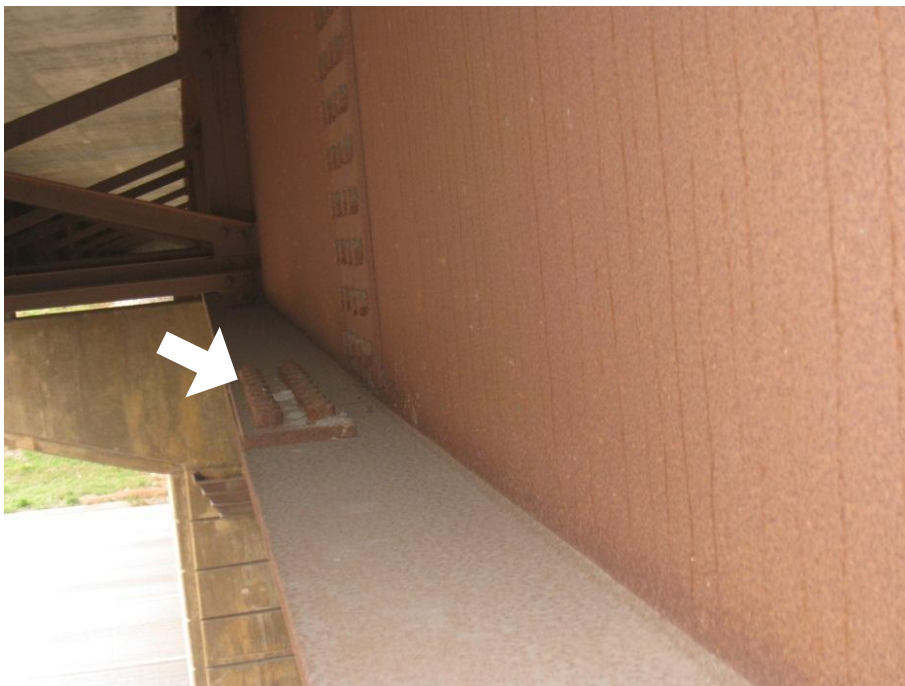
Figure 11. Typical detailing for weathering steel bridges in Iowa, note the narrow flange splice plate that prevents ponding water at the leading edge.

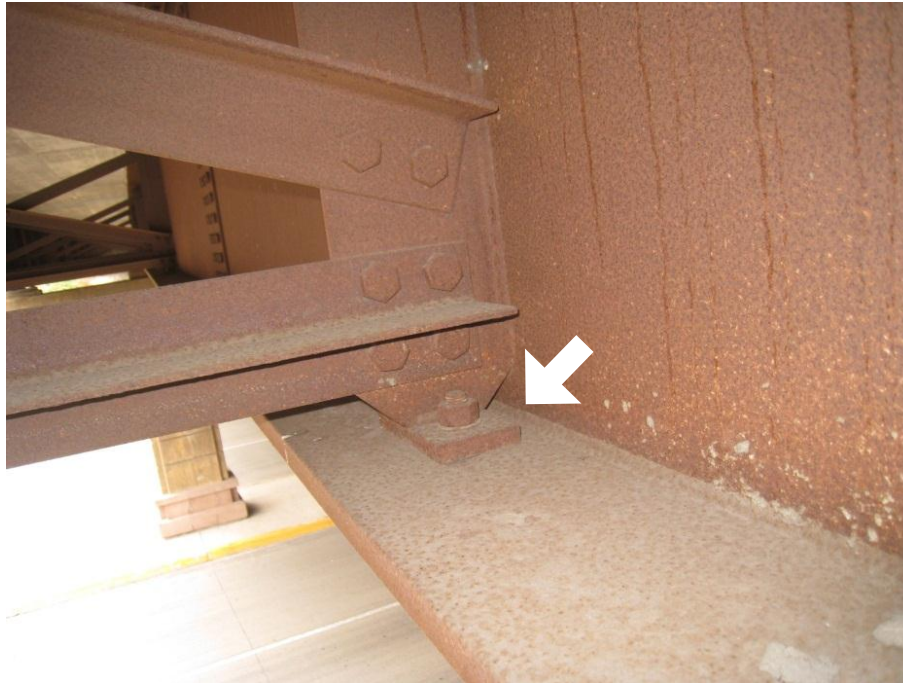
Figure 12. Typical detailing for weathering steel bridges in Iowa, note the coped stiffener that allows water to pass.

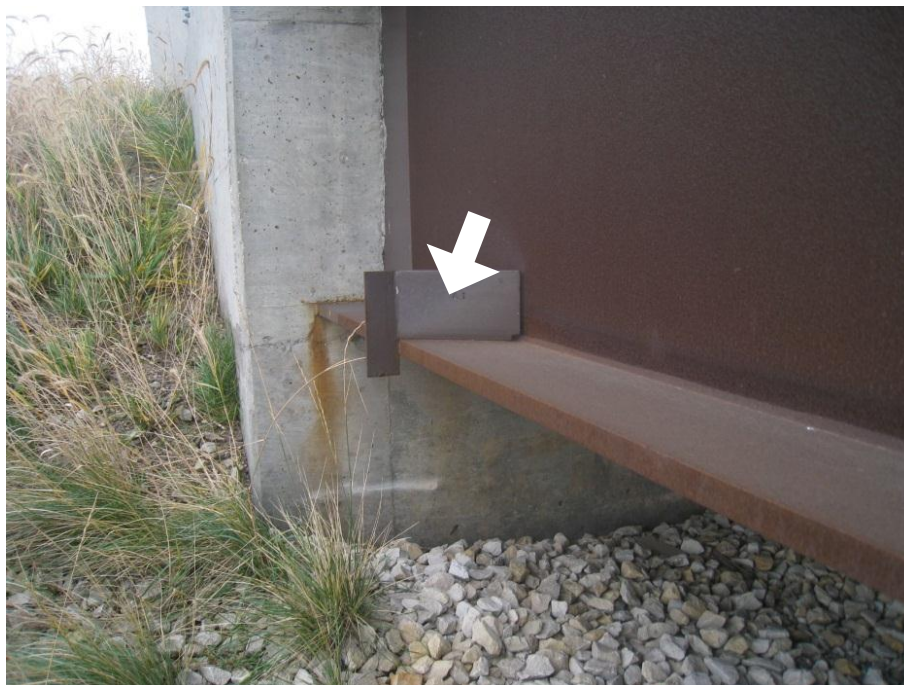
Figure 13. Typical detailing for weathering steel bridges in Iowa, note the water diversion plate (arrow), the painted ends of the girder, and the use of integral abutments.

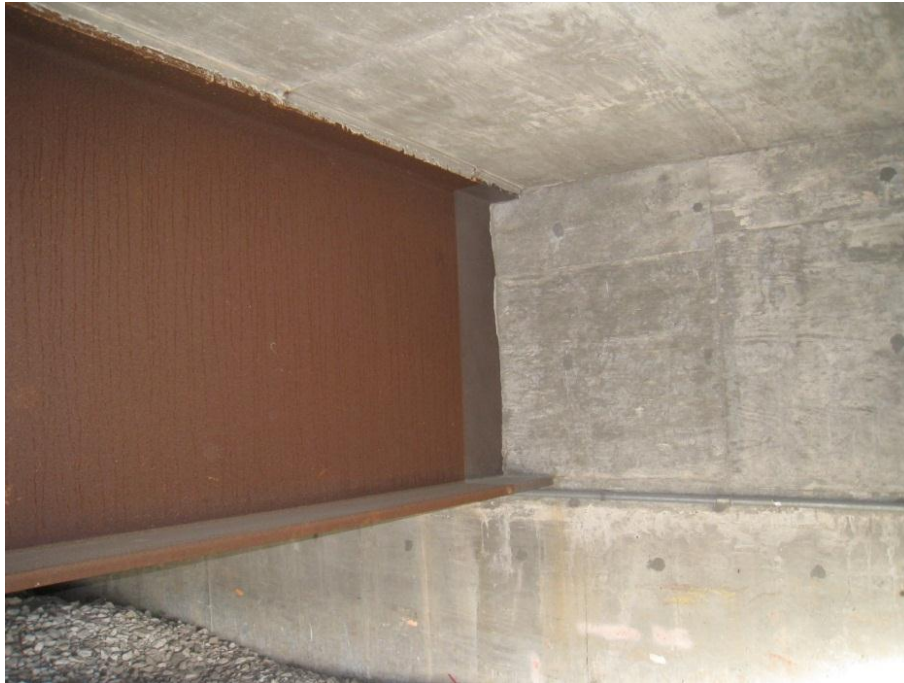
Figure 14. Typical detailing for weathering steel bridges in Iowa, note the use of integral abutments and the painted ends of the girder.

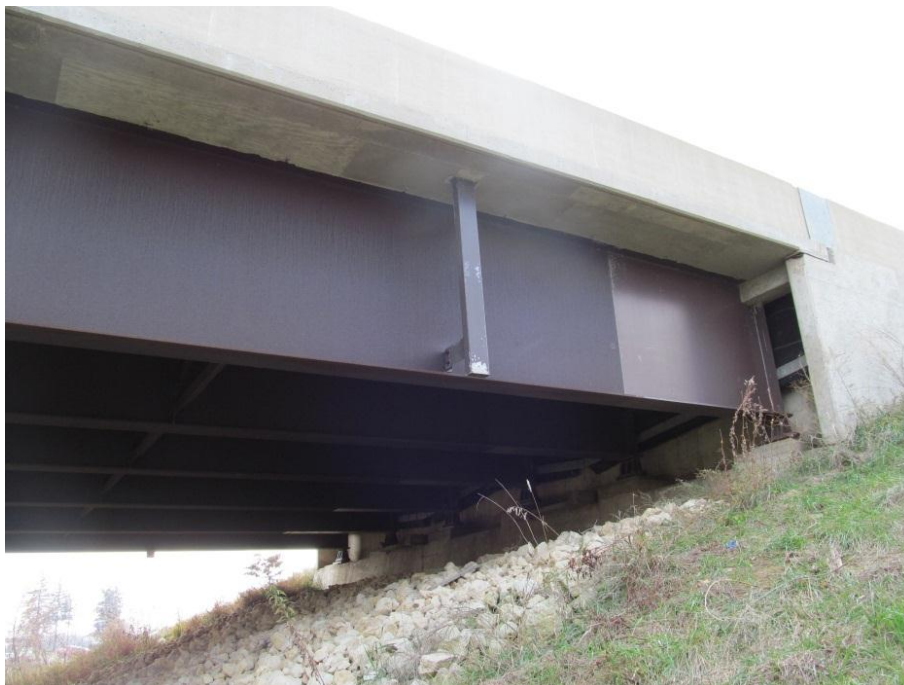
Figure 15. Typical detailing for weathering steel bridges in Iowa, note the painted ends of the girder.

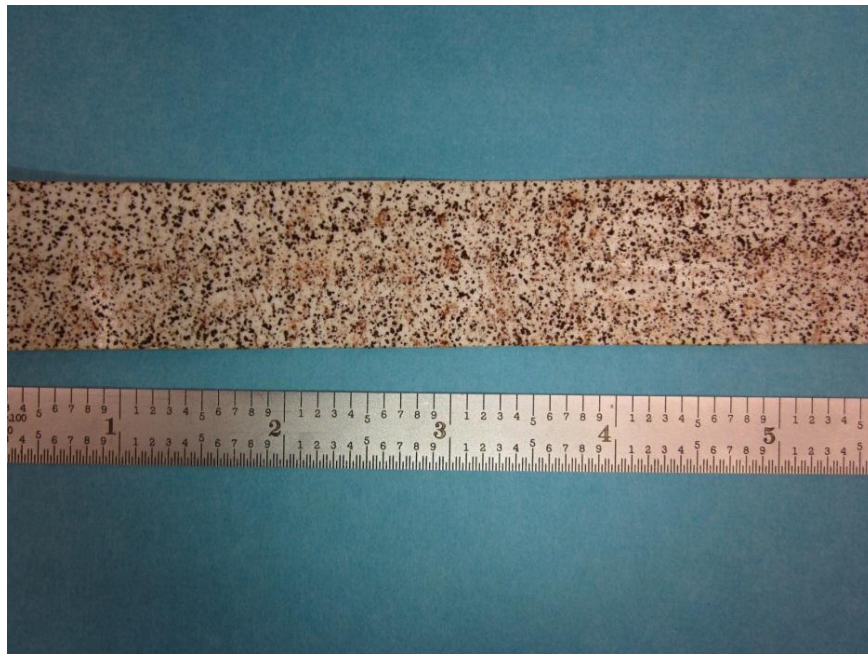
Figure 23. Category 5 tape test sample; note fine reddish rust phase particulates interspersed with more typical dark brown patina flakes.

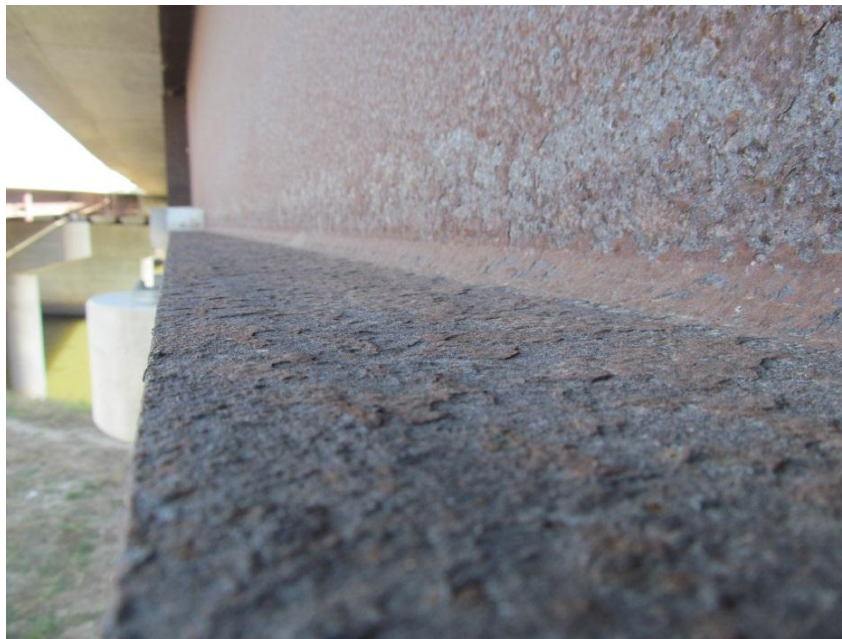
Also of interest are tape tests of a fascia girder from an eastbound on-ramp adjacent to the I-235 Bridge over the Des Moines River, Structure 7708.5A235. The ramp crosses a minor access road parallel to the riverfront. The tape adhesion tests performed on the ramp fascia girder adjacent to the I-235 mainline structure suggest that heavy salt spray from the adjacent interstate caused significant deterioration of the exterior face of the fascia web and bottom flange. The middle portion of the exterior web fared reasonably well with an index of 3, but the patina was increasingly distressed as we examined lower on the girder, as shown in Figure 28. The bottom of the web, top of the bottom flange, and bottom of the bottom flange rated at indices of 2.5, 2, and 1.5, respectively. This corrosion is concerning given that records indicate

this ramp structure was constructed in 2003; however, the damage was limited to a relatively short portion of the bridge where chloride-contaminated snow from plows on the I-235 mainline is deposited onto the ramp fascia girder. At other locations along the girder, the curvature of the ramp brought the exposed fascia surface out of range of direct snow or close enough to the mainline structure that the concrete deck shielded the girder from direct snow, as shown in Figure 29. The interior faces of the fascia girder were in considerably better condition, with an index rating of 3.5. Though some poultice corrosion was present on the interior bottom flange, the patina was adherent and showed no signs of flaking. This may be an indication that the interior surfaces of the ramp have a relatively short time of wetness each year since they see little moisture from the low-speed, minor traffic below.

Figure 28. Fascia girder of I-235 eastbound on-ramp at 2nd Avenue. Note transition from Category 3 patina at mid-height of the web to Category 2 at the top of the bottom flange in areas subjected to direct salt spray from the I-235 mainline.

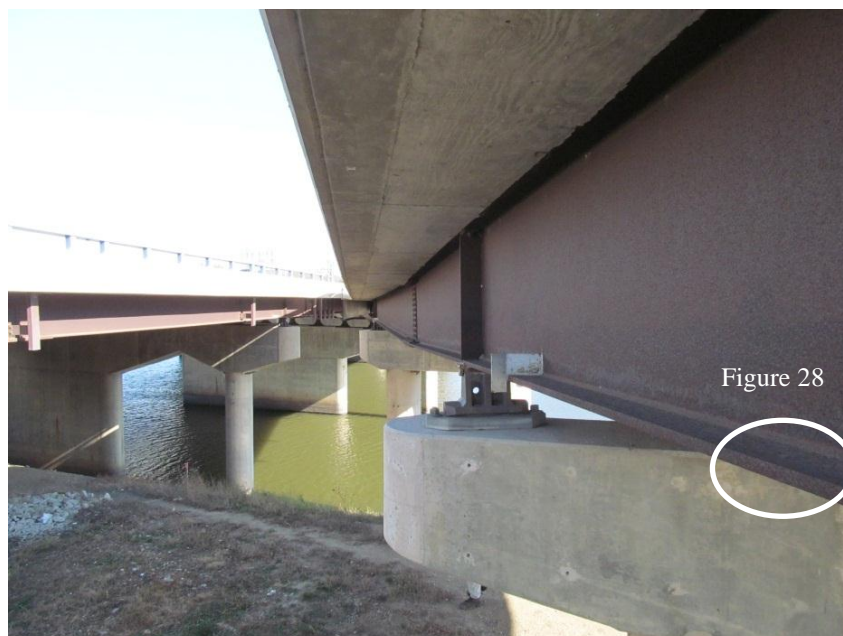
Figure 29. Overall view of I-235 eastbound mainline (left) and on-ramp at 2nd Avenue (right). Note that the portion of the on-ramp fascia girder subjected to salt spray depends on the distance from the mainline structure. As the structures come closer together, the fascia girder is shielded by the deck.

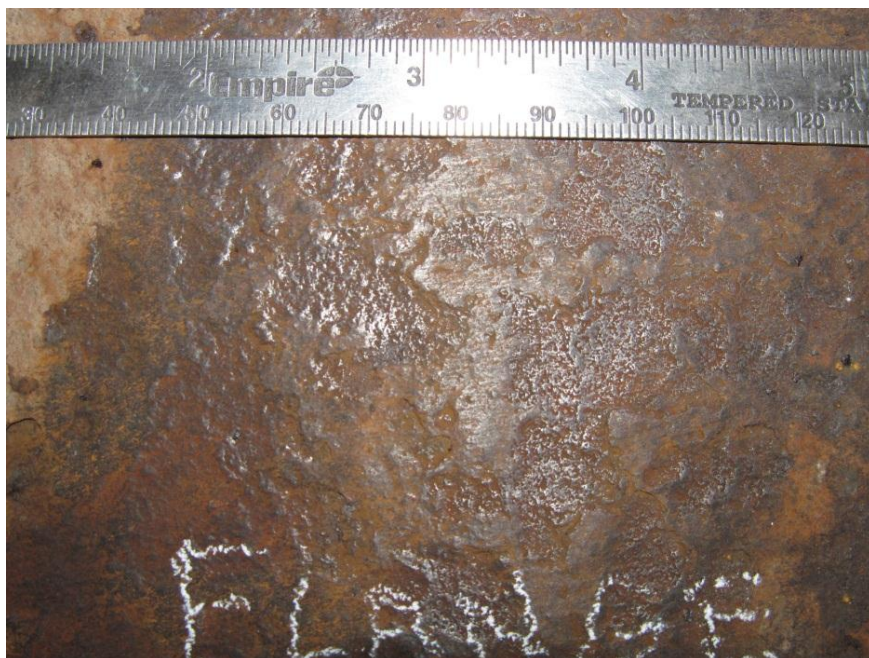
Figure 33. Close-up photo of steel on top surface of girder bottom flange after wire wheel grinding at Field Selection 3; delaminated patina removed down to bare steel with oxide layer remaining in pitted areas.

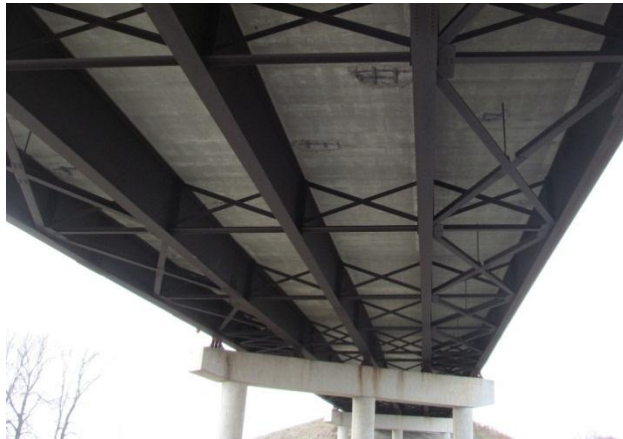
Figure 1. North roadway span showing bracing arrangement and spall locations in the deck.

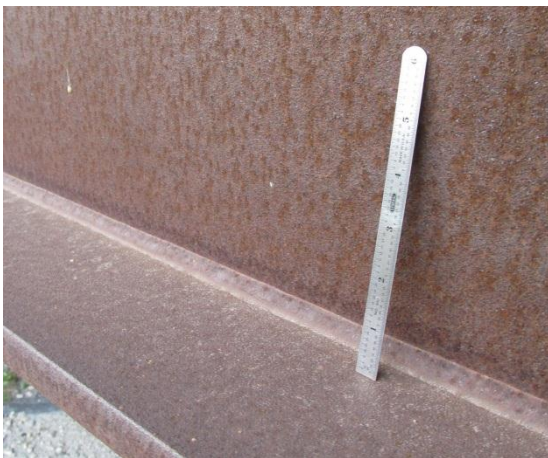
Figure 5. Excellent patina performance on exterior fascia faces after 40 years, typical of rural bridges.

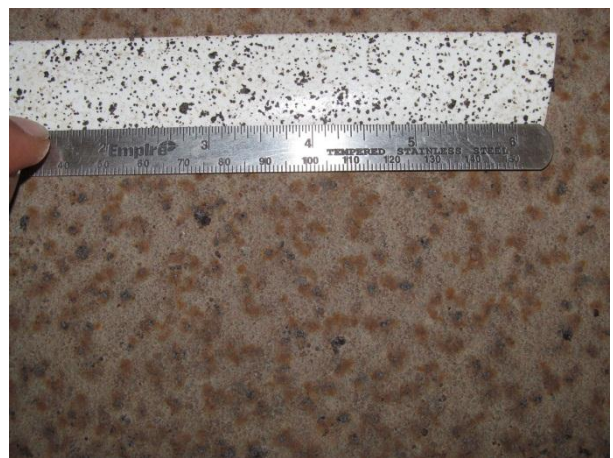
Figure 6. Non-flaky poultice over traffic, typical of narrow rural bridges.

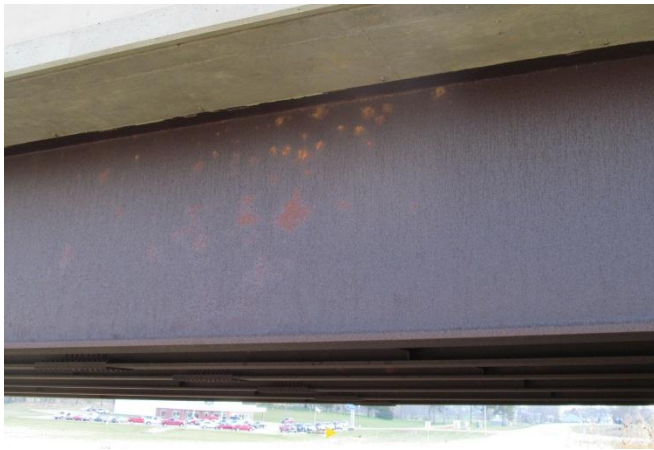
Figure 1. Patina discoloration on west fascia of northbound bridge, possibly due to mill scale (Index = 5 locally in these areas).

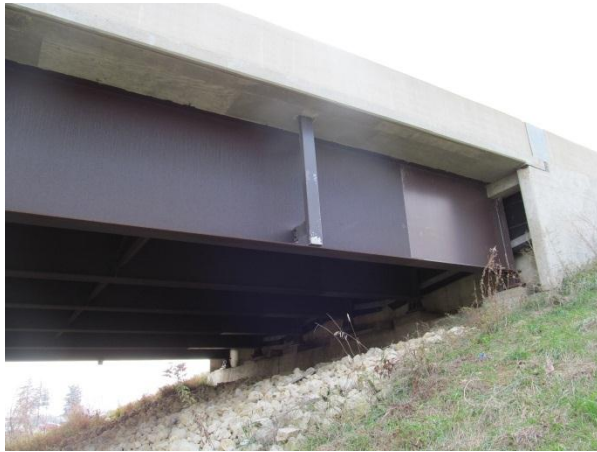
Figure 1. West fascia near south abutment, showing short downspout, painted girder end, and rock apron.

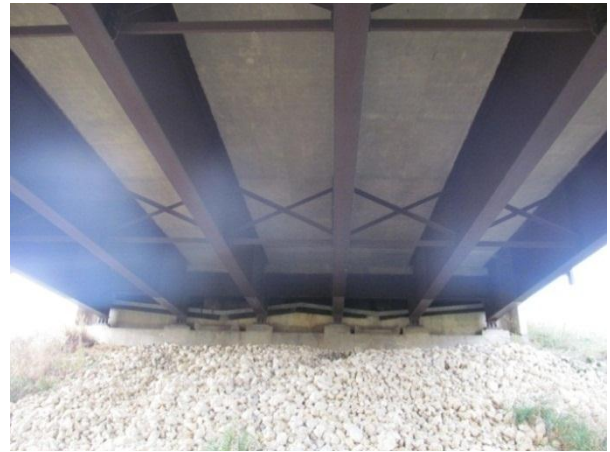
Figure 2. South abutment, showing typical cross-frames and diaphragms detailed to not stain concrete.

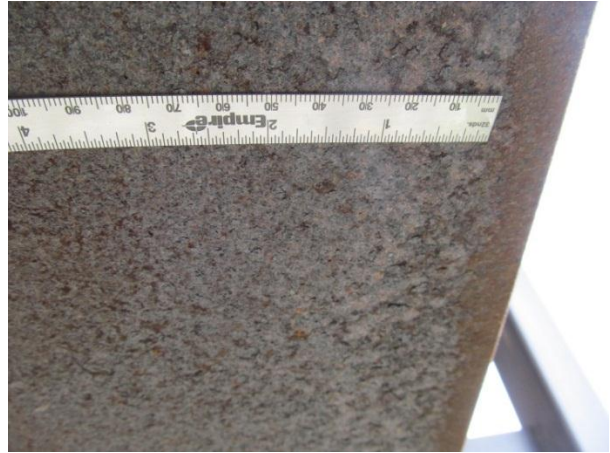
Figure 4. Larger flakes on bottom of fascia bottom flange near downspout by south abutment.

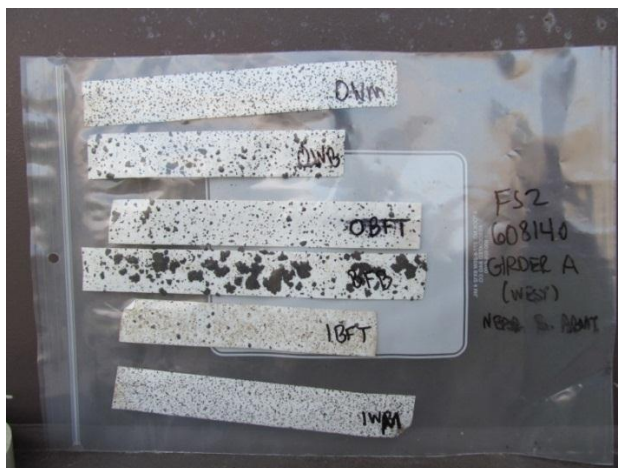
- Visual inspection limited to foot access only since no access road was available.
- Tape, chloride, and color tests taken on exterior and interior surfaces near south abutment; typically little patina variation (Index 4 to 3.5), chlorides measured at 1 ppm or less. No meaningful color data.
- Tape test on west fascia near drain reveals moderate flaking on the bottom of the flange (Index = 2).

Figure 5. Tape test series taken from west fascia girder adjacent to downspout showing large flakes (Index=2) on bottom of bottom flange.

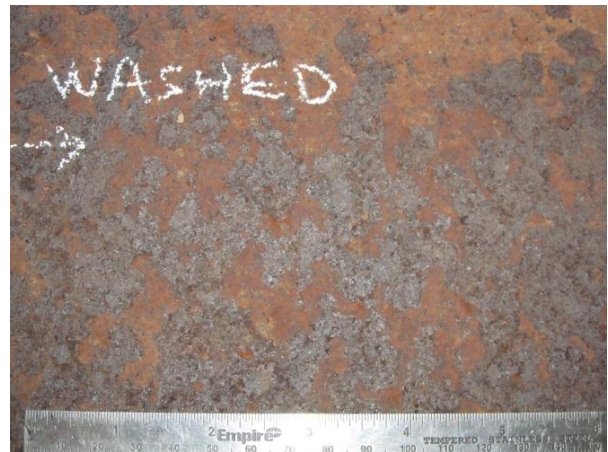
Figure 2. Top of bottom flange after washing; some of poultice remains, Index = 2, chlorides = 10 ppm.

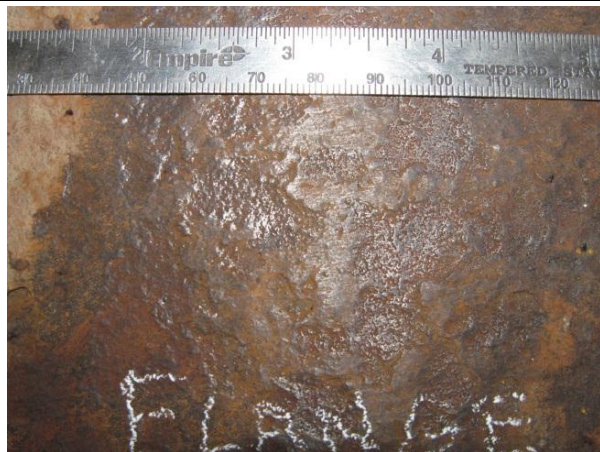
Figure 3. Top of bottom flange ground with wire wheel. Chlorides in ground area before washing = 20 ppm; after washing, 14 ppm extracted by test.

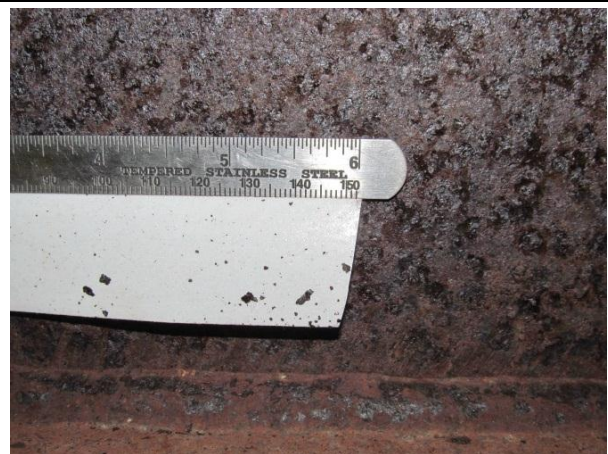
Figure 6. Bottom of web after washing; tape test (sparse, Index = 3) shows improvement in adherence (Index before = 2 with dense coverage).

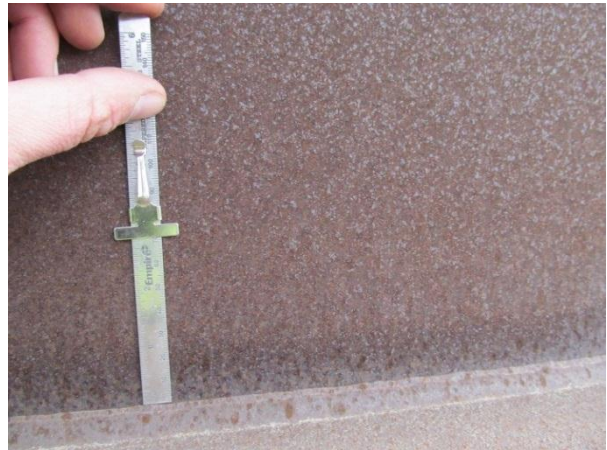
Figure 2. Fascia girder exterior web patina over traffic (Index = 4). Note darker band above weld.

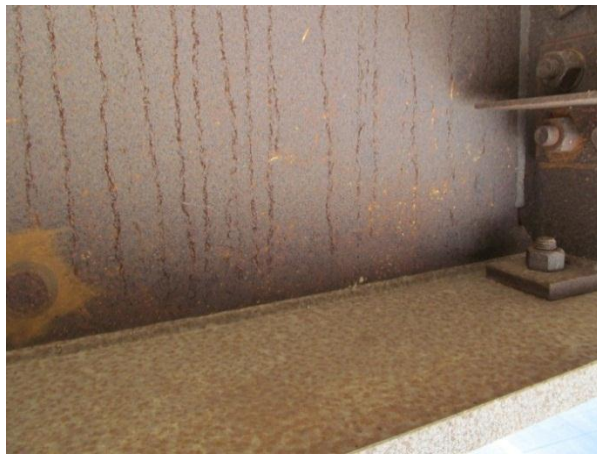
Figure 3. Interior girder over traffic showing poulitice with minimal flaking and reddish web discoloration, possibly due to mill scale.

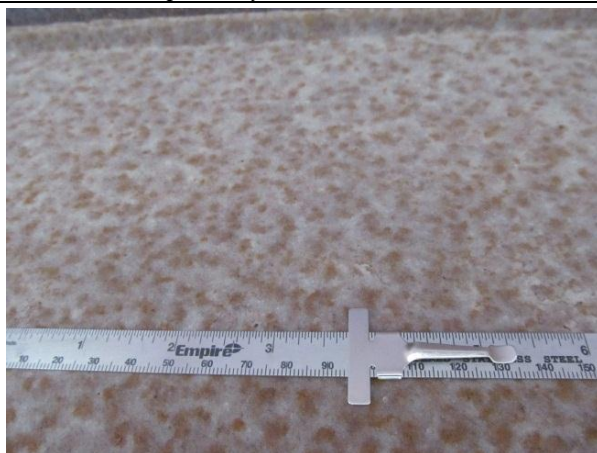
Figure 5. Poulitice on flange before washing.

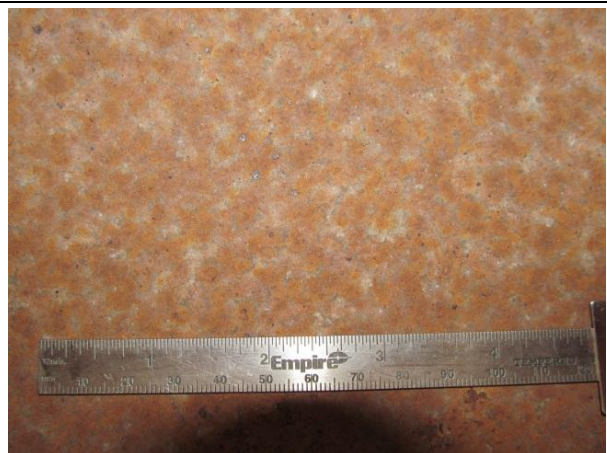
Figure 6. Flange poulitice partially reduced by washing.

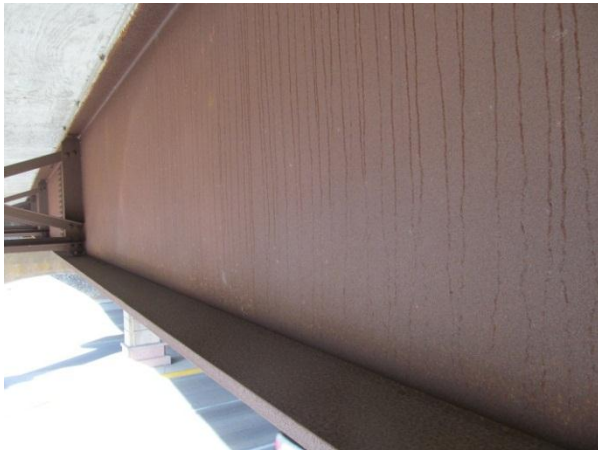
Figure 1. Typical interior girder conditions; good patina performance on web and flange, despite flange poutlice.

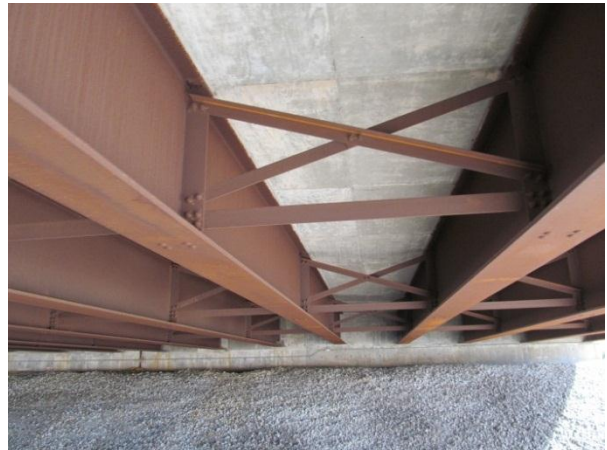
Figure 2. Some discoloration on bottoms of flanges, but only minor flaking. Conditions near abutment similar to those over traffic.

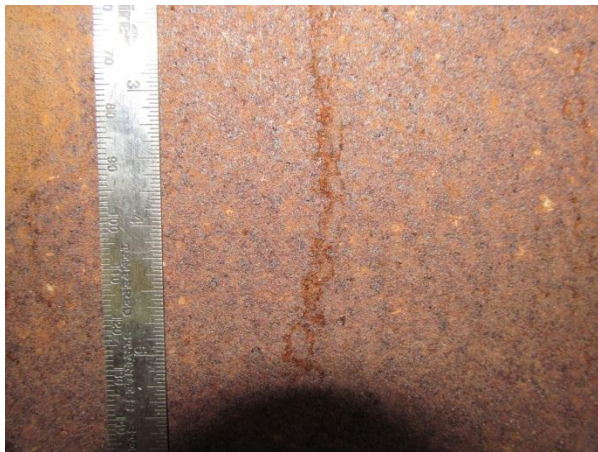
Figure 3. Web patina performing well (Index = 3.5).

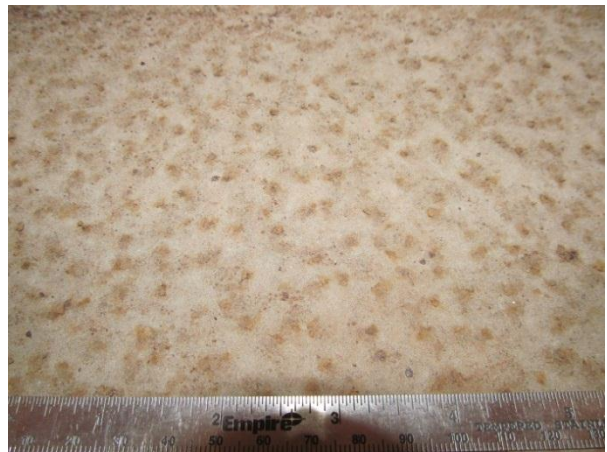
Figure 4. Heavy flange chalking with only minor flaking (Index = 3).

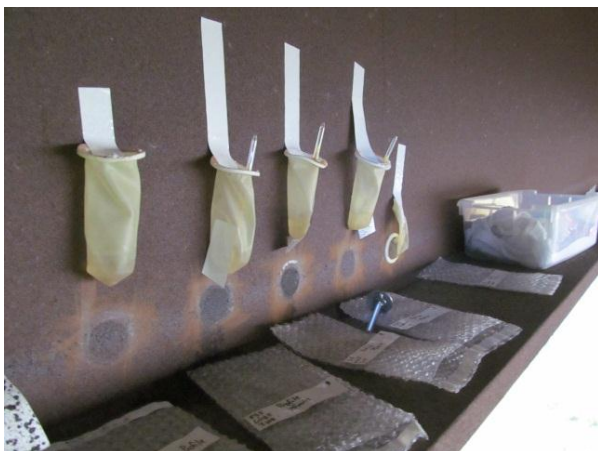
Figure 5. Chloride test time vs. extraction efficiency profile taken on bottom of interior web (Index = 3).

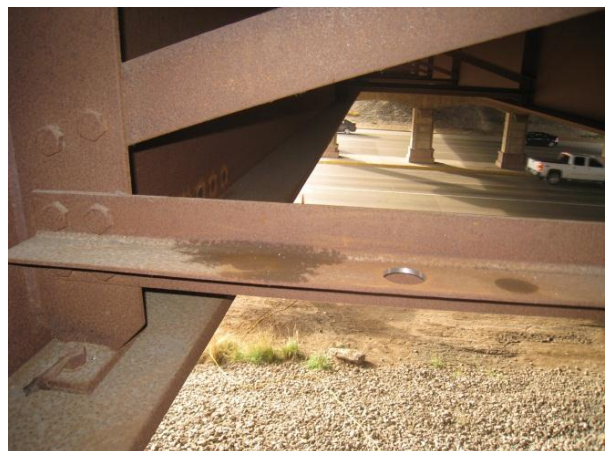
Figure 6. Chloride tests adjacent to core location on both undisturbed and hand brushed poutlice.

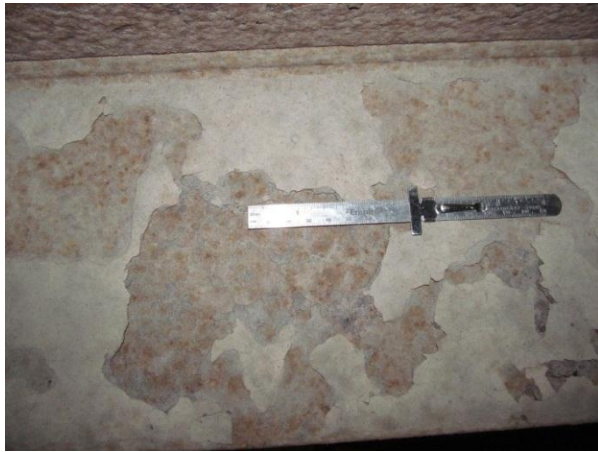
Figure 1. Heavy poultice on interior flange with multiple thin layers of delamination forming.

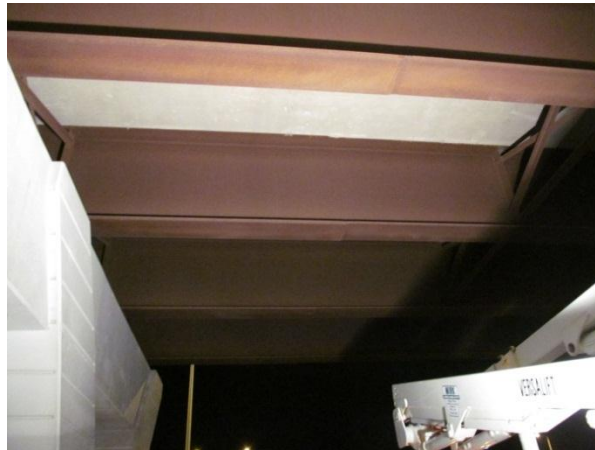
Figure 1. Bottom flanges exhibiting some mild reddish discoloration and possible flaking near pier over eastbound left shoulder.

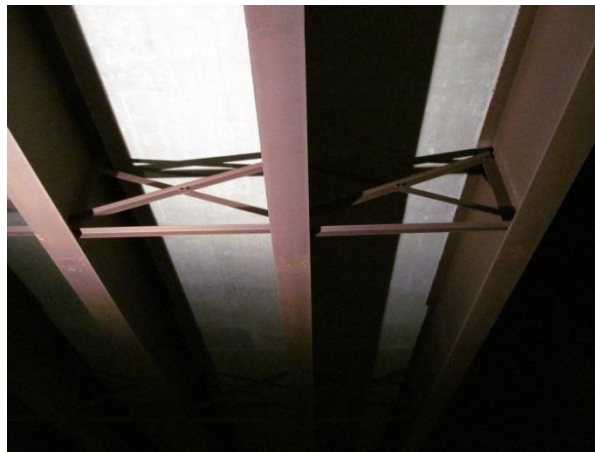
Figure 2. More distinct spots of local discoloration visible near middle of south span.

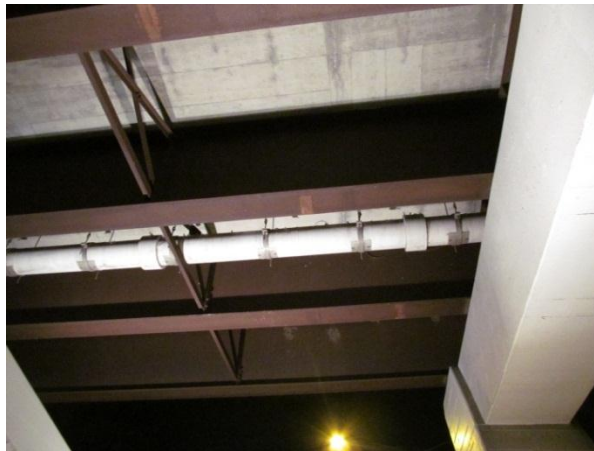
Figure 2. Rectangular, reddish stains on bottom flanges. Also note grayish staining on interior web of fascia girder beyond. Such stains occasionally noticed throughout Field Selection 7.

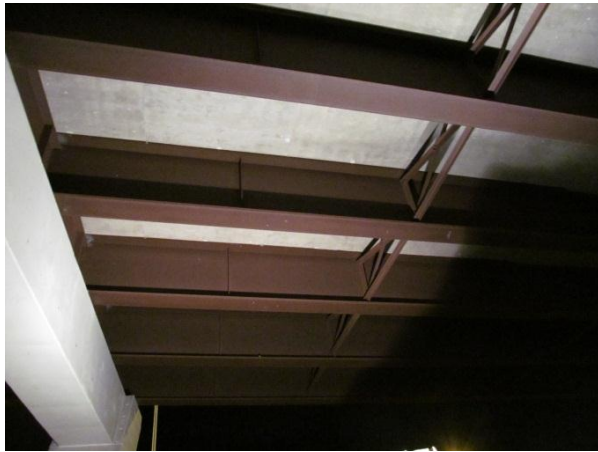
Figure 1. Overall condition of girders and bracing viewed from below, here near pier.

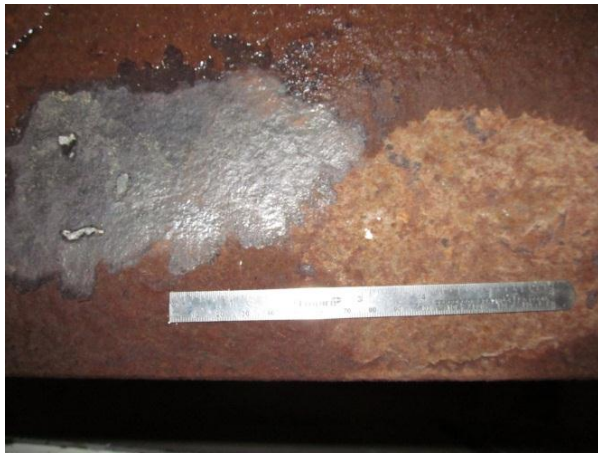
Figure 3. Close-up of wire wheel ground area and adjacent as-is poultice after washing and drying.

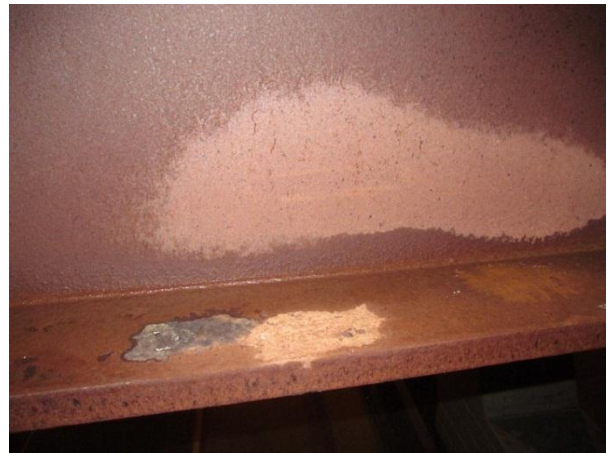
Figure 4. Test area after washing and partial drying: wire wheel area on left, wire brush area on far right.

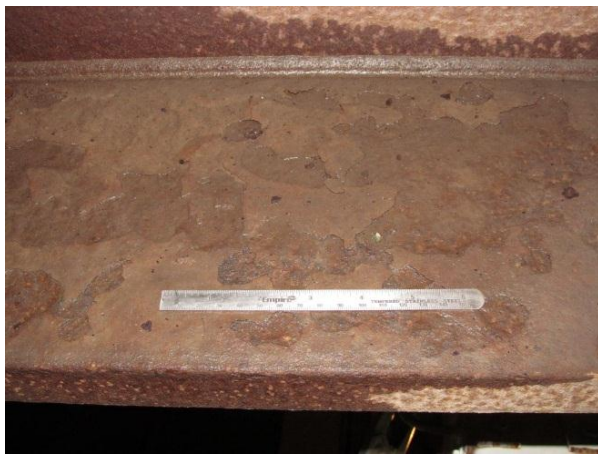
Figure 5. Washing as-is: poultice reduced, but delamination remains.

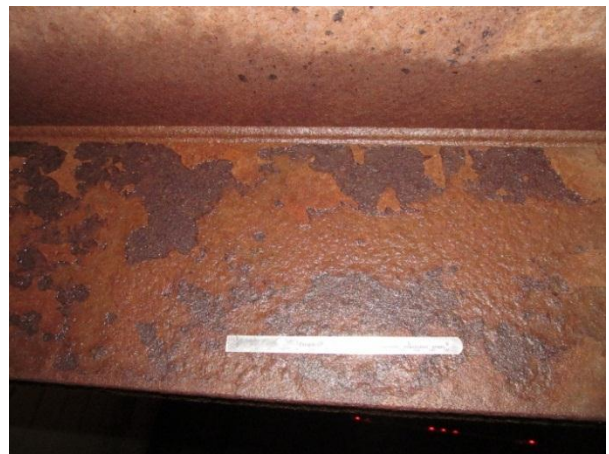
Figure 6. Washing after hand brushing of poultice: Cleaner, but delaminated patina remains.

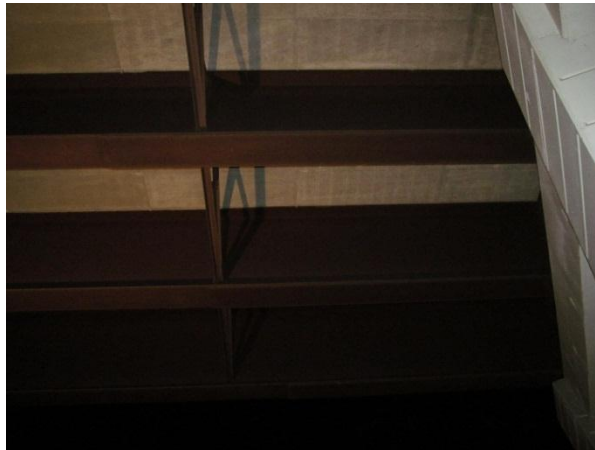
Figure 1. Patina in good condition on all surfaces visible from ground; here near pier.

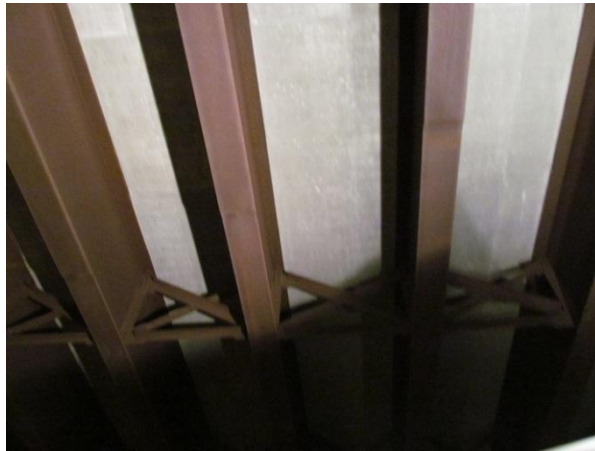
Figure 2. Uniform, dark patina performing well near mid-span.

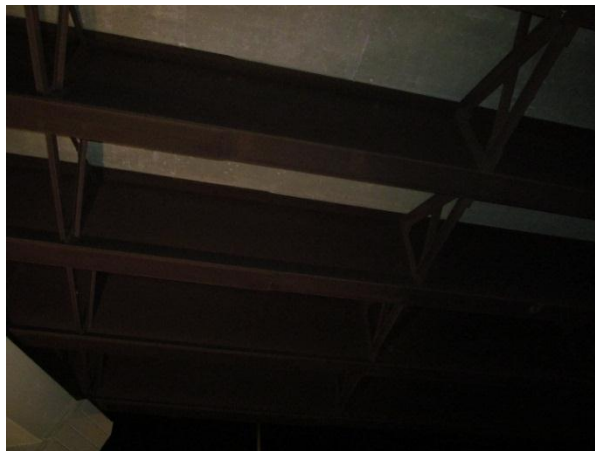
Figure 3. Some localized blotchy stains and flaking; otherwise patina is uniform when viewed from the ground.

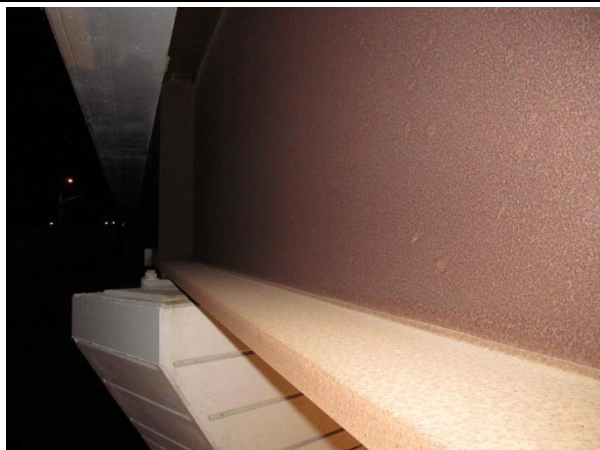
Figure 1. Index = 3.5 to 3 patina on exterior fascia surfaces.

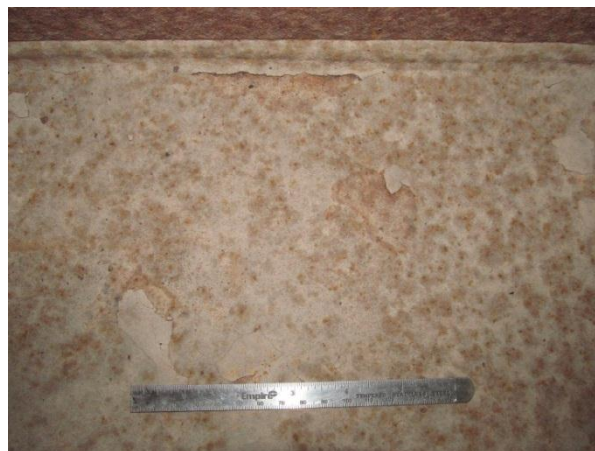
Figure 6. Delaminated, heavy pultice corrosion on interior bottom flange.

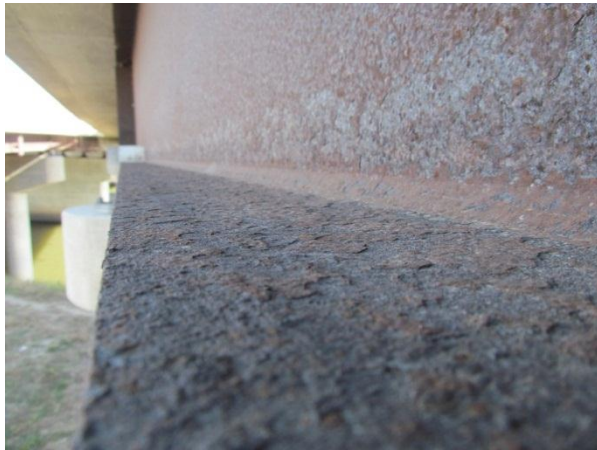
Figure 1. Delamination of top of exterior bottom flange and web of north fascia girder on I-235 eastbound entrance ramp.

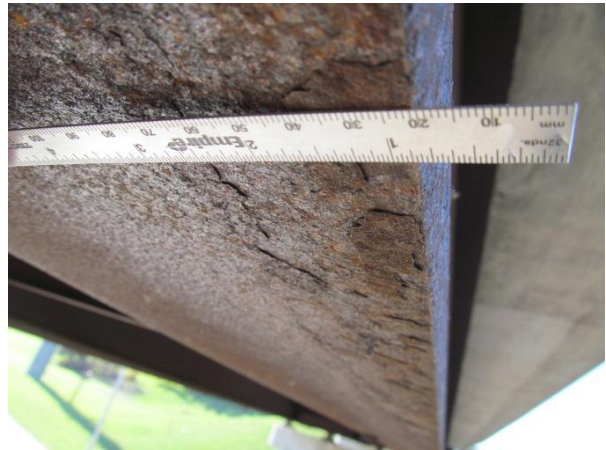
Figure 2. Bottom of bottom flange delaminations, north fascia girder of entrance ramp.

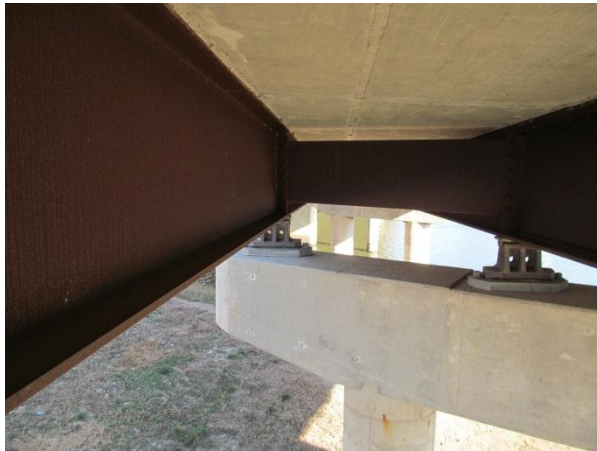
Figure 3. Interior side of entrance ramp north fascia girder demonstrating good patina performance.

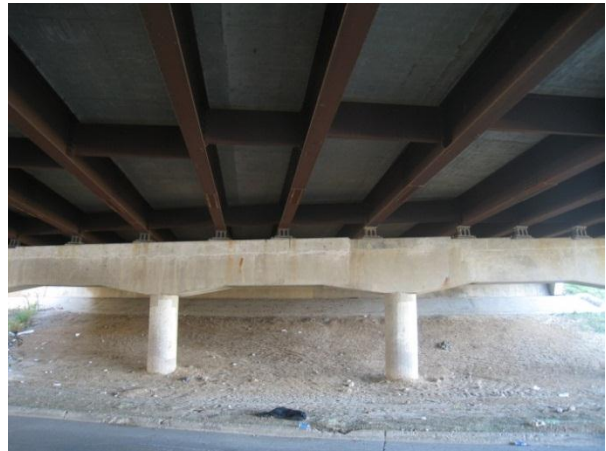
Figure 4. Interior girders of westbound mainline bridge showing good patina performance.

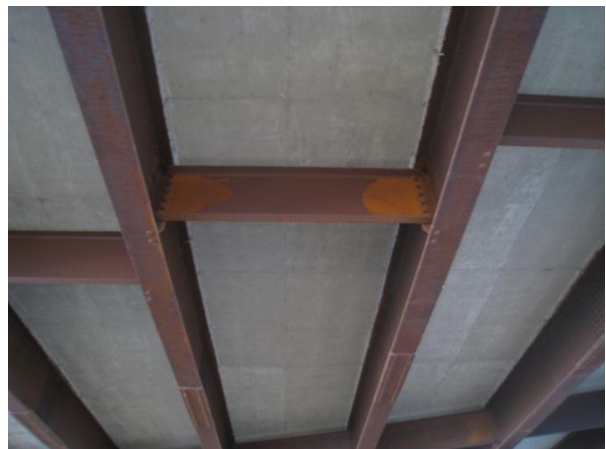
Figure 6. Areas of underdeveloped patina due to spill during construction or mill scale (Index=5).
