ASSESSMENT OF WEATHERING STEEL BRIDGE PERFORMANCE IN IOWA AND DEVELOPMENT OF INSPECTION AND MAINTENANCE TECHNIQUES

Final Report
SPR 90-00-RB17-012
February 21, 2013
WJE No. 2011.1671

Sponsored by:
Iowa Department of Transportation
Office of Bridges and Structures
800 Lincoln Way
Ames, IA 50010

Prepared by:
Wiss, Janney, Elstner Associates, Inc.
330 Pfingsten Road
Northbrook, Illinois 60062
847.272.7400 tel | 847.291.4813 fax

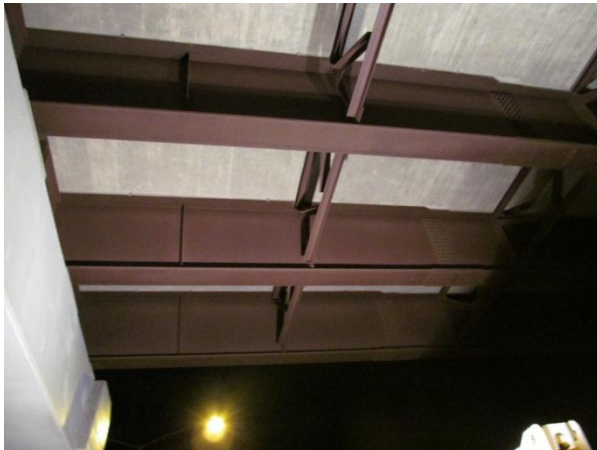
Figure 1. East half of bridge girders near pier; generally good patina condition viewed from below.

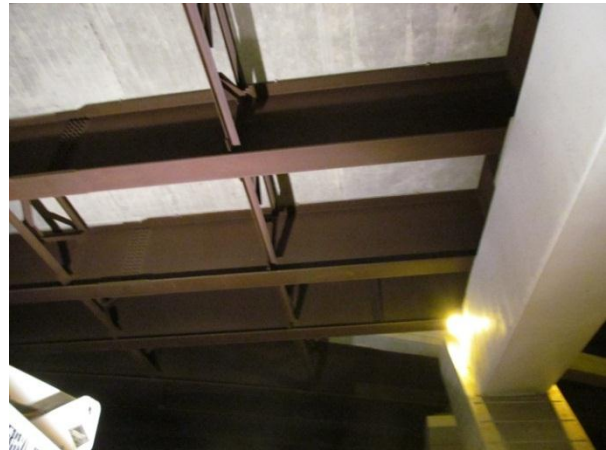
Figure 2. West half of girders near pier, where ramp comes in (background).

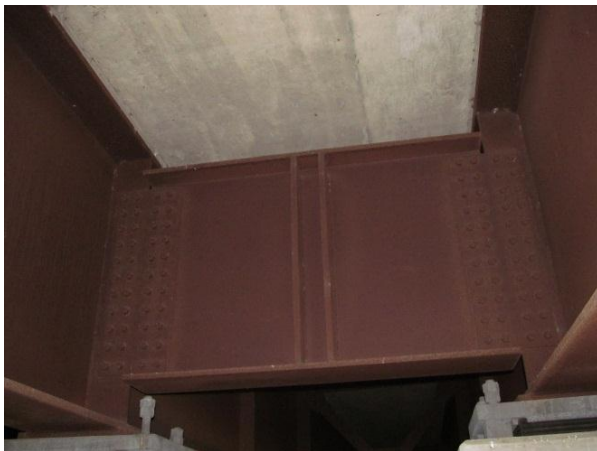
Figure 3. Stiffened I-beam diaphragm at pier.

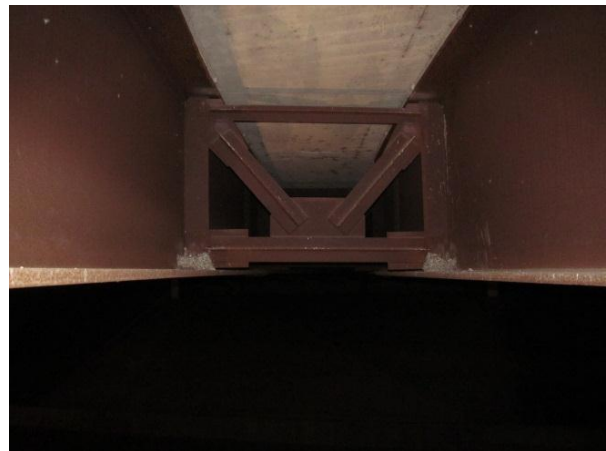
Figure 4. Typical K-brace cross-frame with bird droppings on girder bottom flanges.

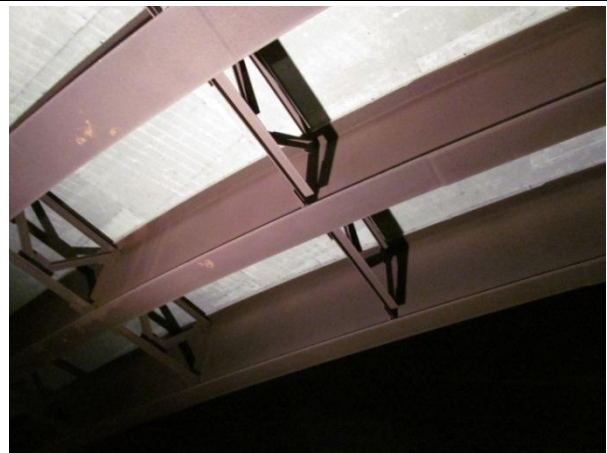
Figure 6. Some localized discoloration and flaky areas on otherwise good patinas near pier.

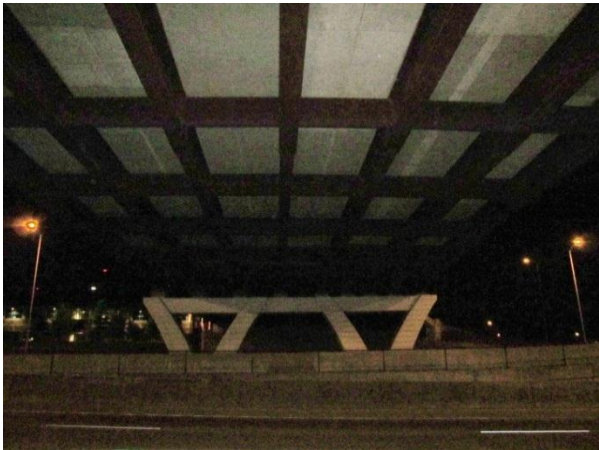
Figure 1. Overall view toward north two spans and north pier.

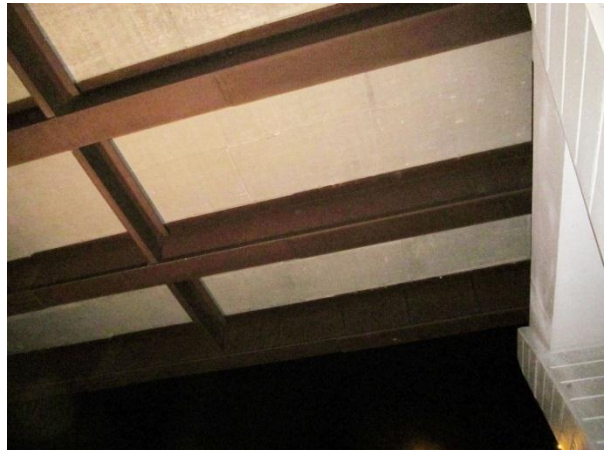
Figure 2. Girders and diaphragms near south pier; appear in good condition from below.

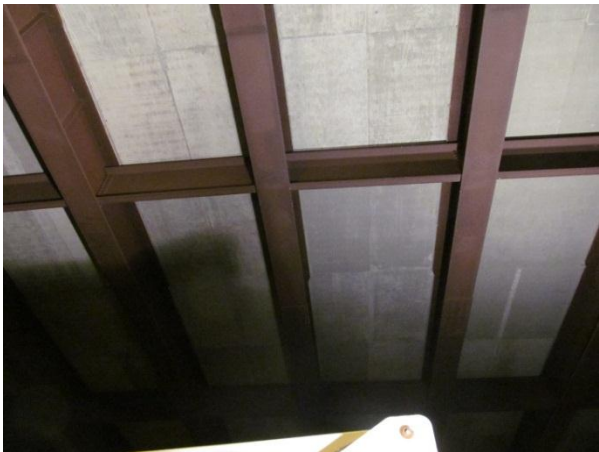
Figure 3. Middle of south span.

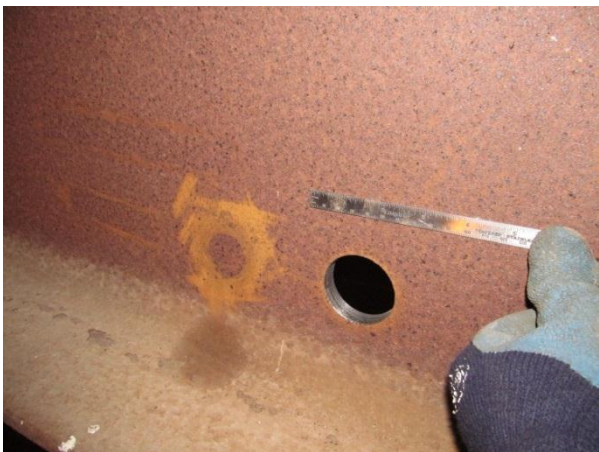
Figure 5. Tape and chloride tests also taken adjacent to core.

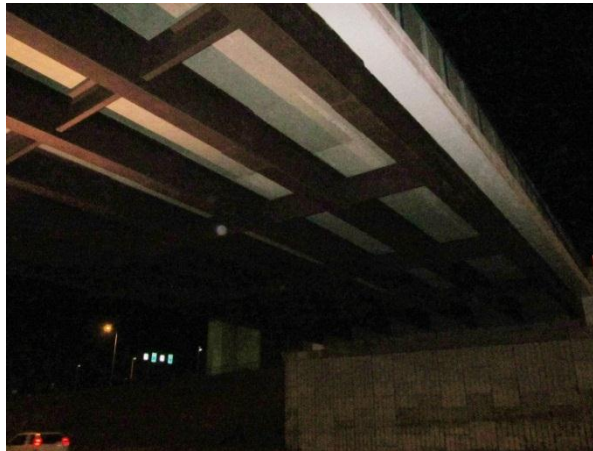
Figure 1. South span over eastbound I-235. Some staining noted on fascia girder and 1st interior girder over the center lane, but not readily visible in this photo.

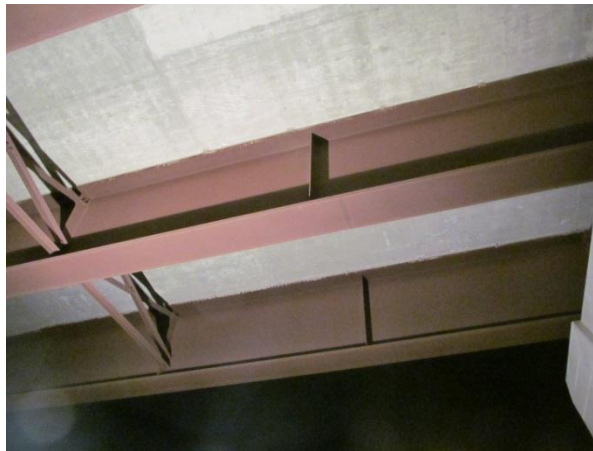
Figure 2. Girders and cross-frames near center pier; no significant deterioration visible from below.

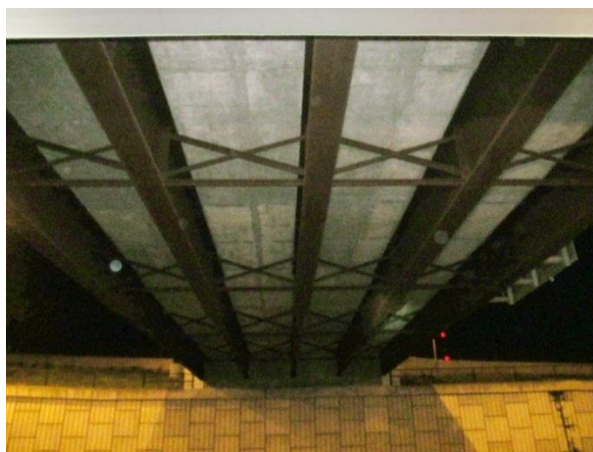
Figure 3. North span over westbound I-235.

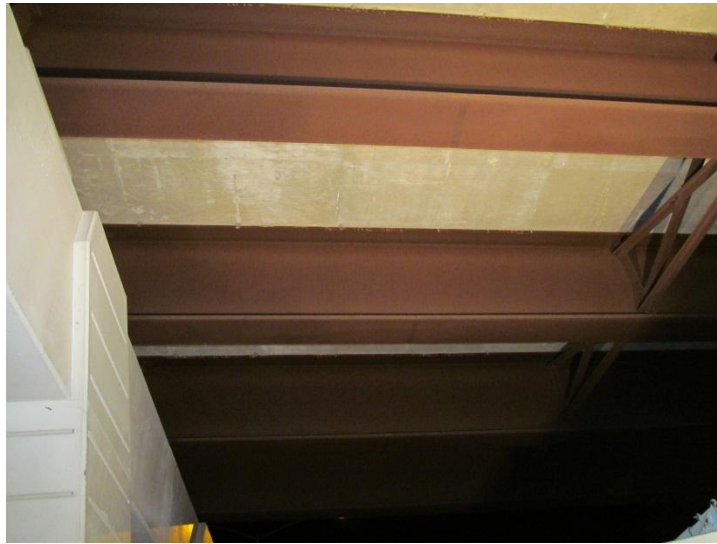
Figure 1. Girders near the intermediate pier; no signs of significant deterioration visible.

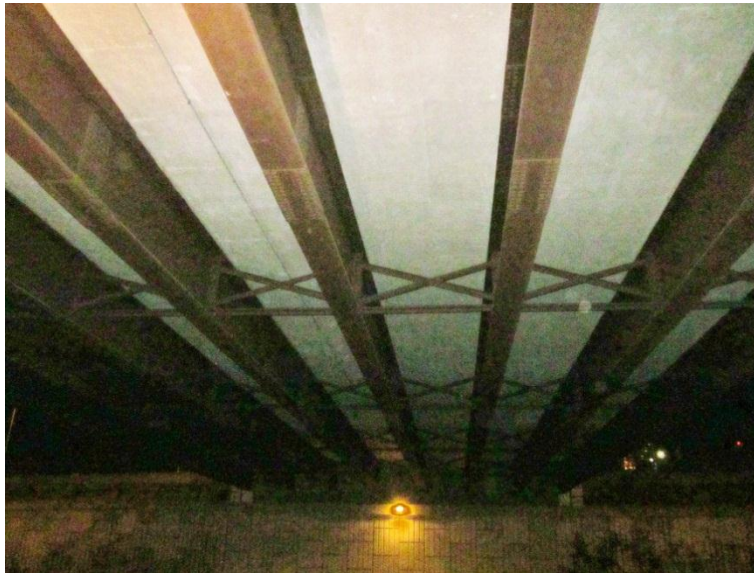
Figure 2. Overall photo of the second span.

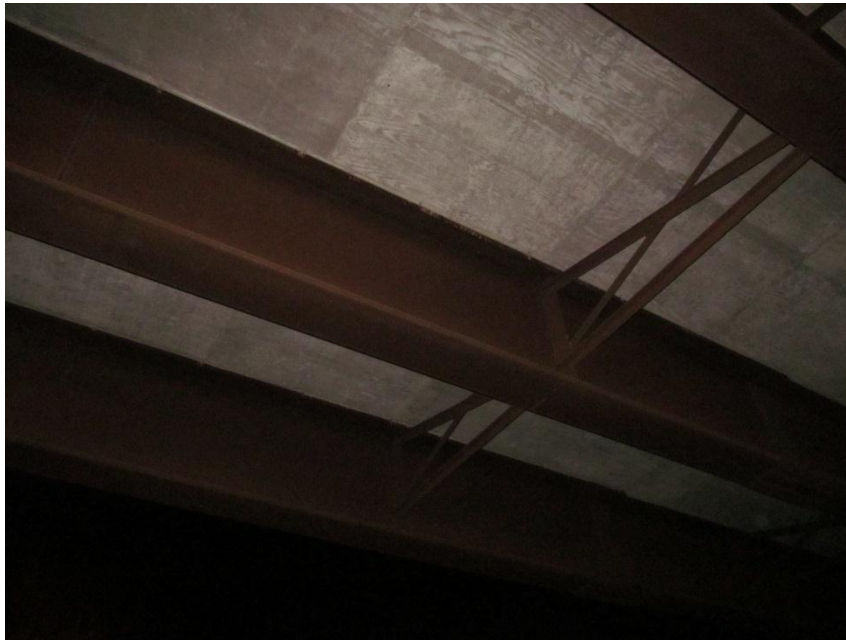
Figure 1. Girder and cross-frames near mid-span; representative of conditions throughout the structure.

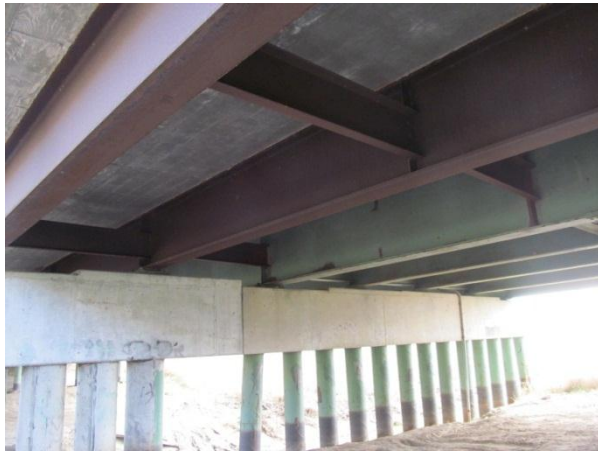
Figure 1. West pier showing framing arrangement and tie-in to original structure.

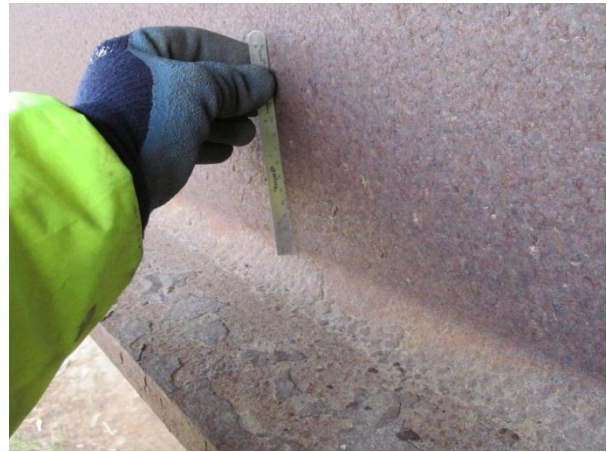
Figure 2. Heavy delamination of fascia bottom flange top (without poultice); also flaky on web.

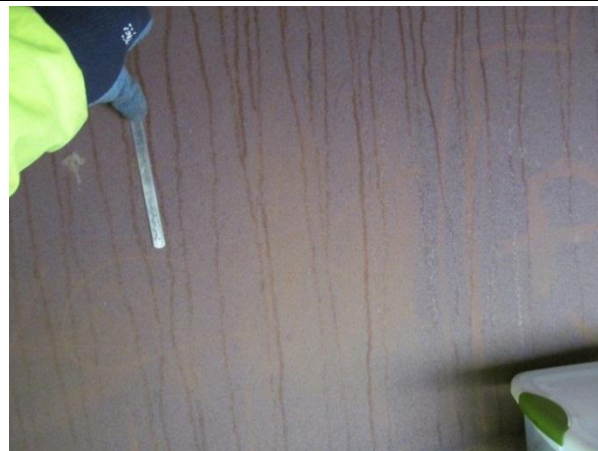
Figure 5. Interior web performing well.

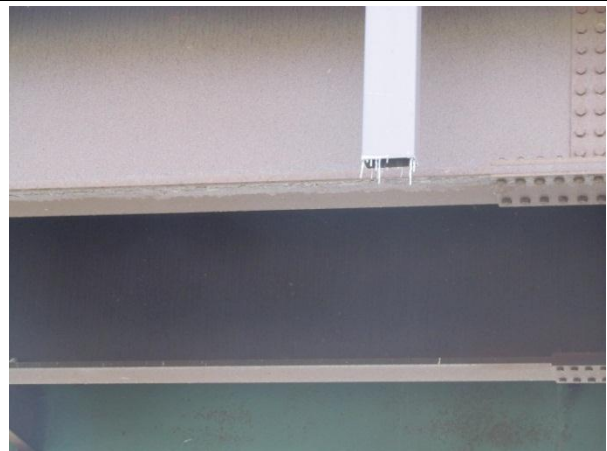
Figure 6. Fascia problems continue over main span.

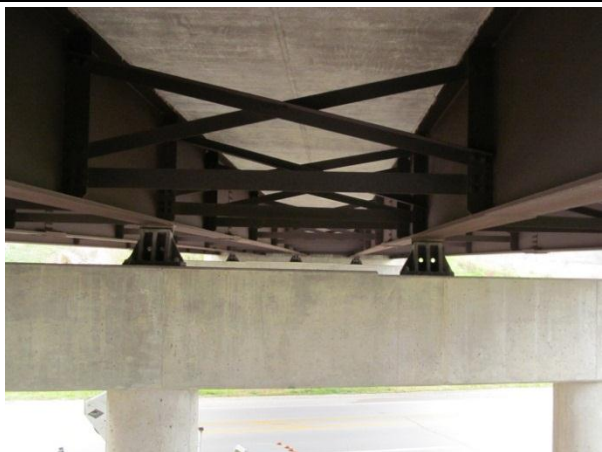
Figure 1. View of south pier looking north; note lack of drainage deflector plates on bottom flanges, typ.

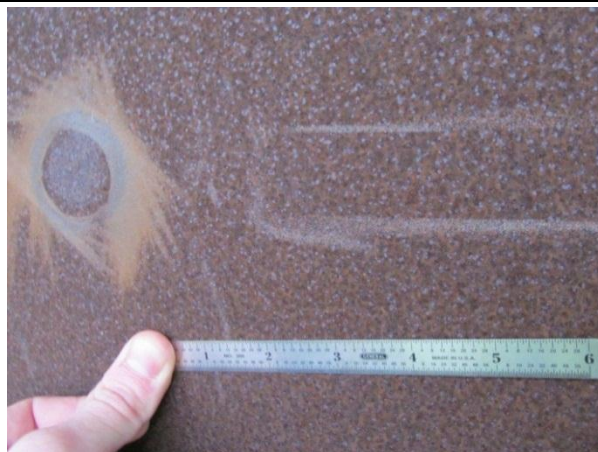
Figure 2. Exterior of east fascia web near south abutment. Index = 4 by tape, chlorides = 0 ppm.

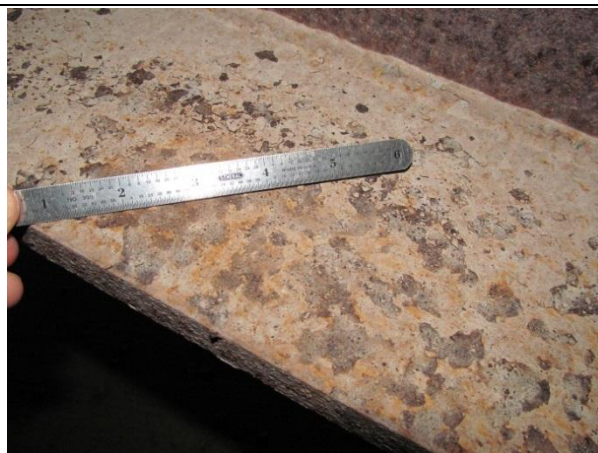
Figure 4. Delamination of interior girder bottom flange with heavy poultice subjected to light scraping.

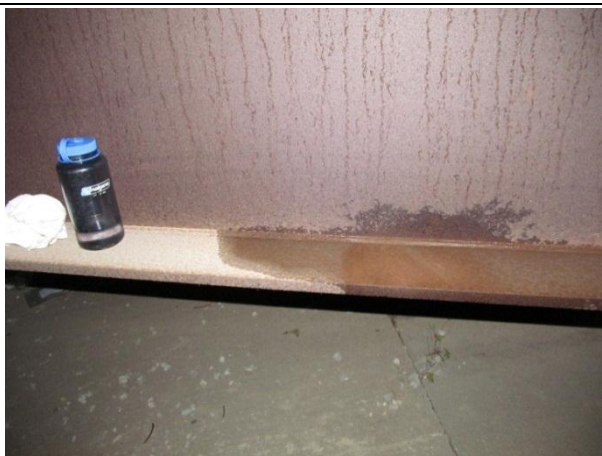
Figure 5. Poultice on east fascia interior side (not flaky). Washed with water and blotted dry.

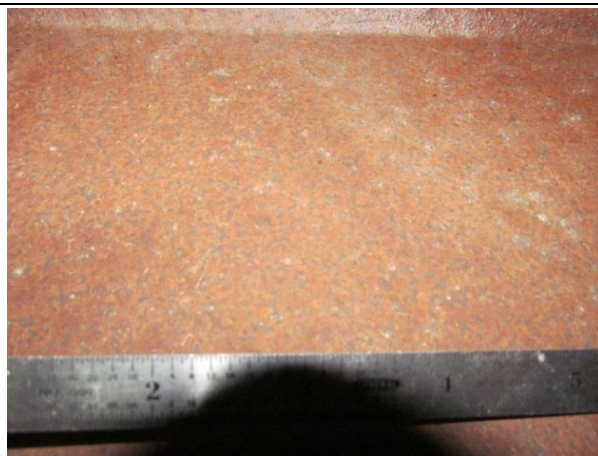
Figure 6. Washed area of top of flange patina after fully dried; adherent, well-behaved beneath chalking.

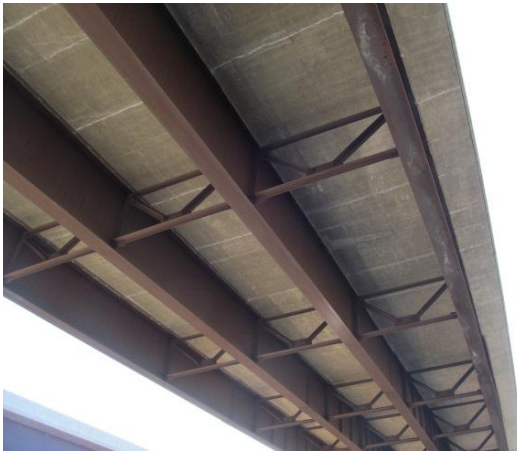
- Typically, the patina condition index rating for these bridges ranges from 4 on the middle and upper portions of the girders and frames to 3 on the bottom flanges and bases of the webs.
- The west fascia girder of each bridge has heavy salt staining on the underside of the bottom flange and larger rust flakes (i.e. Index = 2). Chalking on tops of bottom flanges is slight to moderate.
- Bridge decks have numerous transverse cracks, particularly in the middle spans. Evidence of salt contaminated water leaking onto steel below cracks, with localized delamination/flaking of the top flange beneath the crack (possibly Index = 1 locally). The patina of the lower elements beneath each crack is typically reduced by at least 0.5 index points compared to adjacent surfaces away from the cracks. Sealing the deck cracks will address the root cause of the localized areas of poor patina performance.

Figure 1. Typical middle bay of southbound bridge; note regular cracking with efflorescence and heavy salt staining on west fascia girder bottom flange.

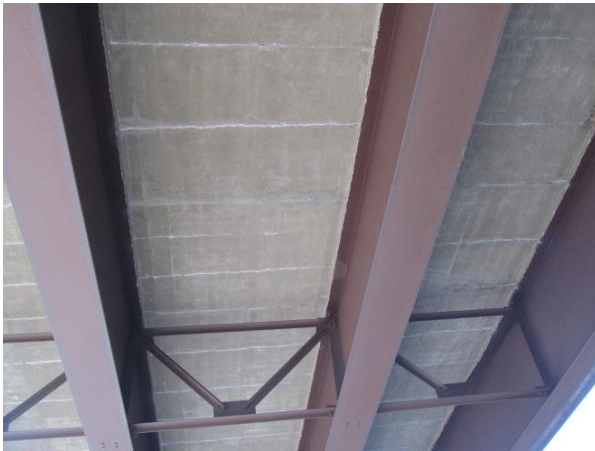
Figure 3. Other girders of southbound bridge show little change in patina condition beneath cracks.

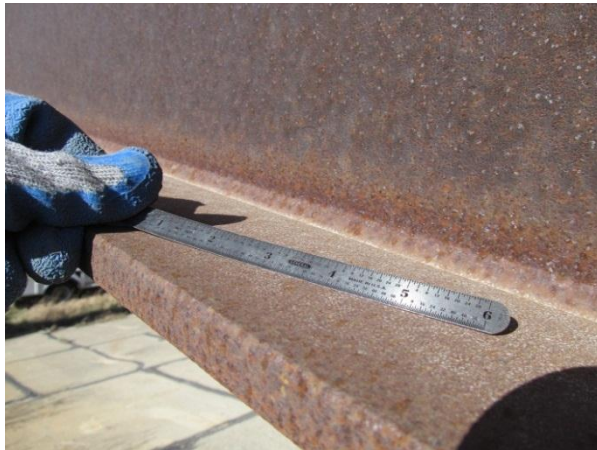
Figure 1. Exterior surfaces over traffic in good condition after more than 40 years.

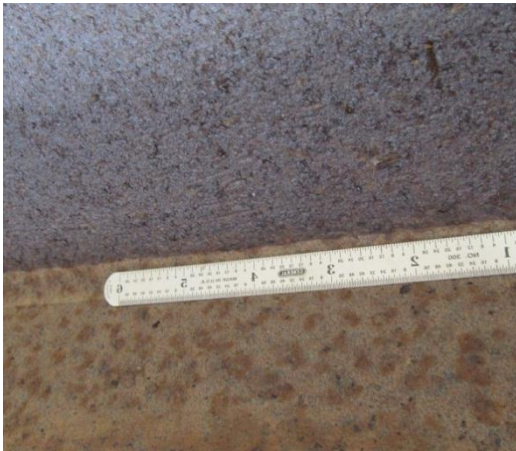
Figure 3. Interior surfaces near east abutment with less deterioration than areas over traffic.

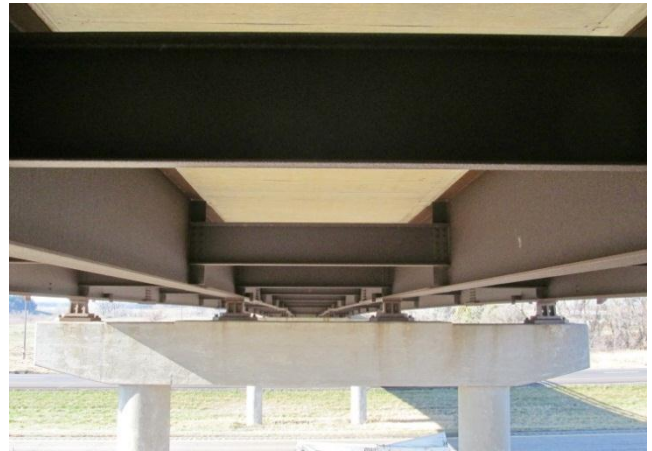
Figure 4. East pier viewed from east abutment. Drainage deflectors separating spans effectively.

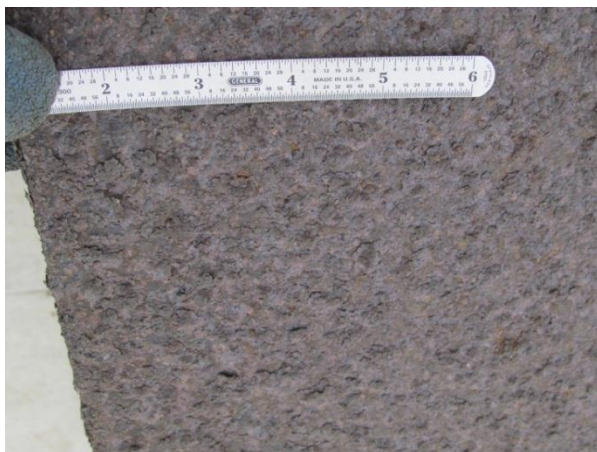
- Patina in good condition considering over 40 years of service; however, interior horizontal surfaces (top and bottom) directly over traffic lanes showing signs of more substantial patina deterioration.
- Index typically = 3.5 on all fascia or other exposed surfaces, whether over traffic or near abutments. Index rating = 3 for interior surfaces near abutments (even bottom flanges, which show moderate poulitice but minor flaking), Index = 2 or worse for all interior surfaces over traffic, especially on the bottom flanges and lower portions of the webs. Drainage deflectors may be reducing bottom flange damage in non-traffic bays.
- Concrete deck in good condition; light traffic above means virtually all salts and water come from below.
- Direct salty spray from high-speed truck traffic over time likely driving deterioration over traffic lanes.

Figure 5. Heavy flaking of bottom of flange in traffic span, typically Index = 2 or worse.

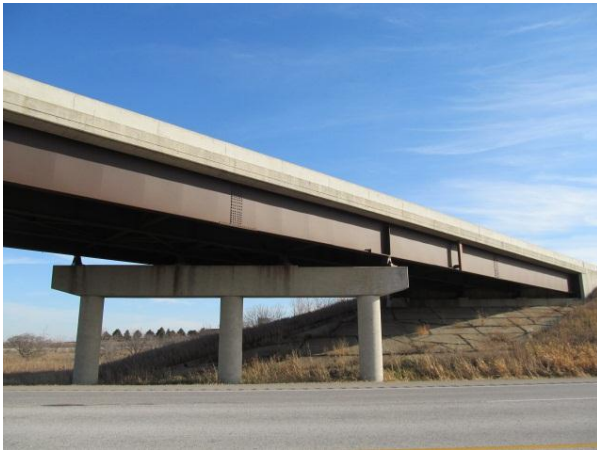
Figure 1. Overall appearance of north end of bridge showing high skew.

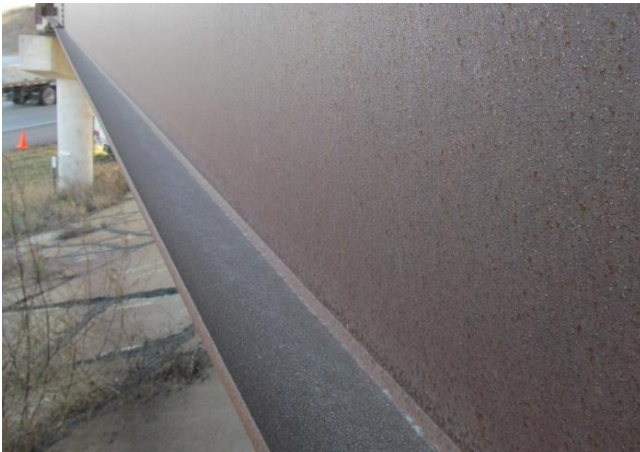
Figure 3. West fascia girder exterior; Index = 3.5 after over 40 years of service.

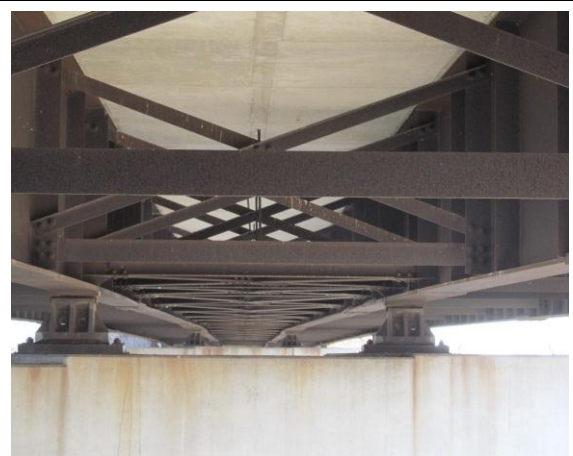
Figure 6. Center bay viewed over top of south pier; note lack of deflector plates and concrete staining.
