# **A Further Evaluation Of Concrete Bridge Deck Surfacing In Iowa**

Highway Division  
Office Of Materials

March 1979

Bernard C. Brown  
Testing Engineer

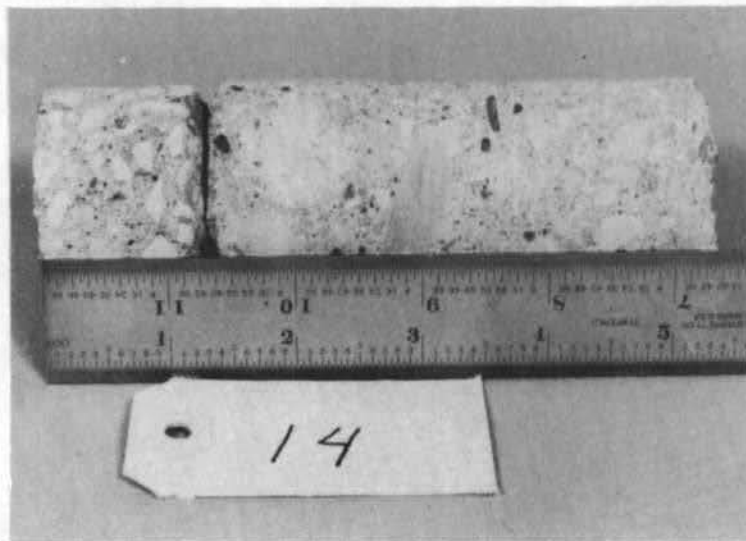
Core #2

DELAMINATION CORES

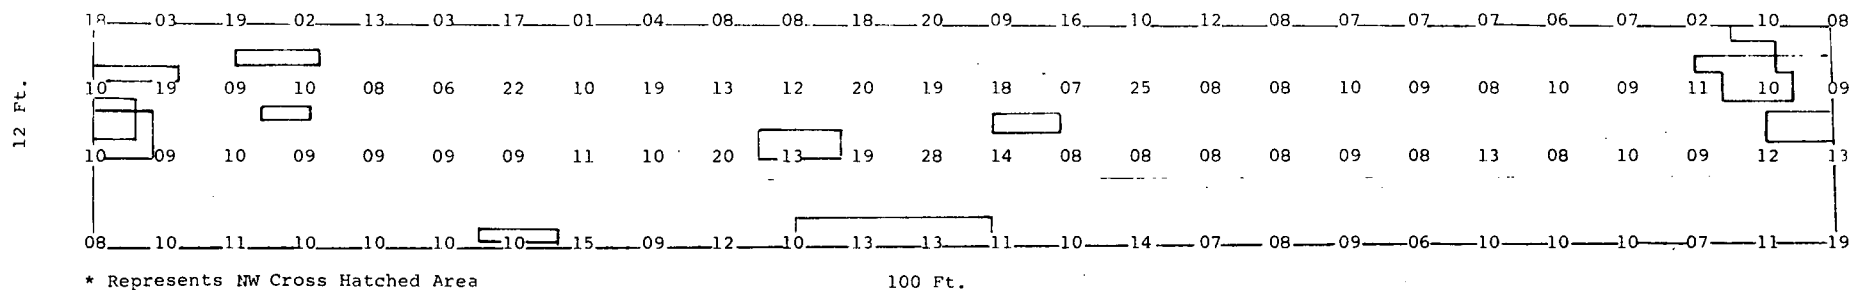
Electrical Potential  
Negative Voltage - Copper Sulfate  
Half Cell  
Detail Sheet

Blocked out areas indicate delamination

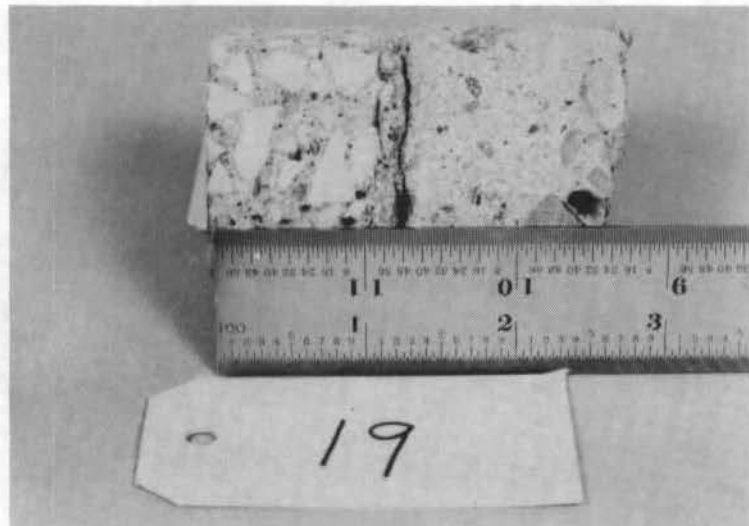
Core #1

DELAMINATION CORES
