Rehabilitation of Concrete Pavements Utilizing Rubblization and Crack-and-Seat Methods: Phase II - Performance Evaluation of Rubblized Pavements in Iowa

National Concrete Pavement
Technology Center

Final Report
April 2008

Sponsored by
the Iowa Highway Research Board (IHRB Project TR-550)

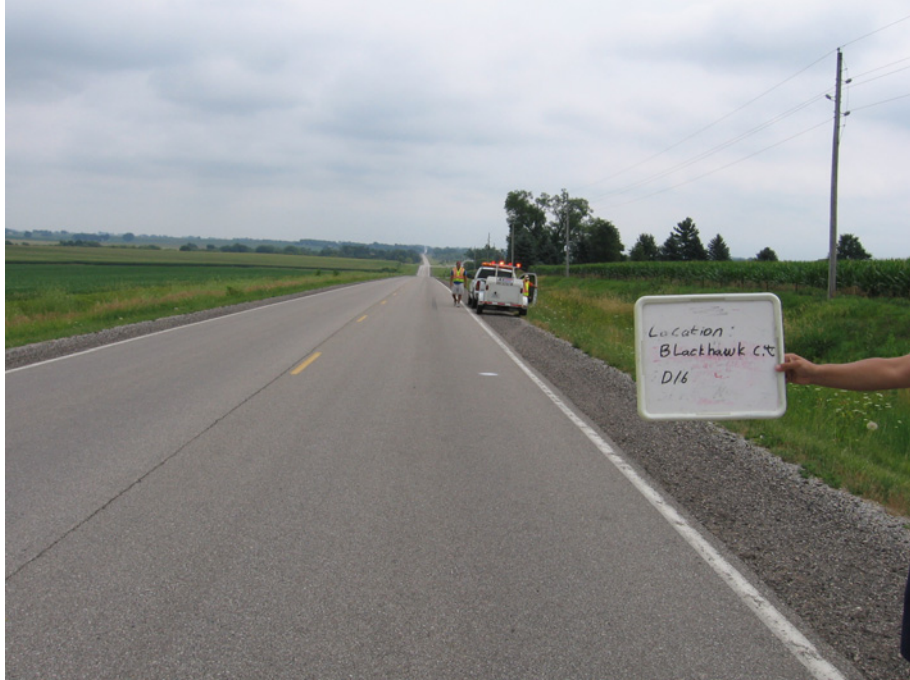
Figure C.1. Overall Pavement Condition on D16 in Black Hawk County, IA (I.D. No. 12): Rubblization

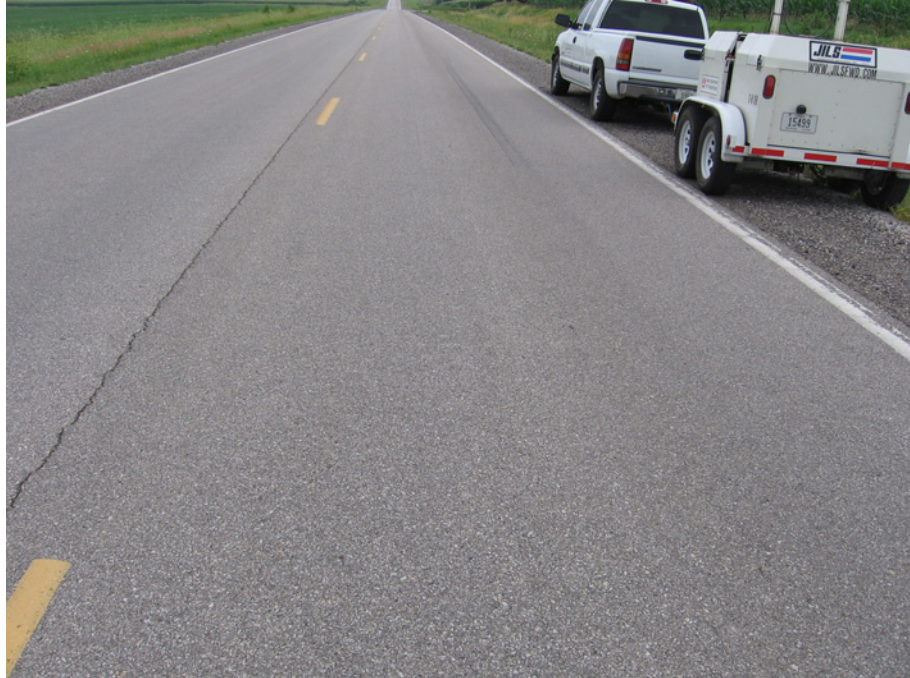
Figure C.2. Pavement Condition on A (Start) of D16 in Black Hawk County, IA (I.D. No. 12): Rubblization

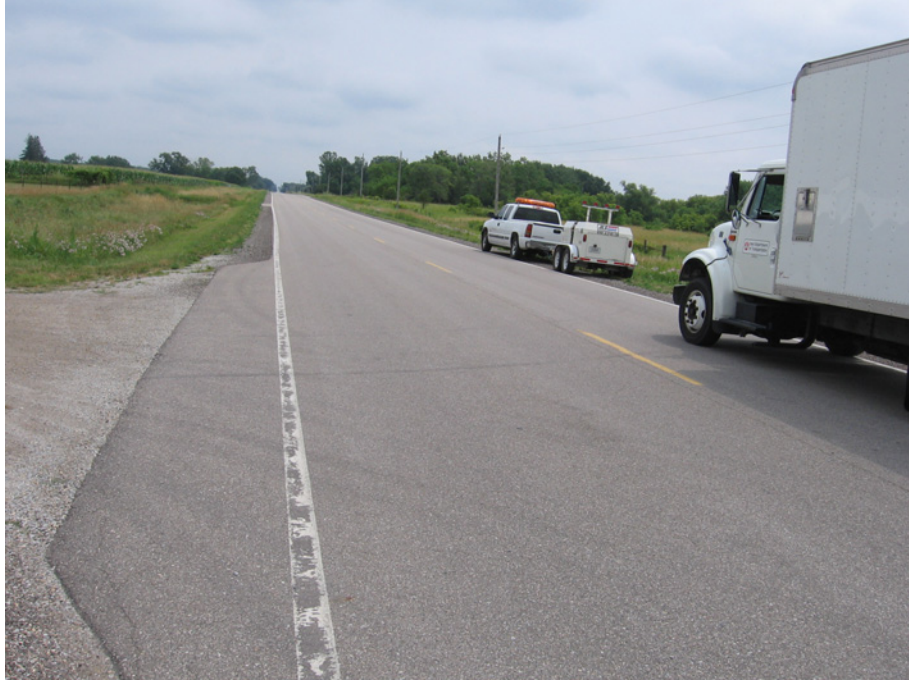
Figure C.3. Pavement Condition at location B (Middle) of D16 in Black Hawk County, IA (I.D. No. 12): Rubblization

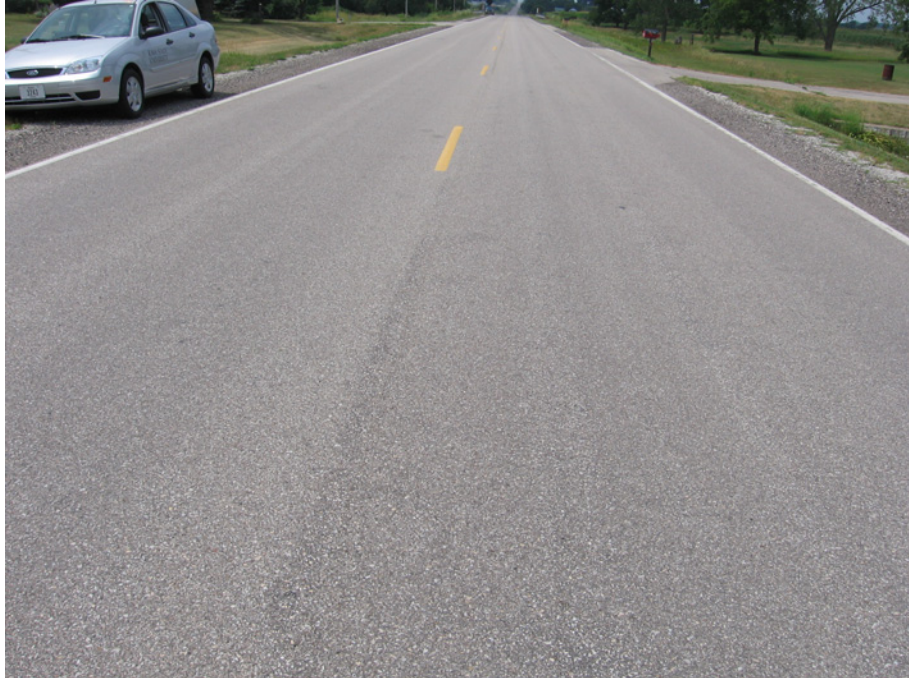
Figure C.4. Pavement Condition on C (End) of D16 in Black Hawk County, IA (I.D. No. 12): Rubblization

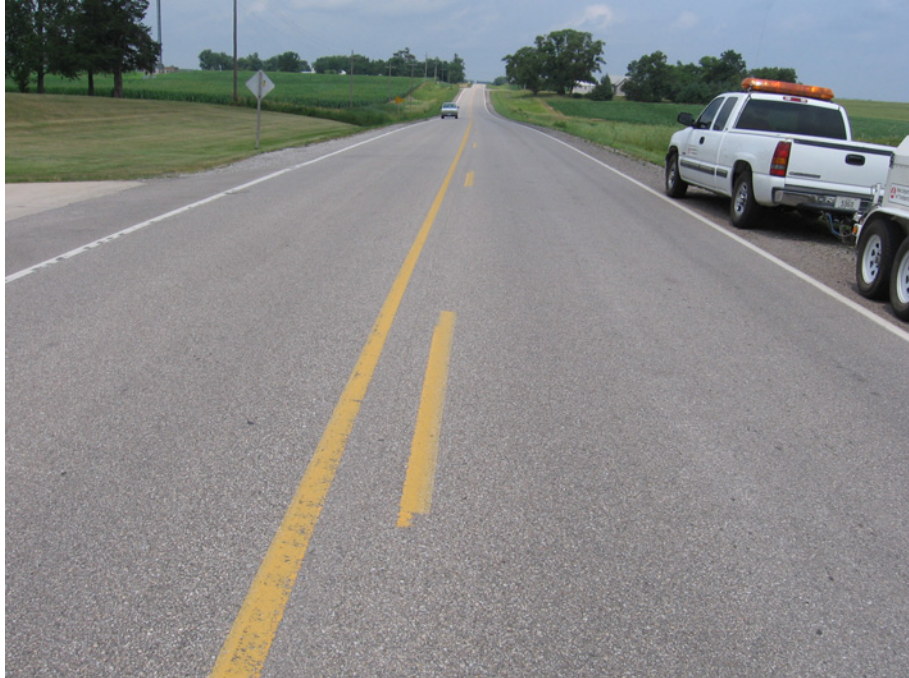
**Figure C.6. Overall Pavement Condition on V43 in Black Hawk County, IA (I.D. No. 13):
Rubbblization**

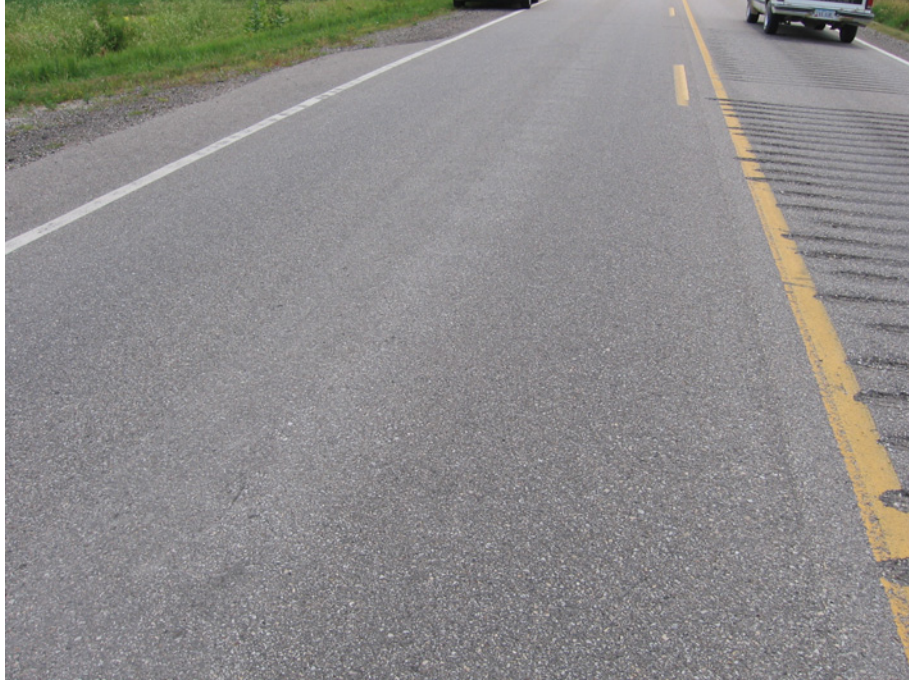
Figure C.7. Pavement Condition on A (Start) of V43 in Black Hawk County, IA (I.D. No. 13): Rubblization

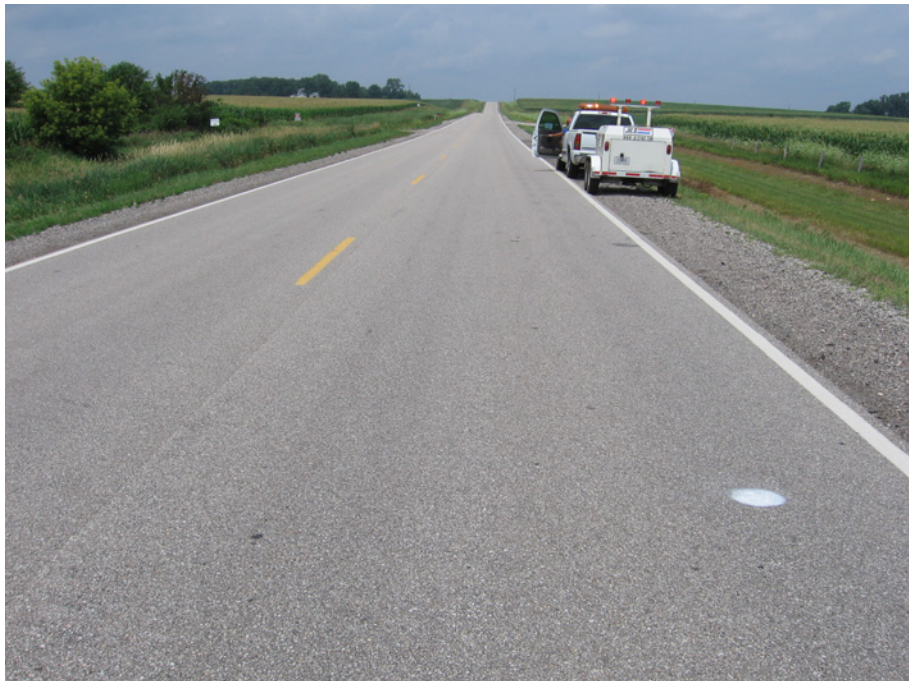
Figure C.8. Pavement Condition on B (Middle) of V43 in Black Hawk County, IA (I.D. No. 13): Rubblization

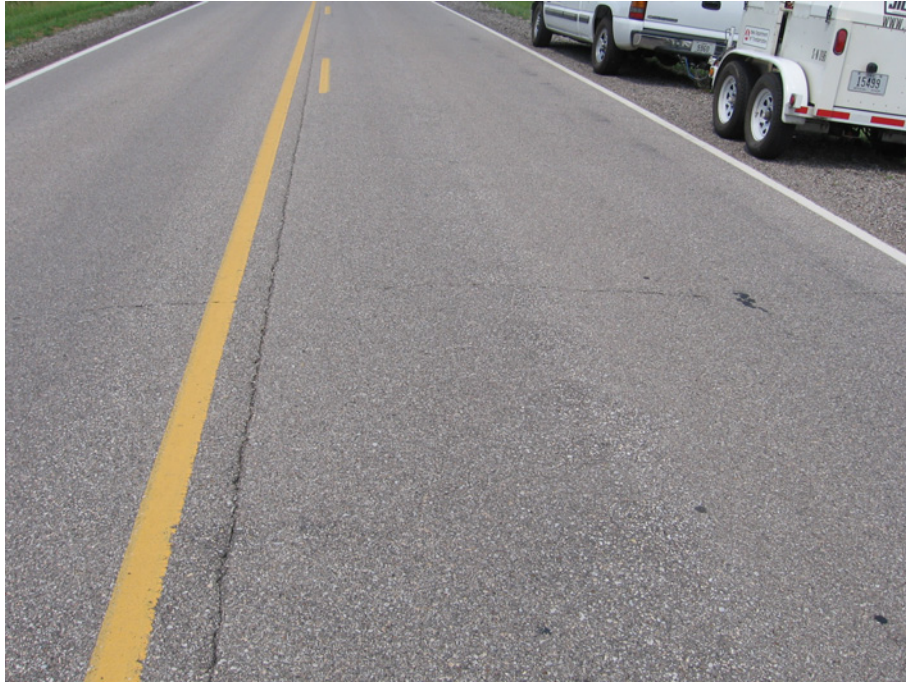
Figure C.9. Pavement Condition on C (End) of V43 in Black Hawk County, IA (I.D. No. 13): Rubblization

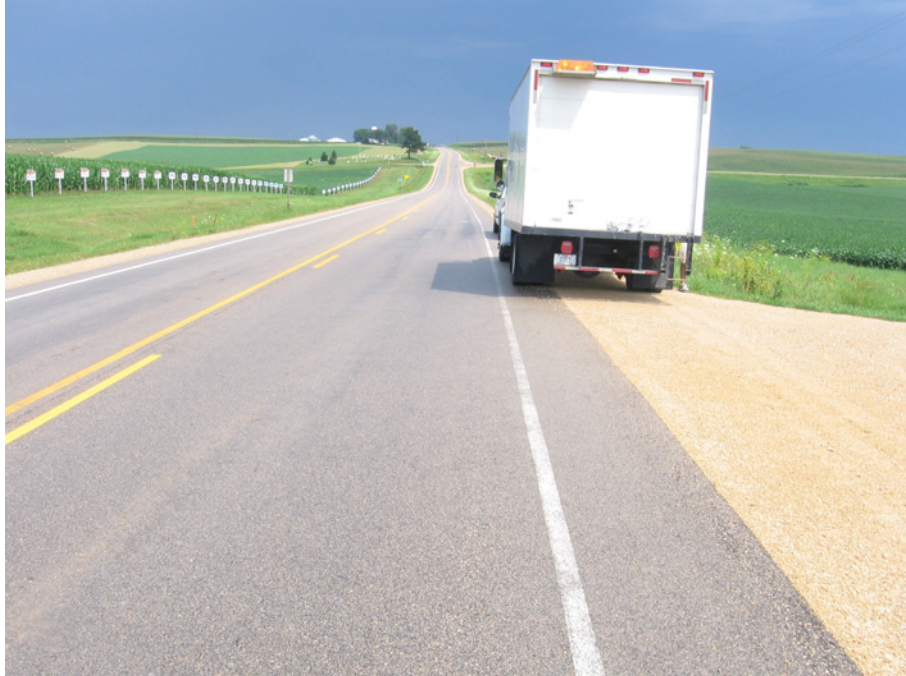
**Figure C.12. Overall Pavement Condition on IA3 in Delaware County, IA (I.D. No. 21):
Rubblelization**

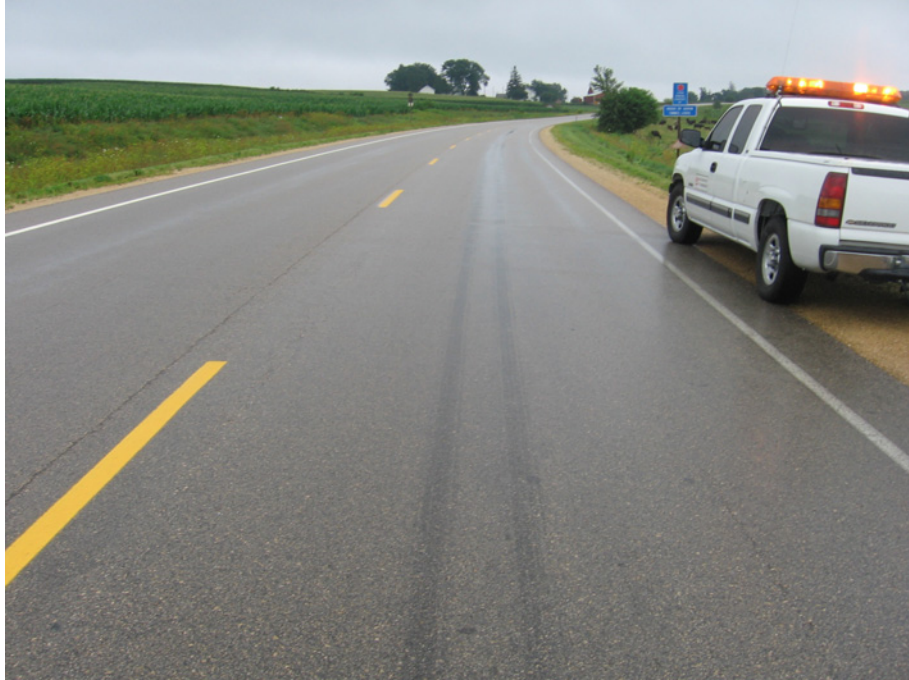
Figure C.13. Pavement Condition on A (Start) of IA3 in Delaware County, IA (I.D. No. 21): Rubblization

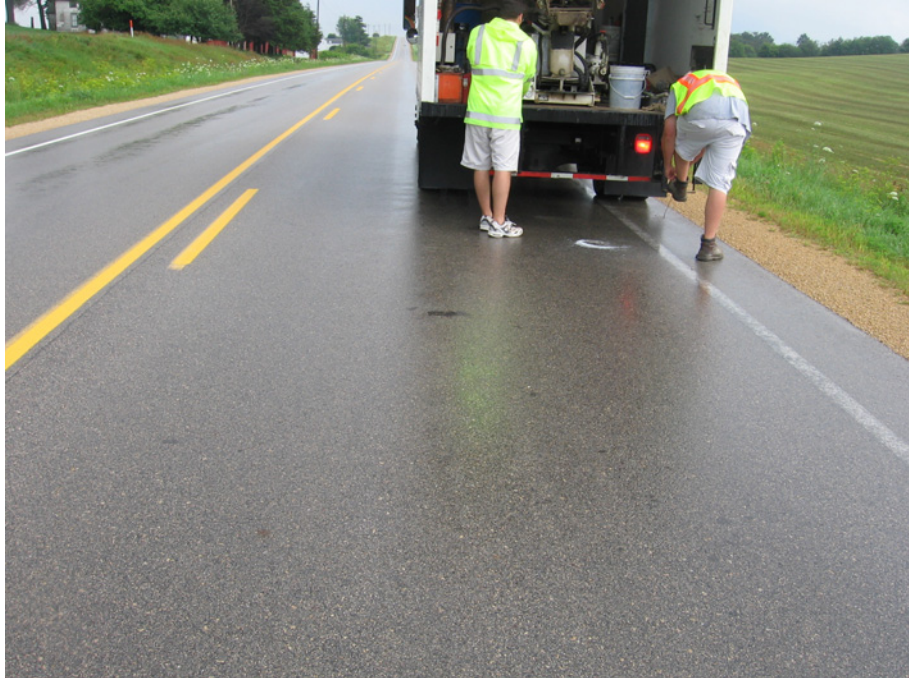
Figure C.14. Pavement Condition on B (Middle) of IA3 in Delaware County, IA (I.D. No. 21): Rubblization

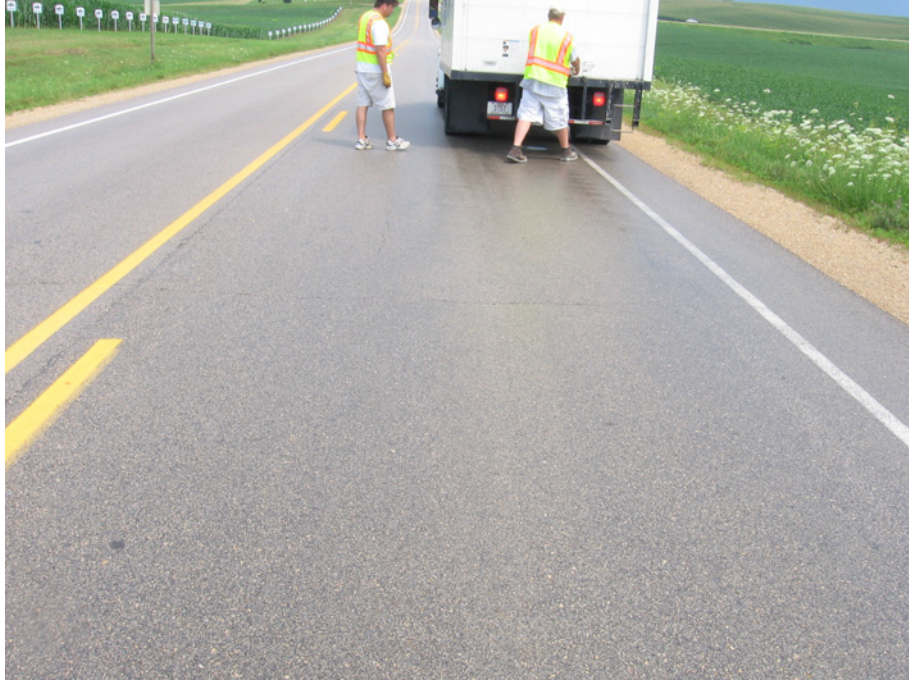
**Figure C.15. Pavement Condition on C (End) of IA3 in Delaware County, IA (I.D. No. 21):
Rubblization**

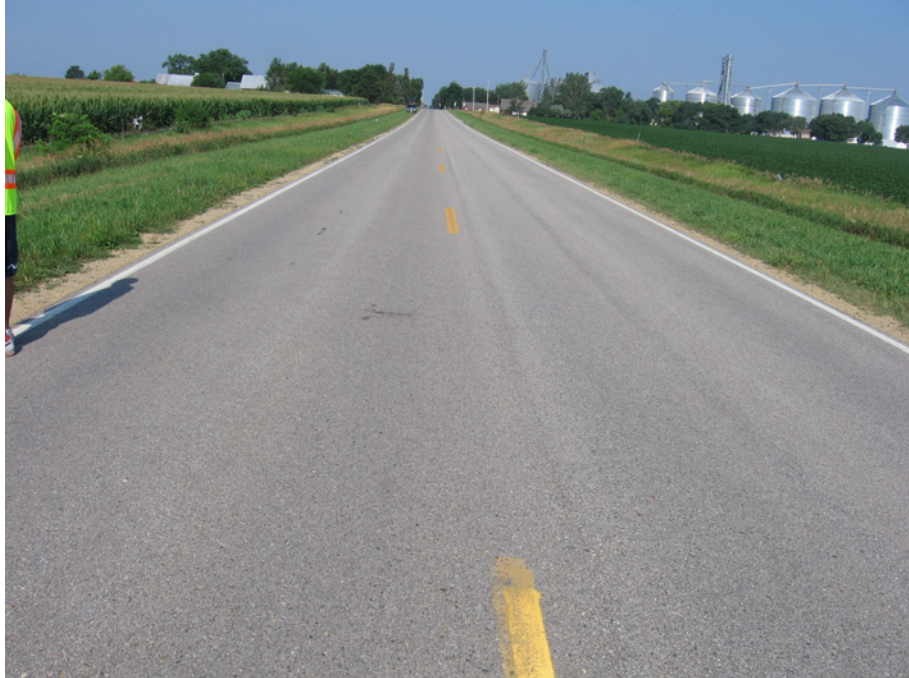
**Figure C.18. Overall Pavement Condition on C23 in Franklin County, IA (I.D. No. 26):
Rubbblization**

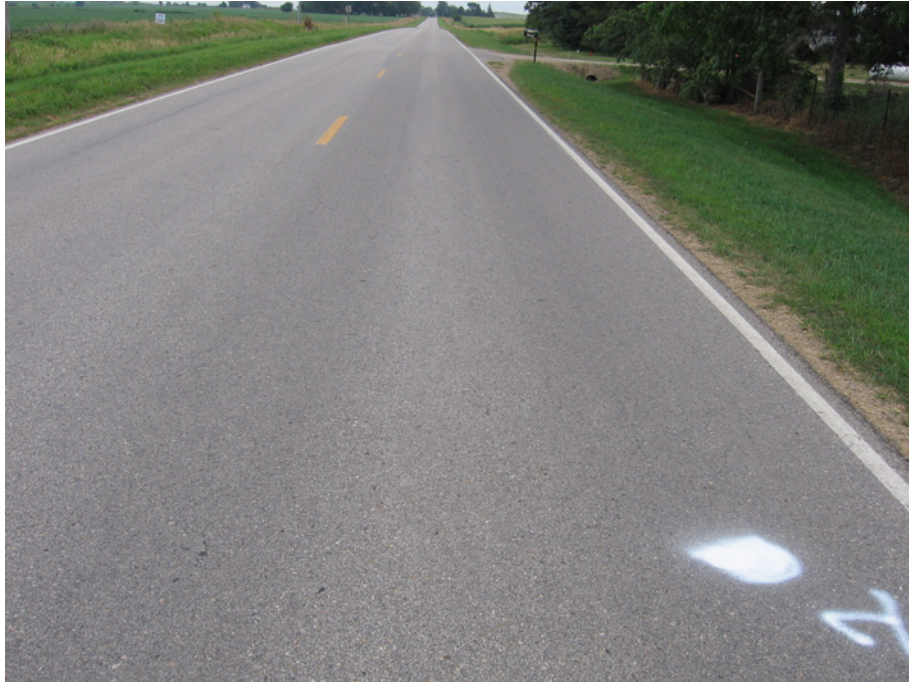
Figure C.19. Pavement Condition on A (Start) of C23 in Franklin County, IA (I.D. No. 26): Rubblization

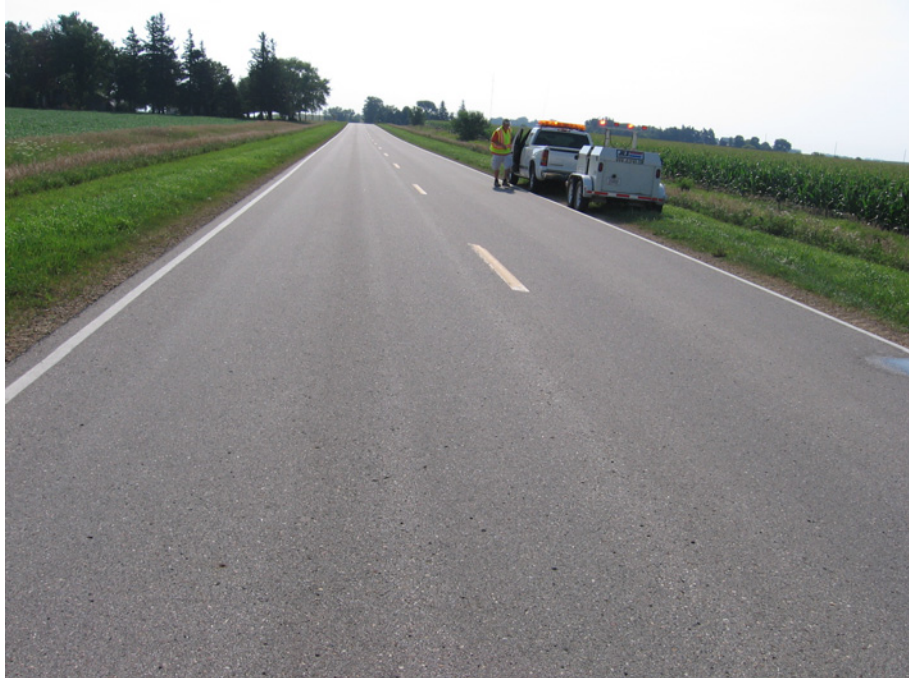
Figure C.20. Pavement Condition on B (Middle) of C23 in Franklin County, IA (I.D. No. 26): Rubblization

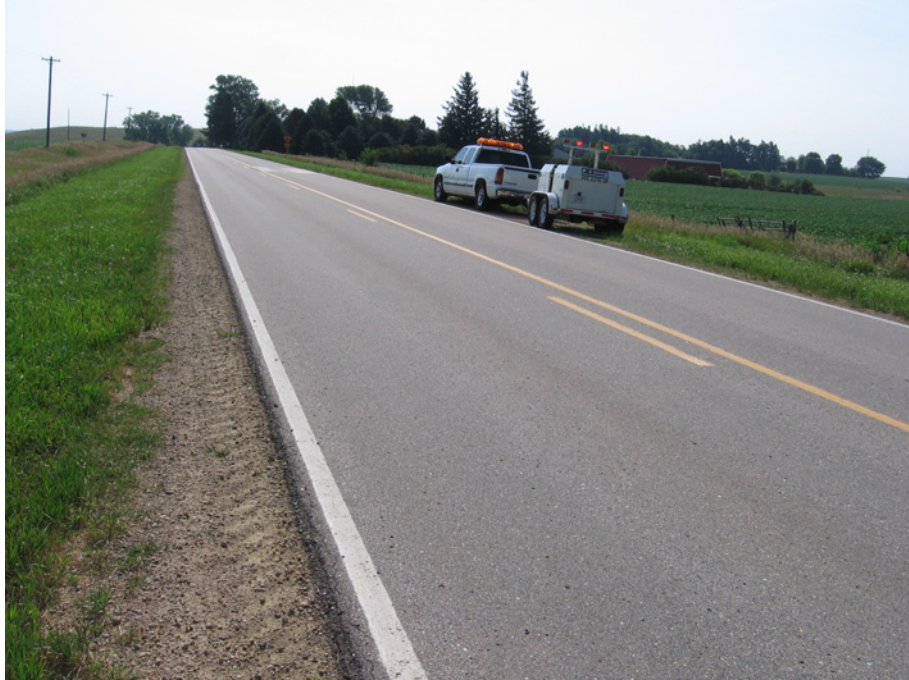
**Figure C.21. Pavement Condition on C (End) of C23 in Franklin County, IA (I.D. No. 26):
Rubblelization**

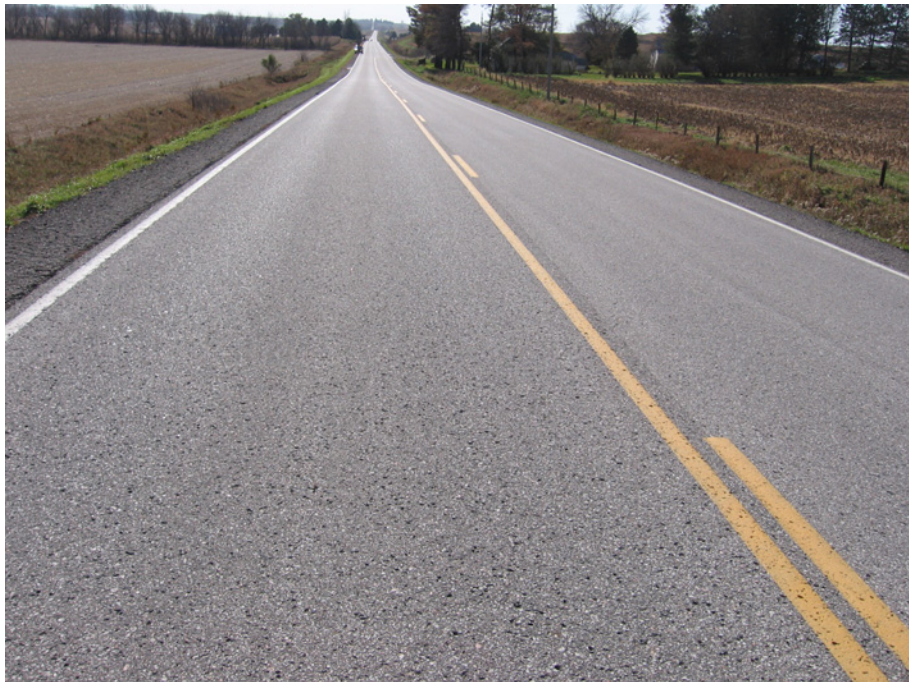
**Figure C.22. Overall Pavement Condition on L55 in Mills County, IA (I.D. No. 32):
Rubblelization**

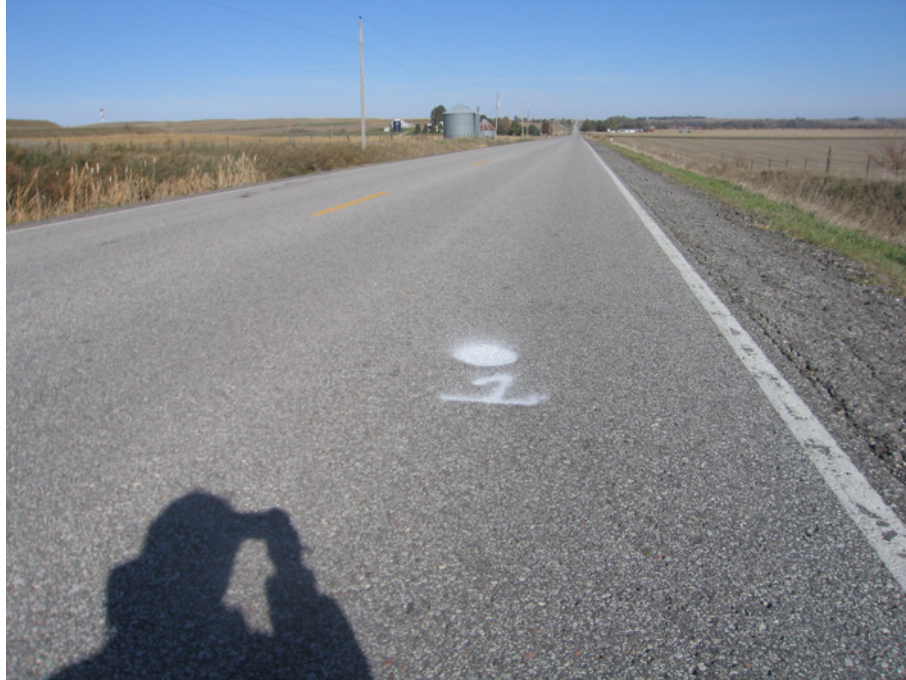
**Figure C.23. Pavement Condition on A (Start) of L55 in Mills County, IA (I.D. No. 32):
Rubblization**

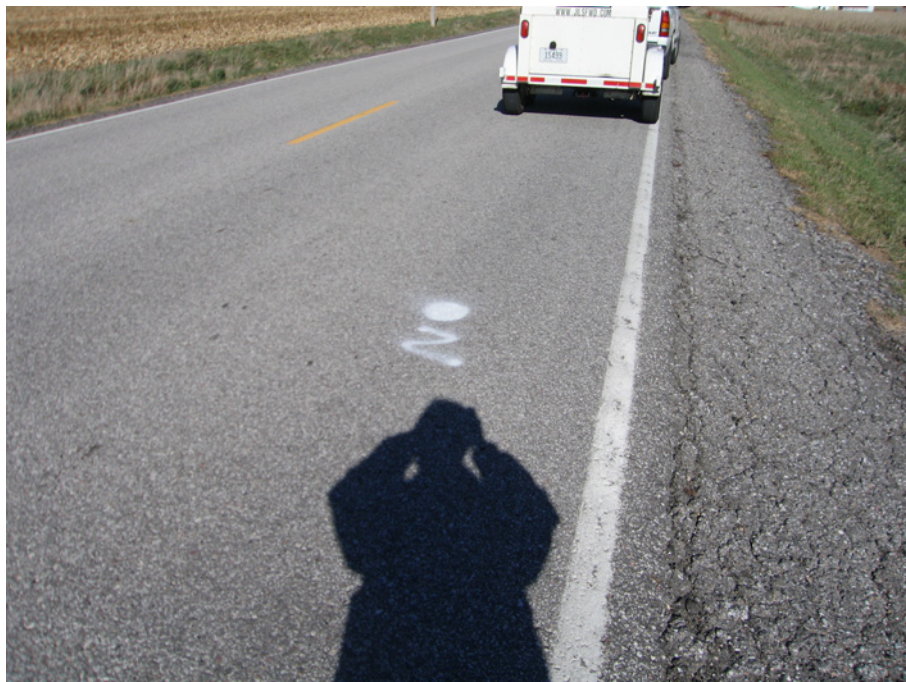
**Figure C.24. Pavement Condition on B (Middle) of L55 in Mills County, IA (I.D. No. 32):
Rubblization**

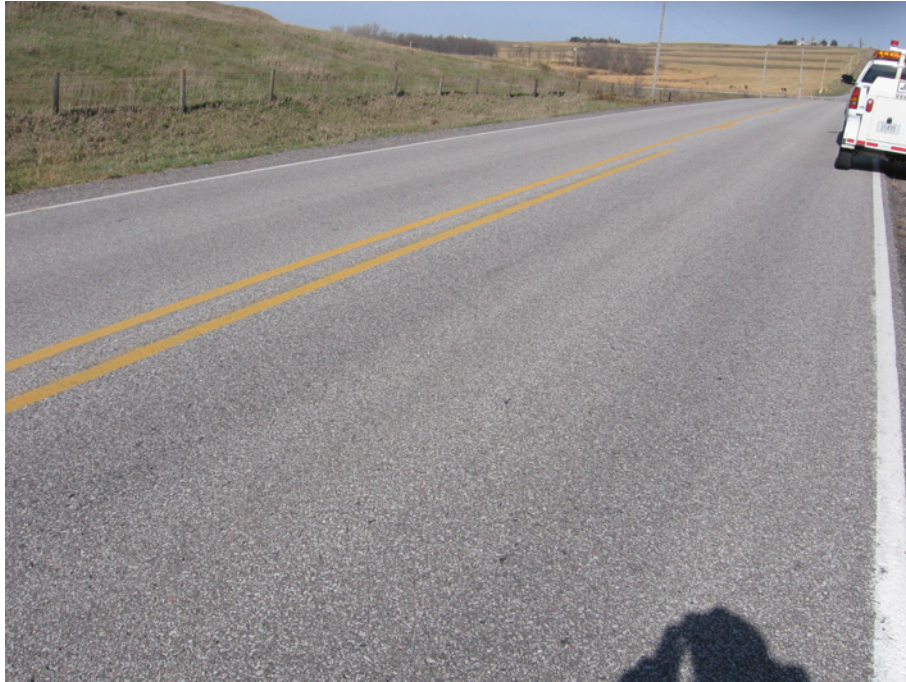
**Figure C.25. Pavement Condition on C (End) of L55 in Mills County, IA (I.D. No. 32):
Rubblization**

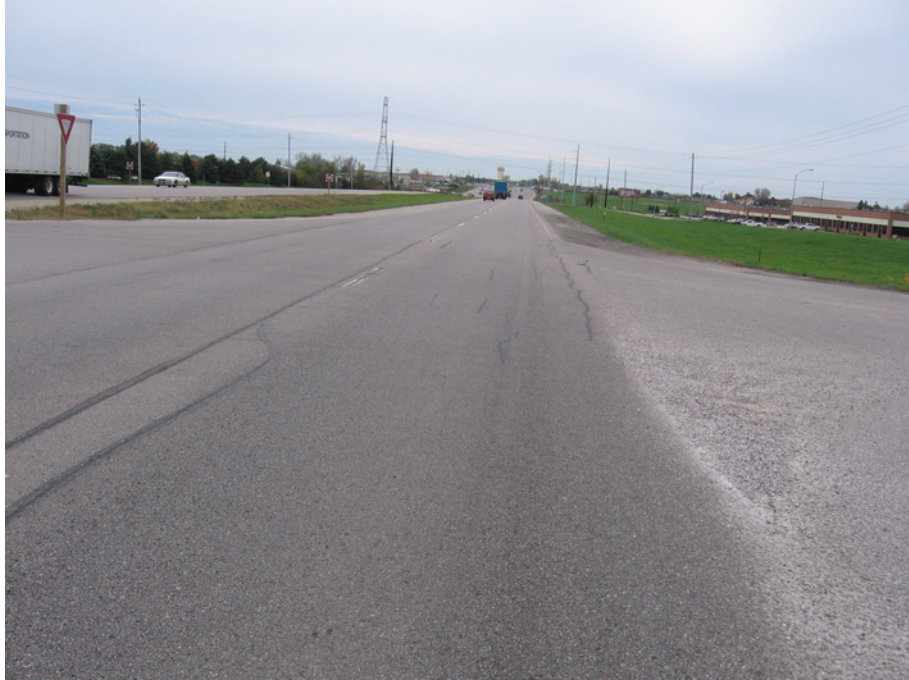
**Figure C.27. Overall Pavement Condition on IA141 in Polk County, IA (I.D. No. 33-1):
Rubbblization**

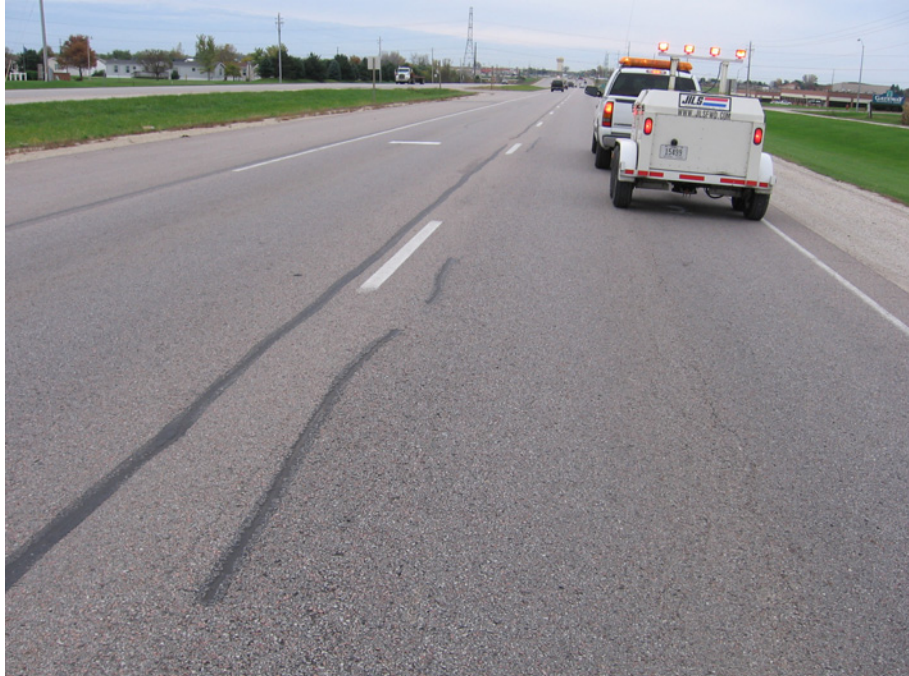
**Figure C.28. Pavement Condition on A (Start) of IA141 in Polk County, IA (I.D. No. 33-1):
Rubbblization**

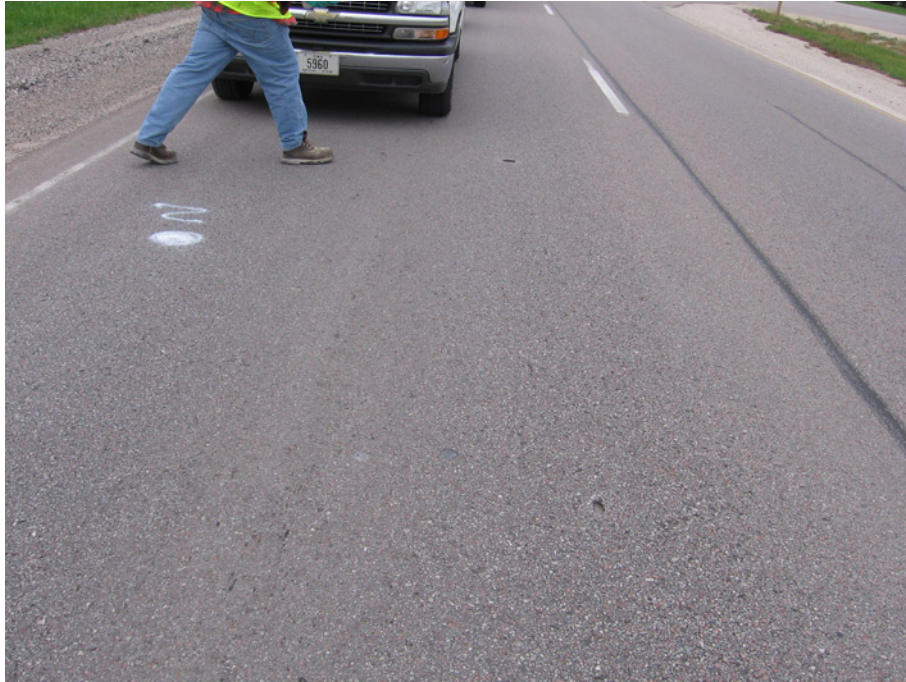
Figure C.29. Pavement Condition on C (End) of IA141 in Polk County, IA (I.D. No. 33-1): Rubblization

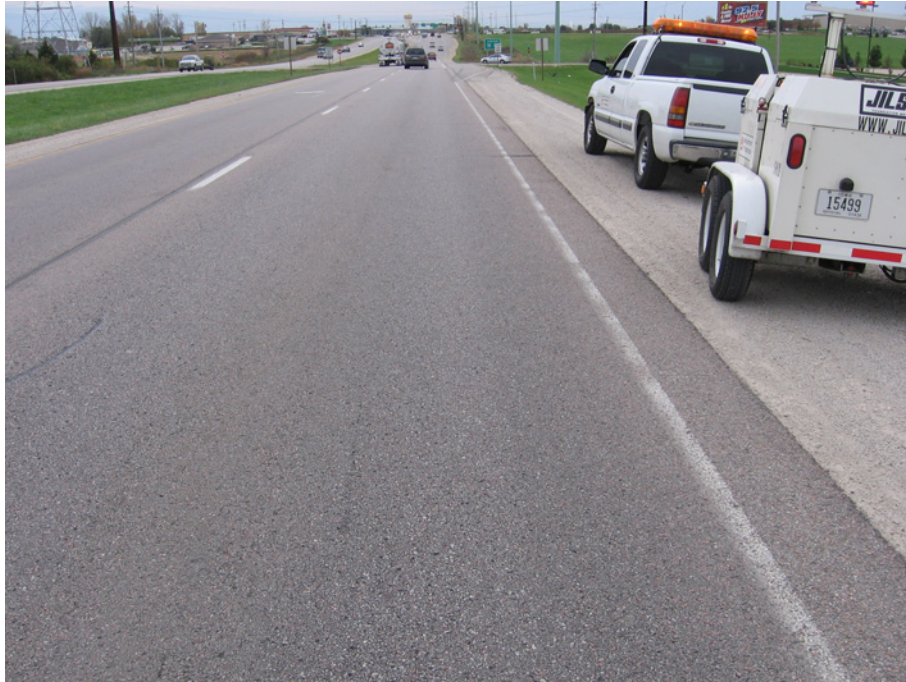
**Figure C.31. Overall Pavement Condition on IA141 in Polk County, IA (I.D. No. 33-2):
Rubblelization**

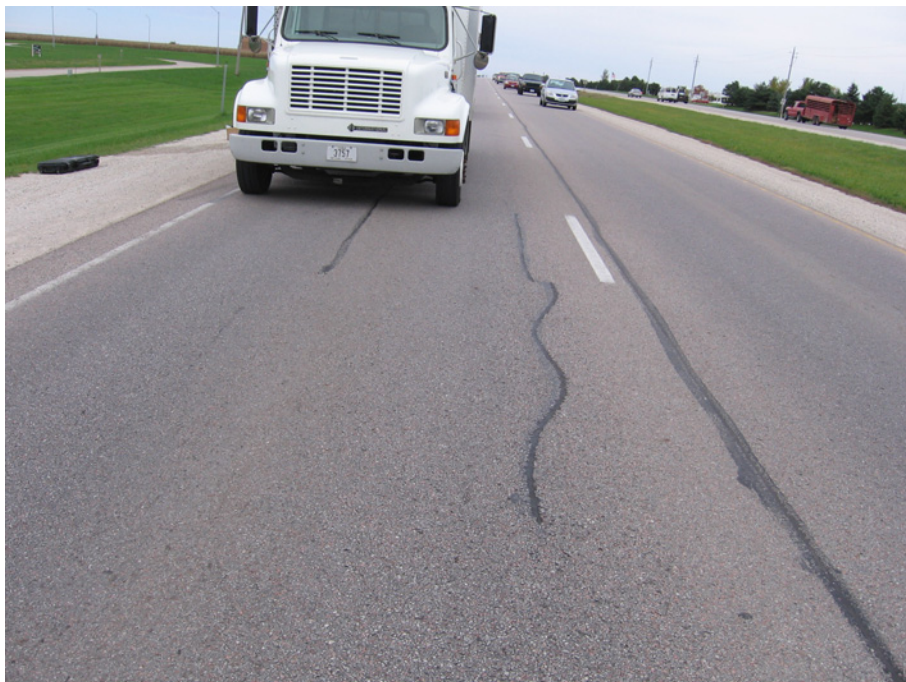
**Figure C.32. Pavement Condition on A (Start) of IA141 in Polk County, IA (I.D. No. 33-2):
Rubblelization**

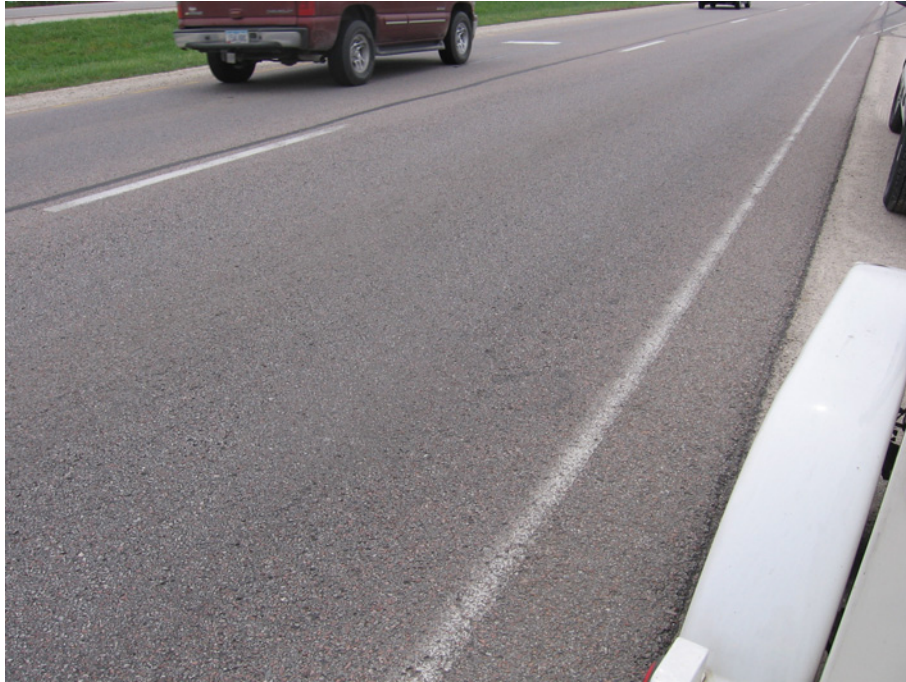
Figure C.33. Pavement Condition on C (End) of IA141 in Polk County, IA (I.D. No. 33-2): Rubblization
