Performance Evaluation of Concrete Pavement Granular Subbase— Pavement Surface Condition Evaluation

Final Report July 2008

Sponsored by Iowa Highway Research Board IHRB Project TR-554

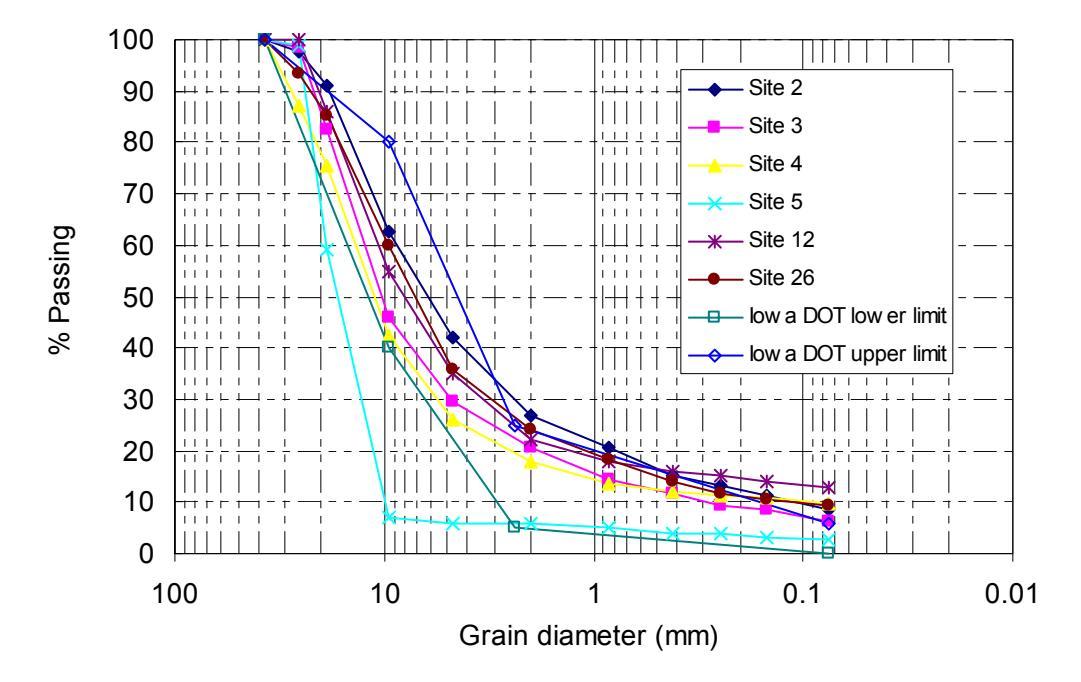
Figure 2. Gradation of virgin material samples

summary of the gradation test results is presented in Tables 10 through 14. The current lowa DOT gradation limits are provided for reference and indicate that several of the samples are outside the specification limits on the fine side.

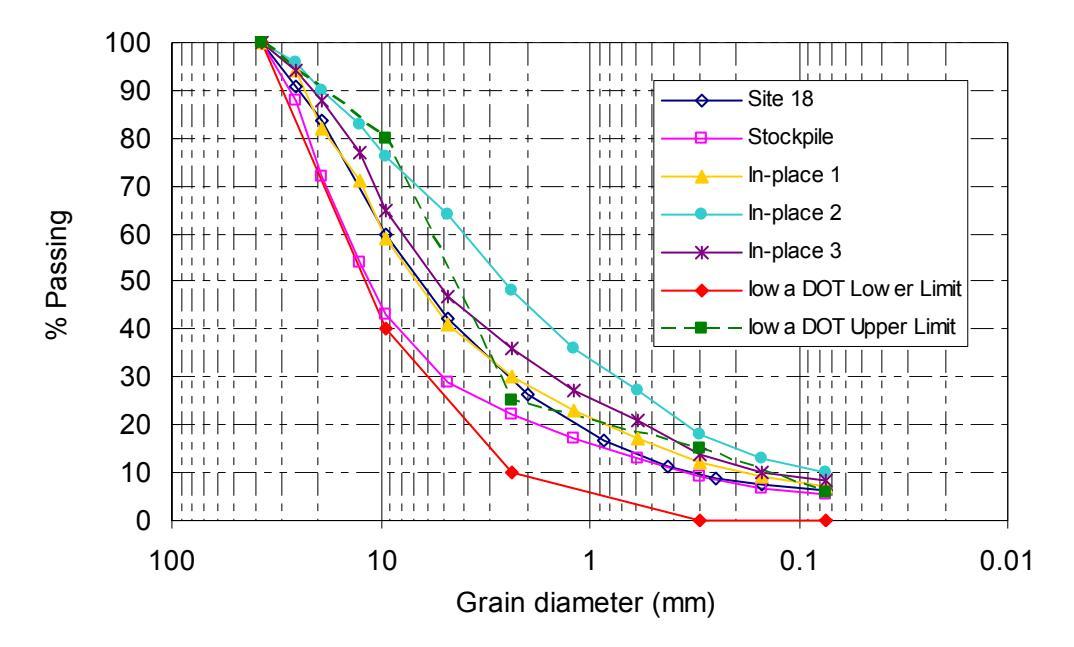
Figure 15. Gradation of materials from test site 18 and area A4

A significant breakdown of RPCC subbase aggregate material due to compaction can be interpreted from Figure 15. The grain-size distribution of the material in the stockpile was close to the upper limit gradation applied for this area. Three in-place samples were tested after the subbase layer was compacted by a roller. The gradations of these samples varied through the gradation limits. The number of fines significantly increased. The gradation curve of the material obtained from site 18 was similar with the curve in place 1 and was close to the lower gradation limit. However, there is no clear indication that more RPCC aggregate material was broken down under the traffic loads (Figures 15 and 16).

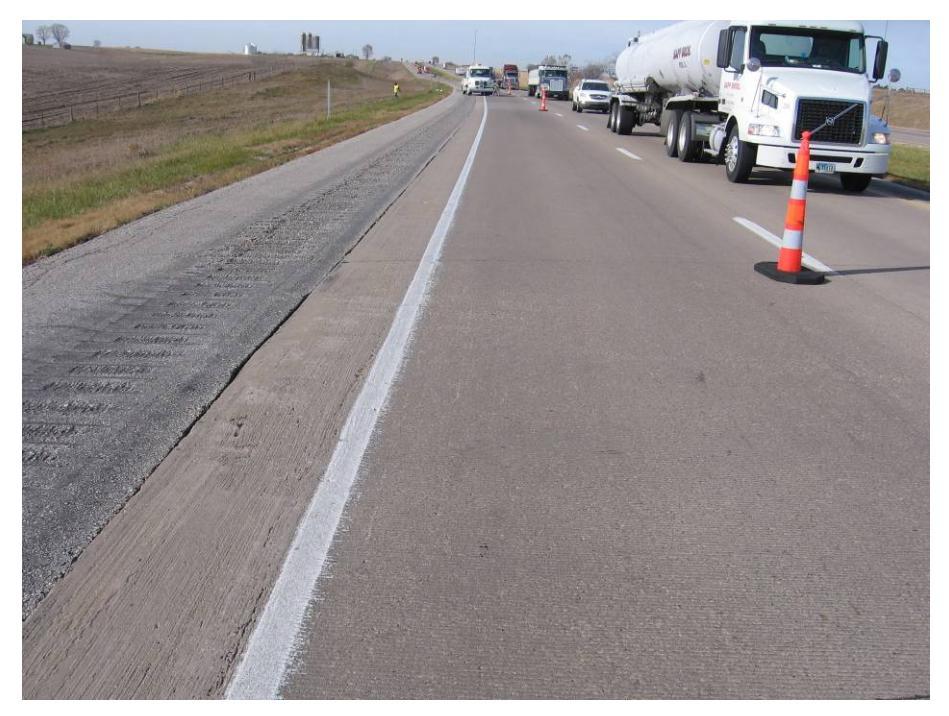
Figure 22. Picture of I-80 (E) pavement section in Cedar County (Mile Post No. 276.60– 276.70)—RPCC subbase section

As seen in Table 27, and in Figures 19 and 20, few longitudinal and transverse cracks were observed in the surveyed field test sections. Although a large number of pictures were taken as part of the visual distress survey for individual test sections, some representative pictures are included here which are indicative of the overall conclusion. The predominant distresses exhibited along all the surveyed test sections are joint sealing damage, spalling, and popouts. Especially, the lane-to-shoulder separation and the lane-to-shoulder drop off as shown in Figures 21 and 22, respectively, are more often observed in RPCC test sections than virgin aggregate subbase test sections. These observations are consistent with those reported by Rollings et al. (2006), who concluded that the cause of the distresses between lane and shoulder is probably due to sulfate attack on the RPCC used as fill and base course.

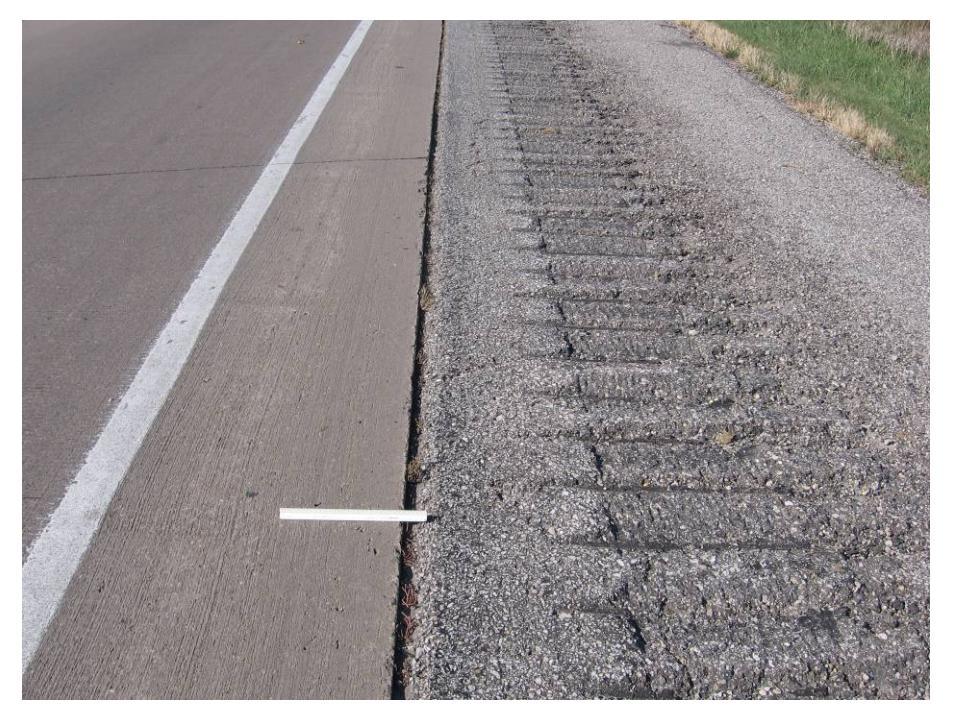
Figure 23. Lane to shoulder separation on I-80 (W) in Cedar County (Mile Post No. 269.30–269.40)—RPCC subbase section

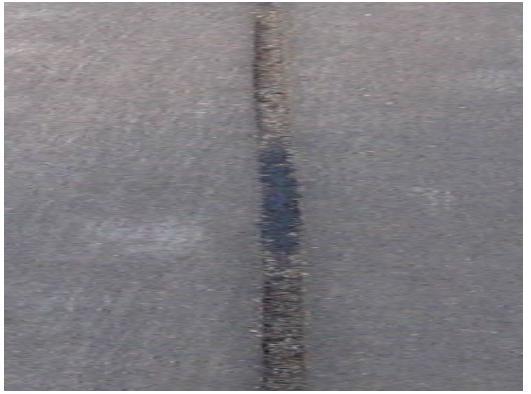
(a) Joint sealing damage of longitudinal joint at slab #1

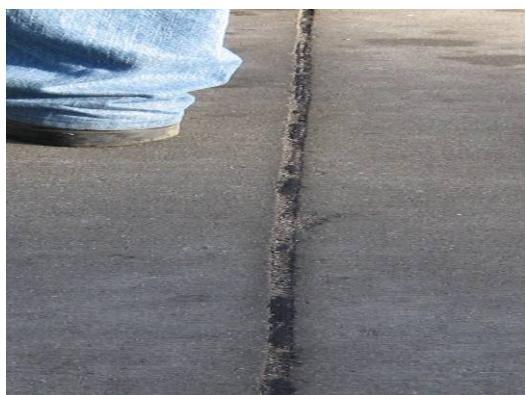
(b) Joint sealing damage of transverse joint at slab #1

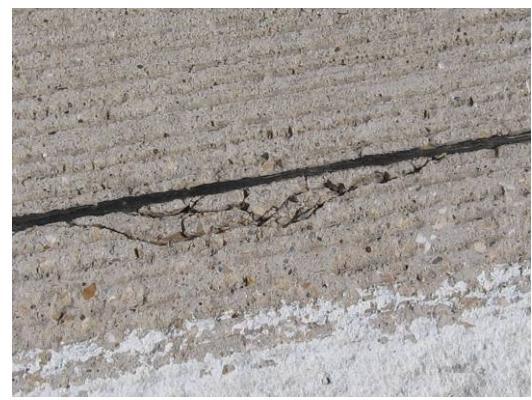
(a) Spalling of longitudinal joint at slab #4

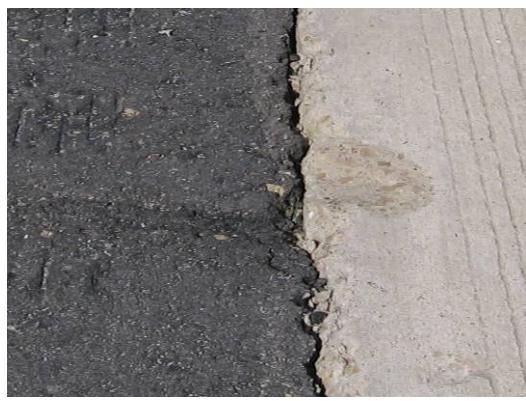
(b) Lane to shoulder separation at slab #5

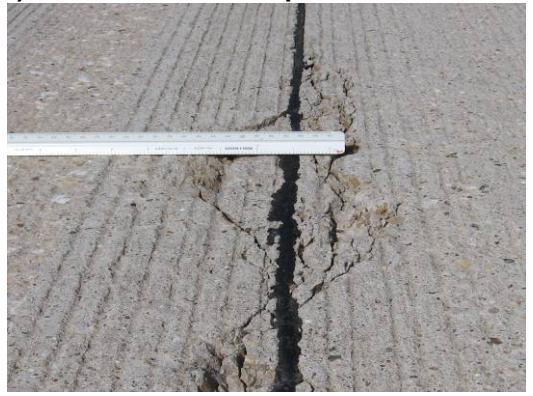
(d) Spalling of longitudinal joint at slab #8

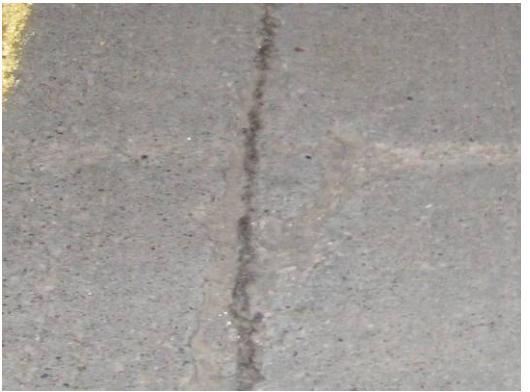
(c) Spalling of longitudinal joint at slab #4

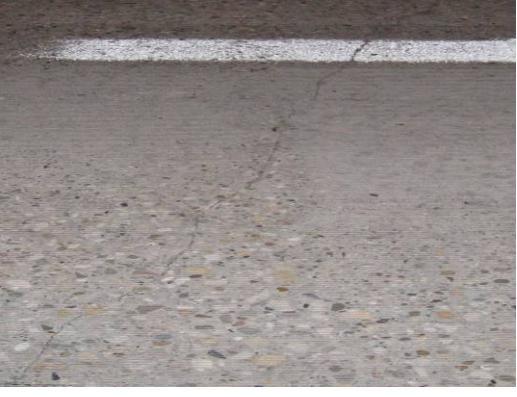
(b) Transverse cracking at slab #3

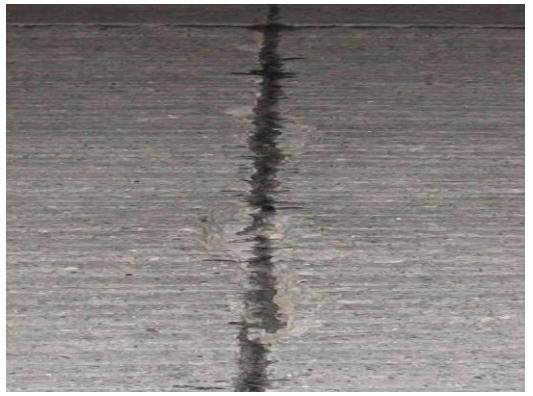
(d) Spalling of transverse joint at slab #4

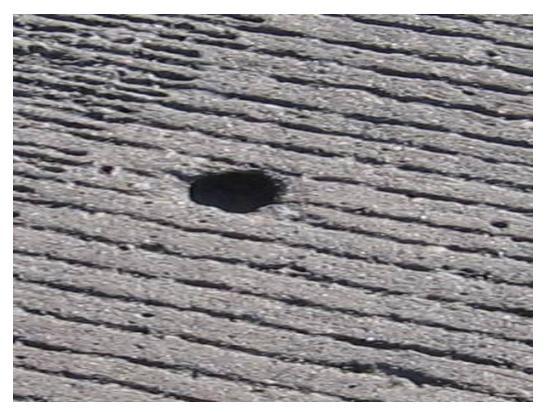
(a) Popout at slab #5

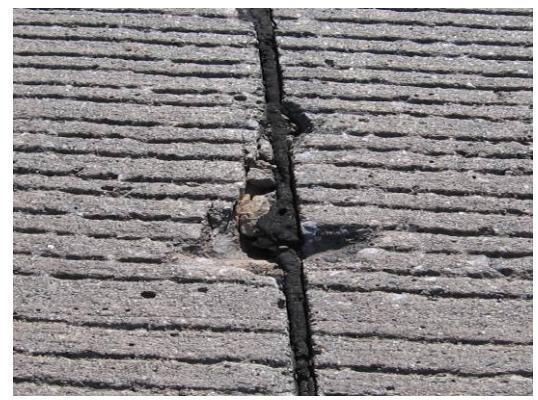
(c) Spalling of transverse joint at slab #9

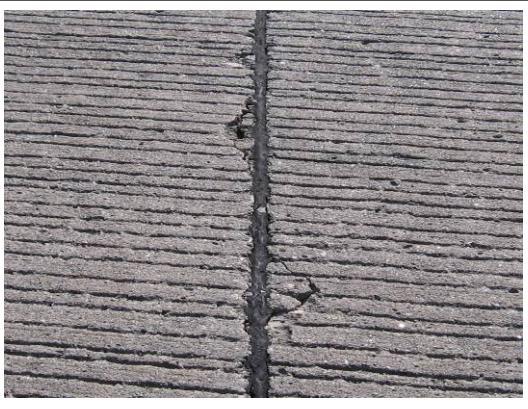
(b) Spalling of transverse joint at slab #5

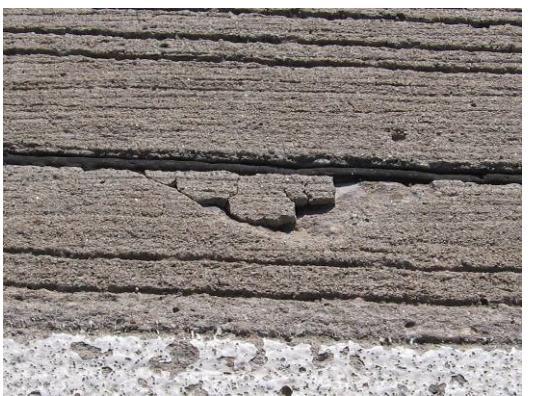
(d) Spalling of longitudinal joint at slab #13

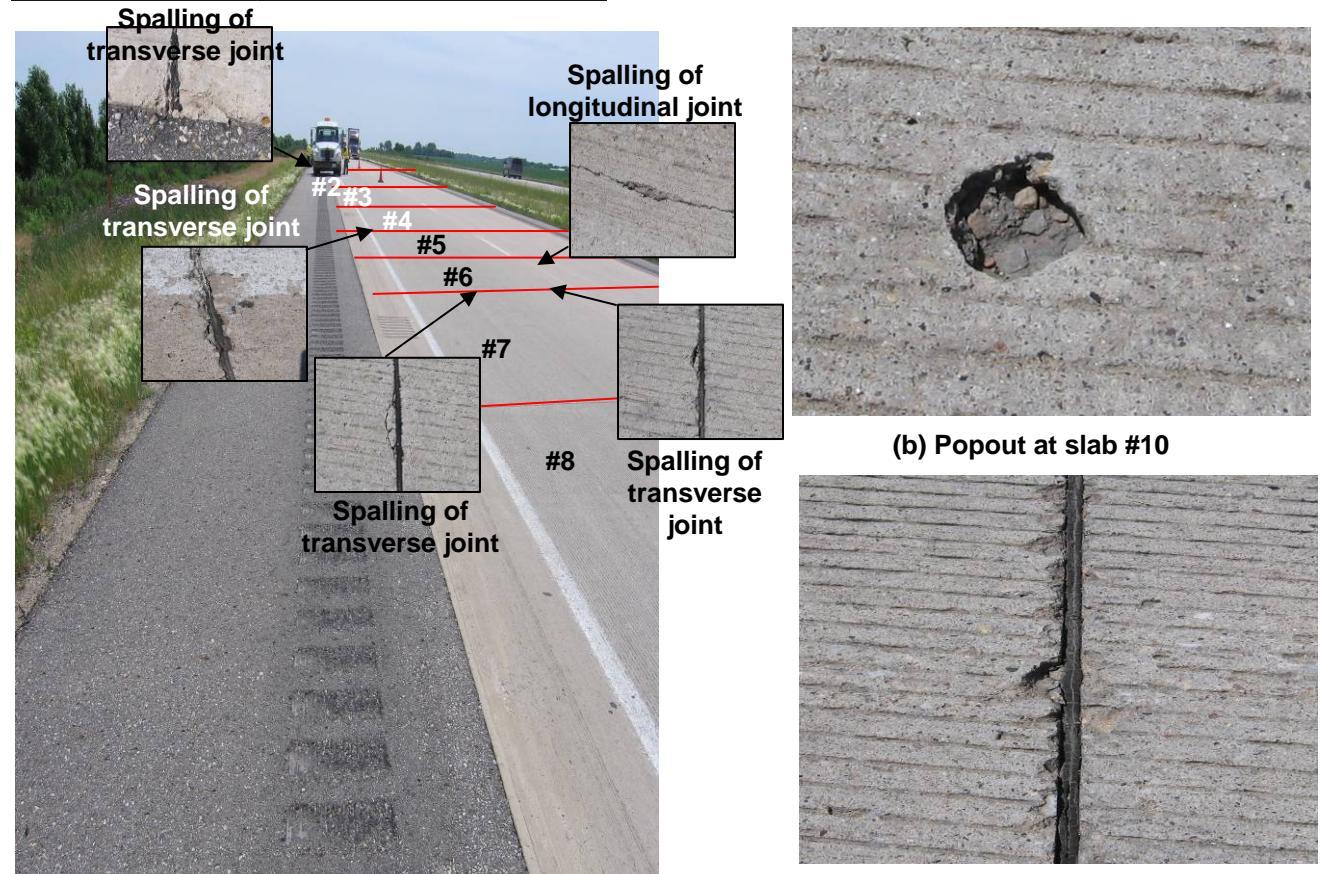
(a) Overall surface distress condition from slab #2 to #8

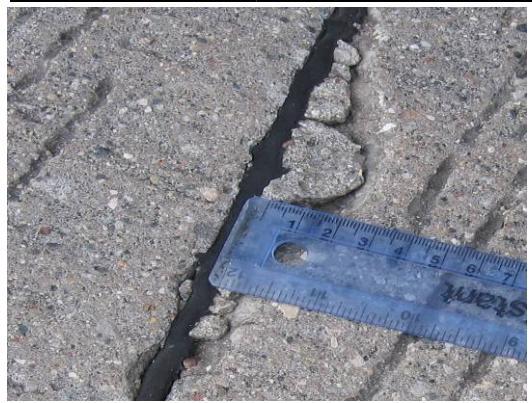
(a) Spalling of transverse joint at slab #4

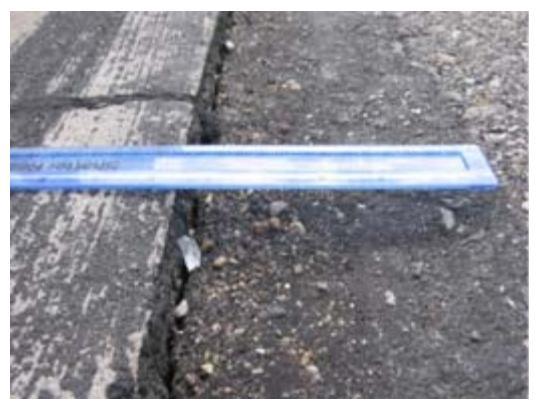
(d) Lane to shoulder drop-off at slab #20

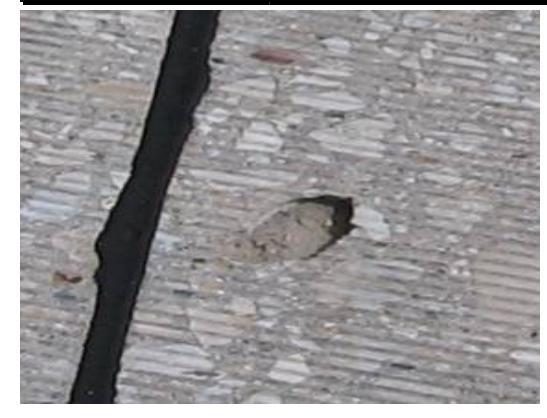
(a) Popout at slab #1

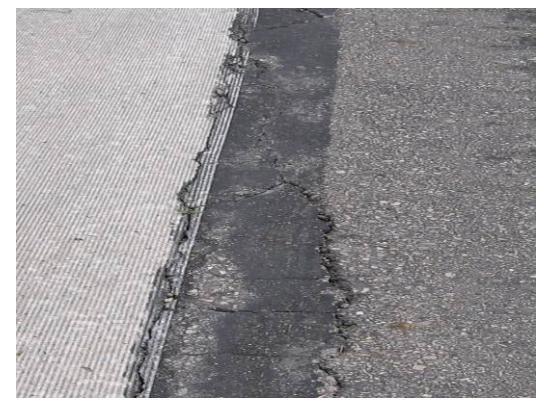
(c) Lane to shoulder separation at slab #15

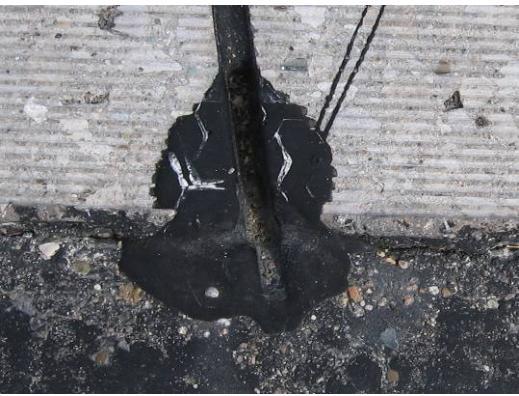
(b) Joint sealing damage of transverse joint at slab #1

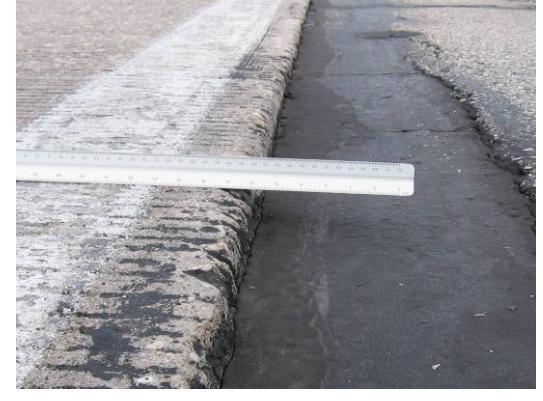
(a) Lane to shoulder drop-off at slab #1

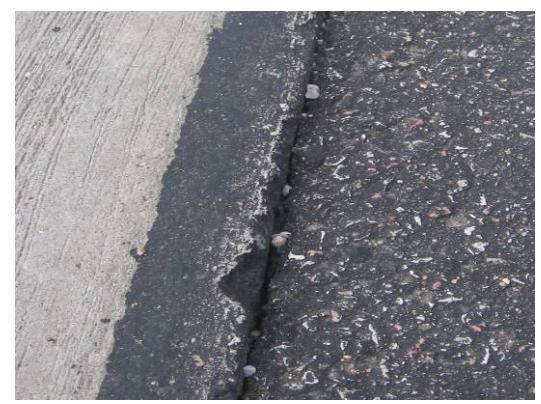
(a) Lane to shoulder separation at slab #2

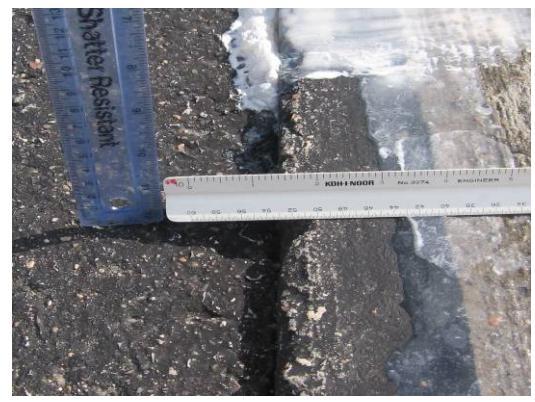
(c) Lane to shoulder drop-off at slab #6

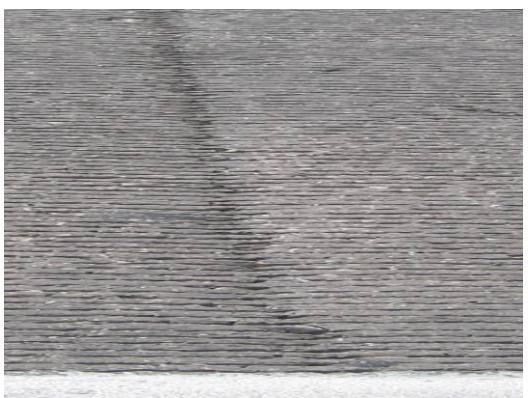
(b) Transverse cracking at slab #5

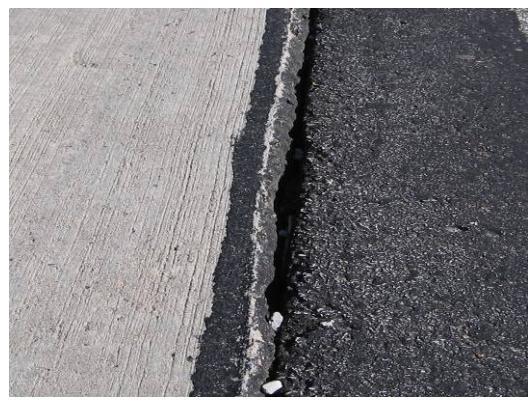
(a) Lane to shoulder separation at slab #1

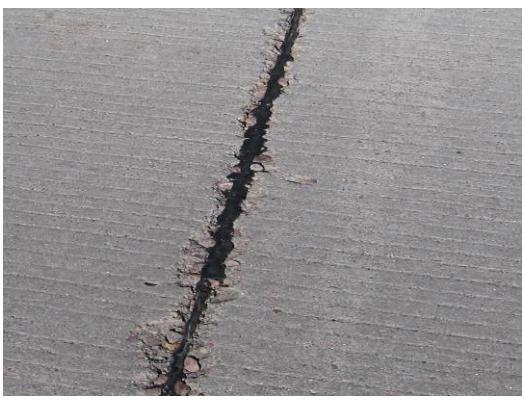
(b) Spalling of transverse joint at slab #5

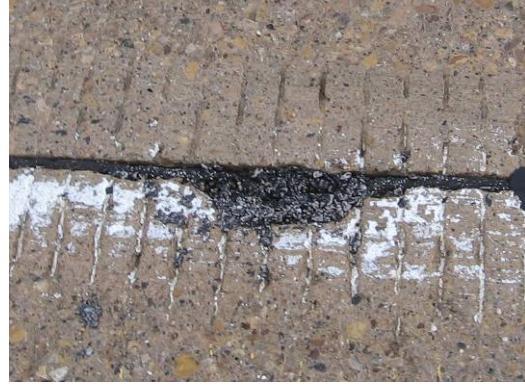
(a) Patch at slab at slab #1

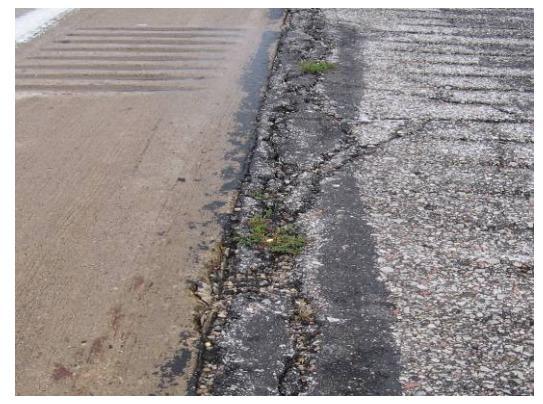
(c) Lane to shoulder separation at slab #13

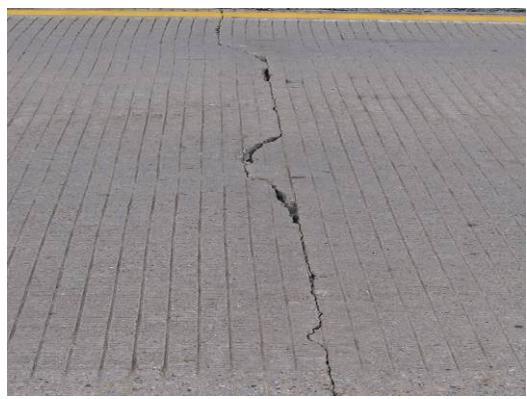
(b) Transverse cracking at slab #5

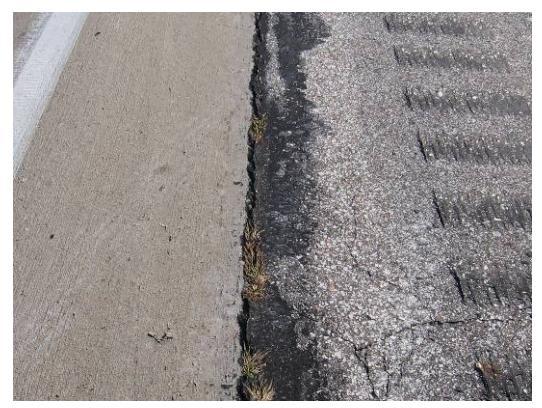
(a) Lane to shoulder separation at slab #2

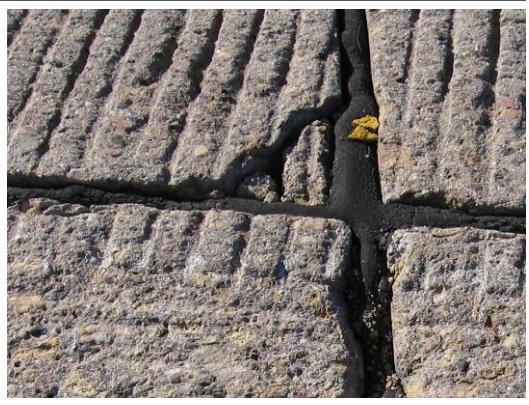
(b) Spalling of transverse joint at slab #5

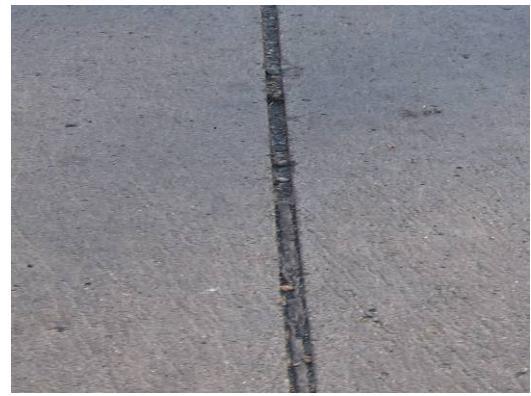
(b) Joint sealing damage of longitudinal joint at slab #6

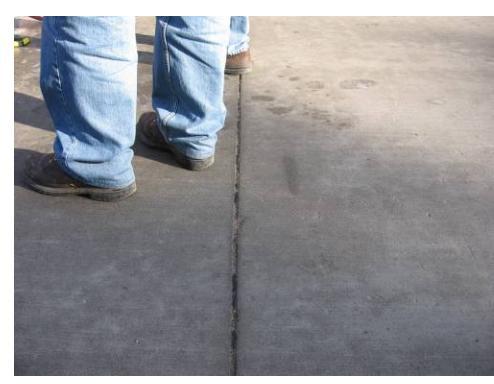
(b) Joint sealing damage of transverse joint at slab #1

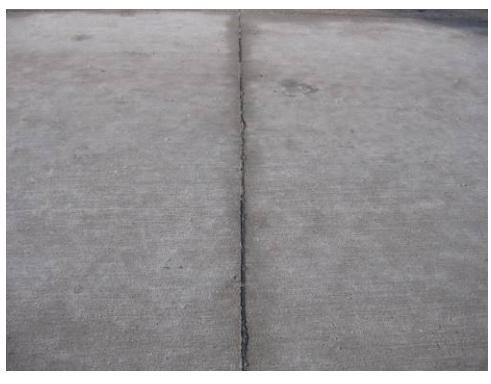
(d) Joint sealing damage of transverse joint at slab #2

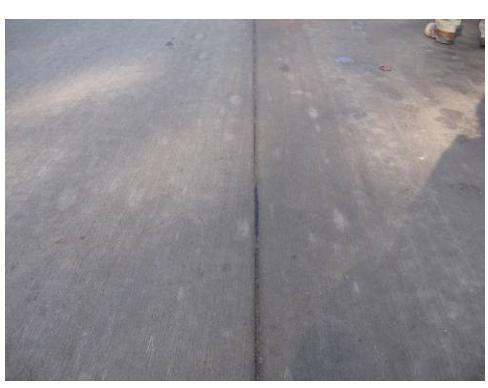
(a) Joint sealing damage of longitudinal joint at slab #1

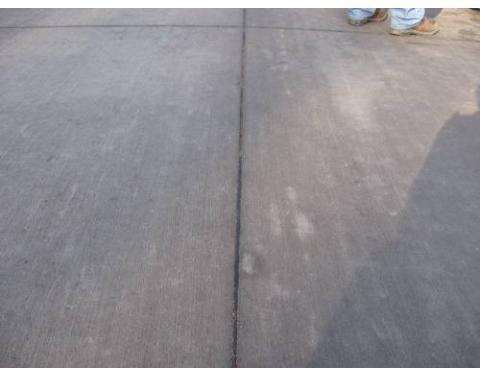
(c) Joint sealing damage of longitudinal joint at slab #2

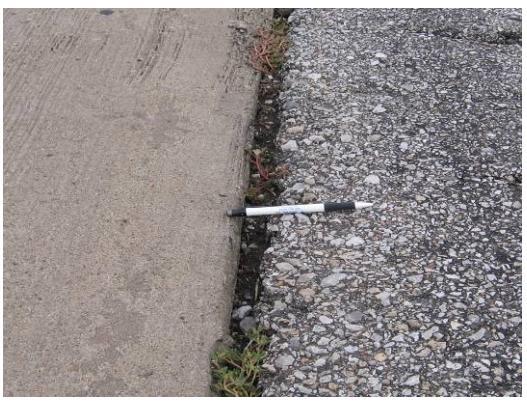
(b) Lane to shoulder separation at slab #10

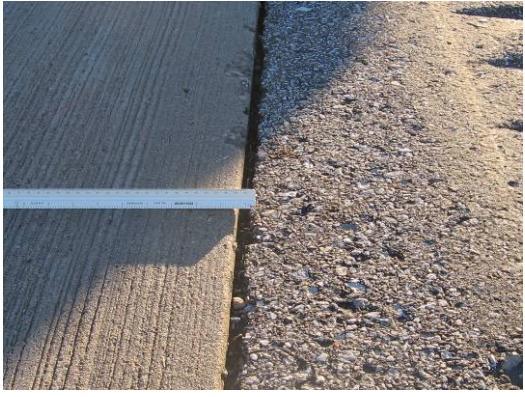
(a) Lane to shoulder separation at slab #3

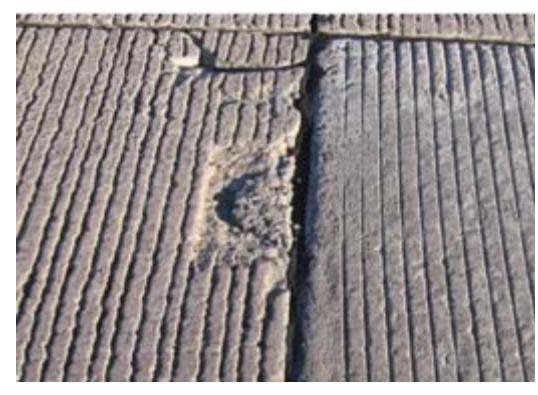
(d) Spalling of transverse joint at slab #18

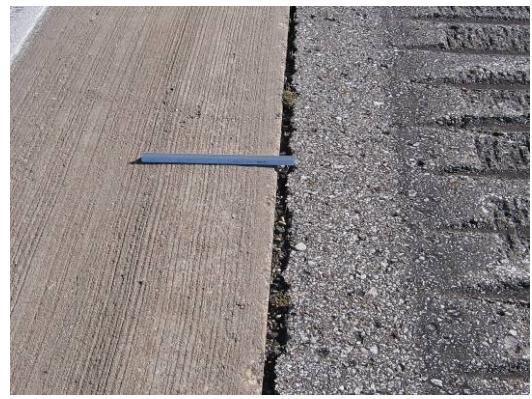
(a) Lane to shoulder separation at slab #2

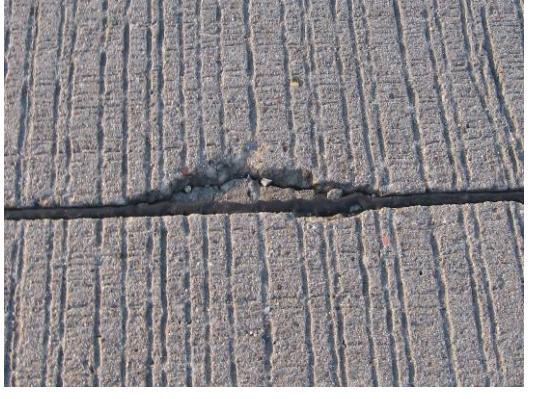
(c) Spalling of longitudinal joint at slab #10

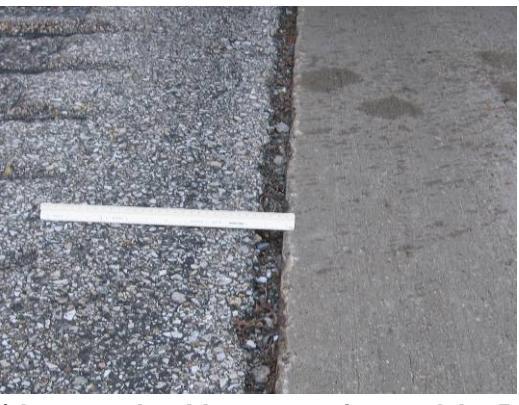
(b) Lane to shoulder separation at slab #5

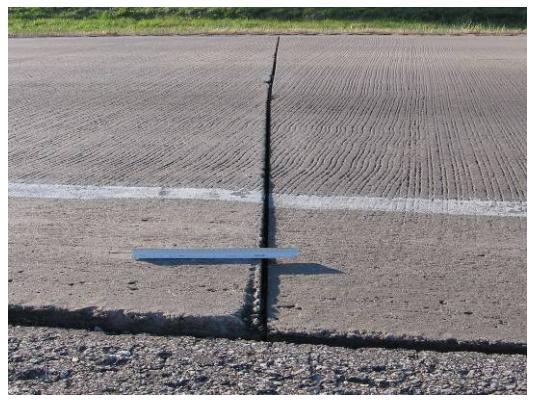
(d) Faulting joint at slab #19

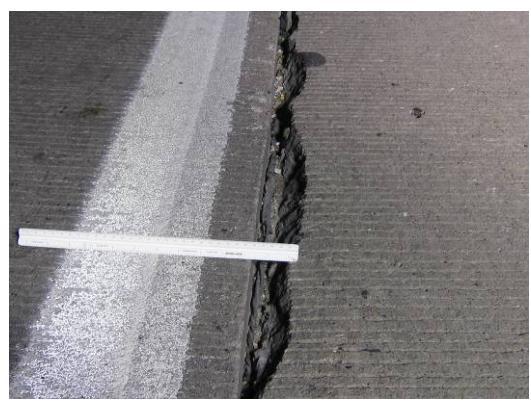
(a) Lane to shoulder separation at slab #1

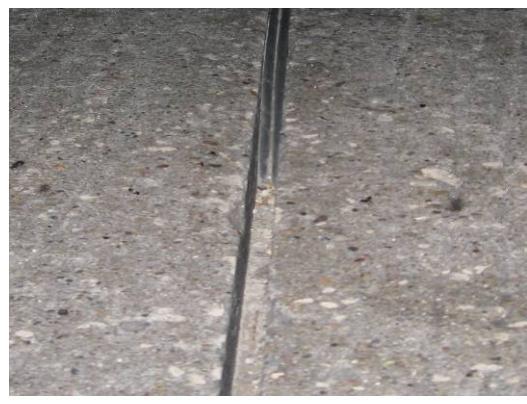
(b) Joint sealing damage of transverse joint at slab #3

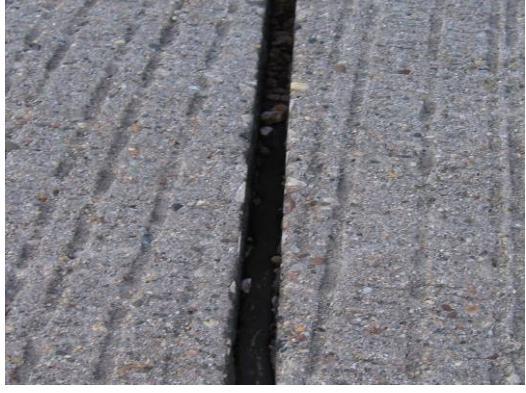
(a) Joint sealing damage of transverse joint at slab #2

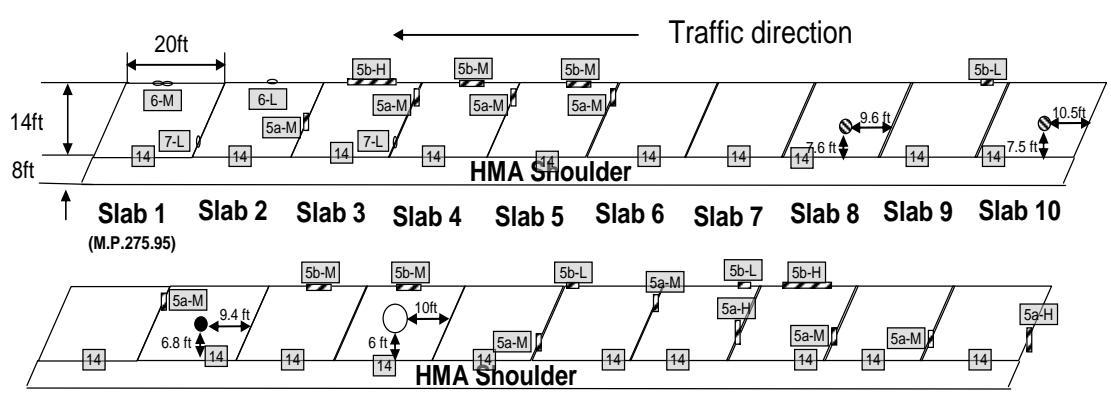
Slab 11 Slab 12 Slab 13 Slab 14 Slab 15 Slab 16 Slab 17 Slab 18 Slab 19 Slab 20 (M.P.275.90)

I-80 in Cedar County: Mile Post No. 275.90 to 275.95 (November/6/2007)

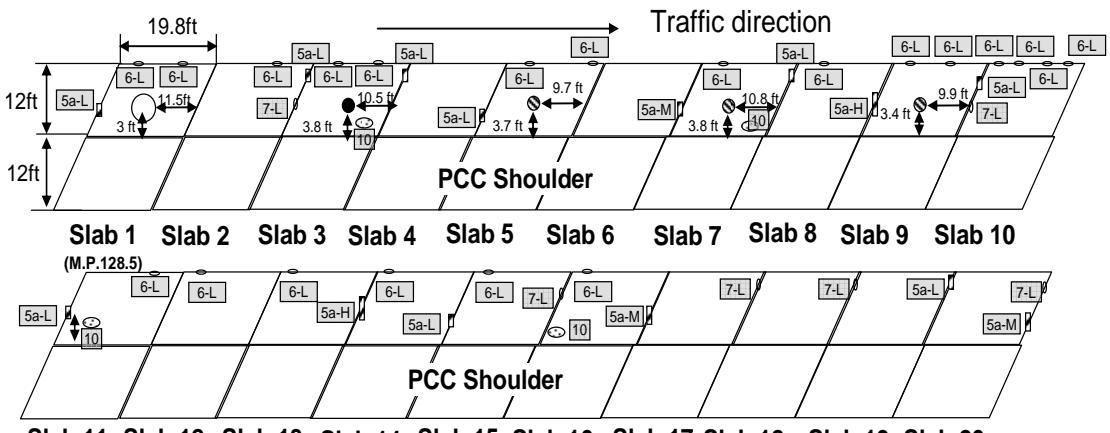
Slab 11 Slab 12 Slab 13 Slab 14 Slab 15 Slab 16 Slab 17 Slab 18 Slab 19 Slab 20 Note:

I-80 in Polk County: Mile Post No. 128.50 to 128.60-Passing Lane (November/8/2007 to November/9/2007)

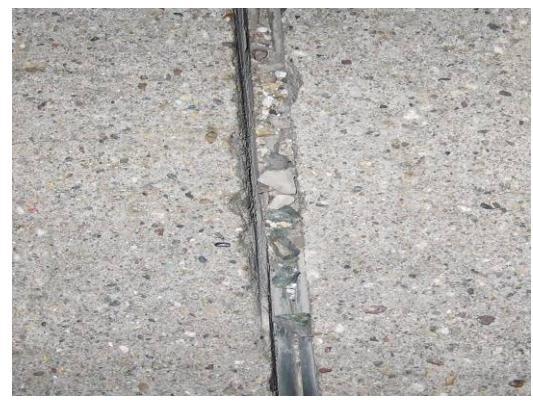
(b) Joint sealing damage of transverse joint at slab #4

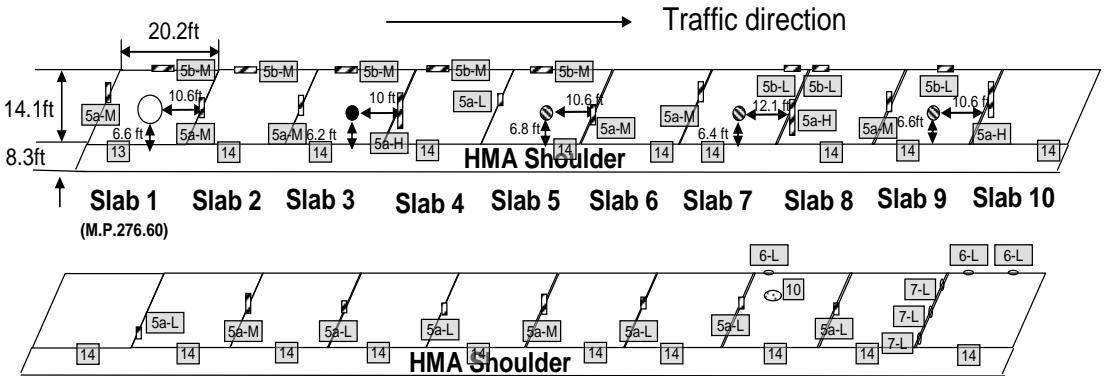
Slab 11 Slab 12 Slab 13 Slab 14 Slab 15 Slab 16 Slab 17 Slab 18 Slab 19 Slab 20 (M.P.276.65)

I-80 in Cedar County: Mile Post No. 276.60 to 276.70 (November/13/2007)

Survey Type	Comment
Slab thickness	13.5 in
Base thickness	9 in (RPCC)
Joint orientation	Diagonal
Joint width	0.6 in
Joint depth	1.4 in
Sealing condition	Bad
Shoulder condition	Bad
Cut or fill	Fill

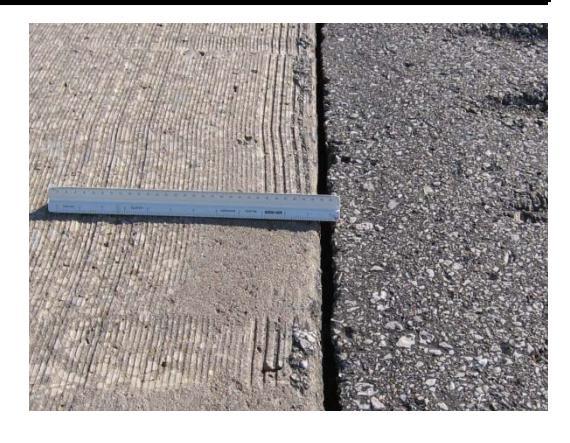
(b) Lane to shoulder separation at slab #9

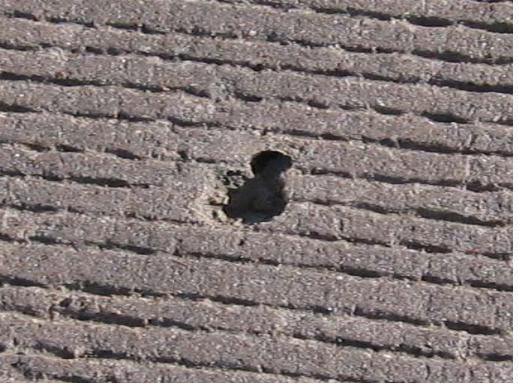
(c) Popout at slab #18
