Lake Delhi Dam Reconstruction Design Alternatives Report

**Lake Delhi Combined Recreational
Facility and Water Quality District**
Delhi, Iowa

Final
December 21, 2011

Stanley Consultants INC.

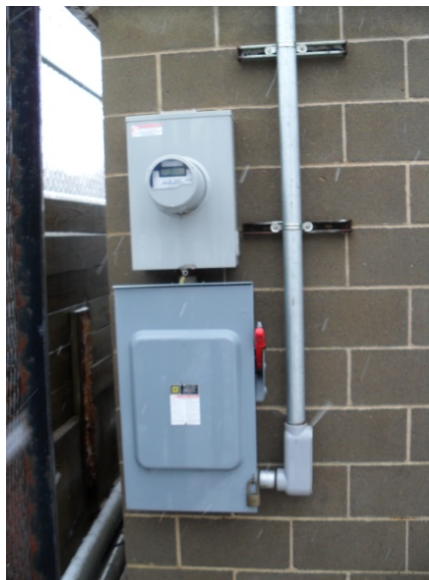
Meter and Main Service Disconnect
Figure 2-4

The Lake Delhi Dam is currently served at 480/277V by three pole-mounted transformers located approximately 150 feet north of the powerhouse structure along 230th Avenue. The transformers and existing service drop to the powerhouse are owned by Alliant Energy. The existing utility meter and service disconnect switch, shown in Figure 2-4 below, are located on the north exterior wall of the powerhouse. The meter and disconnect switch are rated for outdoor environments and appear to be in good condition. The overhead service drop conductors also appear to be in good condition.

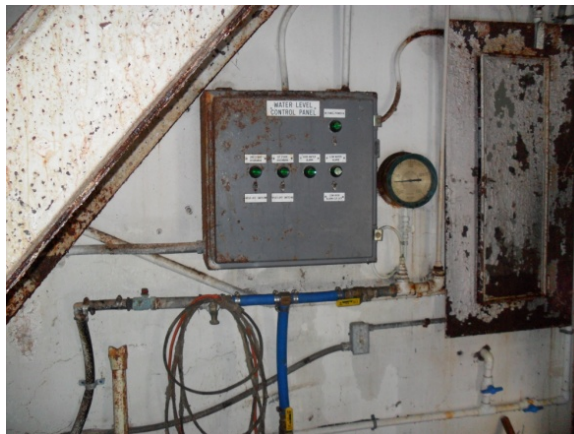
Water Level Control Panel
Figure 2-9

There does not appear to be any electrical equipment for pool level monitoring. There is an existing control panel, shown in Figure 2-9, labeled as 'Water Level Control Panel', which appears to have been used in conjunction with the hydroelectric generation equipment. There were not any field instruments observed in operation with this control panel.

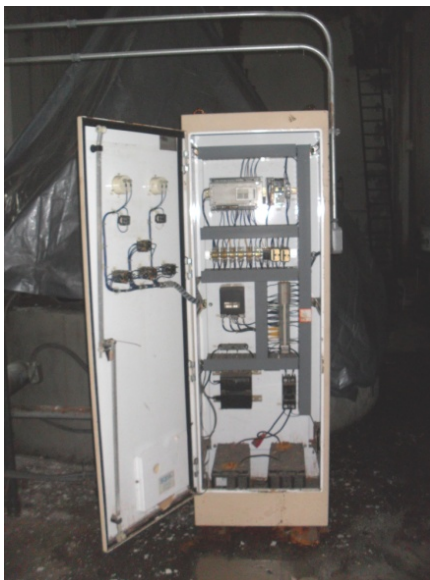
Hydroelectric Generator Control Panel
Figure 2-10

The existing hydroelectric generation equipment is not operational. The control panels for each hydroelectric unit were inundated with water during the 2010 flood event and significant damage was observed to the battery systems and electronic control devices. Figure 2-10 shows one of the hydroelectric unit control panels. The main PLC cabinet for the hydroelectric system is located on the wall in the generator room and was also damaged by water during the flood event.

Each hydroelectric generator control panel also provides power to the associated wicket gate actuators. Currently, the wicket gates are operated manually, as the control system for the hydroelectric equipment and wicket gates are non-operational.

The wicket gates, from the two abandoned hydropower generators, had been maintained to provide minimum flow control. During the flood, the powerhouse was completely inundated and the electronic controls (PLC, battery backup, dc-motor, switches, etc.) were ruined. The wicket gates will require replacement of the existing actuator to bring the system into service. The actual gates and actuator arms will likely need refurbishment as well.

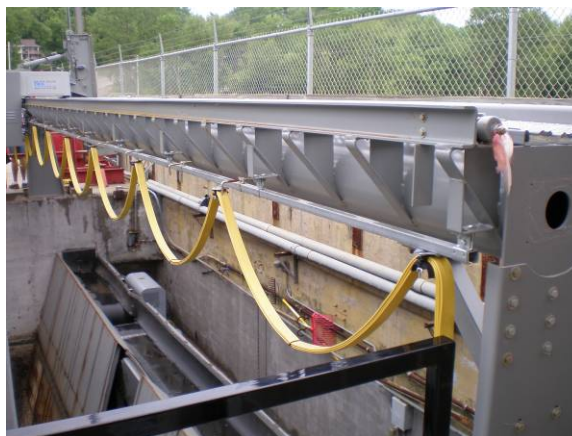
Trash Rake
Figure 2-12

The HydroRake was installed in 2009 to remove the trash that accumulated on the two bar screens protecting the wicket gates. The raking system consists of two bar screens with a hydraulically operated trash raking arm mounted on a traveling chassis that discharges onto belt conveyors that remove the trash to the discharge of the spillway gates. The flood inundated this equipment except for the PLC control cabinet. To make this system operational again, a complete inspection of the equipment is required. At a minimum, the motors would need to be replaced, the local switches and sensors would need to be replaced, the submerged wiring would need to be replaced, and the hydraulic oil would need to be flushed. The belts, bearings, rollers, and hydraulic motor would need to be inspected, oiled, greased, or replaced as necessary. The trash rake is shown on Figure 2-12.

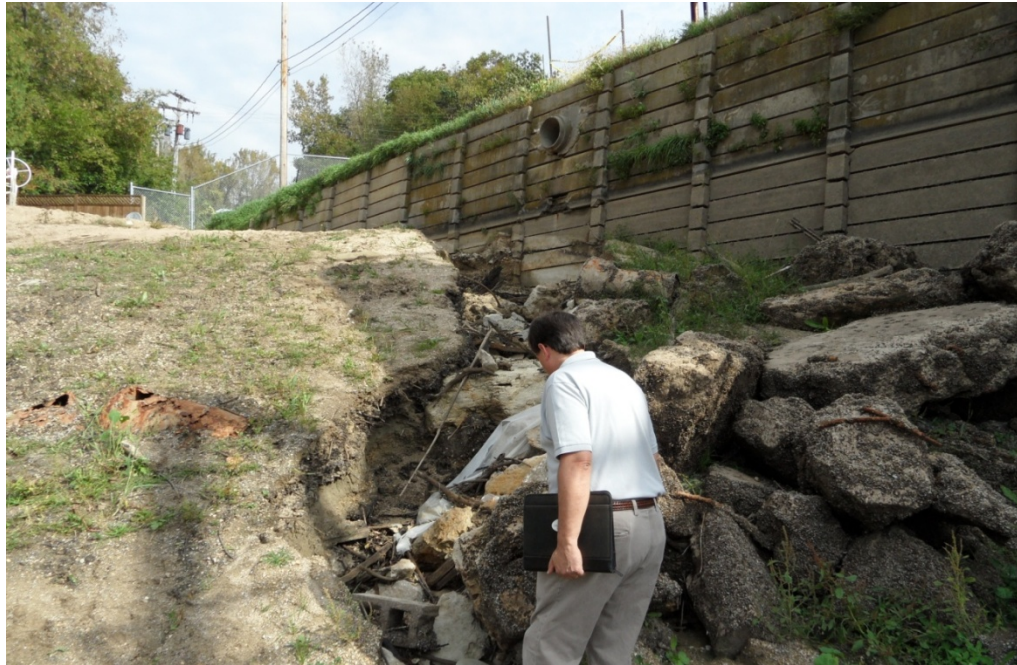
The upstream retaining wall generally appeared to be stable and in good condition, with a localized area of deterioration below the outlet of the storm pipe (Photo 1.3). The grade along the base of the upstream retaining wall shows signs of significant erosion. The eroded area has been partially filled with concrete rubble and/or large riprap (Photo 1.1)

Photo 1.1 – Upstream retaining wall adjacent to north approach roadway – Note eroded area in front of wall partially filled with riprap

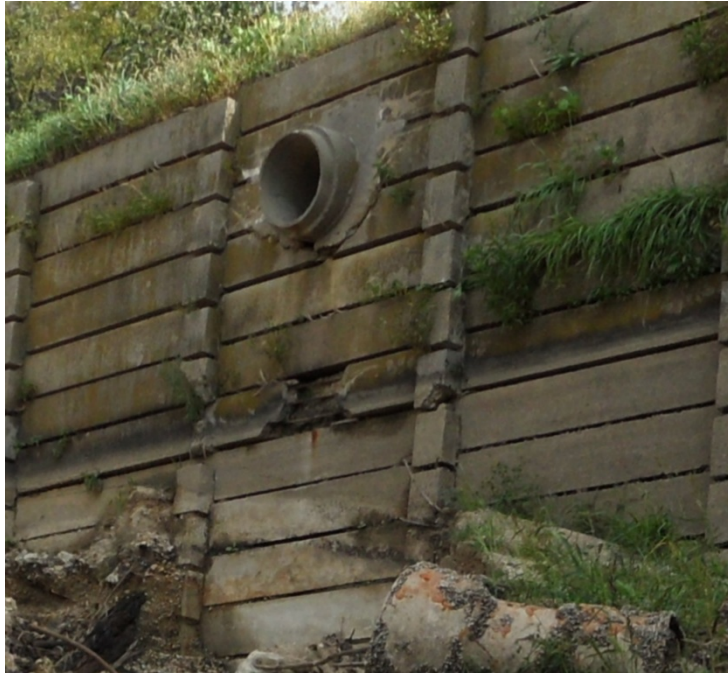
Photo 1.3 – Storm drainage pipe penetration through retaining wall – Note damaged concrete below pipe

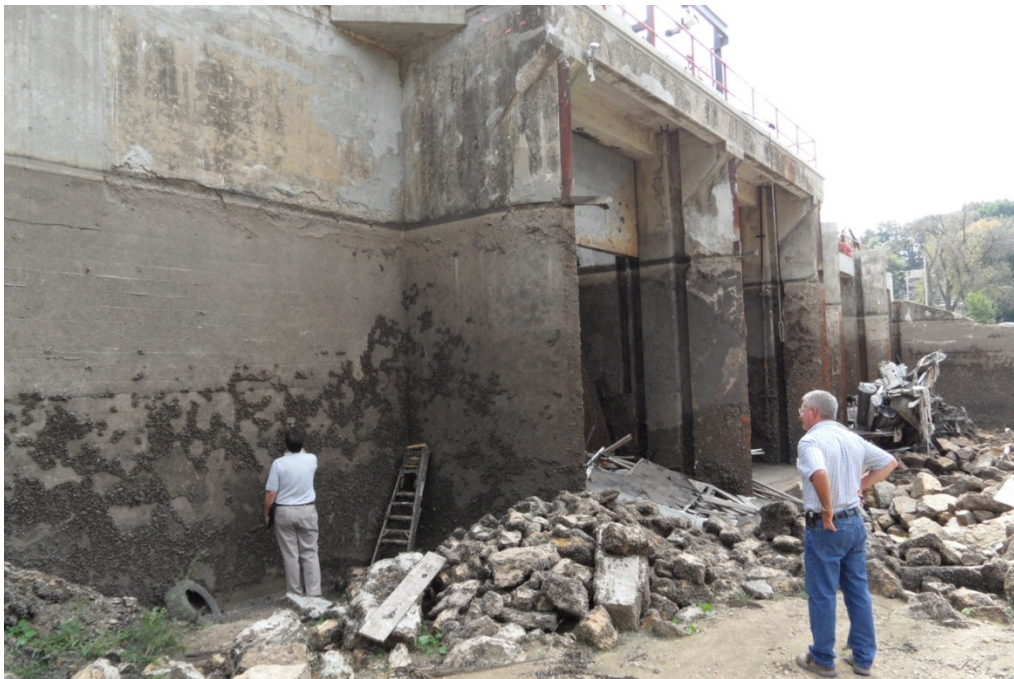
2.3 – Upstream side of Powerhouse – Note apparent spalling and past repairs above original waterline

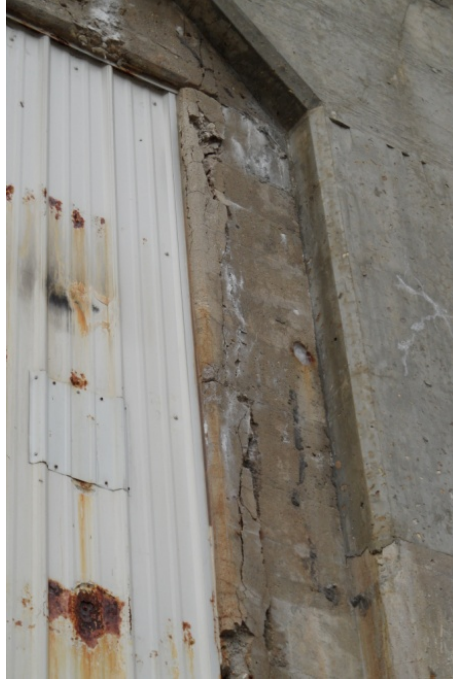
2.8 – Deterioration in downstream wall of Powerhouse

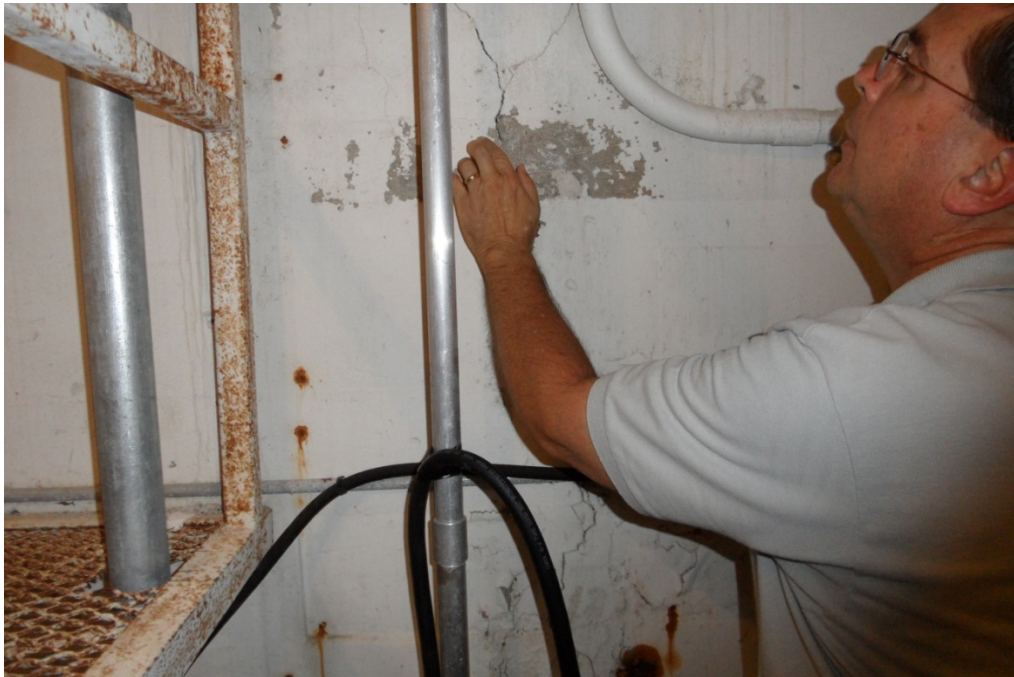
2.11 – Cracking in north wall of Control Room

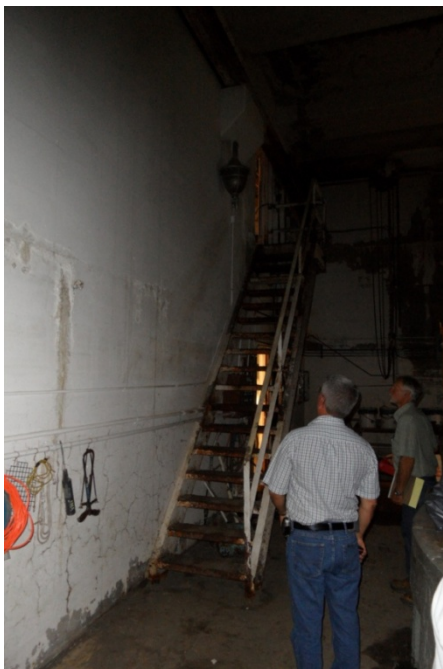
2.14 – Random cracking and efflorescence on upstream wall of Turbine Room

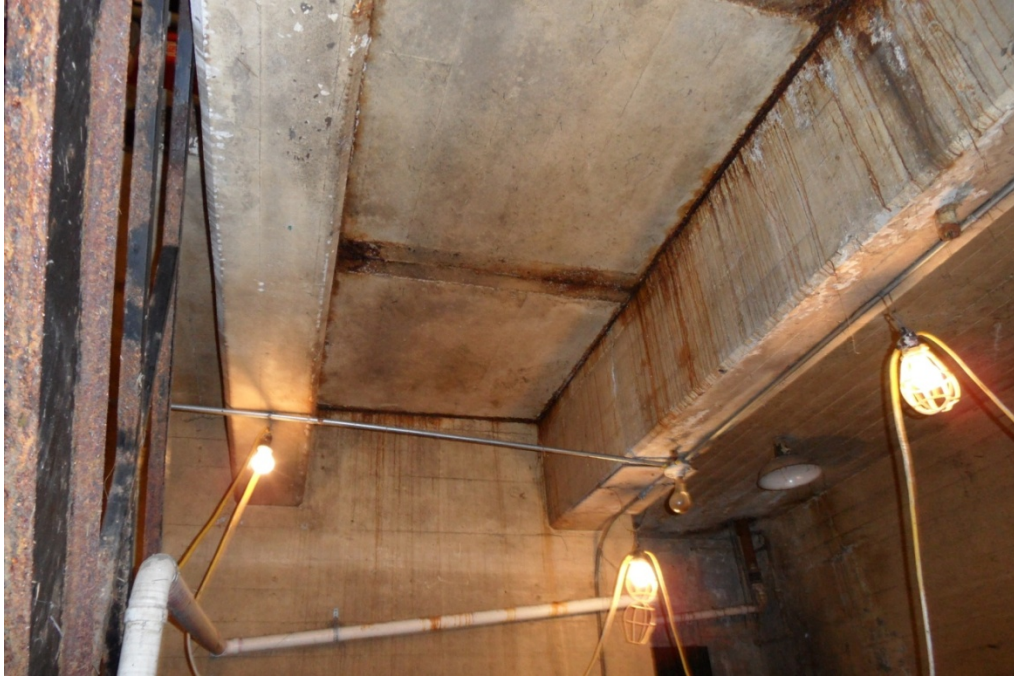
**2.20 – Removable floor panels between Turbine Room and Mechanical Room –
Note heavy corrosion on steel stairs and railings on the left**

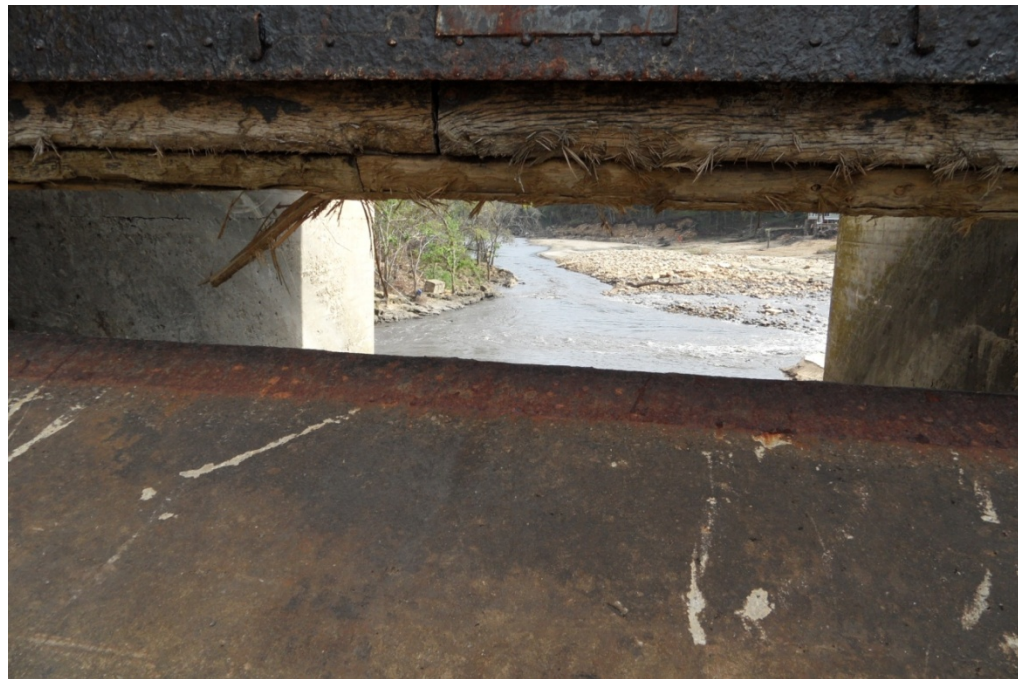
3.3 – Abrasions on the upstream side of a typical spillway

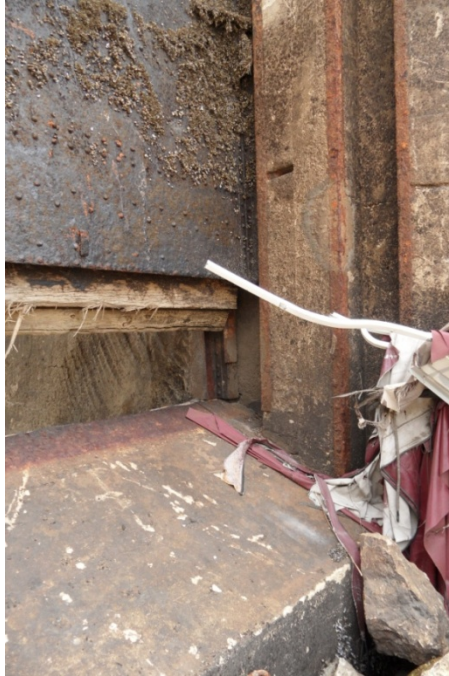
3.4 – Abrasions on the upstream side of a typical spillway

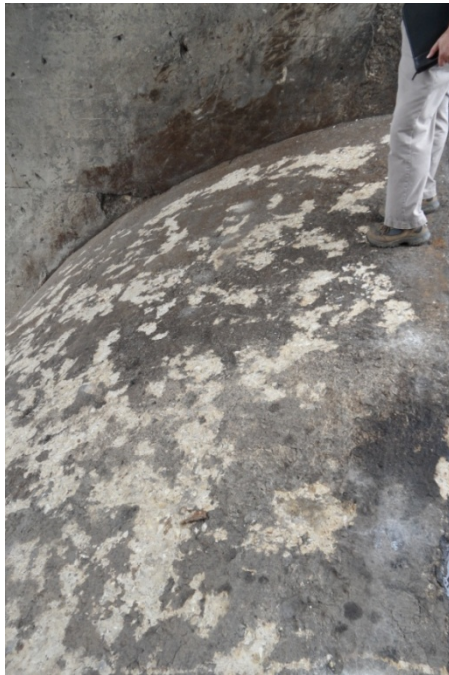
3.5 – Abrasions and erosion in downstream surfaces of a typical spillway

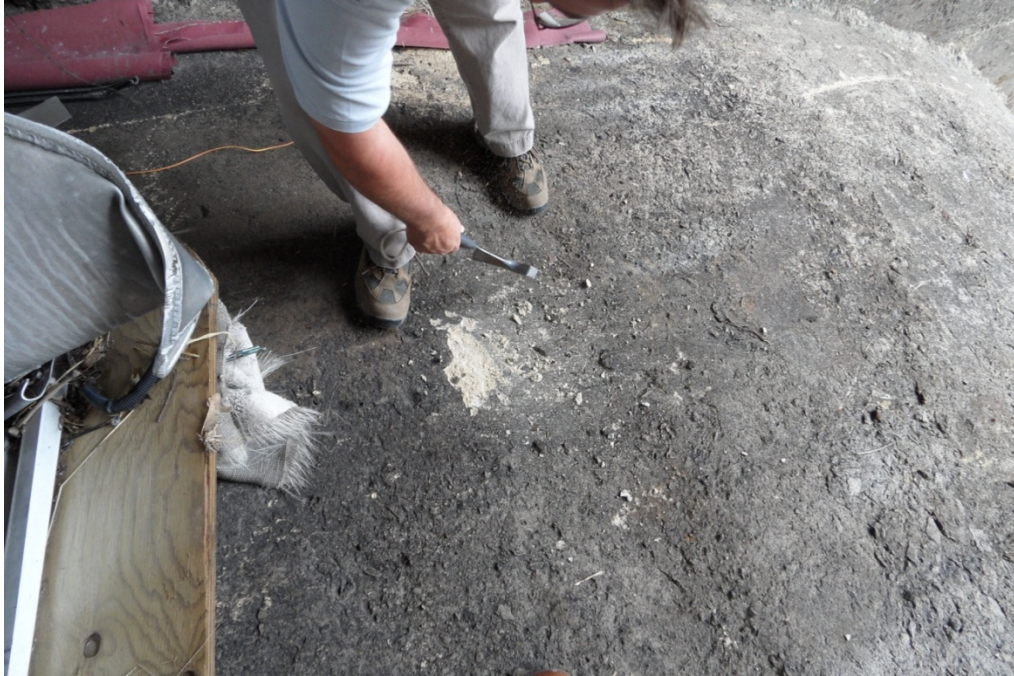
3.6 – Soft surfaces of spillway concrete can be chipped away with light hammer

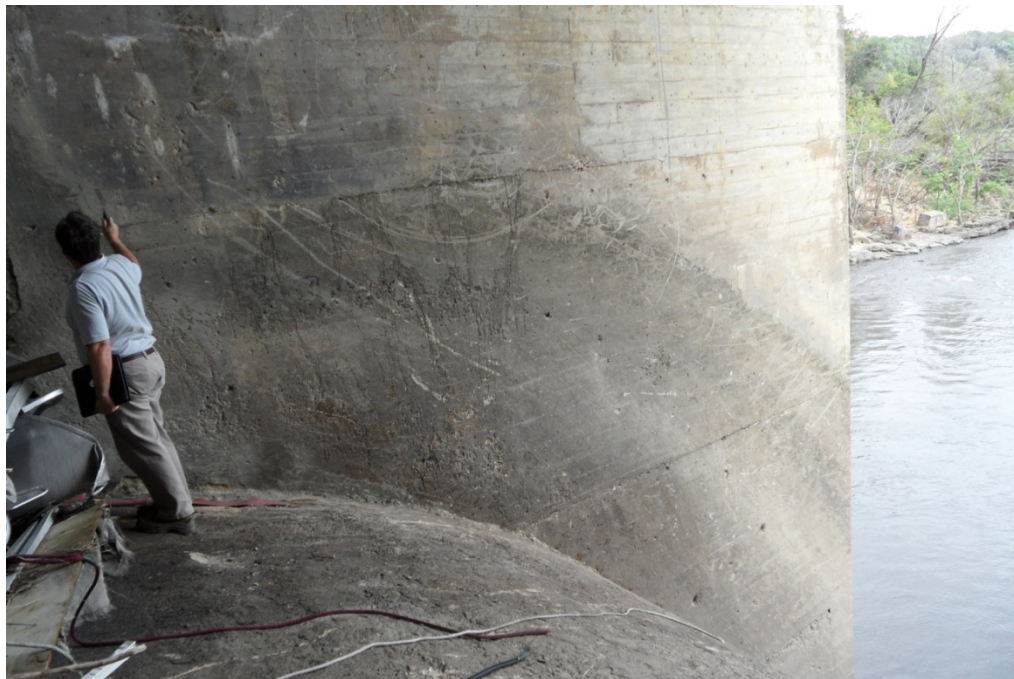
3.7 – Hollow sounding concrete when tapped with hammer at Gates 1 and 2

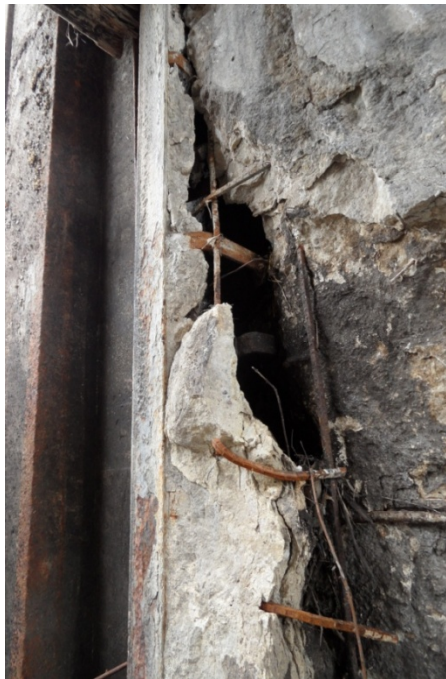
3.9 – Severe concrete deterioration in left pier at Gate 3 – Note how embedded steel guide slot has been pushed away from pier and is out of plumb

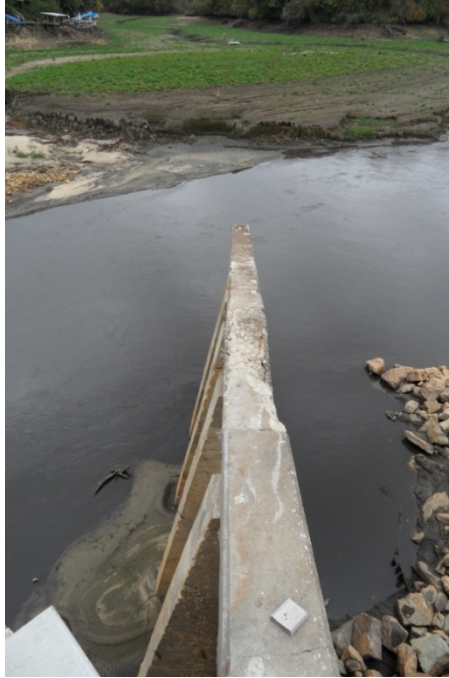
3.14 – Damage to top of upstream abutment wall

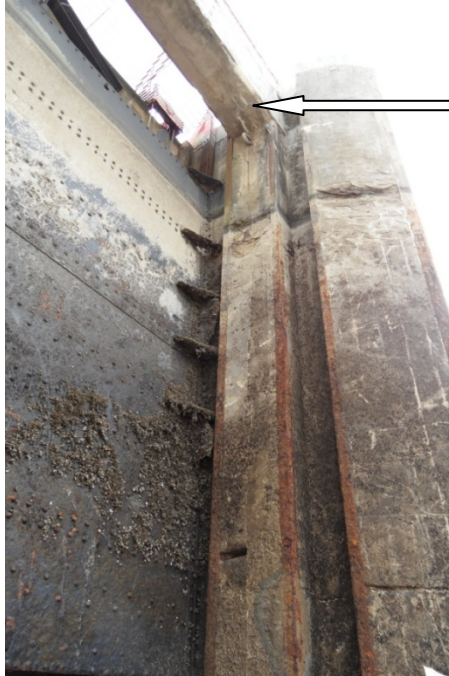
3.22 – Cracking in beams on upstream side of operator's deck

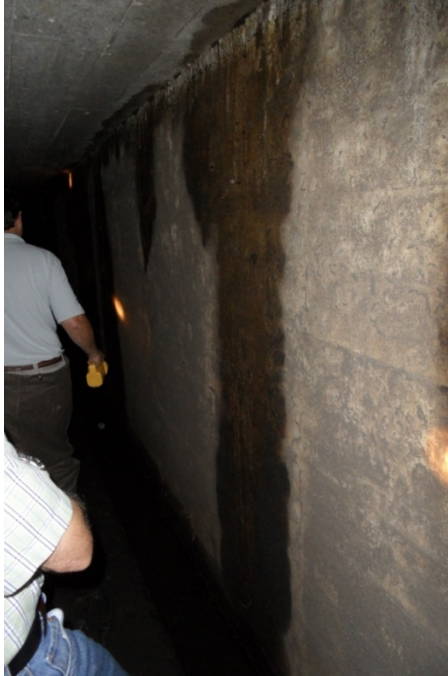
4.5 – Moisture and lime deposits on tunnel walls

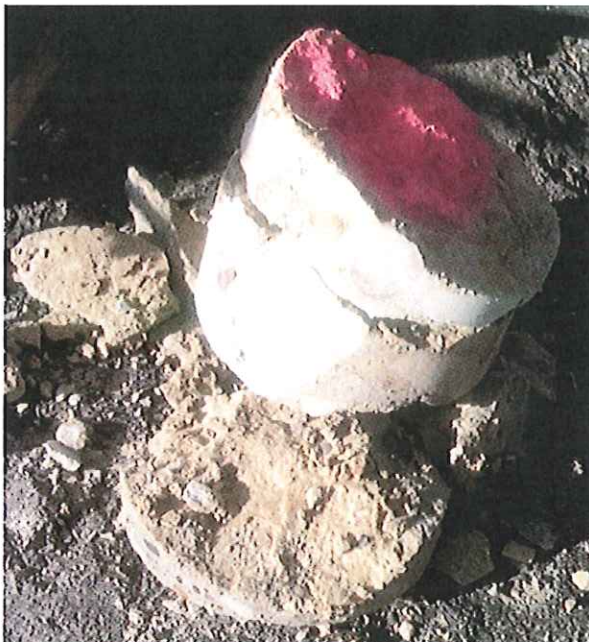
Core Number 5

In general, the concrete did not respond well to coring and many of the cores broke or turned to rubble during the coring operation. The cores taken from vertical surfaces were typically in poorer condition than those taken from horizontal surfaces. Three examples of cores that were too short to test are in the following pictures. More than one attempt was made at several locations to obtain intact cores. The results of the petrographic analysis will be forwarded under separate cover.

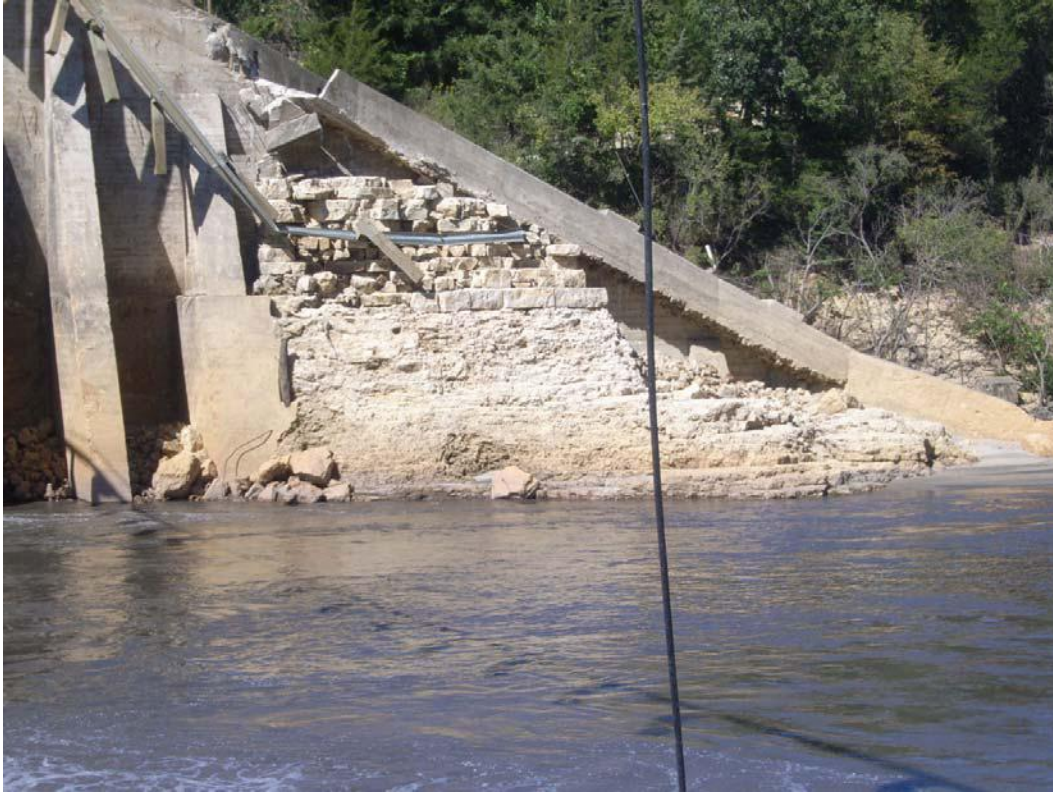
Plate 7. Photograph of the exposed south wall of the gated spillway at Delhi Dam (Reproduced from Fiedler et al. 2010; This limestone pier once supported the south end of the bowstring arch bridge.)

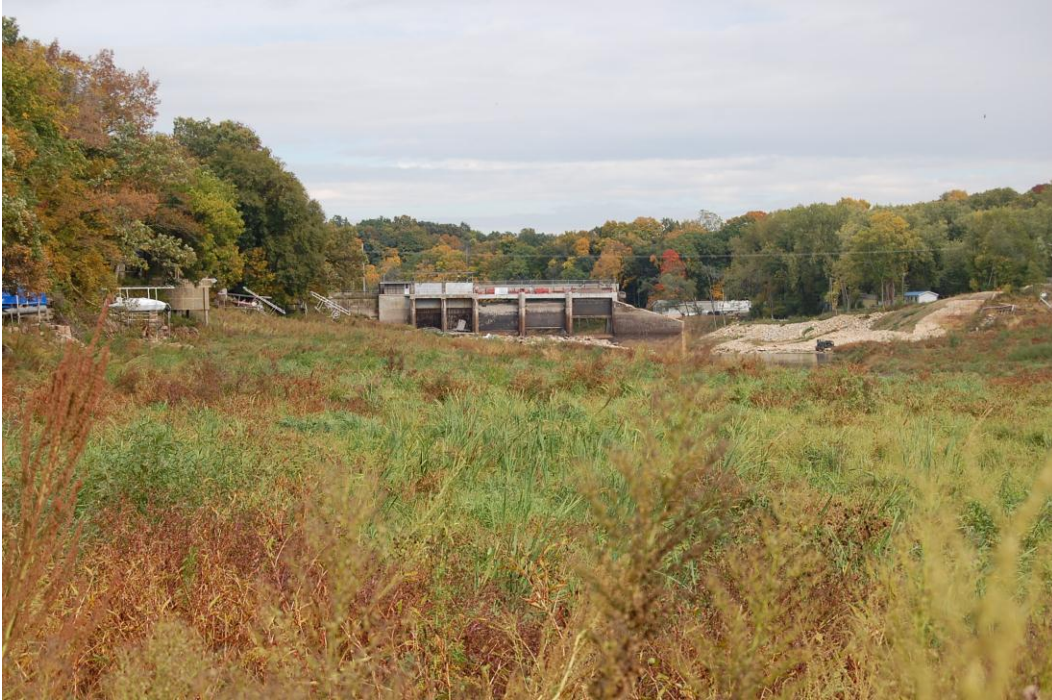
Plate 8. Vegetation Obscures the Lakebed Above Delhi Dam. View downstream.

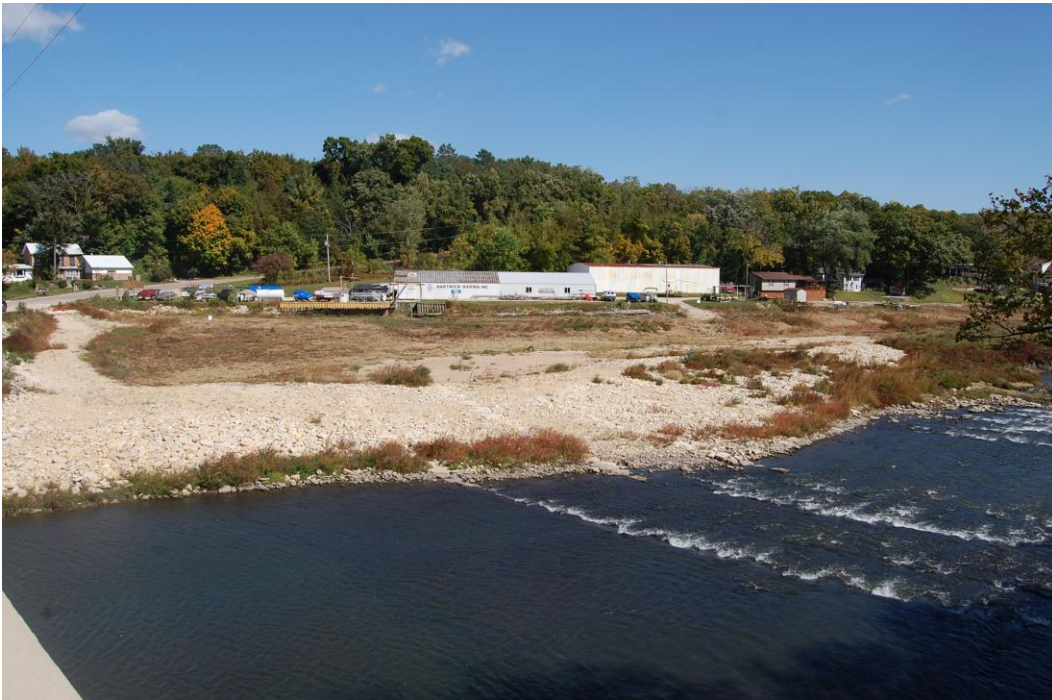
**Plate 9. Hartwick Terrace Downstream from the 220th Avenue Bridge.
(Note new riffle structures and rip-rap material installed during the fall of 2010).**

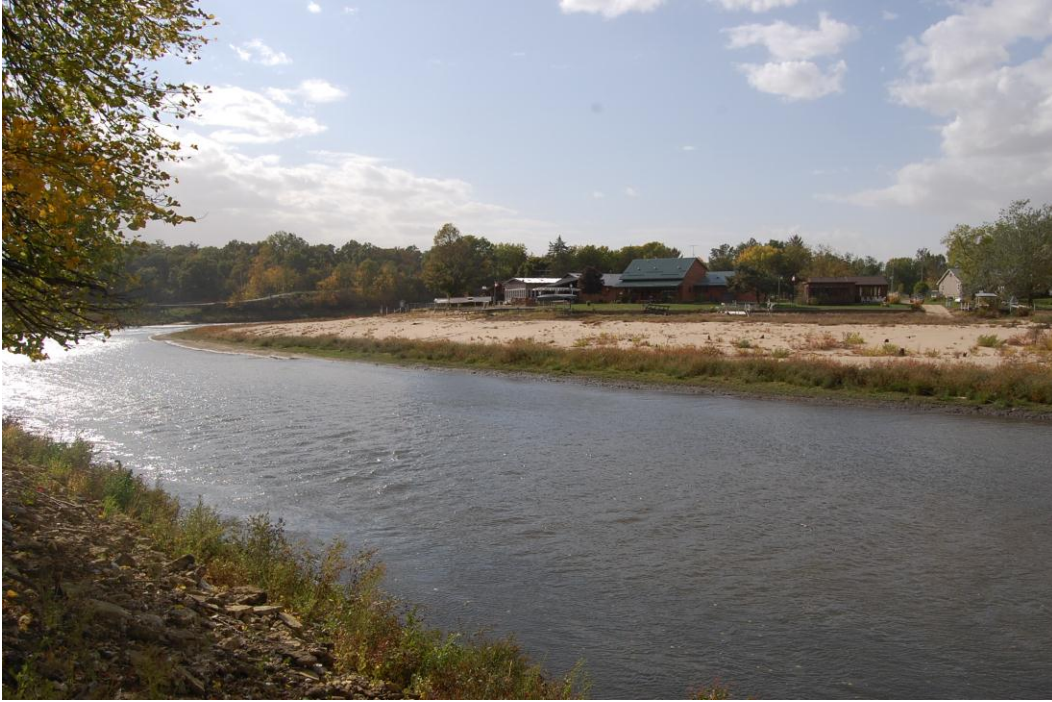
Plate 10. Sand deposits on the Holocene terrace below Linden Acres. View upstream.

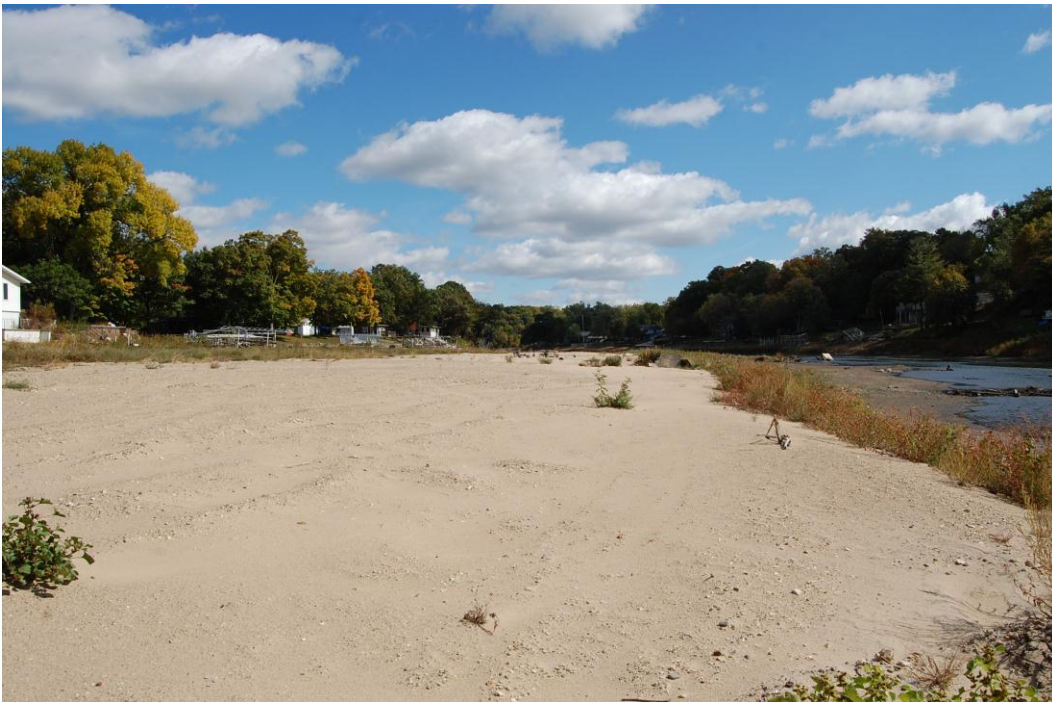
Plate 11. Sand Deposits Cover the Holocene Terrace at Clearview Acres. View downstream.

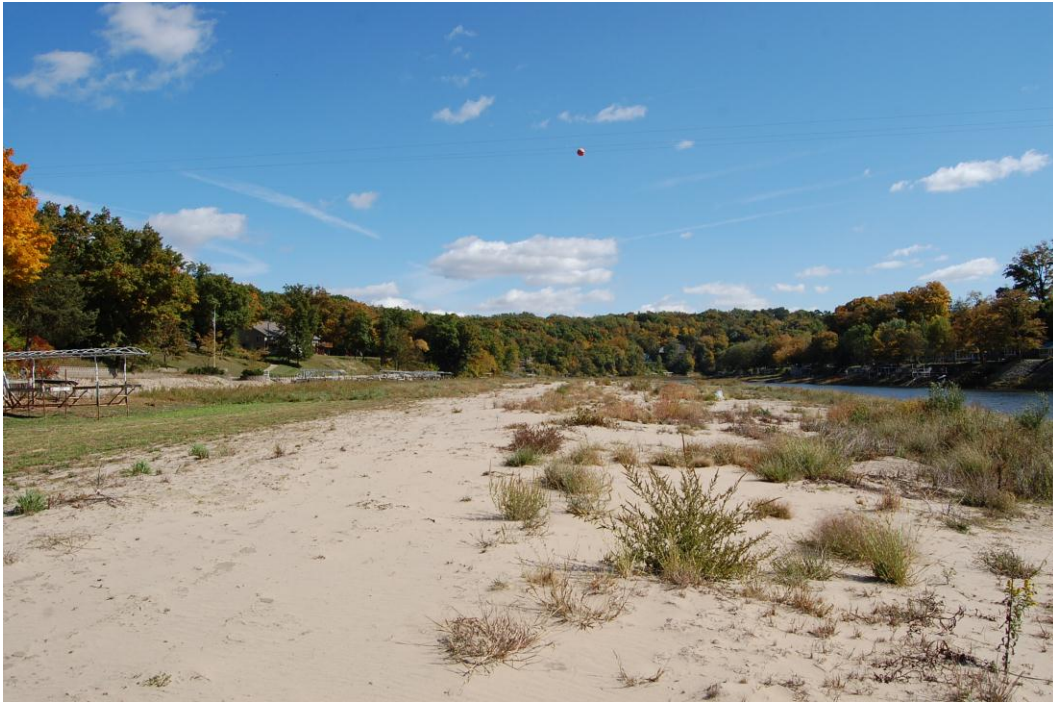
Plate 12. Sand and vegetation on the Holocene terrace below the Maples. View downstream.

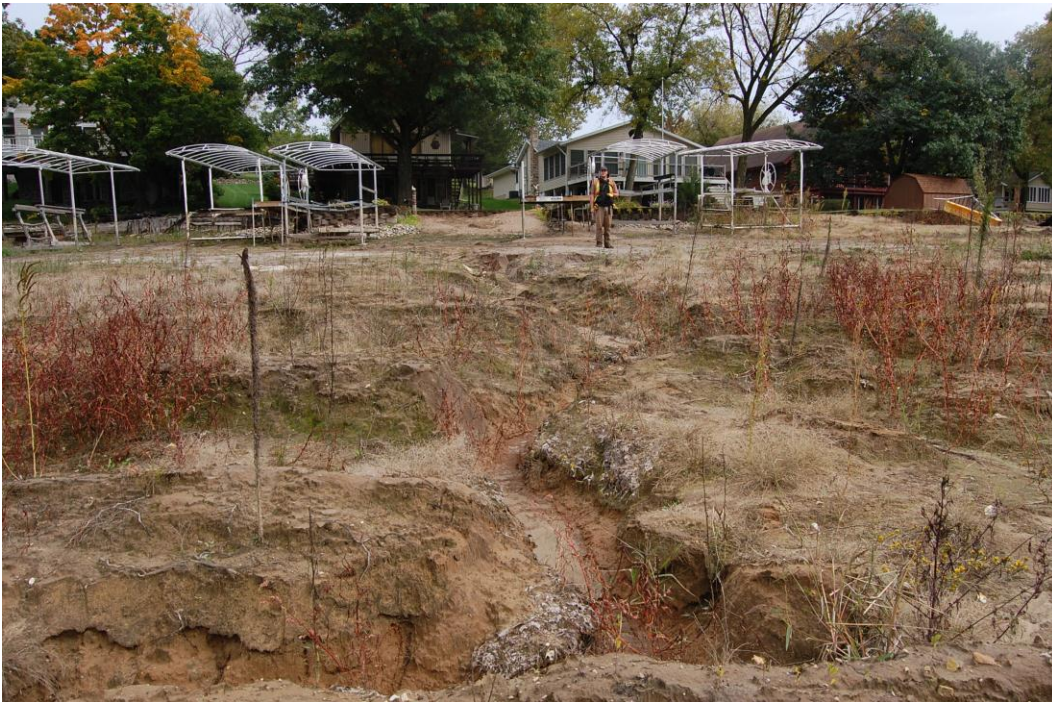
Sheet erosion along with rill and gully erosion is also developing on many of the high terrace slopes from a point beginning about one-half mile above the Hartwick bridge downstream to the Delhi Dam (Plates 14, 15). The damage is caused by normal rainfall and sheet erosion on unprotected surfaces, but the problem is also exacerbated or amplified in many places by stormwater runoff from nearby homes and other developments above the shoreline. In many places, stormwater that was once diverted by drain tile or landscaping directly into the lake is now being drained onto the surface of the exposed terrace landforms. In places where this surface is unprotected, we observed many rills and large gullies developing along the terrace edge. In several places we found gullies like these cutting through what appear to be potentially significant archaeological deposits (e.g., Site 13DW133).

Plate 14. Gullies formed by storm water runoff near Hickory Hollow

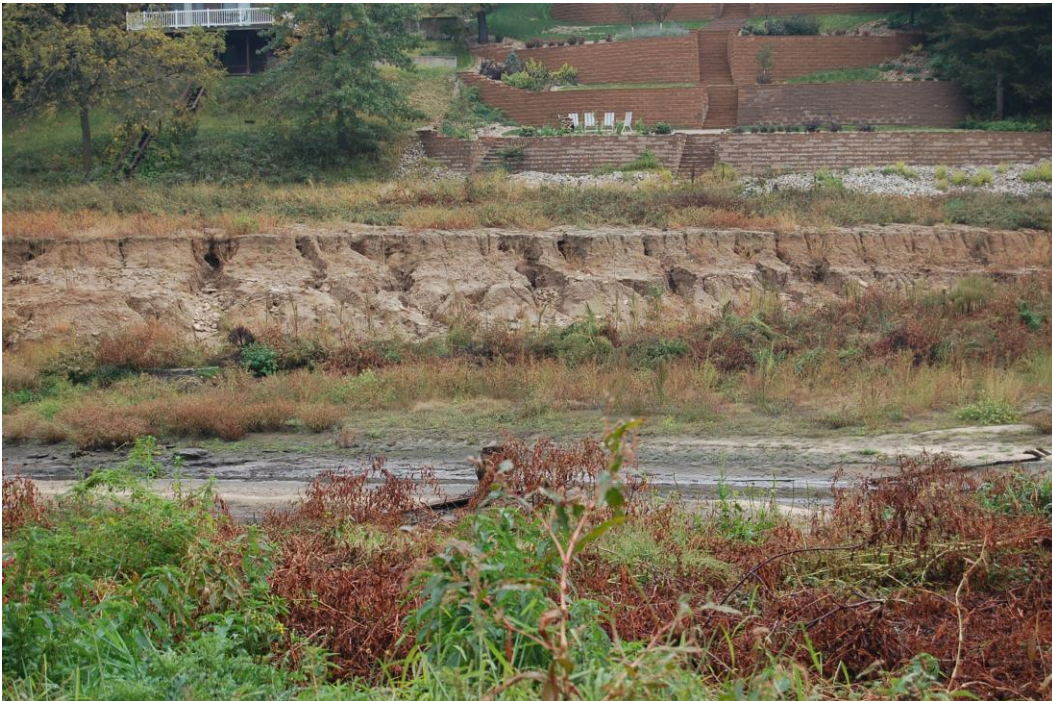
Plate 15. Gully erosion along the point bar terrace at Deer Run below Hartwick. View to south.

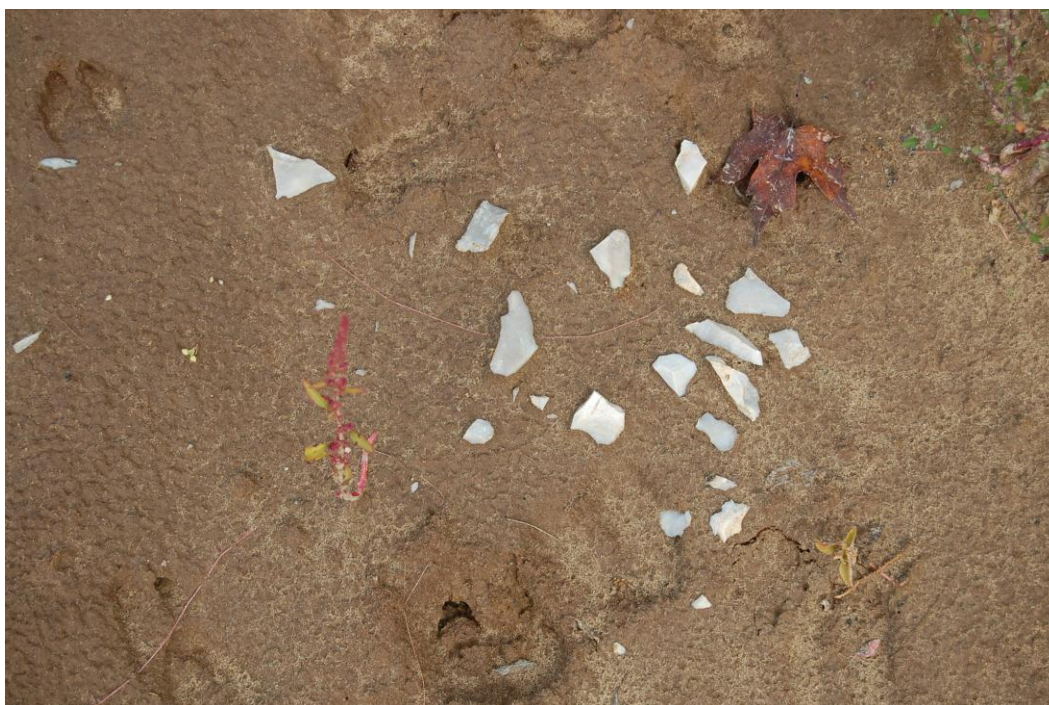
Plate 16. Chipped-Stone Artifacts Exposed on the Eroded Surface of Site 13DW124.

LBG did not collect any additional material from the surface of the site but observed several concentrations of chipped-stone artifacts exposed on the ground surface extending as much as 50 meters north of the site boundary reported by WVA. In each instance, the artifacts appeared to be in-situ and were pedestaled on otherwise eroded subsoil (B horizon) deposits (Plate 16). No modified specimens, tools, or other temporally diagnostic artifacts were observed at the site. Other downstream portions of the site appeared to have experienced less sheet erosion and still retained what appeared to be an intact A horizon; however, surface erosion has progressed to the point where rills and gullies have developed through these deposits, in some places well into subsoil.

No subsurface tests have been excavated at the site which is believed likely to extend above the shoreline onto the adjacent terrace. The site remains unevaluated for listing in the NRHP. Based on the field observations summarized above, LBG recommends that additional archaeological investigations be

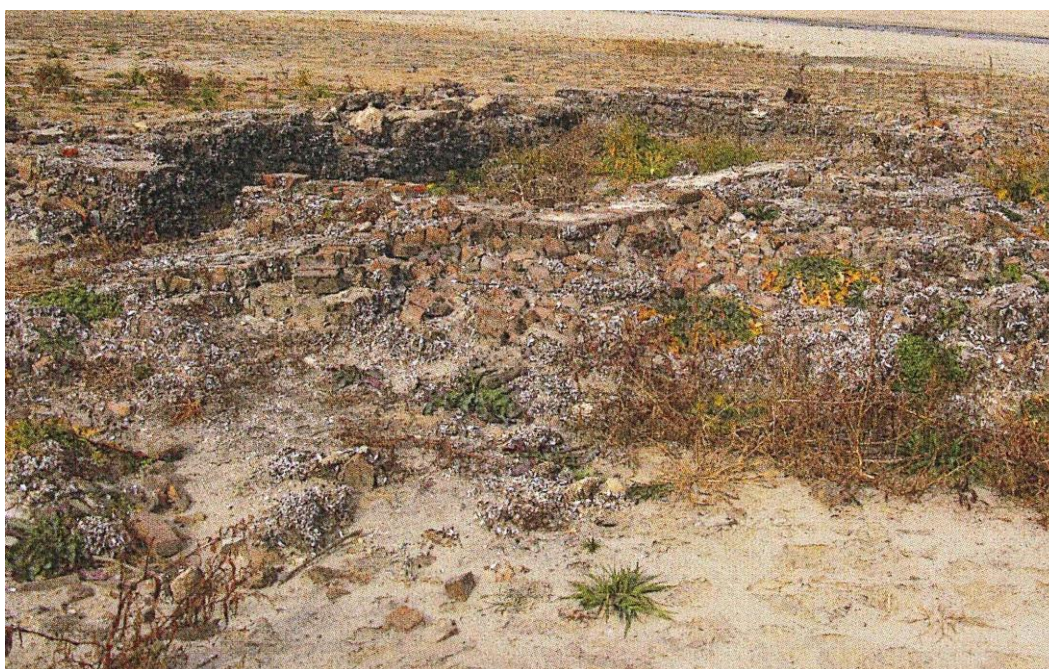
Plate 17. Exposed Building Foundation at 13DW125. (Reproduced from Finn and Morrow 2010).

Site 13DW125 was identified by WVA in the fall of 2010 based on the discovery of a square stone-foundation with brick-wall superstructure. The foundation appeared to have been exposed by floodwaters that scoured overlying sediments from the area. The stone foundation was constructed with cut blocks of

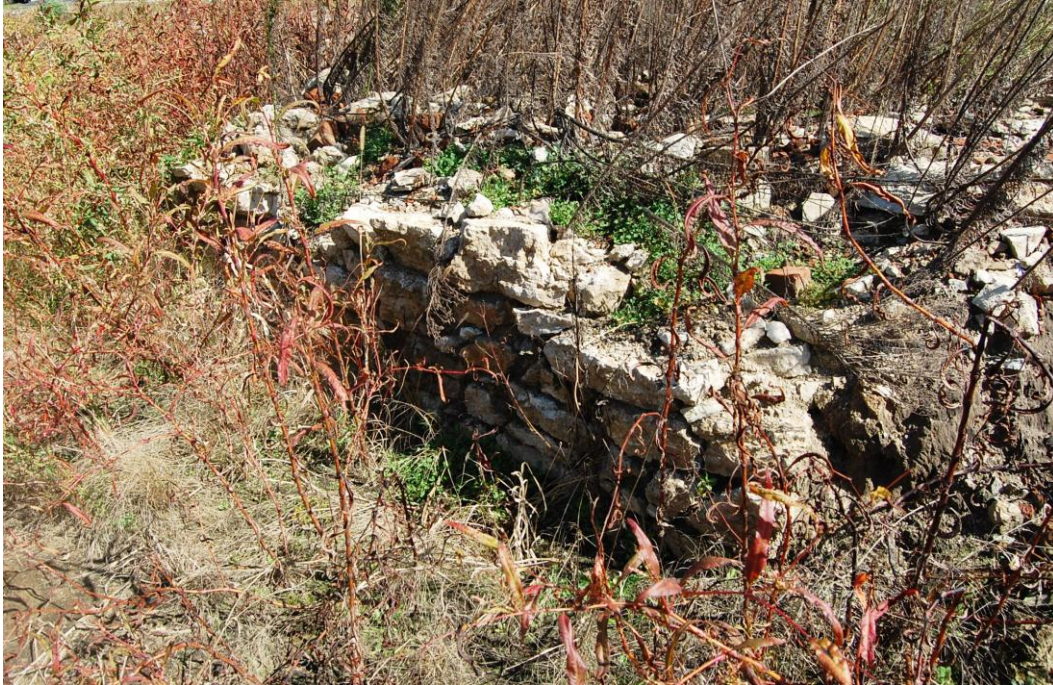
The building's position on the north bank of the river close to the former mill dam at Hartwick, its proximity and orientation to the river, its overall size and its thick-walled foundation suggests that it could be Hartwick's very first building, i.e., John Clark's saw mill built in 1849. The interior of the foundation appears to be filled with rubble and demolition debris suggesting that excavation of the interior may yield materials that could be used to determine its historic use and purpose.

Plate 20. Stone Foundation at Site 13DW136. View of the west wall.

No test excavations have been performed at this location and the site remains unevaluated for listing in the NRHP. Based on the historic background research completed for this report and the information gathered about the building's foundation, LBG recommends that additional archaeological investigations be conducted to determine if the structure has potential to be identified as the saw mill built by John Clark and later operated by the Furman family. These investigations should begin with more comprehensive archival research and interviews with local residents who may be knowledgeable about the early history of the Hartwick area. There may be historic photographs of the original mill complex that could be useful in making this determination without additional archaeological testing. If no conclusive evidence is found, then subsurface investigations both within and outside the foundation should be performed to

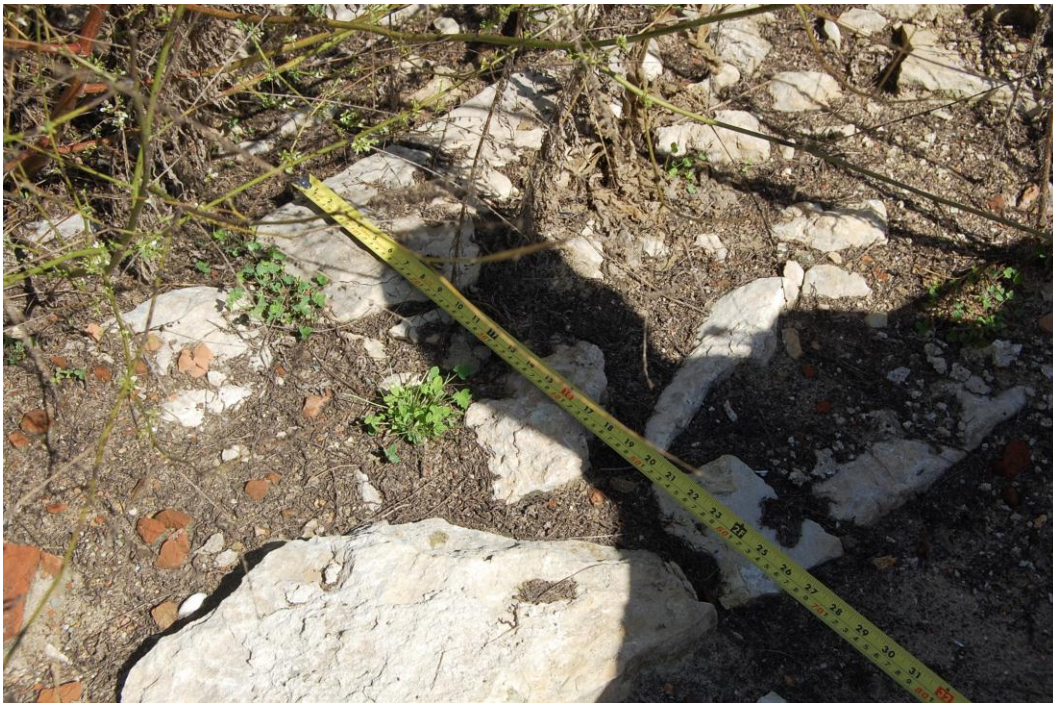
Plate 21. Plan View of the South Foundation Wall at Site 13DW136.
